## 5.4 Industry Standard Nondestructive Evaluations

## 6 Destructive Validation of Nozzle 63

## 7 Correlation of Ultrasonic and Destructive Results

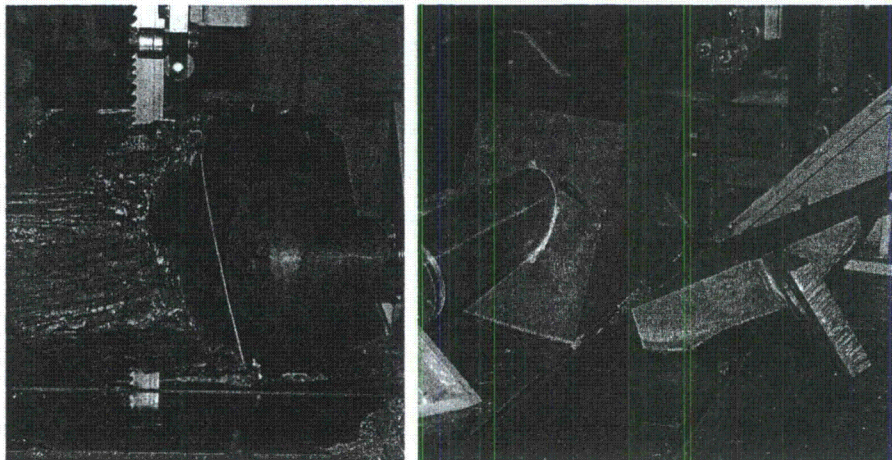
**Figure 6.2 Size Reduction Cutting Activity**

The initial size reduction cuts were performed on the Nozzle 63 specimen using one of the coarse toothed blades prior to the arrival of PNNL staff. Non-essential material was removed to reduce weight and to facilitate proper blade placement on the specimen during critical cuts. Figure 6.2 shows images from the size reduction activity.

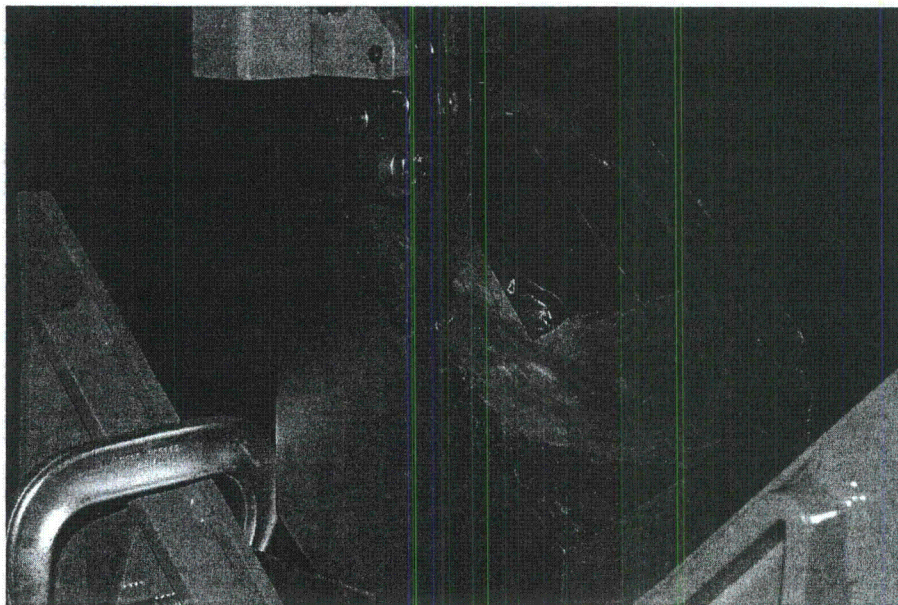
**Figure 6.3 Start of the Dissection Cut**

After size reduction, the nozzle assembly was prepared for the dissection cut that separated the high and low sides of the assembly. The cut line was selected to start at approximately the 95-degree mark (Figure 6.3), and follow through to the 275-degree mark. The line placement was based on the ultrasonic data and chosen to preserve the primary leak path previously identified in the ultrasonic images.

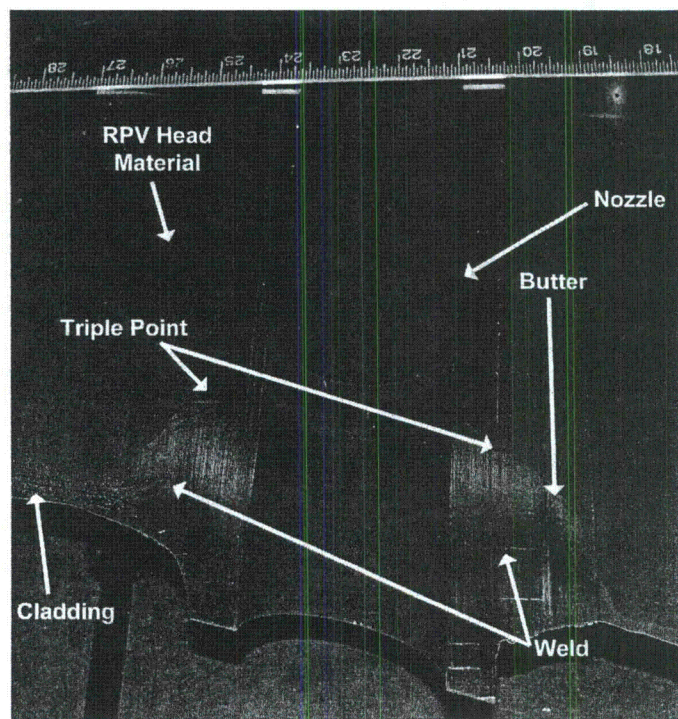
**Figure 6.5 Nozzle 63 Assembly Cut in Half by Dissection Cut**

After cutting through the first side of the nozzle, the carbide blade was exchanged with the fine-toothed cutting blade and the dissection cutting continued. Another hard spot was incurred in the J-groove weld region. Again, the carbide blade was used to cut through the hard spot with a slow feed rate. Finally, the fine-toothed blade was re-engaged and the dissection cut completed. From the exposed surfaces, the triple point was identified along with the weld and butter regions as shown in Figure 6.5.

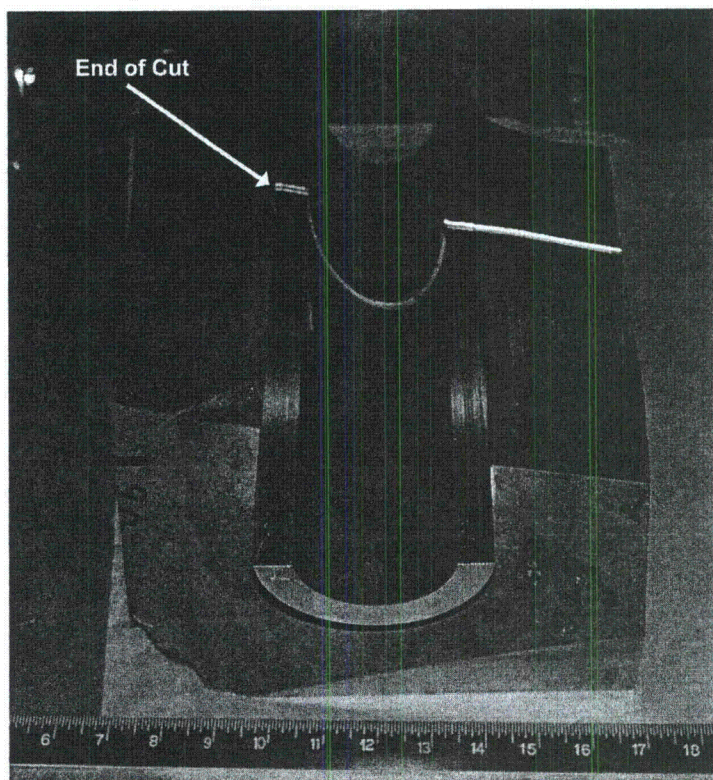
Figure 6.9 End of J-groove Weld Removal Cut

The cutting continued until the entire nozzle was separated from the J-groove weld region as pictured in Figure 6.9. At this point, the nozzle region above the weld was freely released from the RPV head material. Removal of the nozzle exposed the annulus region of the high-side section as shown in Figure 6.10. At this point all available blades were exhausted. Replacement blades were ordered to finish the cut and complete removal of the J-groove weld region. A Nikon D40x camera was used to acquire high-resolution photographic documentation of the annulus region. This activity was provided by B&W. A subsequent cut was conducted on the low-side section to expose its annulus region containing the primary leak path (Figure 6.11). The nozzle freely released from this portion as well.

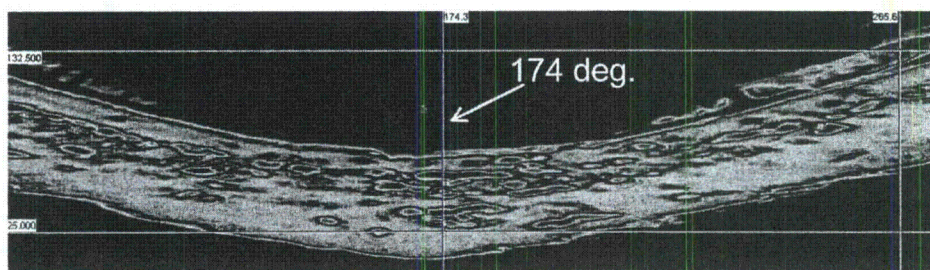
The ultrasonic indications were evaluated for flaw-depth position or distance into the weld material, and all responses appeared to be at or just below the surface with the surface representing the Alloy 600 tube-to-weld or butter interface. Figure 8.4 shows the composite top view of the downhill half of the weld with a vertical line drawn through the 174-degree position. A single plane or slice of data taken at the 174-degree position is displayed in Figure 8.5 and this figure represents a B-scan side view of the data. The horizontal axis in the side-view image represents depth or distance into the material. The first and second ultrasonic echoes are noted and represent reflections from the tube-to-weld interface. The scanner index or nozzle axis is shown in the vertical direction. The profile shape follows the front surface or inside of tube profile displayed in Figure 8.6. The distortion or deviation from vertical is due to the weld heating and subsequent cooling in the material and was measured at approximately 2 mm (0.08 in.). The distortion is magnified in the image due to the velocity difference between water and the Alloy 600 tube. Water velocity is nearly four times slower than the metal, assuming a water velocity of 1483 m/sec (58.4 in./msec) and 5820 m/sec (229.1 in./msec) for the metal. The side-view plots (Figures 8.5, 8.6, and 8.8) display the horizontal axis in units of distance

**Figure 8.4** Location of Single Slice Shown in Figure 8.5. The horizontal axis represents 180 degrees approximately and the vertical axis 145 mm (5.7 in.).

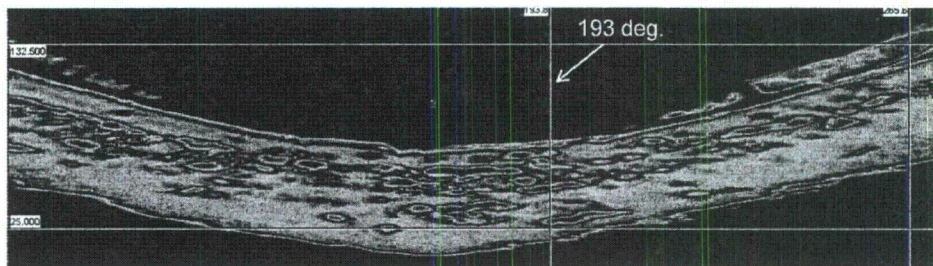
**Figure 8.7 Location of Single Slice Shown in Figure 8.8**

The weld region was evaluated for anomalies throughout the full 360-degree circumference. The indications fell along the Alloy 600 tube-to-weld interface at all but one circumferential position. At the 193-degrees position as noted in Figure 8.7, an indication appeared earlier in time than the other indications. The corresponding B-scan side view is shown in Figure 8.8 with the early indication circled. This earlier indication would plot into the tube material and could possibly be from a gouge in the tube and improper or no weld fill or repair. The indication displacement is shallow at approximately 1 mm (0.04 in.) in depth. No indications of circumferential cracking across or along weld beads were detected.

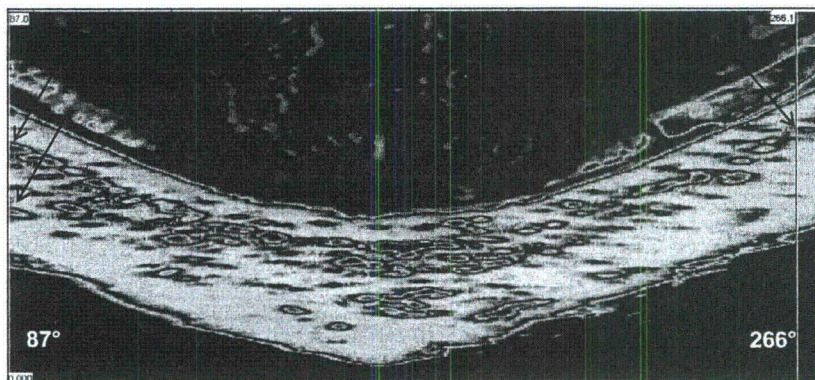
A comparison between the cut surface and ultrasonic data was made. It was observed that the 180-degree or low point on the weld was found to be located at 171 degrees in the ultrasonic image. Therefore, the ultrasonic data was shifted by 9 degrees to account for this offset. By this reasoning, the 95-degree cut surface corresponds to the 86-degree position in the ultrasonic data and the 275 cut surface corresponds to the 266-degree position ultrasonically. Again, note that these positions and the positions of the cut surfaces are estimated. The corresponding ultrasonic positions are noted in the ultrasonic C-scan top view image in Figure 8.11 with the left red vertical line at 87 degrees (on the left edge of the image) and the right blue vertical line at 266 degrees. The image did not extend to the 86-degree position so the 87-degree position is noted instead. The two indications marked by arrows at the 87-degree position in Figure 8.11 correlate to the two indications noted in Figure 8.10. An indication is also marked on the right side at the 266-degree position.

Figure 8.11 C-scan Top View of the Downhill Section of the Weld with the Left Edge Red Line and Right Side Blue Line Slicing through the Image at Locations Corresponding to the Cut Surfaces in Figure 8.9. The horizontal axis represents 180 degrees and the vertical axis 155 mm (6.1 in.) approximately.

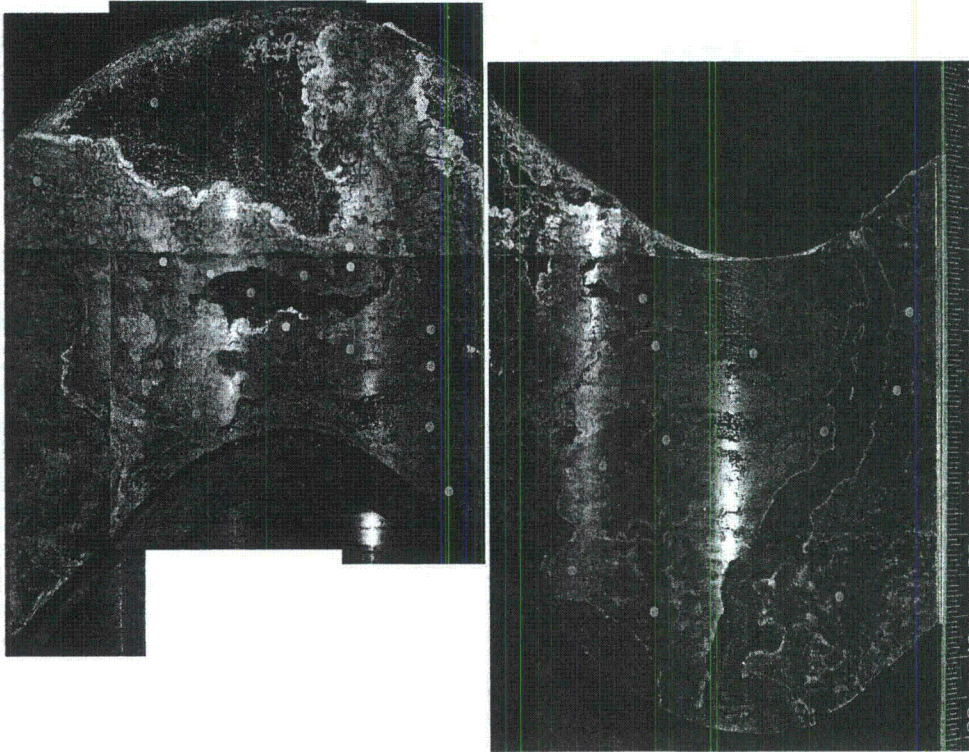
The red dots were selected to represent the main leak path and other partial leak paths or bare metal regions. Lastly, the yellow dots were additional data points chosen for further clarification, such as the two pairs on either side of the uphill interference fit.

**Figure 9.1** Photograph of the RPV Head Material with Boric Acid Measurement Points

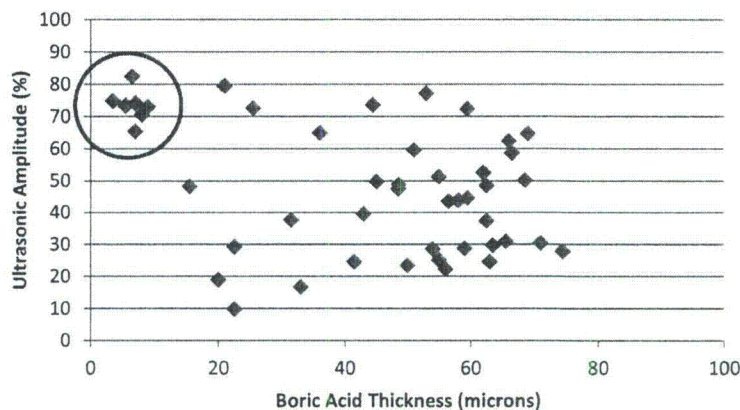
The relationship, if any, between the ultrasonic response values and boric acid values are displayed in graphical form in Figures 9.4 and 9.5. In the first graph, shown in Figure 9.4, the ultrasonic data are displayed as a function of the boric acid values for measurement points in the interference fit region. The points circled in the upper left corner represent bare metal or nearly bare metal points and point from the leak path. These points cluster separately from the remaining data and have ultrasonic values greater than 65% of full screen height and coating layer values less than or equal to 9 microns (0.35 mils). Furthermore, these points represent a strong ultrasonic response such as one associated with a reflection from a gap or void in the interference fit region. There was not close contact between the Alloy 600 tube outer diameter (OD) and the RPV head inner diameter (ID) materials at these locations and minimal or no boric acid or corrosion products were present. The points outside of the circled region represent the rest of the data and show no correlation between the ultrasonic response and the boric acid or coating thickness. The region is, however, bounded by boric acid deposits in the 16 to 75 micron (0.63 to 3.0 mils) range, while the ultrasonic responses almost cover the full range, spanning from 10 to 80% of full screen height.

**Figure 9.4** Ultrasonic Amplitude as a Function of Boric Acid Thickness from Points in the Interference Fit Region

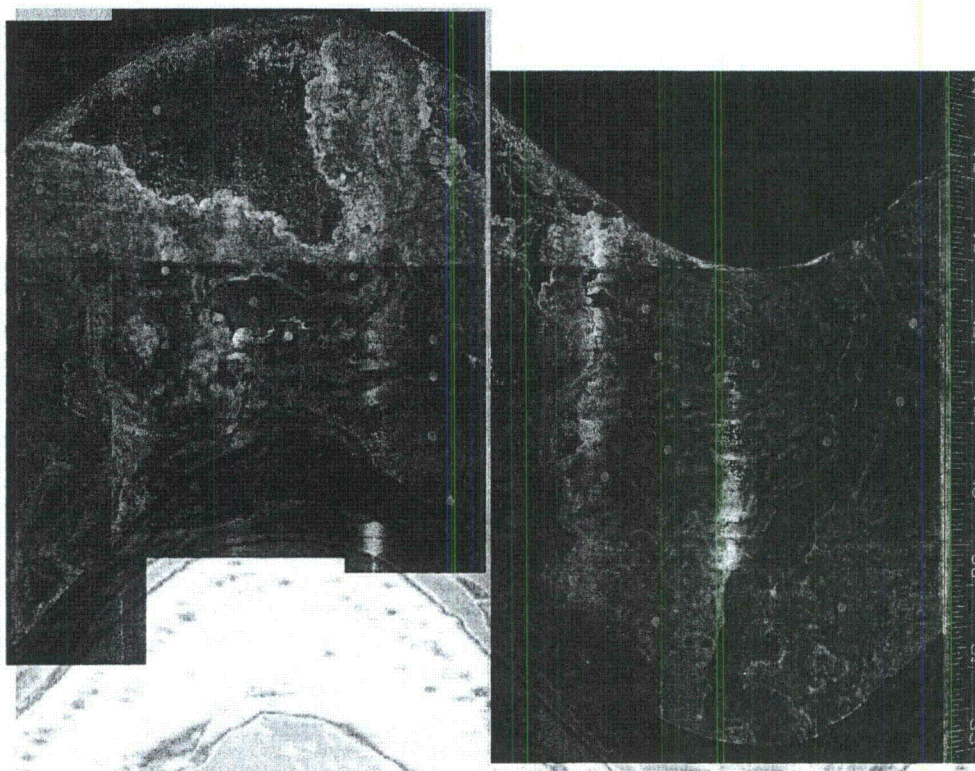
**Figure 9.6 Overlay of Ultrasonic Image on the 70 Measurements Points**

Attempts to correlate the ultrasonic data to the RPV head boric acid data are again simplistic. The ultrasonic responses were sensitive to the entire interaction at the Alloy 600 tube-to-steel RPV head interface including metal-to-metal contact or lack of contact, boric acid and corrosion product presence, and the density of these materials. The earlier proposed tri-level segmentation of ultrasonic responses based on the mockup specimen was inadequate. It was proposed from the ideally machined mockup with well-mated surfaces. In an actual nozzle, the contact area could be as low as 5% at operating temperatures due to out-of-roundness, not straight components, and surface roughness (Hunt and Fleming 2002). Furthermore, the mockup did not contain a counter bore region. Less-than-perfect data registration also likely contributed to error in the correlation between the ultrasonic and boric acid values. The ultrasonic images show large variations between points located in close proximity to each other. Small positional errors in the boric acid measurement could have led to an incorrect matching of the data. An overlay of the ultrasonic data on the RPV head with the 70 measurement points is shown in Figure 9.6 with the multilevel color scheme for reference. The ultrasonic responses in the leak path and bare metal regions are greater than 65%, while interference fit data are in the 10 to 80% range and counter bore data are in the 48 to 83% range. High values, large

reflectance, indicate an interface with a large impedance mismatch such as metal to air. Low values indicate good transmission at the interface due to similar materials tightly bonded. Bare metal and leak path points show large ultrasonic reflectance with a minimal corrosion layer. These data points cluster well. The interference fit data does not. Approximately two-thirds of the interference fit ultrasonic data are below the 50% response level and cluster with boric acid values in the 16 to 75 micron range (0.63 to 3.0 mils). The remaining one-third of the ultrasonic data has response levels in common with the counter bore data. Because a full investigation of the multiple factors affecting the ultrasonic responses was beyond the scope of this project, the data are at best bounded but do not show a direct correlation to the boric acid measurements on the RPV head.

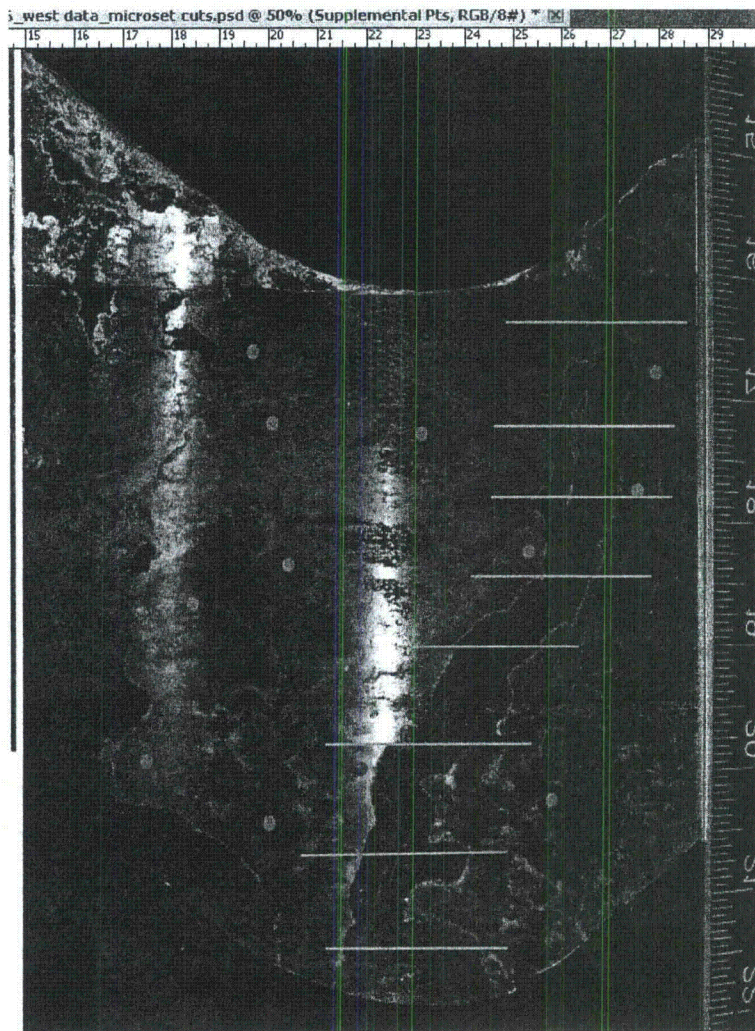
Confirmatory boric acid measurements were also visually made on Microset replicas of the RPV annulus in the main leak path region. This replicating material has better than 0.1 micron (0.004 mils) resolution. Eight areas of interest across the main leak path, as shown in Figure 9.7, were selected for these additional and confirmatory measurements. The sliced and annotated replica is shown in Figure 9.8. Boric acid measurements were made on the edges of the slices with the white arrows showing the cut surfaces that were measured. Several of the measurement values obtained by these surface cross sections were compared to the thickness gage measurements. While only a few data points were compared and these occurred at thicknesses of approximately 40 and 175 microns, the data showed good agreement as Figure 9.9 shows. Ideally, comparisons in the middle of this range, nominally 120 microns, would have been made as well. However, for this best-effort work, several measurements were validated.

Figure 9.7 Eight Areas Selected for Boric Acid Thickness Measurements on Cross-Sectional Slices of Microset Replica

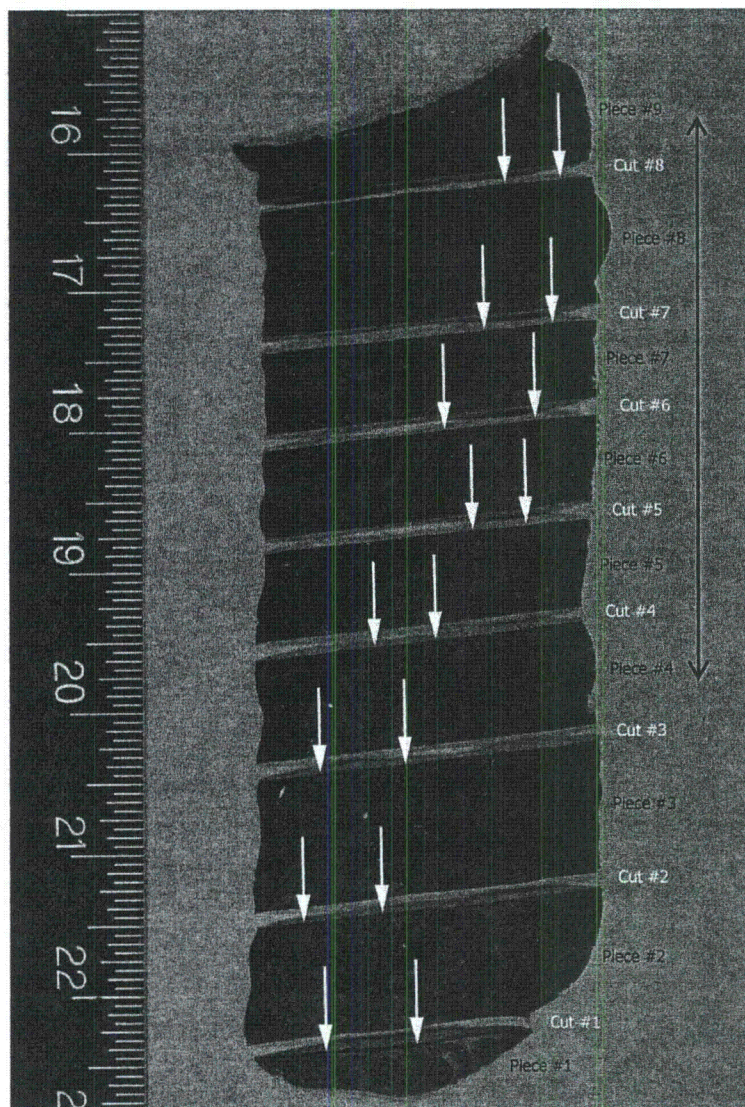
Lastly the replicated surfaces from Figure 9.8 were viewed with a stereomicroscope to better document the surface conditions and to attempt to quantify the corrosion or erosion of the low-alloy steel in the annulus region. Machining marks were observed on the replicated surfaces indicating minimal corrosion, erosion, or wastage throughout the leak path region. Interesting areas are discussed.

**Figure 9.8** Leak Path Replica with Cuts and Pieces Identified. The interference fit region is noted with the black line and is contained in pieces 4 through 9.
