SUBJECT: Review of Draft NUREG/CR – XXXX Entitled, "Ultrasonic Phased Array Assessment of the Interference Fit and Leak Path of the North Anna Unit 2 Control Rod Drive Mechanism Nozzle 63 with Destructive Validation"

**Ultrasonic Phased Array  
Assessment of the Interference  
Fit and Leak Path of the  
North Anna Unit 2 Control Rod  
Drive Mechanism Nozzle 63 with  
Destructive Validation**

NUREG/CR-XXXX  
PNNL-XXXXX

Manuscript Completed: February 2012

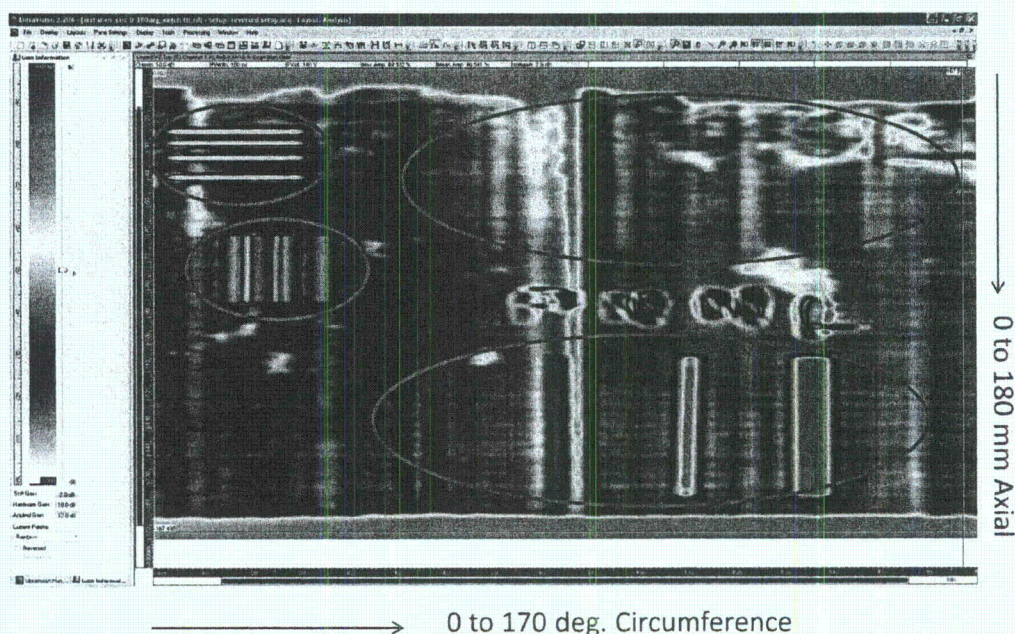
The machined notches in the Alloy 600 tube of the CRDM nozzle mockup simulated potential cracks or degradation of the nozzle penetration. The notched area shown in Figure 4.4 was scanned over approximately a 0 to 170 degree range in the circumferential direction (horizontal axis) and 0 to 180 mm (7.1 in.) in the axial direction (vertical axis) with the data image shown in Figure 4.10. This top view, plan view, or C-scan image shows the resolution notches in the upper-left portion of the image. The variable depth and width notches are also seen as well as the letters "PNNL." The color scale is displayed on the left with lowest amplitudes at the bottom represented by white and the highest amplitude at the top of the color bar represented by red. In this pulse-echo data, the low amplitude signals (blue and green) indicate good transmission or low reflection of the ultrasonic energy at the interface of the tube to the carbon steel. Conversely, the high-amplitude signals (yellow and red) represent poor transmission or large

**Figure 4.10 Top View, Plan View, or C-scan Ultrasonic Image of the Upper Interference Fit Region Containing Calibration Notches in the Alloy 600 Tube. Calibration notches are circled.**

The set of notches in the upper right portion of the scanned image in Figure 4.10 varied in depth but had constant width. These very shallow notches were recognized because their shape and location were known, but they could have been missed based on amplitude response alone. Machining marks on the tube as well as variations in the interference fit produced a non-uniform background response for the fit region, complicating the detection. The center-to-center separations of these notches as ultrasonically measured were 23.84, 24.29, and 23.61 mm (0.939, 0.956, and 0.930 in.), respectively, whereas the actual spacing was 25.4 mm (1.0 in.) between each notch. Flaw depth information was not discernible in the first interference fit echo, but the second echo gave some indication of a flaw tip as noted by the red arrows in the upper part of Figure 4.13. This image represents the B-scan side view of the data while the lower image is a C-scan top view. A higher inspection frequency could have better resolved the small depth variations in these notches. The current second-echo ultrasonic data showed an approximate depth of 0.15 mm (0.006 in.) for all four notches, whereas the actual depths were 0.028, 0.051, 0.76, and 0.13 mm (0.001, 0.002, 0.003, and 0.005 in.), respectively. While these very shallow notches each presented a discontinuity that was ultrasonically detected, their depths were below the system depth or range resolution. For a greater than 50% bandwidth probe, the range resolution is on the order of one wavelength, which in Alloy 600 is approximately 1.1 mm (0.043 in.) at a 5-MHz inspection frequency.

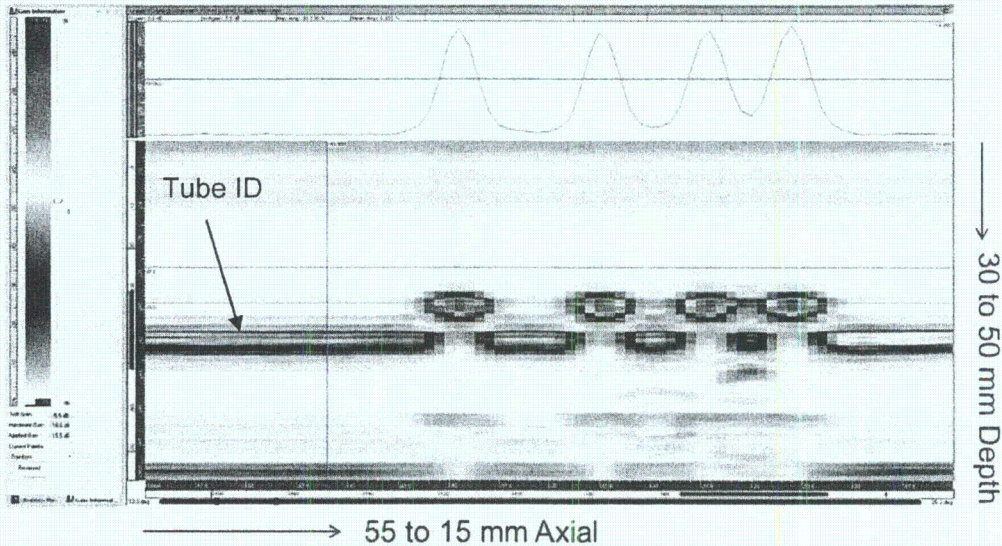
The data analysis software allowed electronic gating of signals in the time or depth dimension as well as positional dimensions Z and theta (axial and circumferential, respectively). The axial resolution notches were first gated or selected for analysis. An enlarged D-scan end view, as depicted in Figure 4.11 was used to measure the center-to-center spacing of the notches. This image was taken as viewed from the left edge of the image in Figure 4.10 and depicts depth into the material (along the sound path) in the vertical axis and the scanner index or nozzle axial direction in the horizontal axis. From this end view, an “echodynamic” curve or profile was generated along the red horizontal line drawn through the responses from the notches, and was plotted above the image. The measured notch widths, from left to right, as measured at the half-amplitude points, were 2.0, 2.0, 2.5, and 2.5 mm (0.08, 0.08, 0.10, and 0.10 in.), respectively. This represents only 4 or 5 pixels with each pixel equal to 0.5 mm (0.02 in.). The actual notch widths were 2.08, 2.06, 2.16, and 2.11 mm (0.082, 0.081, 0.085, and 0.083 in.), respectively. Notch depths were measured as 2.06, 2.06, 2.03, and 2.03 mm (0.081, 0.081, 0.080, and 0.080 in.), respectively. Actual depths were 2.06, 1.95, 2.00, and 2.00 mm (0.081, 0.077, 0.079, and 0.079 in.), respectively. The data suggested that cracks as small as approximately 1 mm (0.04 in.) in depth could be accurately measured. Also, the notches could be clearly distinguished from each other, providing an indication of lateral probe resolution in the nozzle axial direction. In this set of notches, the actual center-to-center separations were 7.11,

5.08, and 4.06 mm (0.28, 0.20, and 0.16 in.), respectively. The measurements from the ultrasonic data gave separations of 7.0, 5.5, and 4.0 mm (0.28, 0.22, and 0.16 in.), respectively. These highly correlated data values and the data image indicated that an axial resolution of better than 4.0-mm (0.16-in.) was achievable.

**Figure 4.11 D-scan End View of the Axial Resolution Notches in the Inconel Tube**

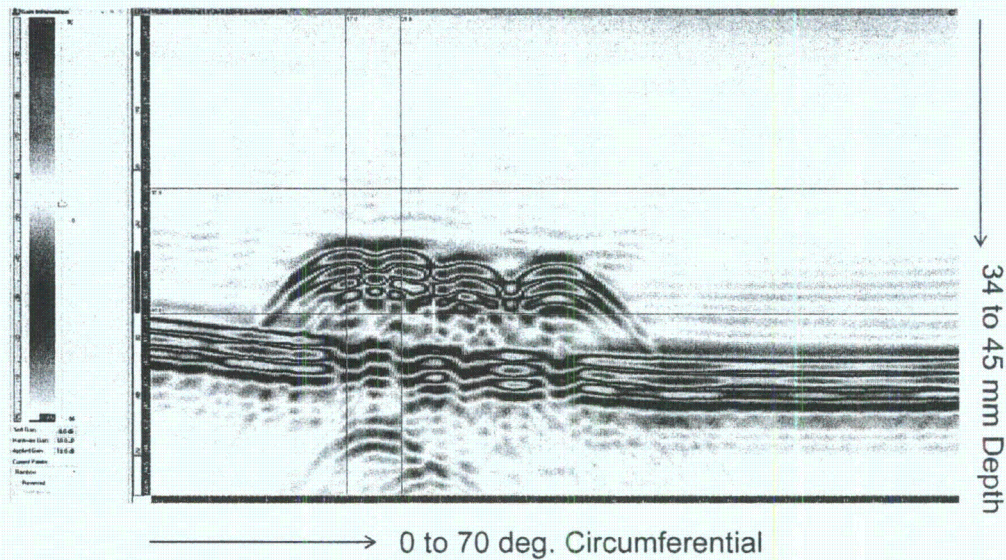
The gated circumferential resolution notch set is shown in Figure 4.12. This image was taken as viewed from the bottom edge in Figure 4.10. Notice that the closely spaced two notches on the left are overlapping but they are still resolvable. Peak-to-peak values gave measured notch separations of 4.36, 5.18, and 6.82 mm (0.17, 0.20, and 0.27 in.), respectively. The actual separations were 4.06, 5.08, and 7.11 mm (0.16, 0.20, and 0.28 in.), respectively. This is greater error than was observed for the axial direction. This test demonstrated a circumferential probe resolution of approximately 4.4 mm (0.17 in.).

**Figure 4.12 B-scan Side View of the Circumferential Resolution Notches in the Inconel Tube**

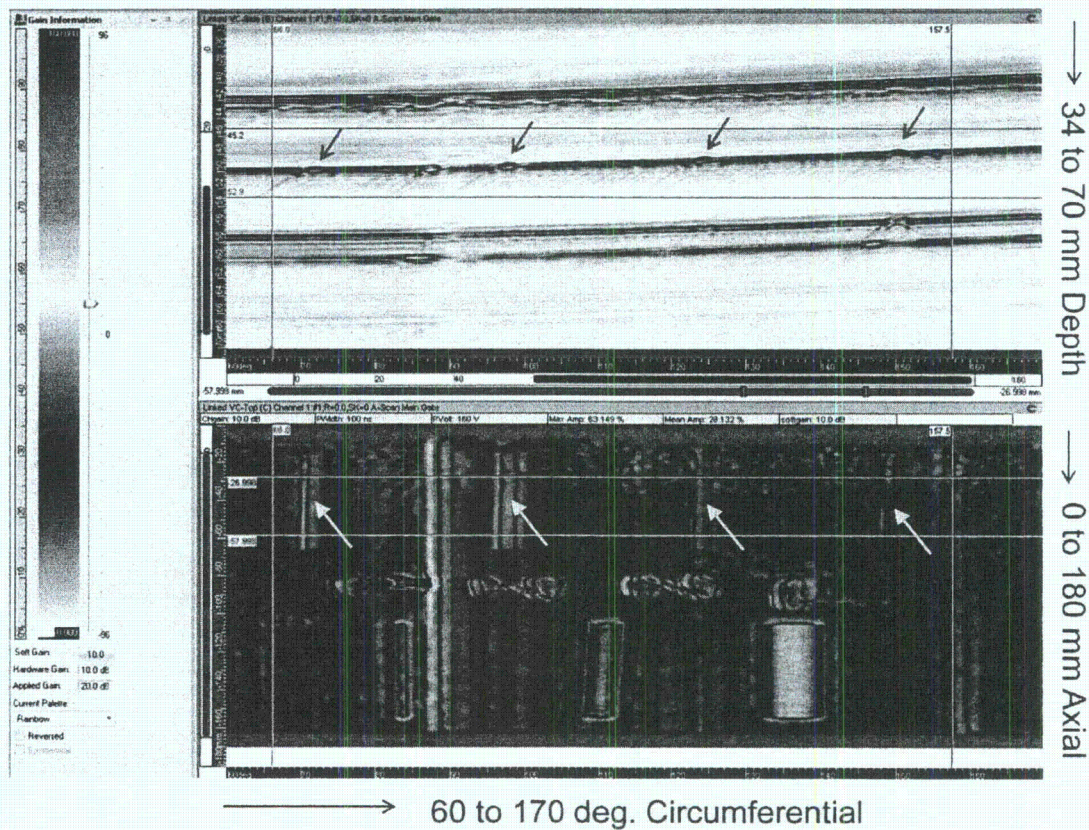
**Figure 4.13** The Second Echo is Gated in the Side View Image in the Top of Figure with the Horizontal Lines. The corresponding C-scan top view is displayed in the bottom image. This second echo captures a disturbance in the back-wall echo showing some depth information, noted by the red arrows at top. The yellow arrows note the depth-varying notches.

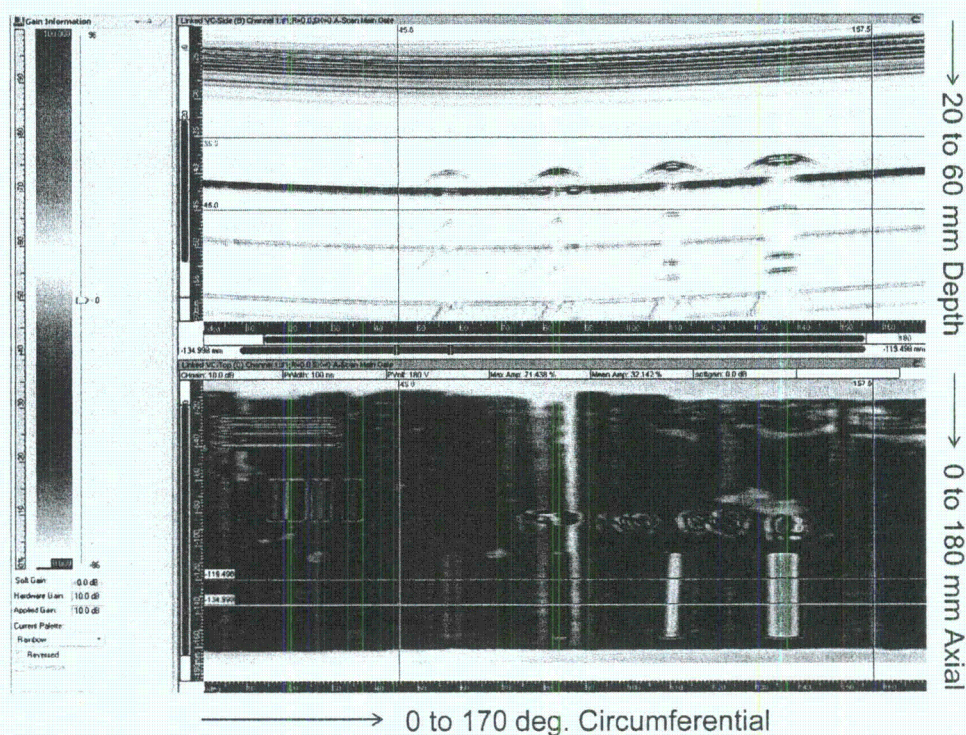
The final set of notches contained width variations and are shown in Figure 4.14. These flaws were ultrasonically measured with depths of 2.2, 2.5, 2.7, and 2.9 mm (0.09, 0.10, 0.11, and 0.11 in.), respectively, left to right in the image, while the actual depth was 2.53 mm (0.10 in.) for all notches. The measured center-to-center spacings were 23.1, 24.8, and 23.8 mm (0.91, 0.98, and 0.94 in.), respectively, while actual spacings were all 24.5 mm (1.00 in.). Finally, the widths of the flaws were measured in two ways. The first method used the width of the upper part of the flaw response, and the second method used the width of the loss of back-wall signal. The loss of back-wall signal technique was more accurate with measured widths of 3.91, 3.36, 5.00, and 8.82 mm (0.099, 0.126, 0.154, and 0.298 in.), respectively. Actual widths were 0.80, 1.61, 3.24, and 6.42 mm (0.031, 0.063, 0.127, and 0.253 in.), respectively. When measured from the second ultrasonic back-wall echo, the loss of signal measurements gave notch widths of 1.36, 2.73, 3.82, and 7.00 mm (0.054, 0.107, 0.150, and 0.276 in.), which were closer to the actual values. The probe spot size when focused at the interference fit, or 15 mm (0.59 in.) into the Alloy 600, was modeled at 1.2 x 1.2 mm (0.047 x 0.047 in.) at the -6 dB points. Flaw width

sizing values are typically oversized by the probe spot size so these measured width values were well within the error expected with this probe.

**Figure 4.14 B-scan Side View on Top and C-scan Plan View on Bottom of the Width Varying Notches in the Inconel Tube**

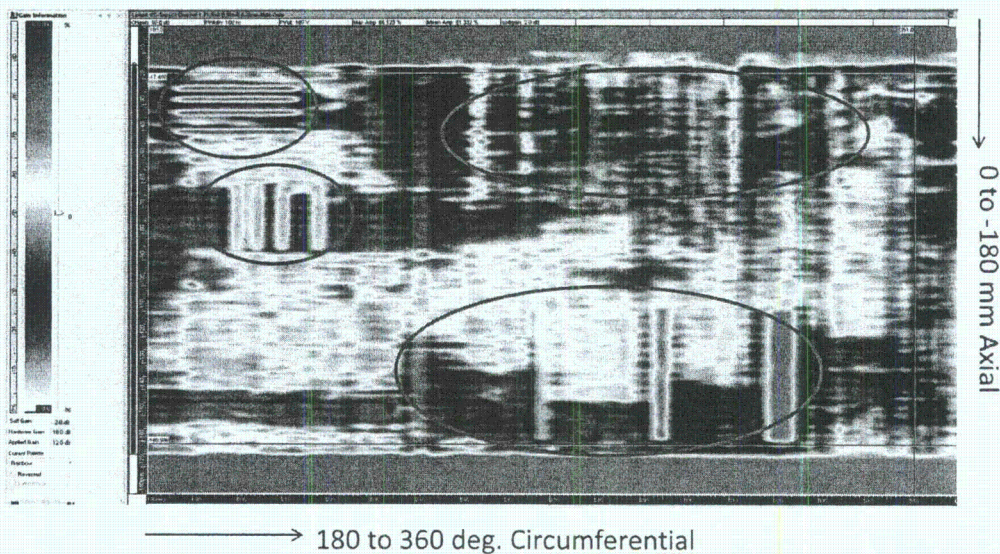
The 180–360 degree portion of the upper fit region in the CRDM mockup contained notches in the carbon steel block to simulate degradation or wastage of the RPV head material. These notches were on the far side of the interference fit relative to the location of the probe. Because the interference fit was not uniform, the notch responses were not as clear as those for notches in the tube, as evident in Figure 4.15.

**Figure 4.15 C-scan Plan View of the Notches in the Carbon Steel from the First Ultrasonic Echo. The calibration notches are circled.**

The axial resolution notches in the top left of the figure were resolved, but the lower notch was on the edge of a high-amplitude region. The measured center-to-center spacings were 3.90, 4.58, and 6.88 mm (0.15, 0.18, and 0.27 in.), respectively, while actual spacings were 4.06, 5.08, and 7.11 mm (0.16, 0.20, and 0.28 in.), respectively. Axial resolution was therefore approximately 4 mm (0.16 in.) or better.

Measurements from the circumferential resolution notch pattern showed center-to-center spacings of 3.82, 5.00, and 7.54 mm (0.15, 0.20, and 0.30 in.), respectively, with actual spacings of 4.06, 5.08, and 7.11 mm (0.16, 0.20, and 0.28 in.). Circumferential resolution was also approximately 4 mm (0.16 in.) or better.

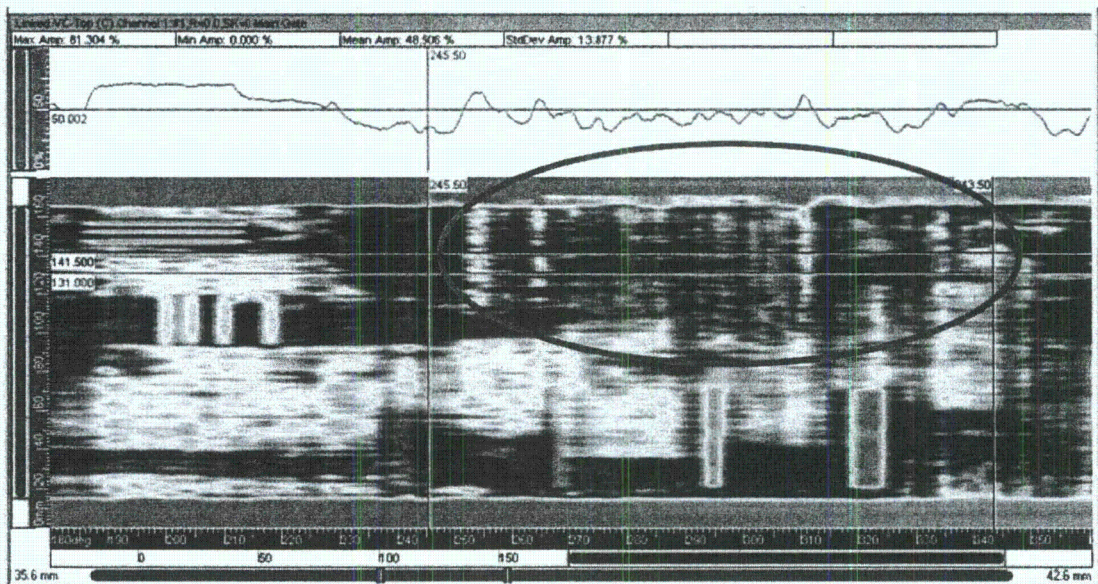
The variable depth notches in the top right of Figure 4.15 were detected but depths could not be measured. First and second echo images are shown in Figures 4.16 and 4.17, respectively. Center-to-center spacing was ultrasonically measured at 23.9, 22.4, and 24.4 mm (0.94, 0.88, and 0.96 in.), respectively, with an actual spacing of 25.4 mm (1.00 in.) for all notches.

Figure 4.16 C-scan Plan View of the Depth Notches in Carbon Steel, Circled on the Upper Right. This image was acquired from the first ultrasonic echo.

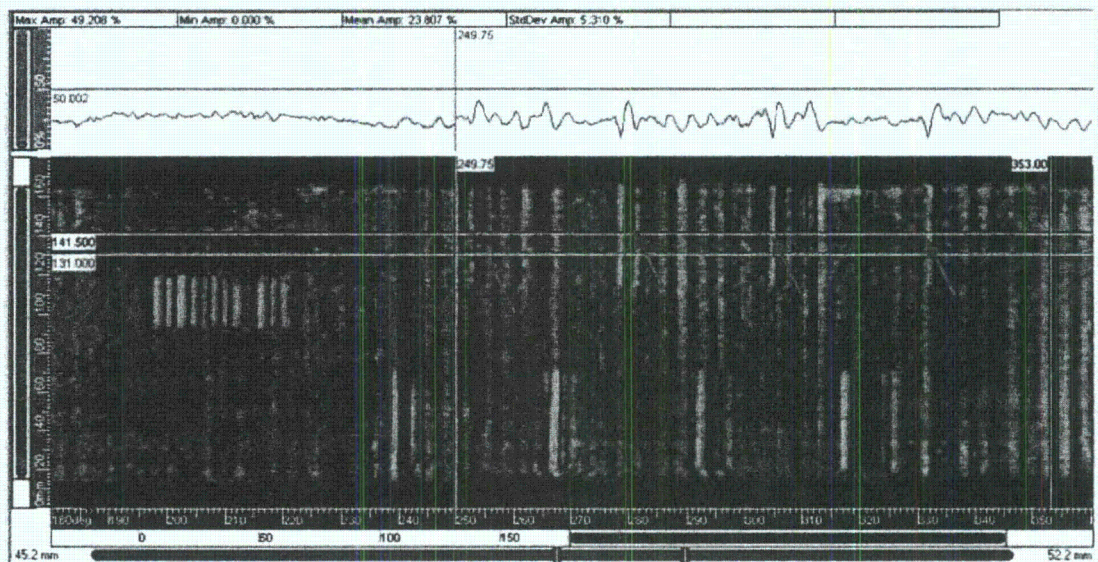
Figure 4.17 C-scan Plan View of the Depth Notches in Carbon Steel, Noted by Red Arrows on the Upper Right. This image was acquired from the second ultrasonic echo.

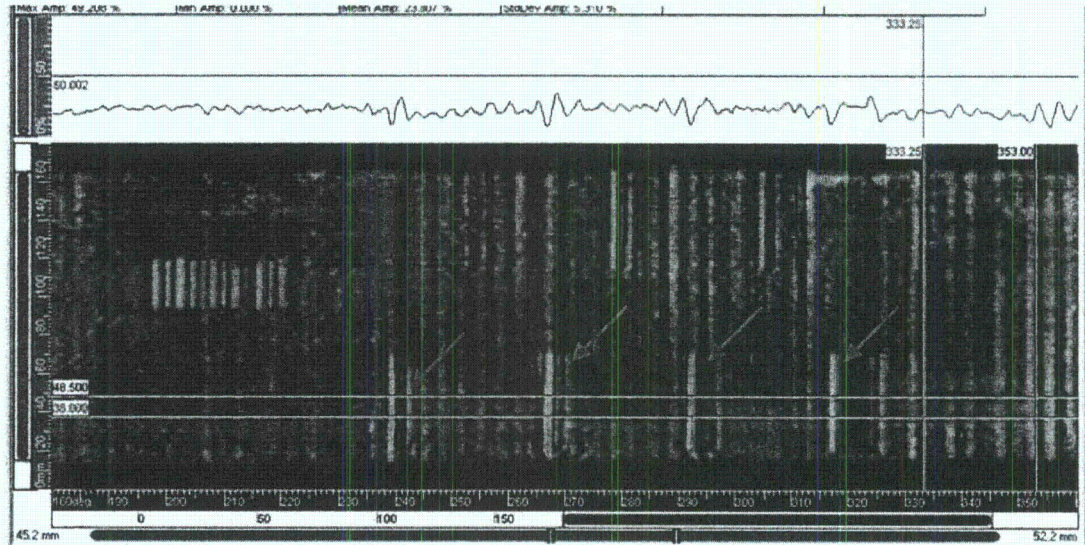
The set of notches with variable widths is shown in Figure 4.18 with the notches marked by red arrows at the bottom of the image. This image represents the second echo. The center-to-center spacing measurements were 25.4, 23.2, and 25.0 mm (1.00, 0.91, and 0.98 in.),

respectively, left to right, with actual spacing of 25.4 mm (1.00 in.). Measured notch width values were 1.82, 2.27, 4.27, and 6.82 mm (0.072, 0.089, 0.168, and 0.268 in.), respectively, with actual values of 0.80, 1.59, 3.18, and 6.39 mm (0.032, 0.062, 0.13, and 0.25 in.), respectively. The notch widths were also measured from the first echo (refer to Figure 4.15, a first ultrasonic echo image) with slightly poorer results.

**Figure 4.18 C-scan Plan View of the Width Notches in Carbon Steel, Noted by Red Arrows on the Bottom. This image was acquired from the second ultrasonic echo.**

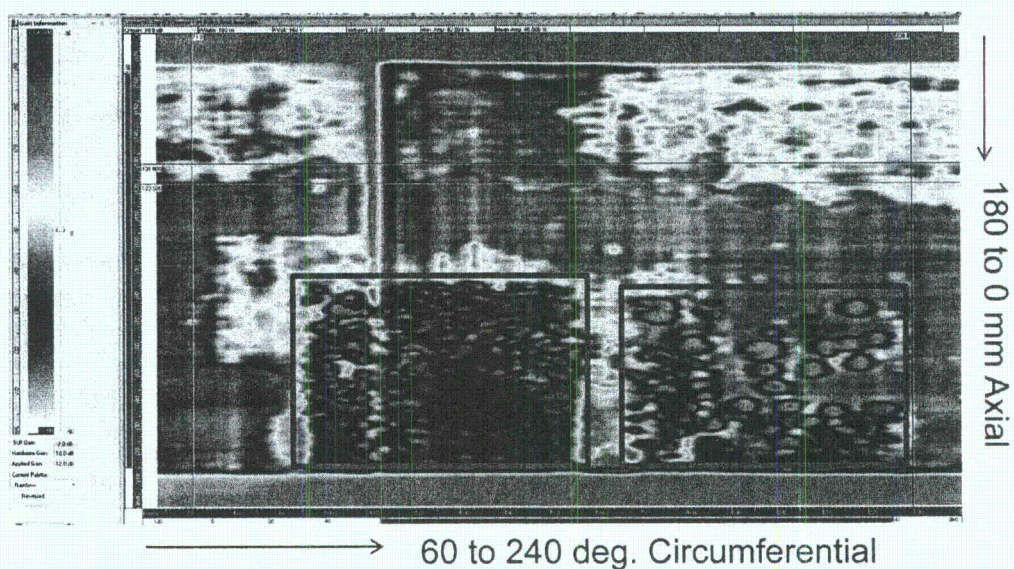
The top view, C-scan images from the mockup with boric acid deposits in the interference fit region are displayed in Figures 4.19 and 4.20. The first image represents the 60 to 240 degree circumferential region and the second image represents the 240 to 60 degree circumferential region, both as captured by the first echo. The boric acid regions were readily detected as lower amplitude response and are outlined with red boxes. Again, notice machining marks and non-uniformity in the interference fit response. The amplitude relevance is discussed in the next section.

Figure 4.19 C-scan Plan View of the Boric Acid Deposits, Boxed in Red, in the Lower Interference Fit Region. The horizontal axis represents the circumferential range of 60–240 degrees. This image is from the first ultrasonic echo.

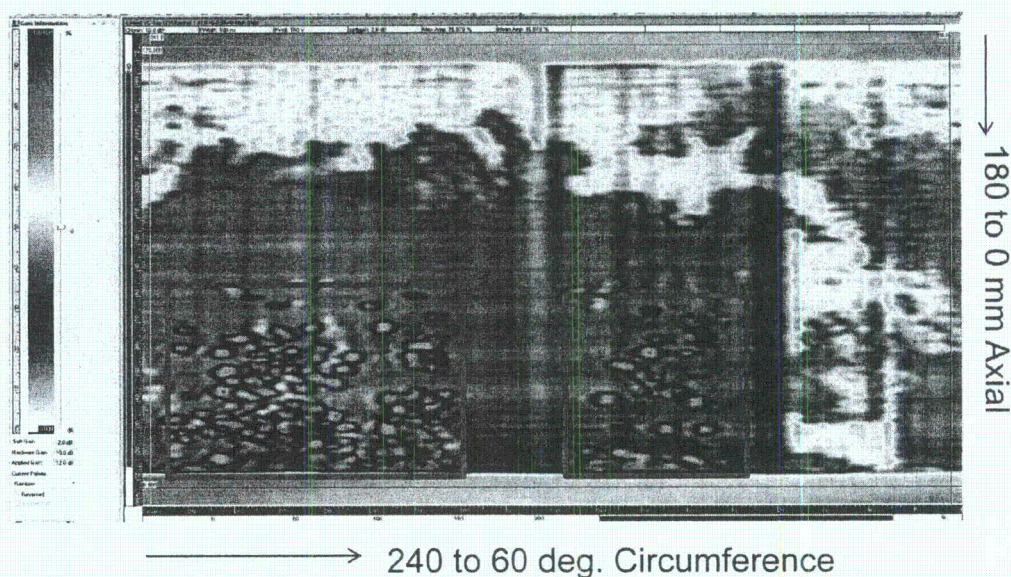
Figure 4.20 C-scan Plan View of the Boric Acid Deposits, Boxed in Red, in the Lower Interference Fit Region. The horizontal axis represents the circumferential range of 240–60 degrees. This image is from the first ultrasonic echo.

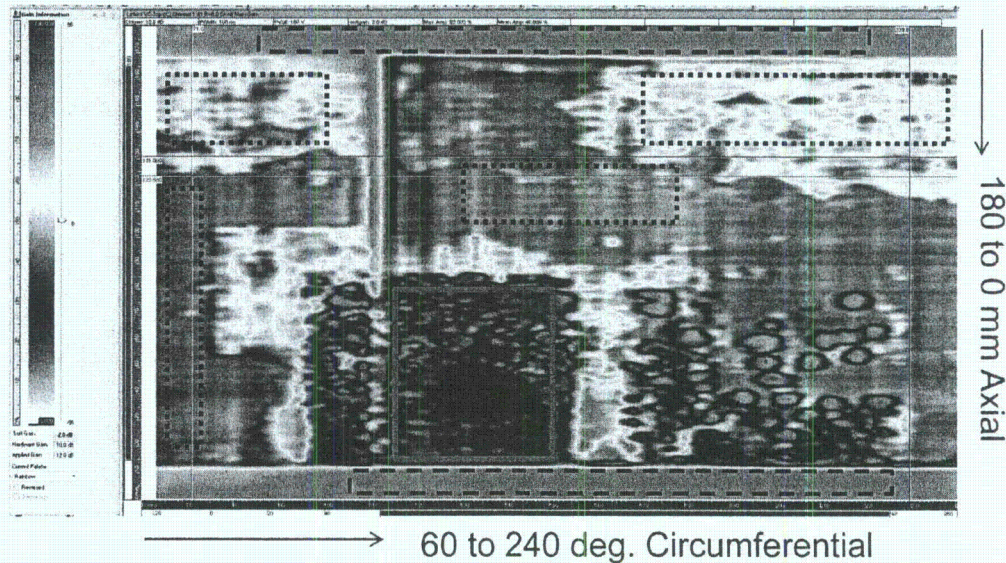
**Figure 4.21 The Interference Fit Region Containing Boric Acid is Subdivided into Three Regions. The red box represents the presence of boric acid in the interference fit region, the black dashed boxes represent the tube region, and the black dotted boxes represent the interference fit region.**

The data images were analyzed with a total image gain of 12 dB. This represented 10 dB of hard gain applied during acquisition and 2 dB of soft gain applied during analysis. The mean responses from the interference fit regions without boric acid deposits were in the range of 40 to 55 percent of full-screen amplitude. This range of values was due to the variability in the fit itself. Some regions of the fit were tight, giving lower reflected amplitude and more transmitted energy. This condition is represented by the green color in the image. Other regions of the fit showed higher reflected energy (not tight), thus less transmitted energy, and this state is represented by the yellow-to-orange colors. Machining marks were evident and also lead to

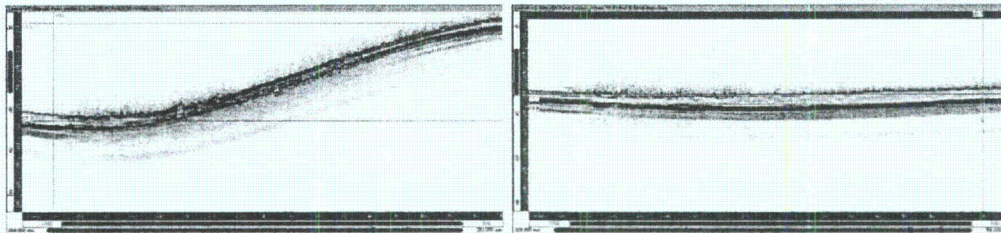
**Figure 5.1 Alloy 600 Tube ID Response Before (left) and After (right) Centering the Scanner on the Nozzle. The horizontal axis represents approximately 180 degree and the vertical axis 20 mm (0.79 in.).**

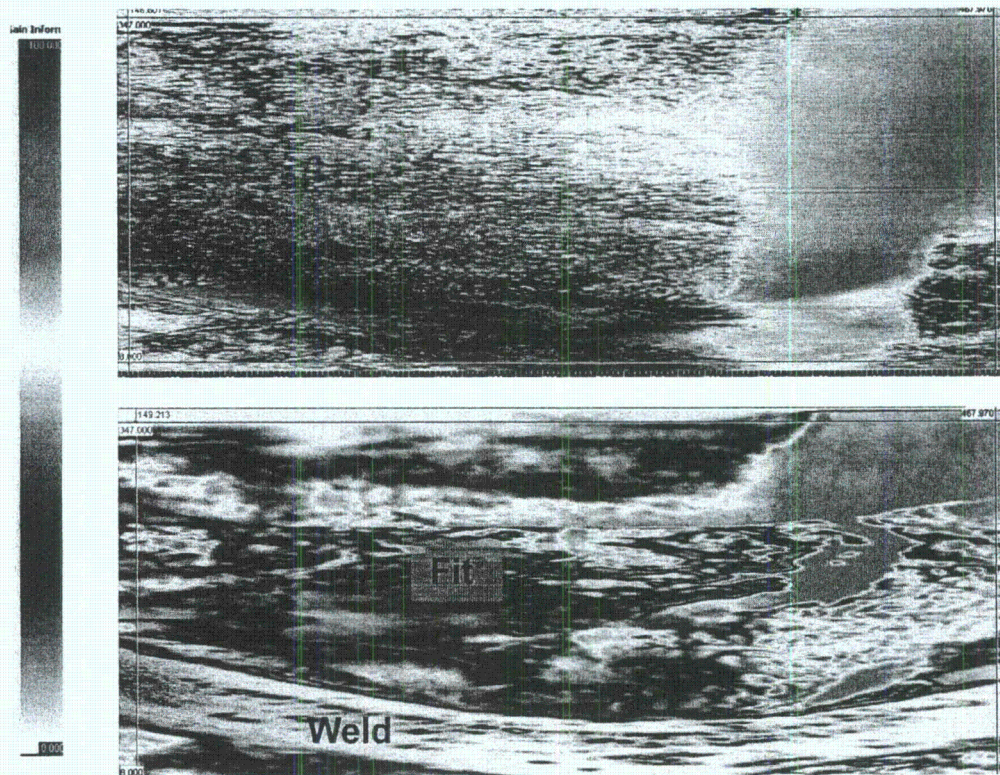
The first data covering the 90 to 270 degree area are shown in Figure 5.2. The front surface echo is displayed on the top and the interference fit echo on the bottom. These C-scan top view images show approximately 180 degrees across the horizontal axis and 360 mm (14.17 in.) on the vertical axis. The color bar on the left shows low-amplitude signals in blue/white, which represent good transmission or poor reflectance. High-amplitude signals in orange/red conversely represent poor transmission and good reflectance. The weld region is shown in the white-to-light-blue color at the bottom of the interference fit image. The interference fit or shrink-fit zone is located between the counter bore regions as was shown in Figure 1.1. The data above the interference fit (dry-side annulus region) represent a tube-to-air interface and should provide a strong and uniform reflection. Such a strong reflection was only evident in the orange-colored regions in the right side of the images. The tube OD-to-air interface is a good reflector, so a uniform orange color would be expected across the top of the image. Therefore, the lack of uniformity across the upper portion of the image (tube OD) was unexpected. The lack of uniformity across the entire front surface echo (upper image in the figure) was also unexpected.

**Figure 5.2 First PA Ultrasonic Data from Nozzle 63. The front surface or nozzle ID echo is on the top and the interference fit echo on the bottom. The horizontal axis represents the 86 to 274 degree area and the vertical axis represents 360 mm (14.17 in.). The color scale is represented on the far left.**

After the first scanning attempt, the probe was lifted above the water line and found to be dirty. The probe face was carefully wiped with a dry cloth. It was also suspected that bubbles on the ID tube surface could be partly responsible for the degraded image. After carefully brushing the inside of the tube several times, a good data set was obtained.

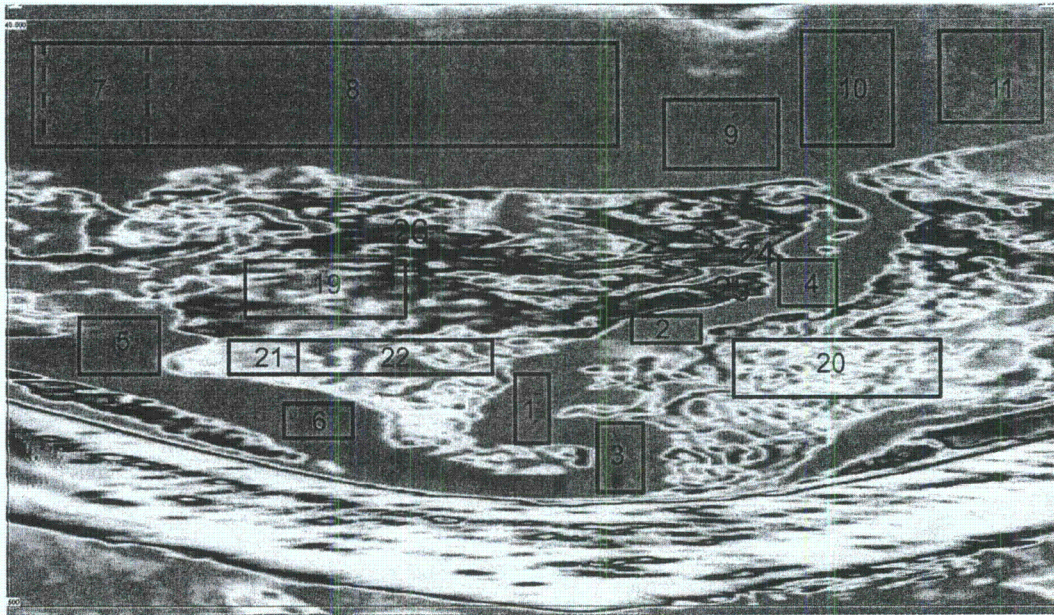
An analysis based on amplitude responses was conducted on the data images. The first such analysis was conducted on the 90 to 270 degree data acquired after the first brushing. The image was segregated into regions as depicted in Figure 5.4. The peak and mean amplitude responses were measured in each boxed region. Regions 1 through 6 are suspected leakage path zones. Regions 7 through 11 represent the response from the tube. The interference fit and lower counter bore areas are represented by regions 19 through 22 while regions 24 through 26 represent the interference fit with suspected boric acid present. The same procedure was used on the -90 to +90 degree data with the boxed regions shown in Figure 5.5. These suggested associations were based on the mockup data results and need to be confirmed by destructive analyses. Next the mean amplitudes within each boxed region were plotted with results in Figure 5.6. The suspected leakage path and tube responses all were in the range of 60 percent of full screen height and greater. At the other extreme, the regions with suspected boric acid deposits had mean amplitudes 25 percent and below. Finally, the interference fit/counter bore region mean amplitudes were in the 41 to 58 percent range. A proposed segregation of the regions is denoted by the orange, green, and blue colored zones in

the plot. A 30 percent mean amplitude or less is thought to indicate the presence of boric acid in the interference fit while greater than 60 percent represents an air gap and possible leakage path if connected all the way through (top to bottom) the interference fit. These results will need to be verified with destructive testing.

**Figure 5.4** Interference Fit Data Image After First Brushing. The horizontal axis represents approximately 90 to 270 degrees. The vertical axis represents 360 mm (14.17 in.). Boxed regions were used in an amplitude analysis.

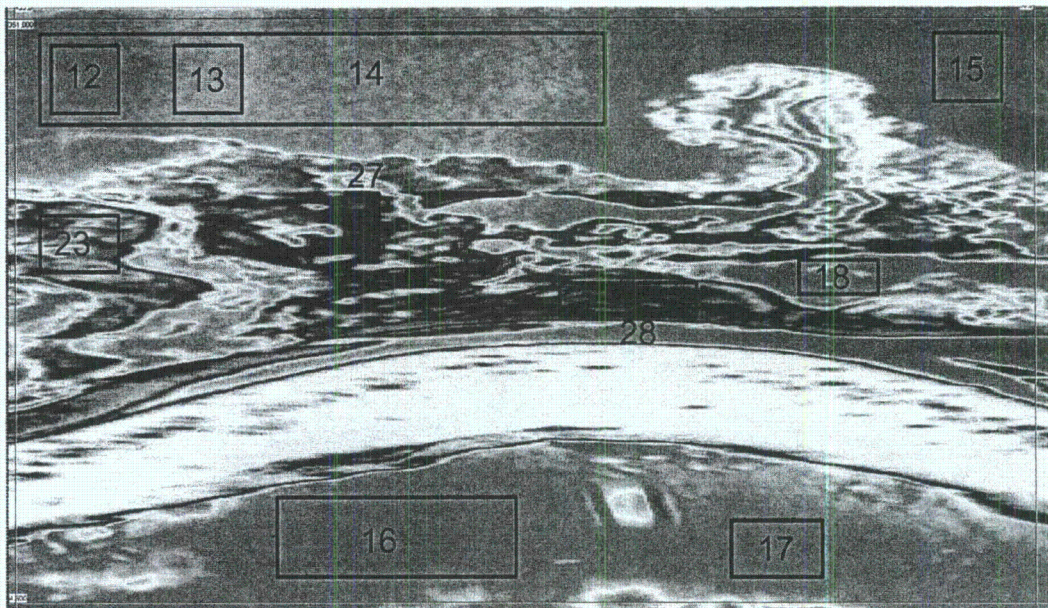
**Figure 5.5 Interference Fit Data Image After First Brushing.** The horizontal axis represents approximately  $-90$  to  $+90$  degrees. The vertical axis represents 360 mm (14.17 in.). Boxed regions were used in an amplitude analysis.

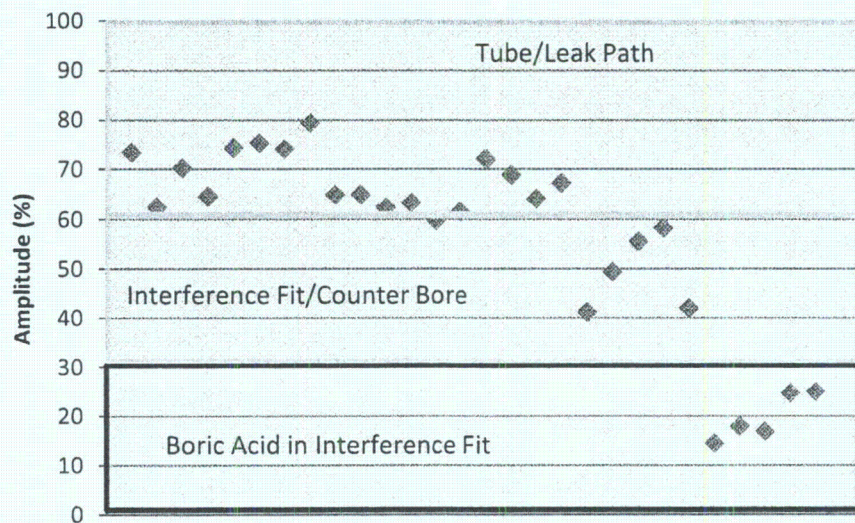
**Figure 5.6 Mean Amplitude Response from the Regions Indicated in Figures 5.4 and 5.5**

In summary, the mean amplitude responses from the different regions in the data image were measured. Based on this analysis, the regions are separable and compare favorably to the responses measured previously on the calibration mockup specimen. A comparison of the responses is presented in Table 5.1. Note that the Nozzle 63 data were acquired with 1 dB

Region	Calibration Mockup	Nozzle 63
Tube/Leak Path	60–75	60–79
Interference Fit/Counter Bore	40–55	41–58
Interference Fit – with Boric Acid	24–30	14–25

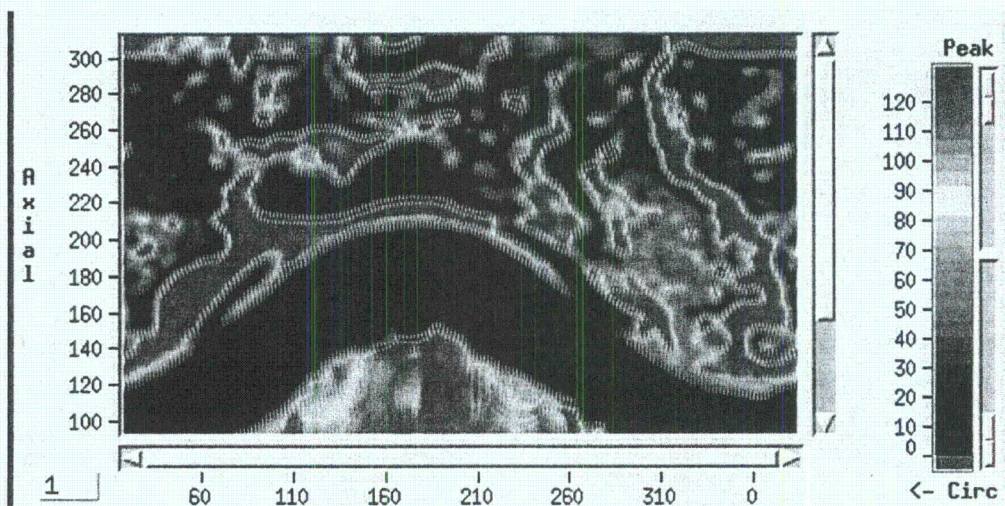
**Figure 5.9** Ultrasonic Data from Nozzle 63 as Obtained by WesDyne International. The image was acquired with a 2.25-MHz probe. The horizontal axis represents the nozzle circumference in units of degrees. The vertical axis represents the nozzle axis in units of millimeters.

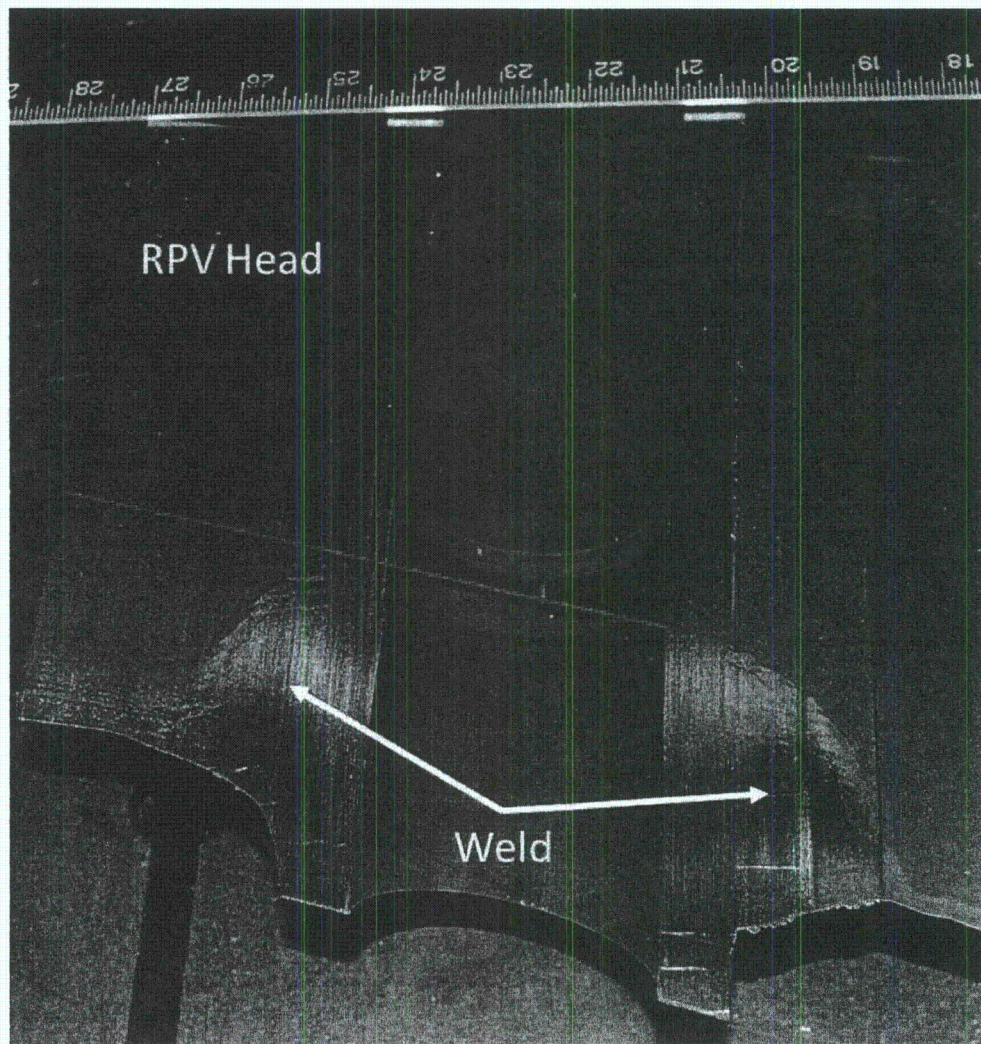
The cut to remove the J-groove weld was made 6.35 mm (0.25 in.) above the butter/triple point region in the reactor pressure vessel (RPV) head as seen in Figure 6.3. The high or uphill side half-portion was selected for the first cutting. As previously stated, the 'high' side has several potential leak paths whereas the 'low' or downhill side had the primary leak path as identified in the ultrasonic data. The specimen was secured and the band saw tilted to an approximate 43-degree angle to match the angle between the nozzle and head. Cutting at this angle maximized the annulus region that was exposed while keeping the weld and butter regions intact for future evaluation. As the cut was designed to pass only through the low-alloy RVH material, the fine toothed cutting blade was selected for use. However, other blades had to be used when cutting difficulties, as detailed in Appendix C, were encountered.

**Figure 6.3 Nozzle 63 Assembly Cut in Half by Dissection Cut. The red line indicates where the weld removal cut was made.**

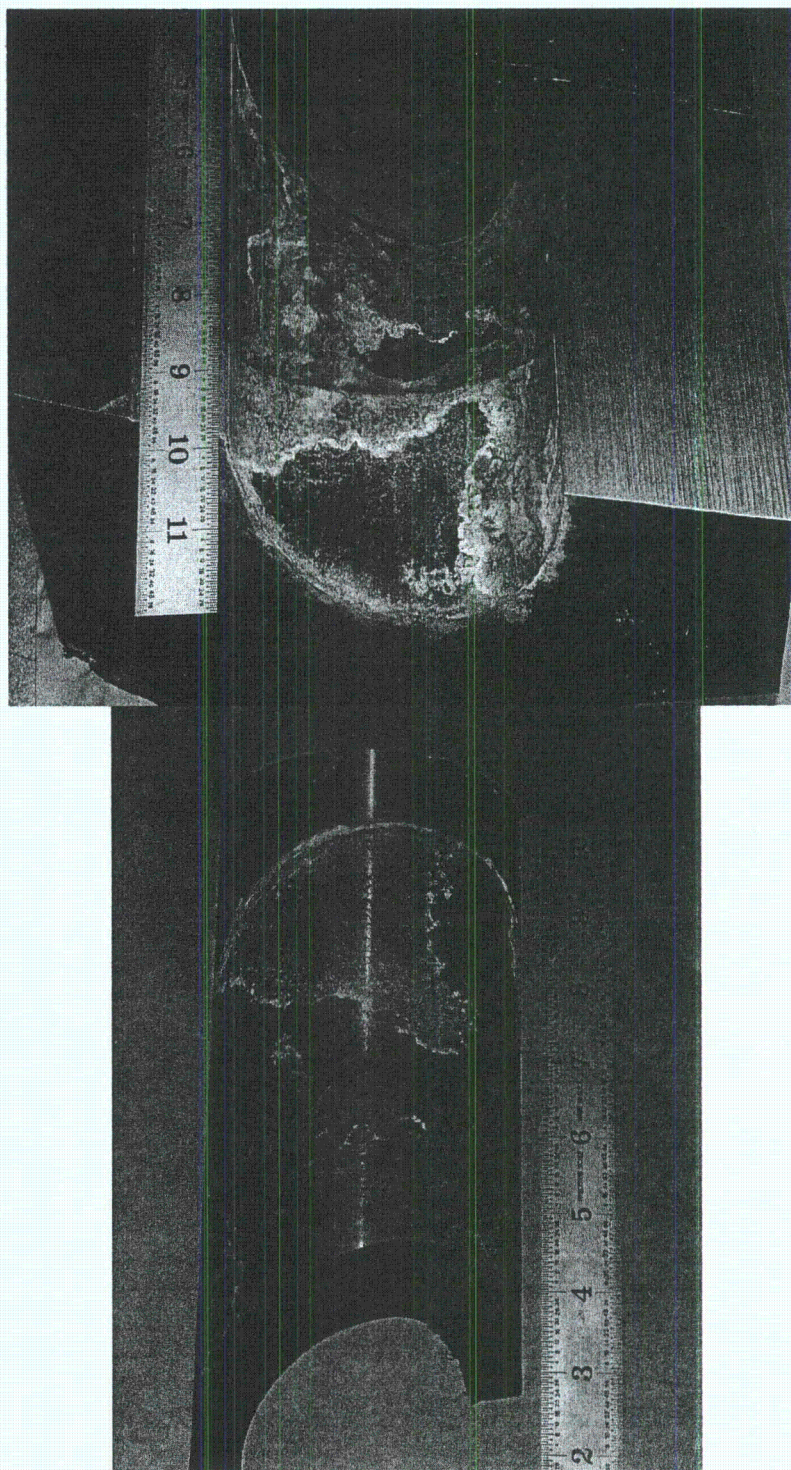
The cutting continued until the entire nozzle was separated from the J-groove weld region as pictured in Figure 6.4. At this point, the nozzle region above the weld was freely released from the RPV head material. Removal of the nozzle exposed the annulus region of the high-side section as shown in Figure 6.5. A Nikon D40x camera was used to acquire high-resolution photographic documentation of the annulus region. This activity was provided by B&W. A subsequent cut was conducted on the low-side section to expose its annulus region containing the primary leak path (Figure 6.6). The nozzle freely released from this portion as well.

Figure 6.5 Exposed RPV Head and Nozzle from High Side Section

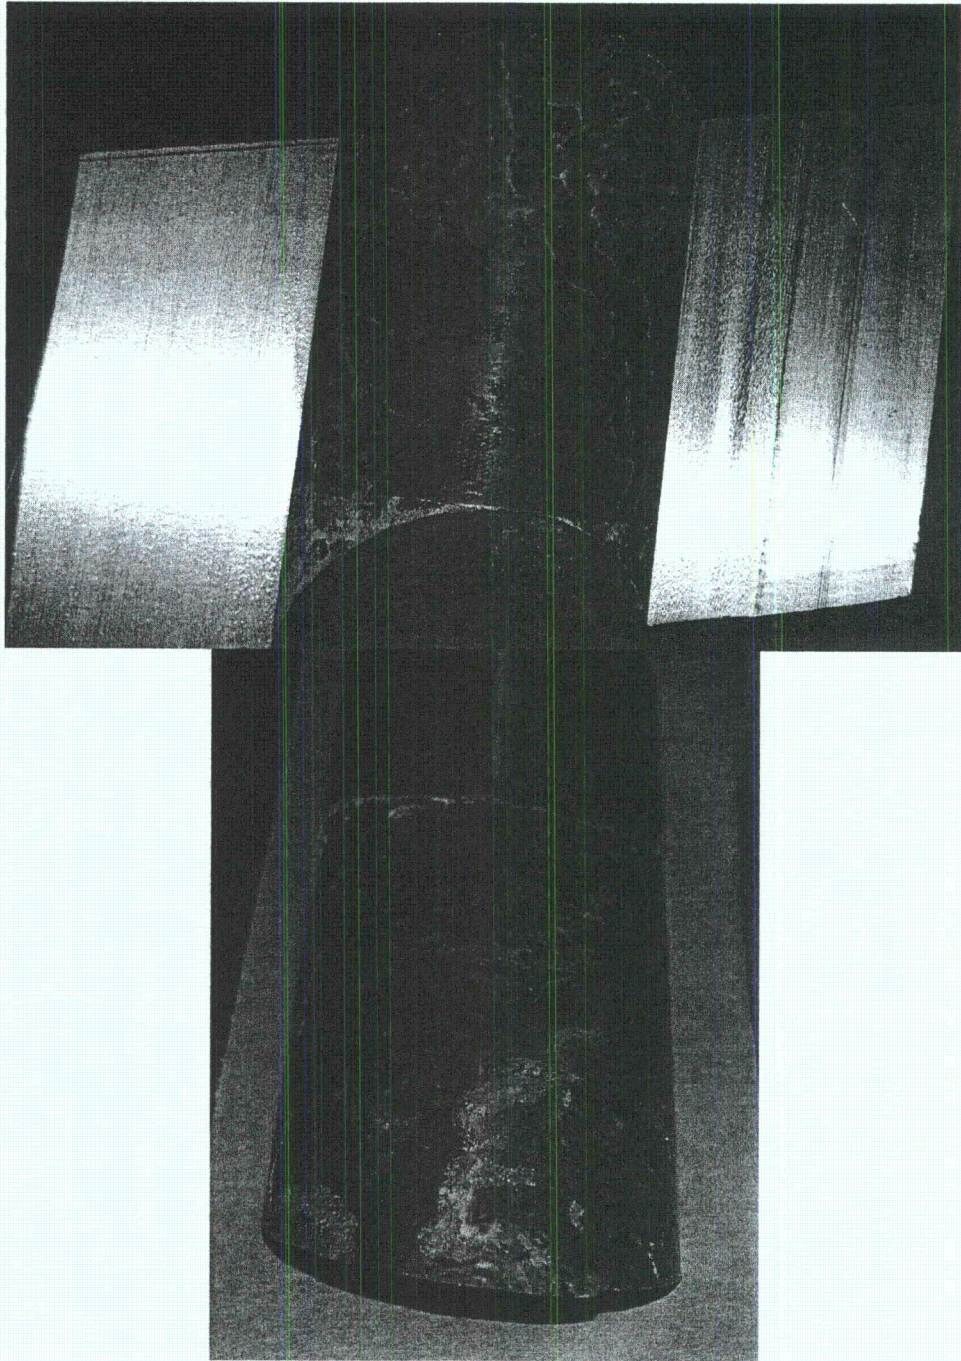
**Figure 6.6 Exposed RPV Head and Nozzle from Low-Side Section**

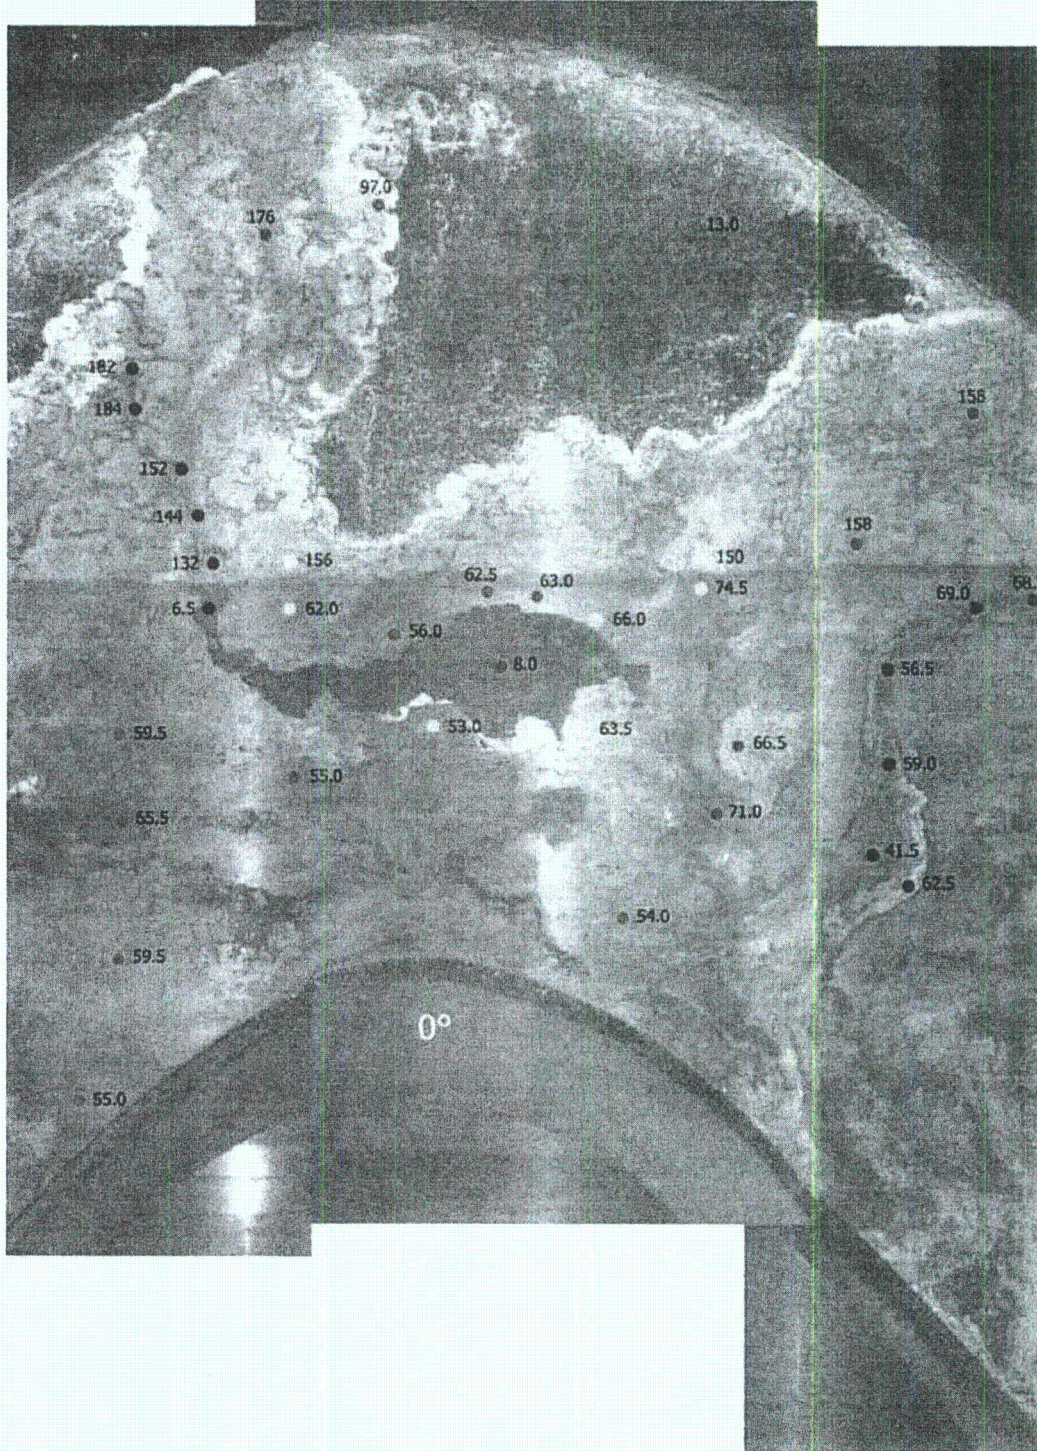
Figure 8.2 Boric Acid Thickness Values in Microns

Each of the 70 data points was numbered and the boric acid measurements were entered into a spreadsheet. The thickness measurements in microns are displayed adjacent to the data points in Figure 8.2. Some general observations were:

- 1) Boric acid values above and below the interference fit region outside of leak path and bare metal or nearly bare metal regions are nominally in the 130 to 200 micron (5.1 to 7.9 mils) range.
- 2) The two pairs of data (yellow dots) on either side of the interference fit on the uphill section show boric acid values of 156 and 150 microns (6.1 and 5.9 mils) above the fit region and 62 and 74.5 micron (2.4 and 2.9 mils) in the fit region.
- 3) Leak path and bare metal or nearly bare metal points have a thin surface corrosion layer, not visible boric acid deposits, with deposits at 16 microns (0.63 mils) or less.
