SUBJECT: Review of Draft NUREG/CR – XXXX Entitled, "Ultrasonic Phased Array Assessment of the Interference Fit and Leak Path of the North Anna Unit 2 Control Rod Drive Mechanism Nozzle 63 with Destructive Validation"

**Ultrasonic Phased Array  
Assessment of the Interference  
Fit and Leak Path of the  
North Anna Unit 2 Control Rod  
Drive Mechanism Nozzle 63 with  
Destructive Validation**

NUREG/CR-XXXX  
PNNL-XXXXX

Manuscript Completed: February 2012

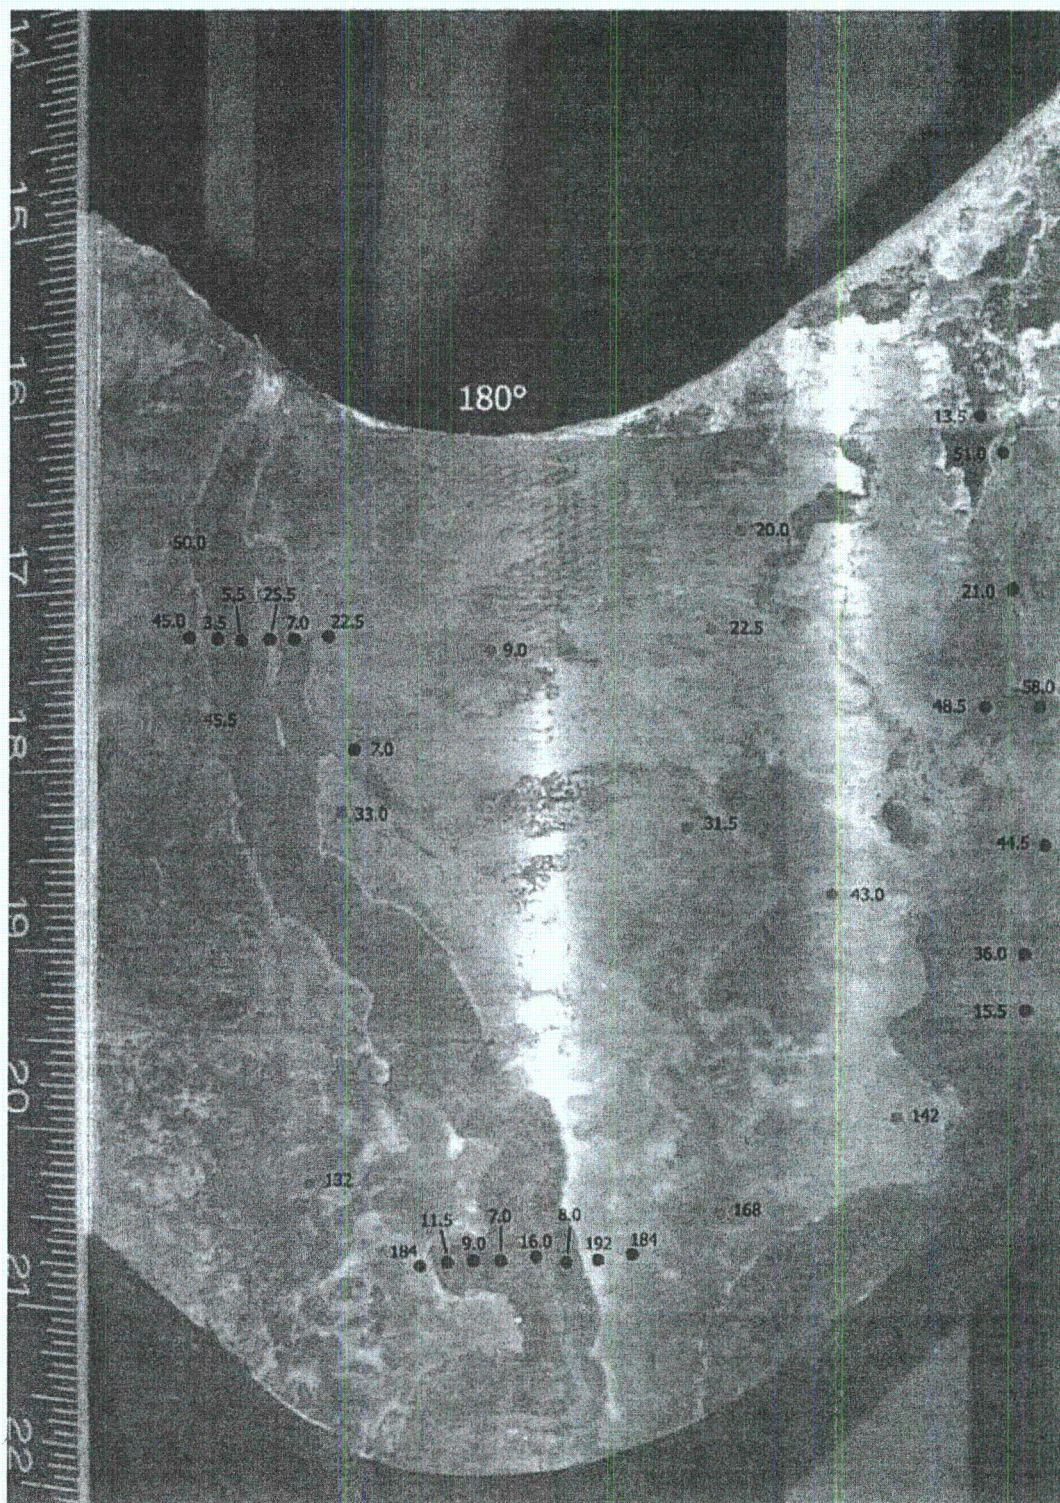
Figure 8.2 (Continued)

- 1) Boric acid values above and below the interference fit region outside of leak path and bare metal or nearly bare metal regions are nominally in the 130 to 200 micron (5.1 to 7.9 mils) range.
- 2) The two pairs of data (yellow dots) on either side of the interference fit on the uphill section show boric acid values of 156 and 150 microns (6.1 and 5.9 mils) above the fit region and 62 and 74.5 micron (2.4 and 2.9 mils) in the fit region.
- 3) Leak path and bare metal or nearly bare metal points have a thin surface corrosion layer, not visible boric acid deposits, with deposits at 16 microns (0.63 mils) or less.

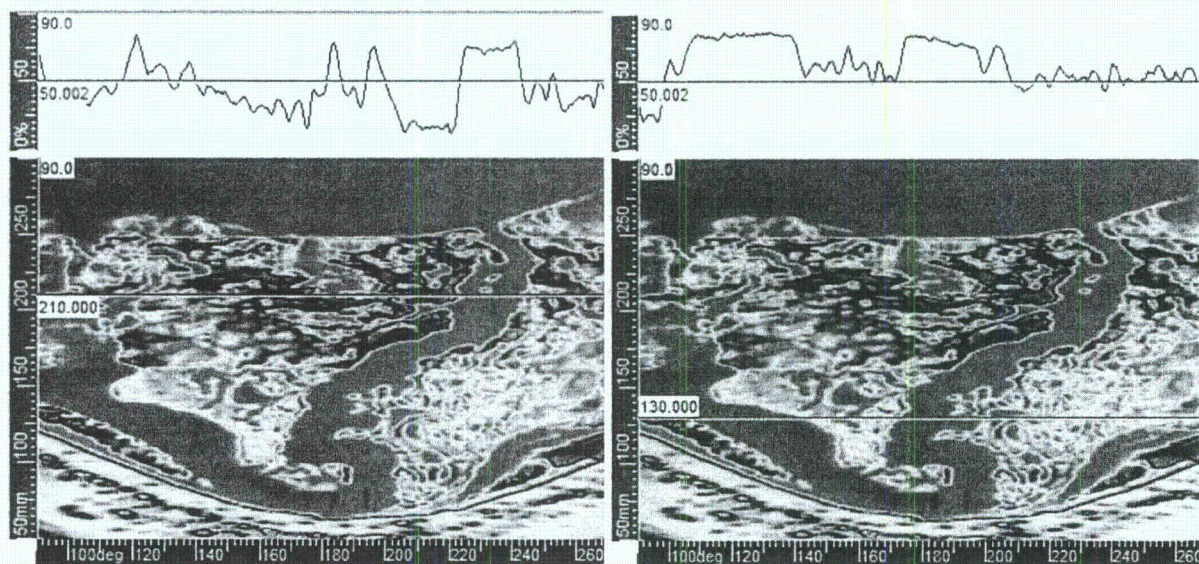
The relationship between the ultrasonic response values and eddy current (EC) thickness values was explored in more detail. As was previously demonstrated in the mockup evaluation, the large-amplitude ultrasonic data represent a gap in the interference fit. These data regions are represented by the color orange in the rainbow color bar previously shown in Figure 5.3, for example. Two horizontal profiles that display ultrasonic amplitude variations along the selected measurement line in the image are shown in Figure 8.3. The left image displays a profile taken along the red horizontal line located in the interference fit region. Clearly the high ultrasonic response is evident across the main leak path and then the response falls off on either side, of the leak path. The left side drop off is more severe in the profile and is associated with the blue color in the image, while the right side drop off is moderate and is associated with the yellow color in the image. The right image displays a profile taken along the red horizontal line in the image below the interference fit. The profile as well as the data image, again, shows a high-amplitude ultrasonic response for the leak path regions with signal drop off on both sides of the leak paths. At this axial position in the annulus, the drop off is smaller than that observed in the data from within the interference fit on the left.

**Figure 8.3** Ultrasonic Response Profile at Top, Acquired Along the Red Horizontal Line in the Image Below. The left image profile is in the interference fit and the right image profile is outside of the interference fit.

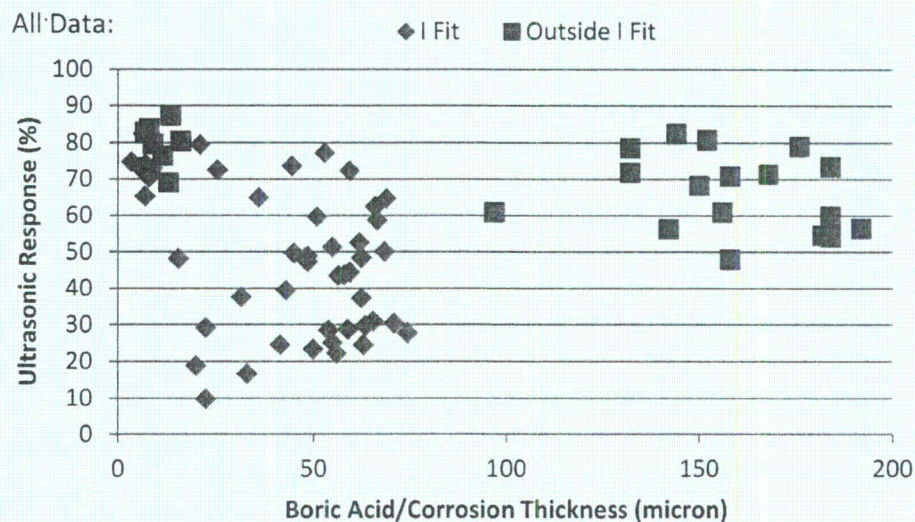
Lastly, an attempt was made to correlate the ultrasonic and eddy current measurements at all 70 data points. In this analysis, the data points were segregated as the interference fit region and outside of the interference fit region. Initially, all of the points were plotted with results shown in Figure 8.6. Points with high ultrasonic response and BA/corrosion thickness, upper left, are primarily associated with the main leak path region and represent areas where any potential deposits are flushed out and not allowed to remain. In addition to the primary leak path, other partial leak paths and regions with possible bare metal, lacking deposits, were identified. All of these leak path and bare metal points are plotted in Figure 8.7. These points represent a gap in the annulus, noted by the high ultrasonic response. Deposits as measured with the EC probe could be present but are not compacted throughout the annulus thickness. The remaining points (70 original points minus the leak path and bare metal points) represent the nominal annulus condition and are plotted in Figure 8.8. An ultrasonic amplitude level of approximately 50% divides the data between an interference fit response and one outside the interference fit region. For this nozzle, the BA/corrosion layer thickness values in the interference fit are less than 75 microns (3.0 mils), and outside the interference fit are greater than 130 microns (5.12 mils). The center point, with a layer thickness of 97 microns (3.82 mils) in Figure 8.8, can be excluded as it was obtained at a location where there is a noticeable boric acid deposit on the nozzle side. This additional deposit, though not quantitatively known, would increase the layer thickness value moving the point to the right and likely in the range of the other "Outside I Fit" data points. The other outlier point (EC value of 9 microns [0.35 mils] and UT value of 73%) is from the interference fit data and was obtained at a rust-colored region so it was not included in the bare metal points. This outlier is possibly explained by positional registration error of the data points. For example, ultrasonic data in a narrow secondary leak path varied from a value of 83 to 44% within and outside the leak path, respectively. Also the accuracy in acquiring EC data at the exact points specified on the photograph varied as definitive local boundary markers on the component were not always present. This is to say that these measurements have some positional error that cannot be eliminated. Nevertheless,

a clustering of the data is evident. These results are specific to this nozzle, Nozzle 63, as the fabrication of each nozzle represents a unique geometrical condition; however, these data likely show expected trends for nozzles in general. A summary of the Nozzle 63 results is listed.

- Leak paths
  - a. High UT response, >60%
  - b. Minimal boric acid/corrosion layer EC measurement, <16 microns (0.63 mils)
- Outside the leak path
  - a. Inside the interference fit region
    - i. UT response <50%
    - ii. EC measurement low, 15–75 microns (0.59–3.0 mils)
  - b. Outside the interference fit region
    - i. UT response >50%
    - ii. EC measurement larger, 130–190 microns (5.12–7.48 mils)

**Figure 8.6 Comparison of Ultrasonic Response and Boric Acid/Corrosion Layer Thickness at all 70 Acquired Data Points**

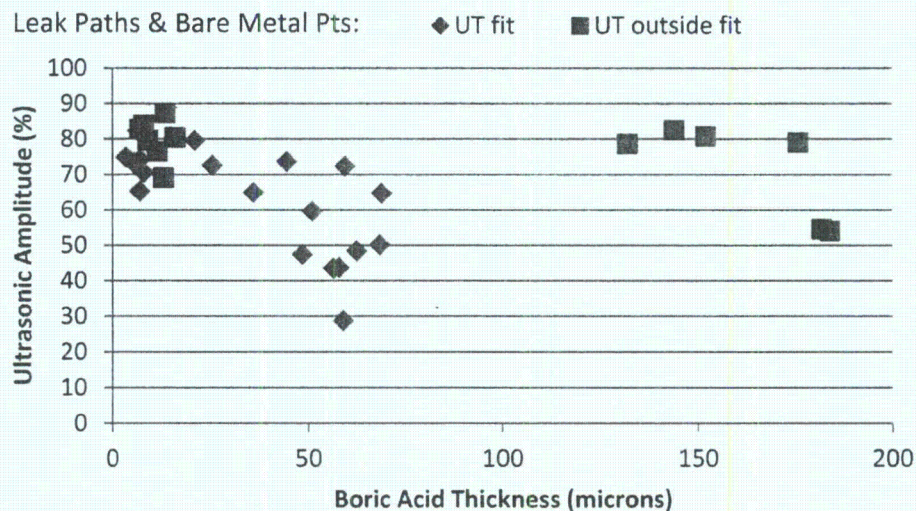
**Figure 8.7 Comparison of Ultrasonic Response and Boric Acid/Corrosion Layer Thickness at the Leak Path and Bare Metal Data Points**

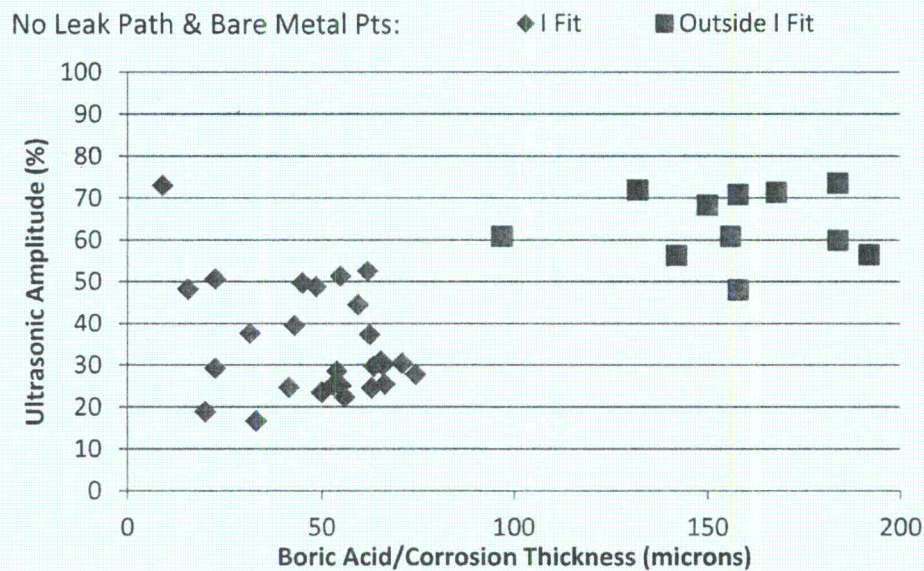
**Figure 8.8 Comparison of Ultrasonic Response and Boric Acid/Corrosion Layer Thickness at Data Points Not in the Leak Paths Nor at Bare Metal Points**

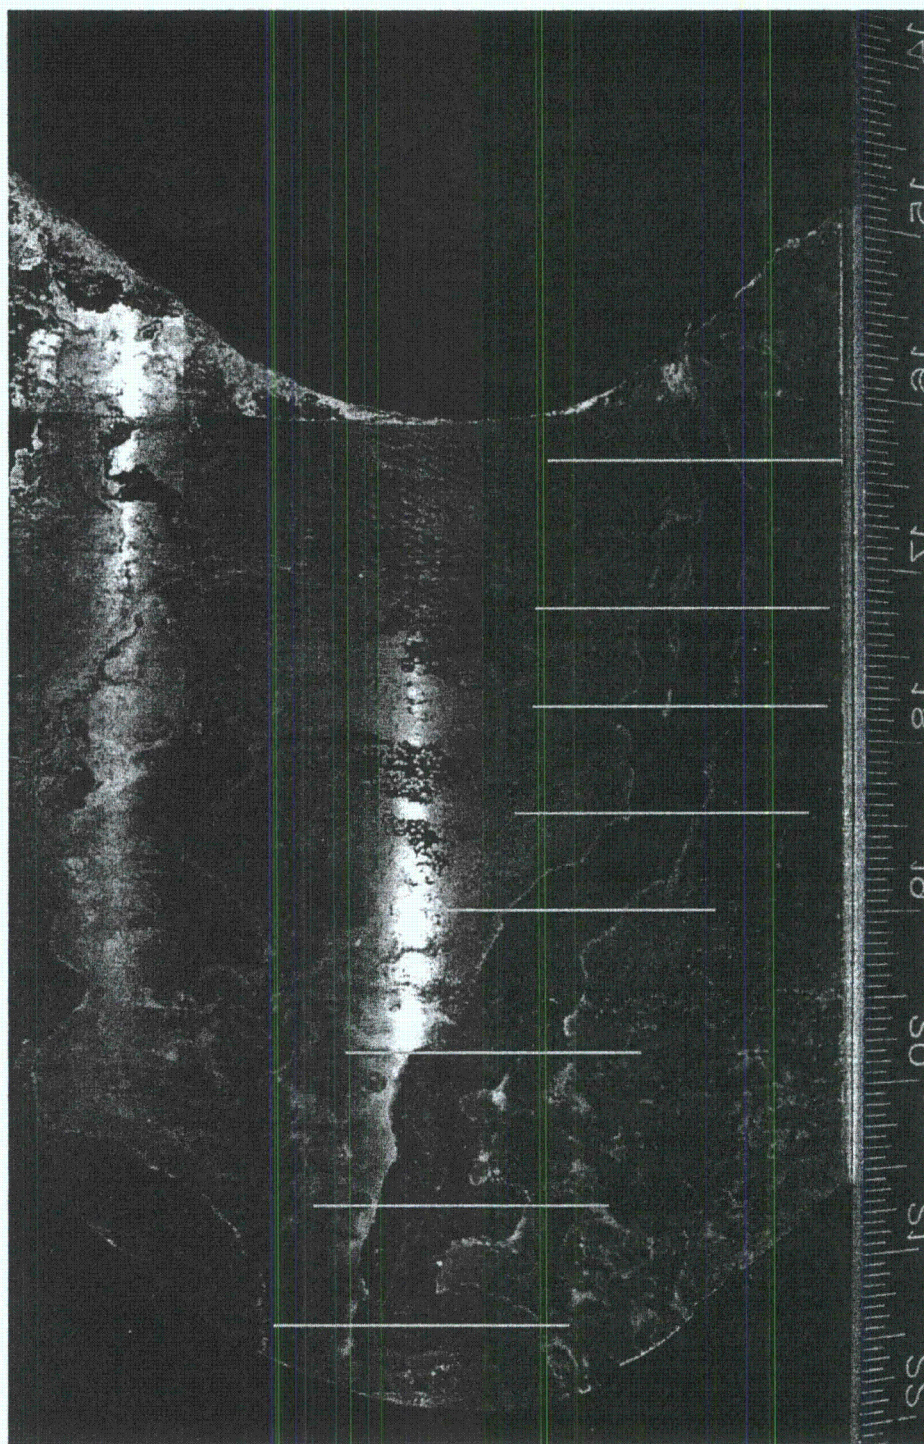
Confirmatory boric acid measurements were also visually made on Microset replicas of the RPV annulus in the main leak path region. This replicating material has better than 0.1 micron (0.004 mils) resolution. Eight areas of interest across the main leak path, as shown in

Figure 8.9, were selected for these additional and confirmatory measurements. The sliced and annotated replica is shown in Figure 8.10. Boric acid measurements were made on the edges of the slices with the white arrows showing the cut surfaces that were measured. Several of the measurement values obtained by these surface cross sections were compared to the thickness gage measurements. While only a few data points were compared, the root mean squared error (RMSE) between measurements was 14 microns. This error is assumed to be primarily due to data registration.

**Figure 8.9** Eight Areas Selected for Boric Acid Thickness Measurements on Cross-Sectional Slices of Microset Replica

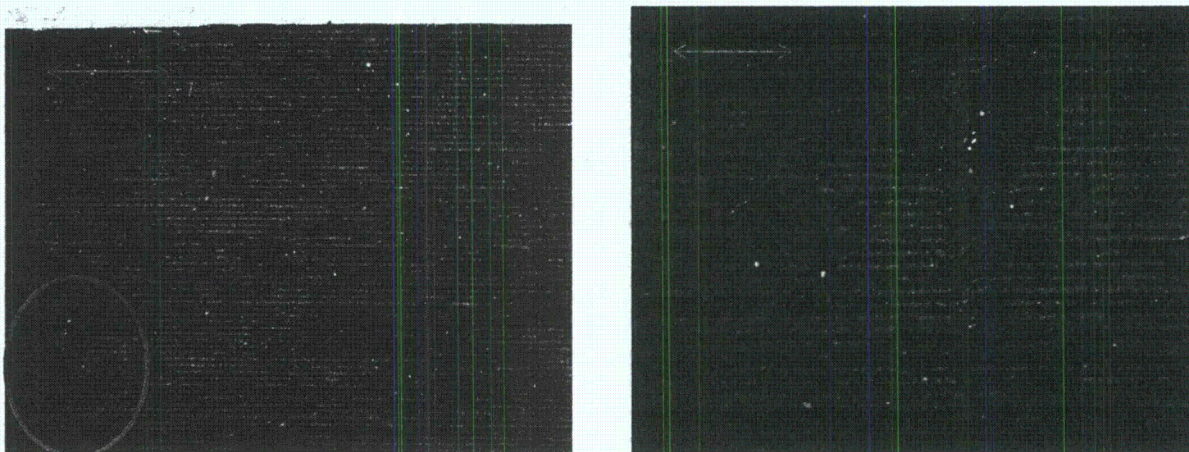
Piece 5 contained an angular feature or anomaly with an approximate length of 2.3 mm (0.090 in.) and is shown in Figure 8.13. The right image is at a twice the magnification as the image on the left and shows more detail. This feature appeared to be more of a dent or scrape and not corrosion. Piece 5 lies in the interference fit region.

**Figure 8.13** Piece 5 from the Interference Fit Region Shows an Indication of a Scrape. In the left image the red line represents 2.0 mm (0.80 in.) in length. The image on the right at twice the magnification of the left shows more detail.

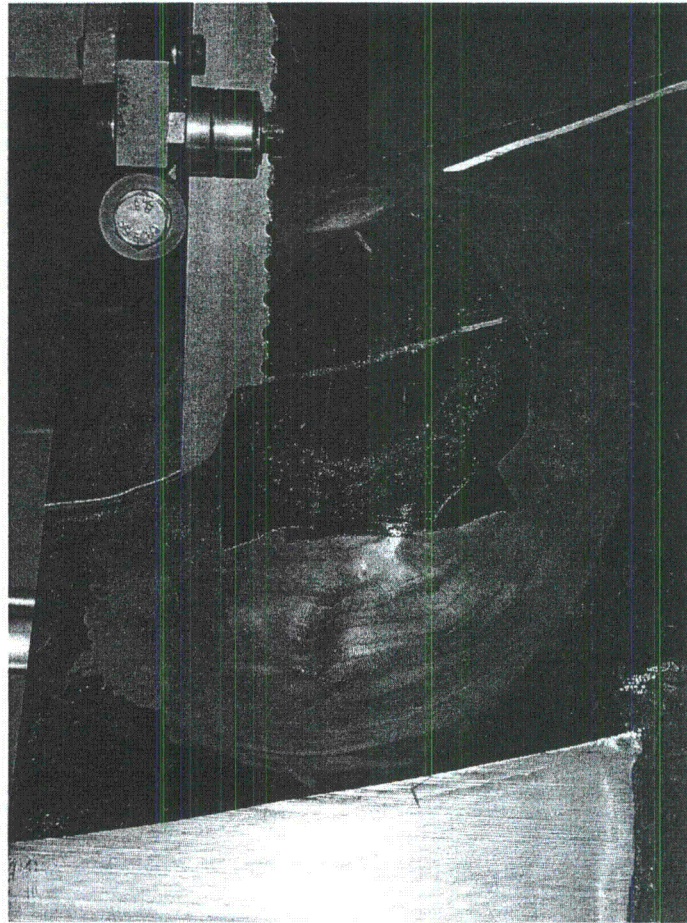
Dissection cutting began with the coarse-toothed blade. The cut progressed for approximately 20 minutes until an unidentified 'hard spot' was reached at the outer edge of the Alloy 600 nozzle region and stopped the cutting progression. A slower feed rate with a faster blade speed was attempted, but did not traverse the hard spot. The cause of the hard spot was not fully investigated, but a likely cause was from a cold-worked region of material within the heat-affected zone of the J groove weld adjacent to the nozzle outer diameter (OD). The coarse-cut blade was exchanged with a fine-toothed cutting blade and the cut was attempted again without success. Finally, the carbide blade was employed to abrasively grind through the hard spot. This blade required a greatly reduced feed rate, thus lengthened the cutting time. Further, the kerf of the carbide blade was thicker than the cutting blades, requiring the cut to be restarted at the initial cut path. The carbide grit abrasive blade is shown in Figure C.4. The cut through this hard spot required approximately 2 hours to complete.

**Figure C.4 Abrasive Carbide Blade Progressing Through the Hard Spot**

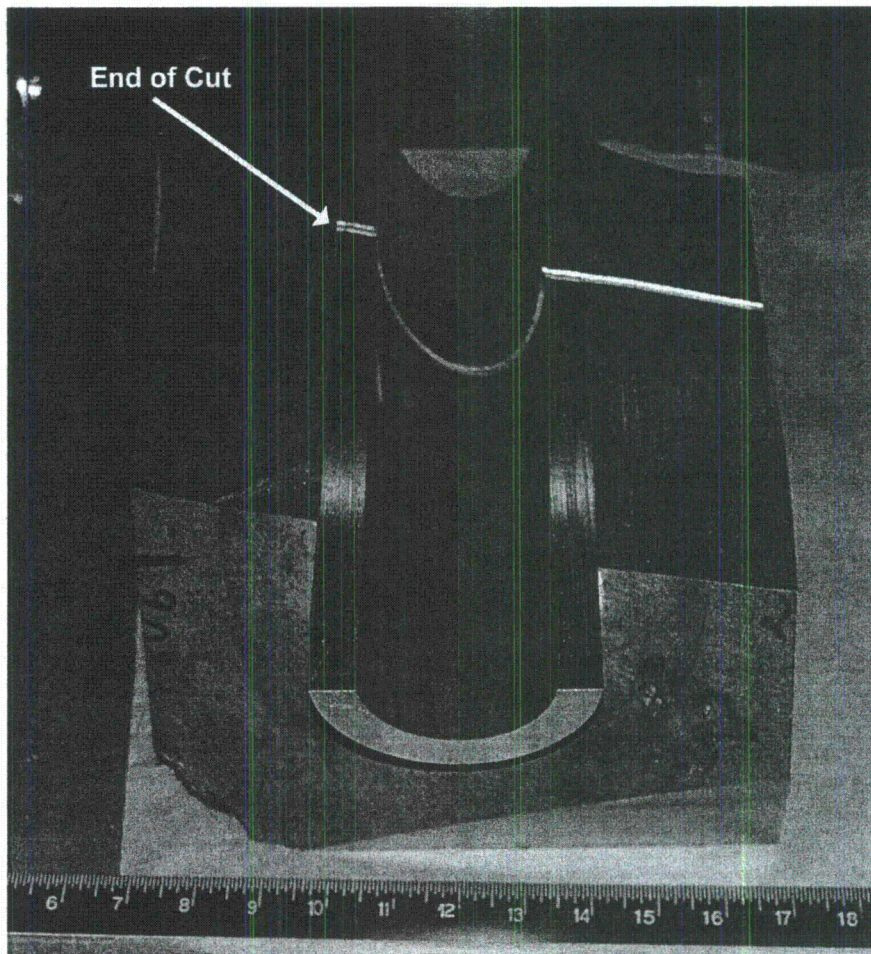
The cutting continued until the entire nozzle was separated from the J-groove weld region as pictured in Figure C.9. At this point, the nozzle region above the weld was freely released from the RPV head material. Removal of the nozzle exposed the annulus region of the high-side section as shown in Figure C.10. At this point all available blades were exhausted. Replacement blades were ordered to finish the cut and complete removal of the J-groove weld region. A Nikon D40x camera was used to acquire high-resolution photographic documentation of the annulus region. This activity was provided by B&W. A subsequent cut was conducted on the low-side section to expose its annulus region containing the primary leak path (Figure C.11). The nozzle freely released from this portion as well.

Figure C.9 End of J-groove Weld Removal Cut

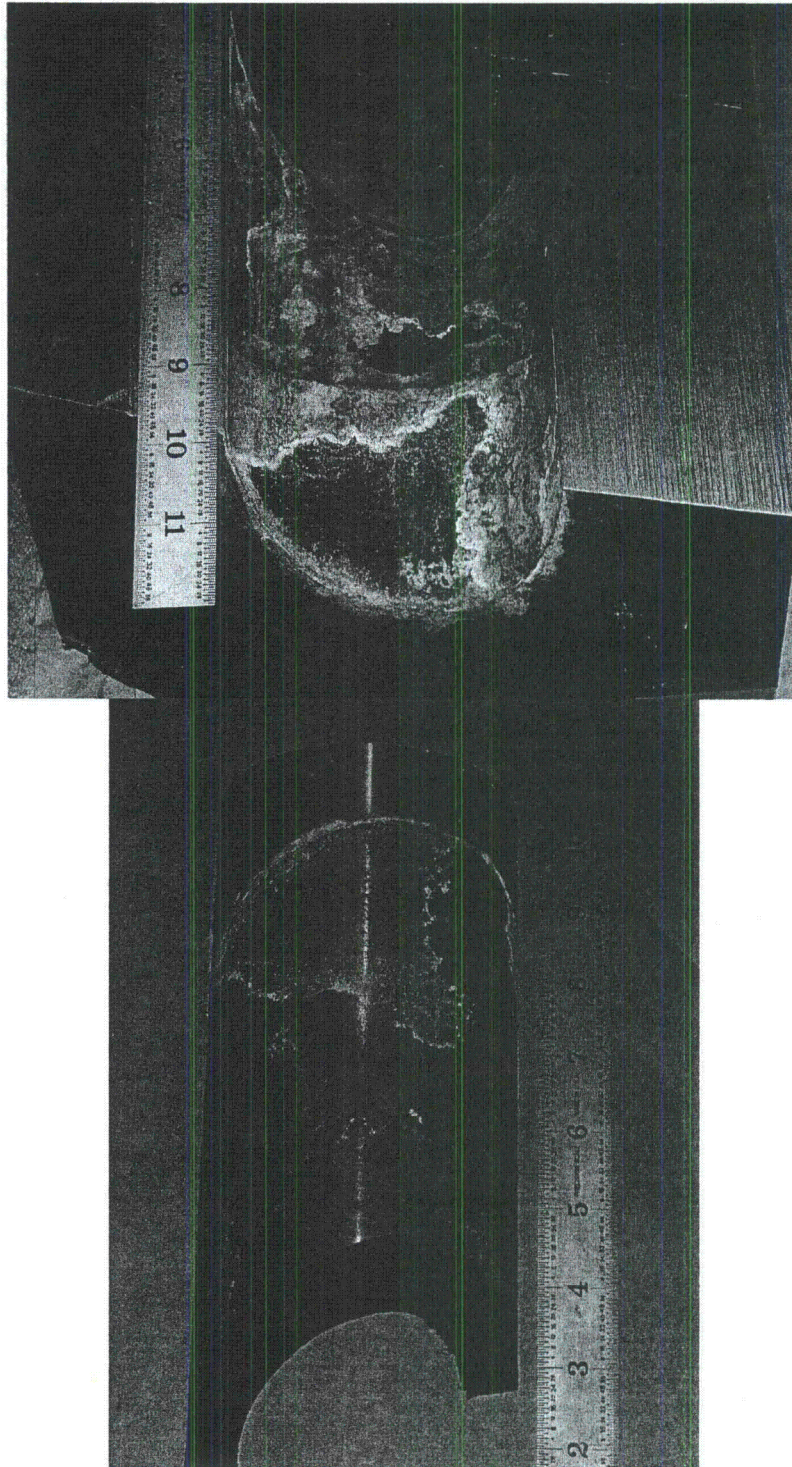
Figure C.10 Exposed RPV Head and Nozzle from High Side Section

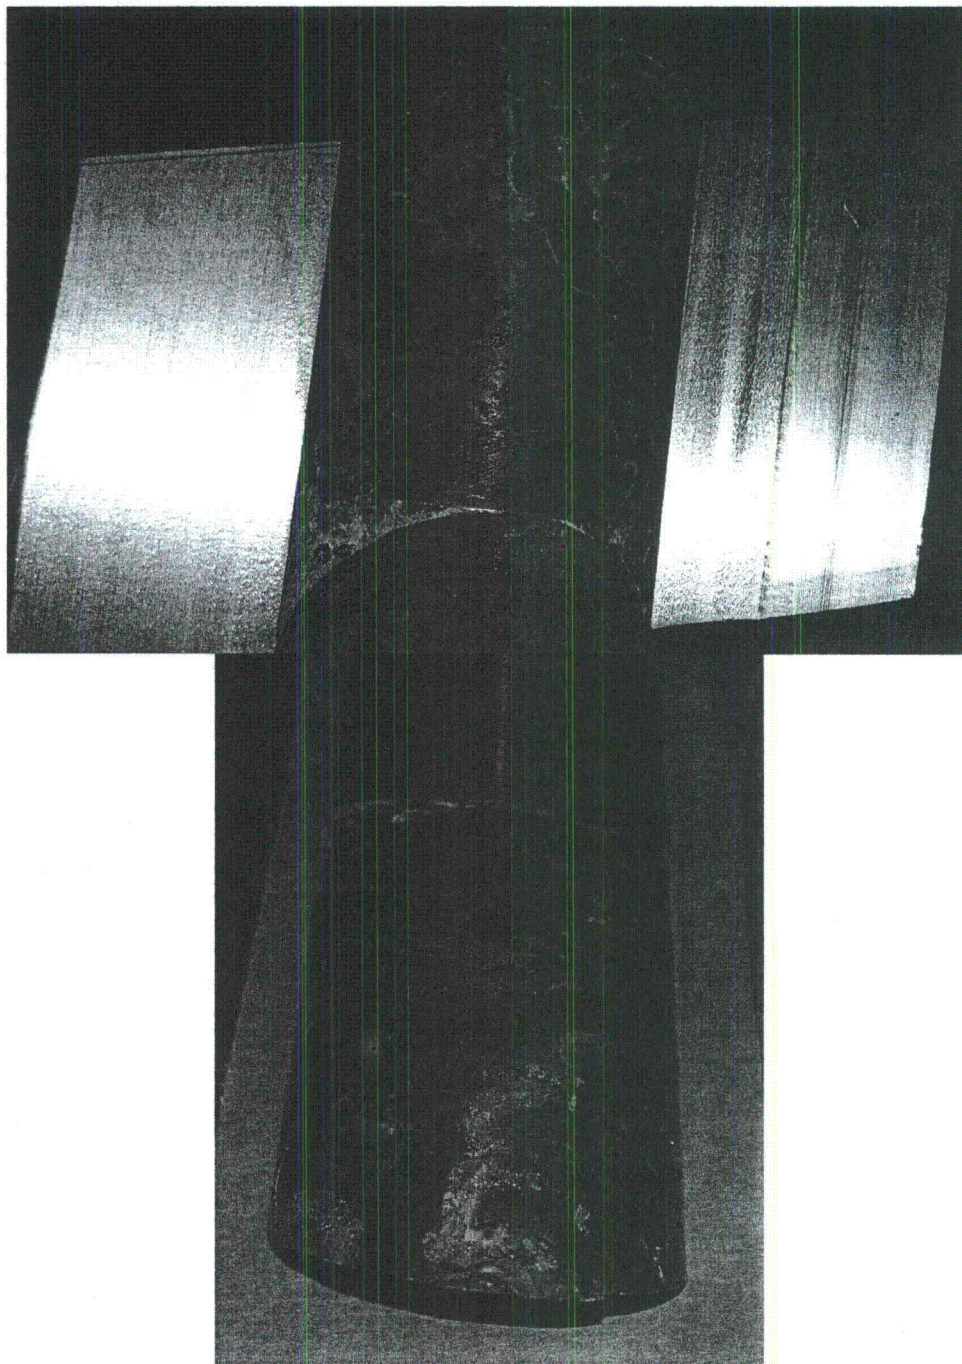
**Figure C.11 Exposed RPV Head and Nozzle from Low-Side Section**
