## Comparison of an Ultrasonic Phased Array Evaluation with Destructive Analysis of a Documented Leak Path in a Nozzle Removed from Service

AD Cinson, SL Crawford, PJ MacFarlan, BD Hanson, and RA Mathews  
Pacific Northwest National Laboratory<sup>1</sup>, Richland, WA, USA

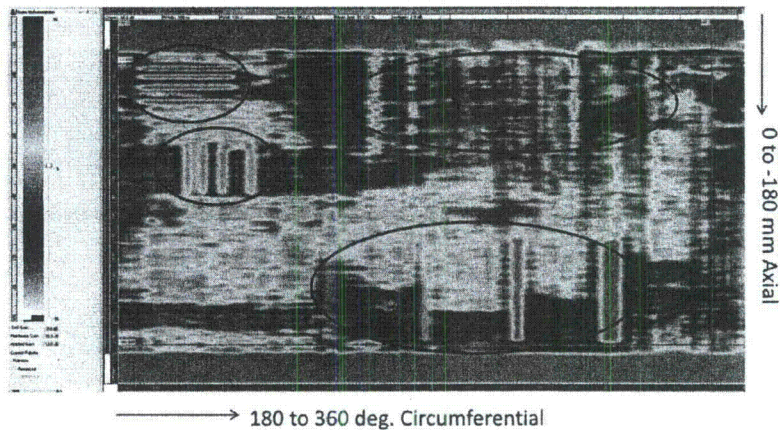
Figure 3 – Top view, plan view or C-scan ultrasonic image of the interference fit region containing calibration notches in the carbon steel head.
