**Ultrasonic Phased Array  
Assessment of the Interference  
Fit and Leak Path of the  
North Anna Unit 2 Control Rod  
Drive Mechanism Nozzle 63 with  
Destructive Validation**

Manuscript Completed: January 2012  
Date Published:

Prepared by  
S. L. Crawford, A. D. Cinson, P. J. MacFarlan, B. D. Hanson,  
R. A. Mathews

Pacific Northwest National Laboratory  
P.O. Box 999  
Richland, WA 99352

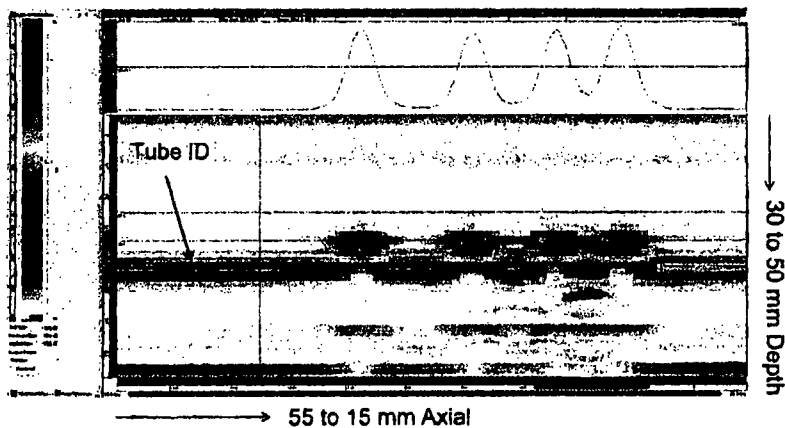
**Figure 4.14 D-scan End View of the Axial Resolution Notches in the Inconel Tube**

The data analysis software allowed electronic gating of signals in the time or depth dimension as well as positional dimensions Z and theta (axial and circumferential, respectively). The axial resolution notches were first gated or selected for analysis. An enlarged D-scan end view, as depicted in Figure 4.14 was used to measure the center-to-center spacing of the notches. This image was taken as viewed from the left edge of the image in Figure 4.13 and depicts depth into the material (along the sound path) in the vertical axis and the scanner index or nozzle axial

direction in the horizontal axis. From this end view, an "echodynamic" curve or profile was generated along the red horizontal line drawn through the responses from the notches, and was plotted above the image. The measured notch widths, from left to right, as measured at the half-amplitude points, were 2.0, 2.0, 2.5, and 2.5 mm (0.08, 0.08, 0.10, and 0.10 in.), respectively. This represents only 4 or 5 pixels with each pixel equal to 0.5 mm (0.02 in.). The actual notch widths were 2.08, 2.06, 2.16, and 2.11 mm (0.082, 0.081, 0.085, and 0.083 in.), respectively. Notch depths were measured as 2.06, 2.06, 2.03, and 2.03 mm (0.081, 0.081, 0.080, and 0.080 in.), respectively. Actual depths were 2.06, 1.95, 2.00, and 2.00 mm (0.081, 0.077, 0.079, and 0.079 in.), respectively. The data suggested that cracks as small as approximately 1 mm (0.04 in.) in depth could be accurately measured. Also, the notches could be clearly distinguished from each other, providing an indication of lateral probe resolution in the nozzle axial direction. In this set of notches, the actual center-to-center separations were 7.11, 5.08, and 4.06 mm (0.28, 0.20, and 0.16 in.), respectively. The measurements from the ultrasonic data gave separations of 7.0, 5.5, and 4.0 mm (0.28, 0.22, and 0.16 in.), respectively. These highly correlated data values and the data image indicated that an axial resolution of better than 4.0-mm (0.16-in.) was achievable.

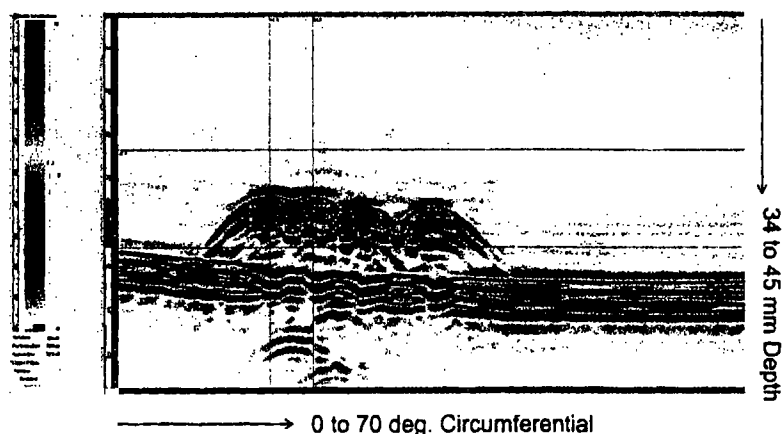
**Figure 4.15 B-scan Side View of the Circumferential Resolution Notches in the Inconel Tube**

The gated circumferential resolution notch set is shown in Figure 4.15. This image was taken as viewed from the bottom edge in Figure 4.13. Notice that the closely spaced two notches on the left are overlapping but they are still resolvable. Peak-to-peak values gave measured notch separations of 4.36, 5.18, and 6.82 mm (0.17, 0.20, and 0.27 in.), respectively. The actual separations were 4.06, 5.08, and 7.11 mm (0.16, 0.20, and 0.28 in.), respectively. This is greater error than was observed for the axial direction. This test demonstrated a circumferential probe resolution of approximately 4.4 mm (0.17 in.).

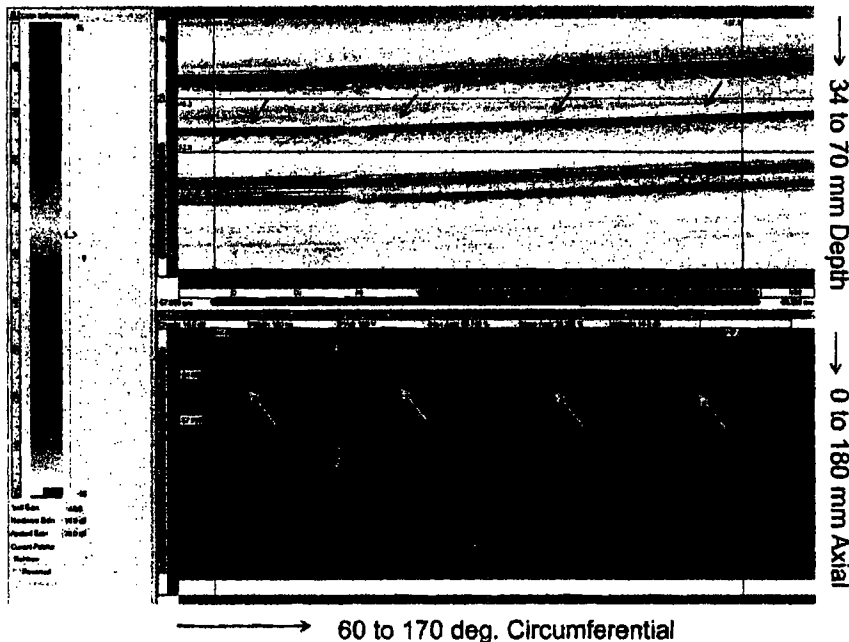
**Figure 4.16 The Second Echo is Gated in the Side View Image in the Top of Figure with the Horizontal Lines. The corresponding Scan in the Side View is displayed in the bottom image. This second echo captures a disturbance in the back-wall echo showing some depth information, noted by the red arrows at top.**

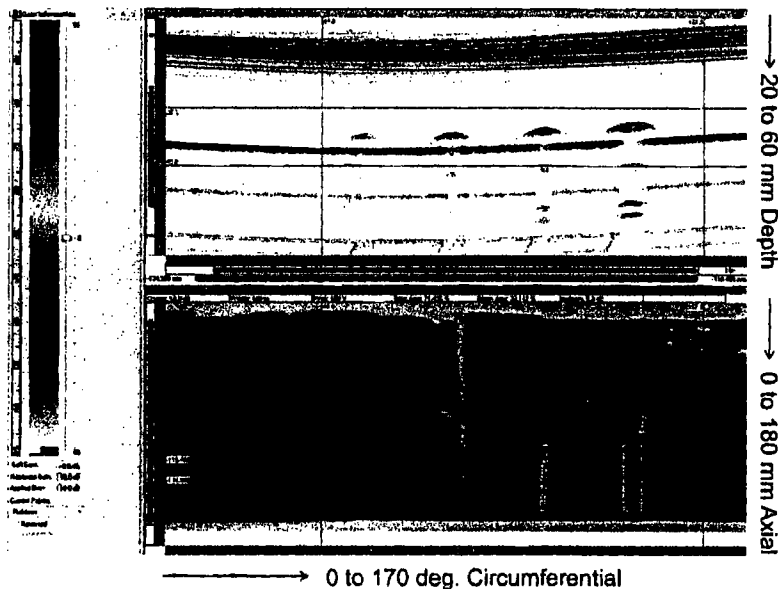
**Figure 4.17 B-scan Side View on Top and C-scan Plan View on Bottom of the Width Varying Notches in the Inconel Tube**

The final set of notches contained width variations and are shown in Figure 4.17. These flaws were ultrasonically measured with depths of 2.2, 2.5, 2.7, and 2.9 mm (0.09, 0.10, 0.11, and 0.11 in.), respectively, left to right in the image, while the actual depth was 2.53 mm (0.10 in.) for all notches. The measured center-to-center spacings were 23.1, 24.8, and 23.8 mm (0.91, 0.98, and 0.94 in.), respectively, while actual spacings were all 24.5 mm (1.00 in.). Finally, the widths of the flaws were measured in two ways. The first method used the width of the upper part of the flaw response, and the second method used the width of the loss of back-wall signal. The loss of back-wall signal technique was more accurate with measured widths of 3.91, 3.36, 5.00, and 8.82 mm (0.099, 0.126, 0.154, and 0.298 in.), respectively. Actual widths were 0.80, 1.61, 3.24, and 6.42 mm (0.031, 0.063, 0.127, and 0.253 in.), respectively. When measured from the second ultrasonic back-wall echo, the loss of signal measurements gave notch widths of 1.36, 2.73, 3.82, and 7.00 mm (0.054, 0.107, 0.150, and 0.276 in.), which were closer to the actual values. The probe spot size when focused at the interference fit, or 15 mm (0.59 in.) into the Alloy 600, was modeled at 1.2 x 1.2 mm (0.047 x 0.047 in.) at the -6 dB points. Flaw width sizing values are typically oversized by the probe spot size so these measured width values were well within the error expected with this probe.

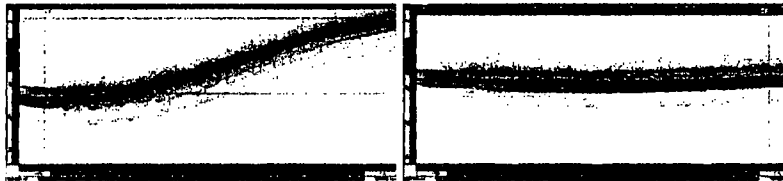
Figure 5.4 Alloy 600 Tube ID Response Before (left) and After (right) Centering the Scanner on the Nozzle. The horizontal axis represents approximately 180 degree and the vertical axis 20 mm (0.79 in.).

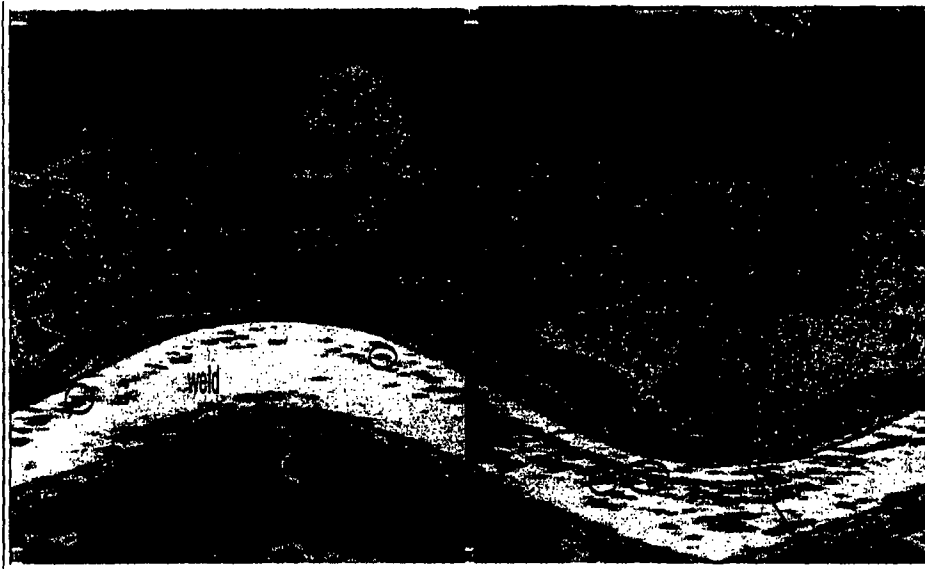
Data acquired after the first brushing from the two scans were pieced together to form the composite image of the interference fit region in Figure 5.11. This image displays a full 360-degree representation of the weld and interference fit region with -90 degrees at the left and 270 degrees at the right. The suspected leakage path at the low point, near 180 degrees, is marked with arrows. Also observed from the weld region response are suspected inclusions or fabrication flaws. Several of these indications are circled in red in the figure.

Figure 5.11 PA Ultrasonic Data from the interference fit in Nozzle 51 Acquired After the First Brushing of the Nozzle ID. The horizontal axis represents the full 360-degree area and the vertical axis represents 360 mm (14.17 in.).

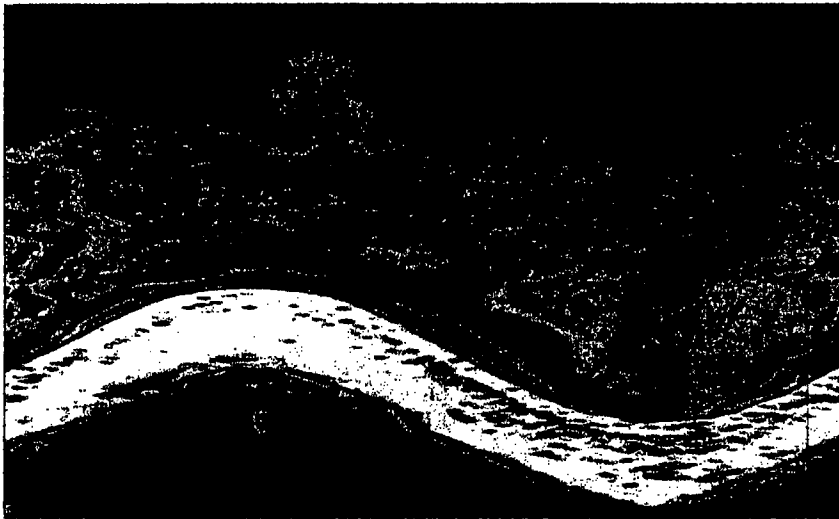
A composite view of the data acquired after the second brushing is presented in Figure 5.15. This is the best representation of the interference fit region and from this data a cut was selected for destructive evaluation.

**Figure 5.15 Nozzle 63 Interference Fit Data After Second Brushing. The horizontal axis represents -95 to 275 degrees. The vertical axis represents 360 mm (14.27 in.).**

While PNNL did not specifically perform an evaluation for axial cracking in the Alloy 600 tube, the two axial cracks noted by industry were detected. The zero-degree PNNL inspection was not optimized for crack detection as an axial crack presented only a knife-edge profile to the ultrasonic beam and did not reflect much energy. Nevertheless, the cracks were visible in the interference fit response, and on further analysis also marginally detected in the water-to-Alloy 600 tube reflection (ID surface of the tube). Figure 5.20 shows the uphill images for the ID tube and interference fit responses. Similarly Figure 5.21 shows the responses for the downhill images. Both flaws appear to be ID surface connected as they were detected in the data acquired at the ID surface of the Alloy 600 tube. These two flaws are also evident in the image in Figure 5.15. The ultrasonic data did not provide any depth-sizing information.

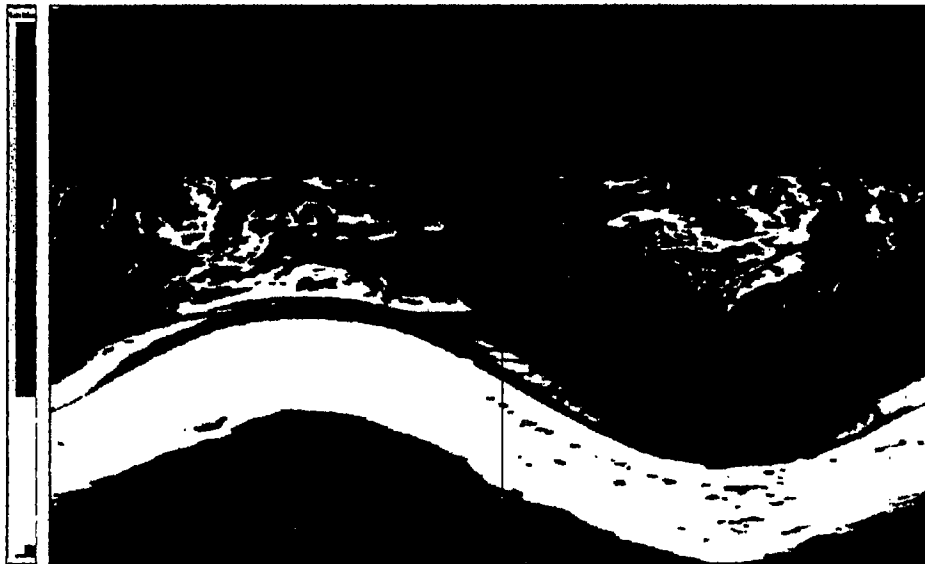
Based on the amplitude analyses conducted, the data were also plotted with a tri-level color bar to represent the three categories previously discussed. The tri-level color bar implementation is shown in Figure 5.16. White represents the less than 30% amplitude range and indicates good transmission such as in the weld or possible boric acid in the interference fit region. Light blue represents the 30 to 60% amplitude range and indicates the interference fit and counter bore regions. Dark blue represents the above 60% amplitude range and indicates poor transmission such as in the tube above the interference fit or an air gap in the interference fit and counter bore regions. A leakage path exists if a gap in the interference fit region extends fully through the interference fit connecting the weld and annulus region immediately above the weld to the dry side of the tube. From this image as well as the rainbow color-coded images, one clear leakage path is visible. The leakage path starts in the vicinity of 180 degrees circumferentially, or the low point of the nozzle, and meanders upwards and toward the right in the image. Other leakage paths are also evident but may not connect all the way through to the dry side of the assembly. Destructive analyses are needed to confirm the cause of these regions of differing reflectivity.

Figure 5.16 A Tri-Color Representation of the Interference Fit Data

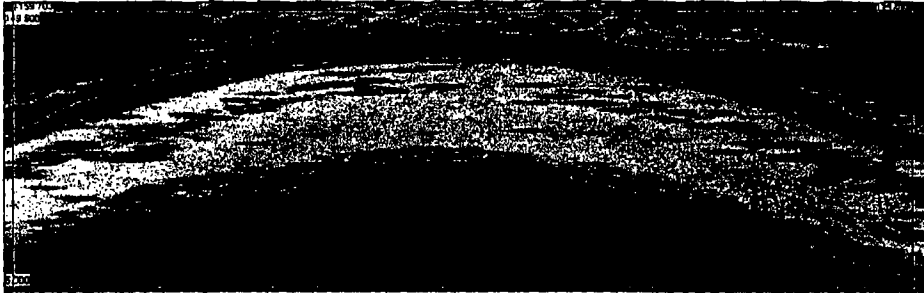
A composite view of the ultrasonic indications in the weld are presented in the C-scan top view or plan view images in Figures 8.2 and 8.3 for the uphill and downhill halves of the weld, respectively. Each figure represents approximately 150 mm (5.91 in.) in the vertical or axial direction and 180 degrees in the horizontal or circumferential direction. The indications were generally all located at the Alloy 600 tube-to-weld interface, or near surface, as will be discussed in more detail below. These indications appear to be volumetric in shape, indicative of fabrication flaws and assumed to be welding anomalies. The types of fabrication flaws expected would include incomplete or lack of fusion between individual weld beads, inclusions, voids, etc. Notice that the downhill image contains more indications. This is not unexpected due to the more difficult configuration at this position in the nozzle assembly. One would be welding upside down, in a deeper cavity, and with limited access at this location; and therefore more likely to introduce imperfections in the weld. A connected string of indications following the curvature of the weld are observed in Figure 8.3—likely a lack of fusion between weld bead passes. These indications are noted by the red arrow in the figure.

**Figure 8.2 Uphill Half of the Weld.** The horizontal axis represents approximately 180 degrees and the vertical axis represents approximately 150 mm (5.9 in.).

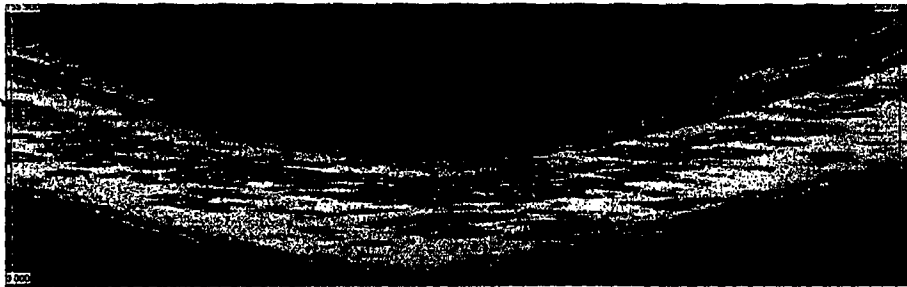
**Figure 8.3 Downhill Half of the Weld.** The horizontal axis represents approximately 180 degrees and the vertical axis represents approximately 150 mm (5.9 in.).

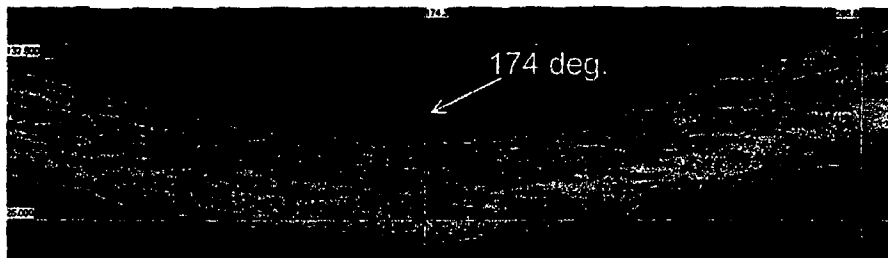
The ultrasonic indications were evaluated for flaw-depth position or distance into the weld material, and all responses appeared to be at or just below the surface with the surface representing the Alloy 600 tube-to-weld or butter interface. Figure 8.4 shows the composite top view of the downhill half of the weld with a vertical line drawn through the 174-degree position. A single plane or slice of data taken at the 174-degree position is displayed in Figure 8.5 and this figure represents a B-scan side view of the data. The horizontal axis in the side-view image represents depth or distance into the material. The first and second ultrasonic echoes are noted and represent reflections from the tube-to-weld interface. The scanner index or nozzle axis is shown in the vertical direction. The profile shape follows the front surface or inside of tube profile displayed in Figure 8.6. The distortion or deviation from vertical is due to the weld heating and subsequent cooling in the material and was measured at approximately 2 mm (0.08 in.). The distortion is magnified in the image due to the velocity difference between water and the Alloy 600 tube. Water velocity is nearly four times slower than the metal, assuming a water velocity of 1483 m/sec (58.4 in./msec) and 5820 m/sec (229.1 in./msec) for the metal. The side-view plots (Figures 8.5, 8.6, and 8.8) display the horizontal axis in units of distance

**Figure 8.4** Location of Single Slice Shown in Figure 8.5. The horizontal axis represents 180 degrees approximately and the vertical axis 145 mm (5.7 in.).

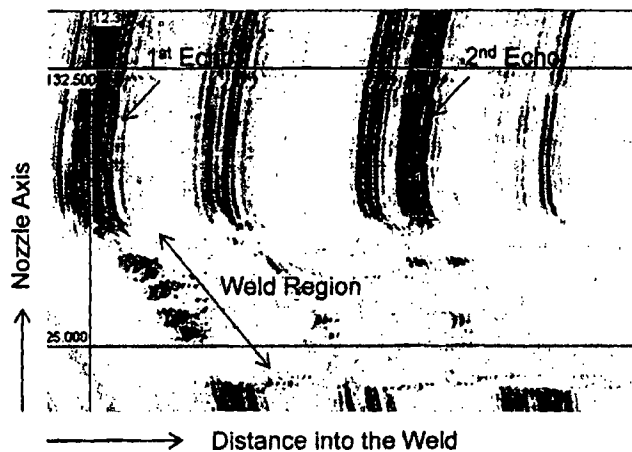
**Figure 8.5** B-scan Side View at the 174-Degree Circumferential Position. Near-surface indications are visible in the weld material. The horizontal axis represents approximately 40 mm (1.6 in.) in metal and the vertical axis 155 mm (6.1 in.).

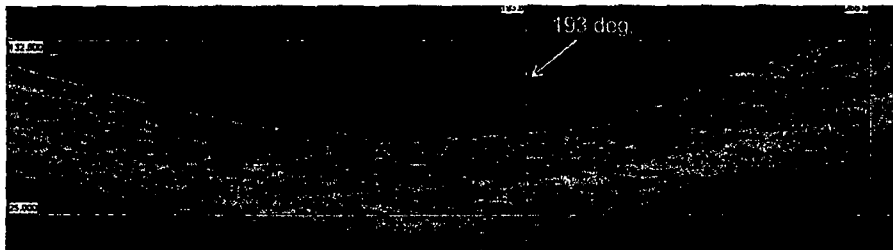
**Figure 8.7 Location of Single Slice Shown in Figure 8.8**

The weld region was evaluated for anomalies throughout the full 360-degree circumference. The indications fell along the Alloy 600 tube-to-weld interface at all but one circumferential position. At the 193-degrees position as noted in Figure 8.7, an indication appeared earlier in time than the other indications. The corresponding B-scan side view is shown in Figure 8.8 with the early indication circled. This earlier indication would plot into the tube material and could possibly be from a gouge in the tube and improper or no weld fill or repair. The indication displacement is shallow at approximately 1 mm (0.04 in.) in depth. No indications of circumferential cracking across or along weld beads were detected.

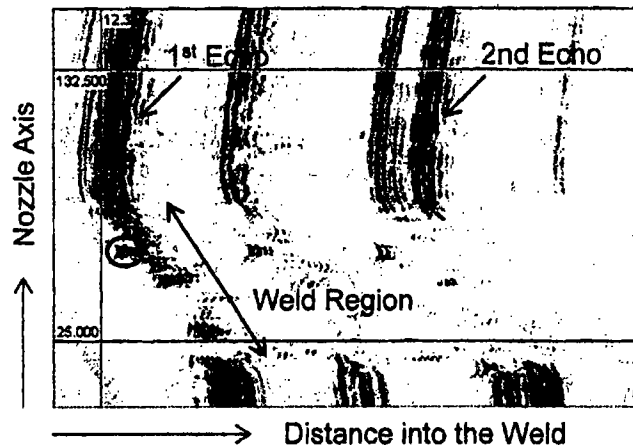
**Figure 8.8 B-scan Side View at the 193-Degree Circumferential Position. Near-surface indications and one indication, circled in red, occurring earlier in time are visible. The horizontal axis represents approximately 40 mm (1.6 in.) in metal and the vertical axis 155 mm (6.1 in.).**

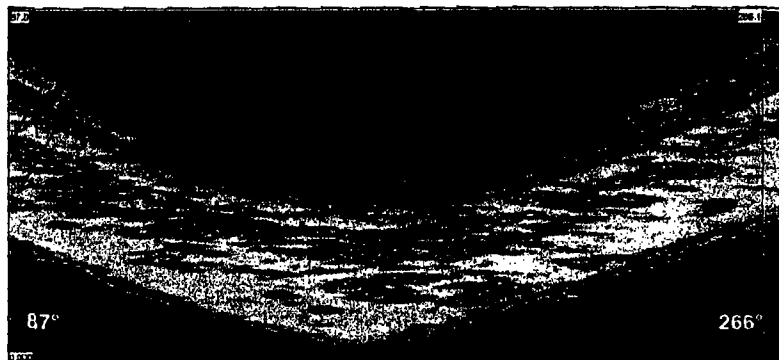
**Figure 8.11 C-scan Top View of the Downhill Section of the Weld with the Left Edge Red Line and Right Side Blue Line Slicing through the Image at Locations Corresponding to the Cut Surfaces in Figure 8.9. The horizontal axis represents 180 degrees and the vertical axis 155 mm (6.1 in.) approximately.**

B-scan side view images are displayed in Figure 8.12 for the 87- and 266-degree positions from Figure 8.11. The left side view image in Figure 8.12 at the 87-degree circumferential position shows the two defects with anomalous signals in between. The right image at the 266-degree position shows two possible defects with much lower signal amplitude, indicating smaller flaws.

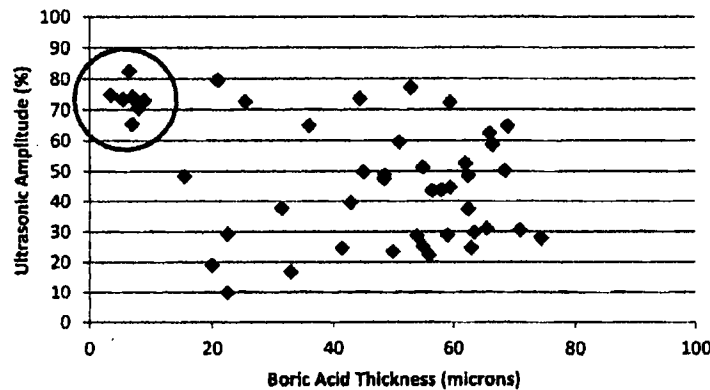
The relationship, if any, between the ultrasonic response values and boric acid values are displayed in graphical form in Figures 9.4 and 9.5. In the first graph, shown in Figure 9.4, the ultrasonic data are displayed as a function of the boric acid values for measurement points in the interference fit region. The points circled in the upper left corner represent bare metal or nearly bare metal points and point from the leak path. These points cluster separately from the remaining data and have ultrasonic values greater than 65% of full screen height and coating layer values less than or equal to 9 microns (0.35 mils). Furthermore, these points represent a strong ultrasonic response such as one associated with a reflection from a gap or void in the interference fit region. There was not close contact between the Alloy 600 tube outer diameter (OD) and the RPV head inner diameter (ID) materials at these locations and minimal or no boric acid or corrosion products were present. The points outside of the circled region represent the rest of the data and show no correlation between the ultrasonic response and the boric acid or coating thickness. The region is, however, bounded by boric acid deposits in the 16 to 75 micron (0.63 to 3.0 mils) range, while the ultrasonic responses almost cover the full range, spanning from 10 to 80% of full screen height.

Figure 9.4 Ultrasonic Amplitude as a function of Boric Acid Thickness from Points in the Interference Fit Region

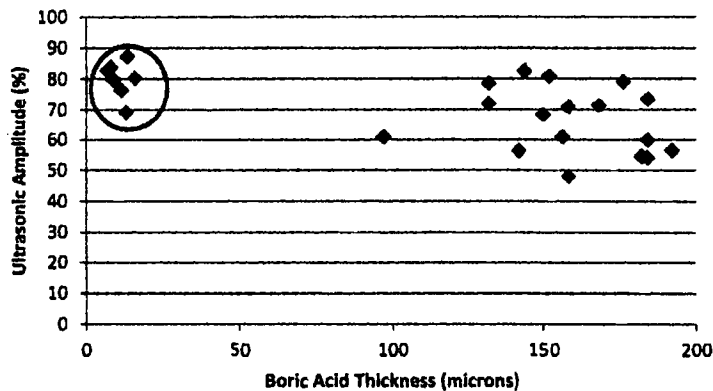
The data above and below the interference fit are displayed in Figure 9.5. The leak path or bare metal points are circled and have ultrasonic values between 69 and 87% and boric acid or corrosion thickness values of 16 microns (0.63 mils) or less. Outside of this circled cluster and the one isolated data point in the middle, the remaining data have boric acid thickness between 132 and 192 microns (5.2 and 7.6 mils) and ultrasonic amplitudes between 48 and 83%. The one outlier point is from the dry side on the uphill half and is towards the edge of a boric acid patch with a center-of-patch (0.7 in. or 17.8 mm to the center) thickness of 176 microns (6.9 mils).

**Figure 9.5** Ultrasonic Amplitude as a Function of Boric Acid Thickness (Low Points Above and Below the Interference Fit Region)

If this outlier or transitional point from Figure 9.5 is excluded, all of the boric acid measurements can be segmented into three categories. The leak path or bare metal regions have approximately less than 16 microns (0.63 mils) of boric acid/corrosion products. The interference fit points contain between 16 and 75 microns (0.63 to 3.0 mils) of boric acid, and the annulus region above and below the interference fit contain 132 to 192 microns (5.2 to 7.6 mils) of boric acid. These numbers are assumed to depend on the geometry of the particular control rod drive mechanism (CRDM) assembly and more specifically on the size of the interference fit and counter bore regions outside of the interference fit. It is reasonable to assume that with a leak, any interference fit or counter bore gap could fill with boric acid and corrosion products.

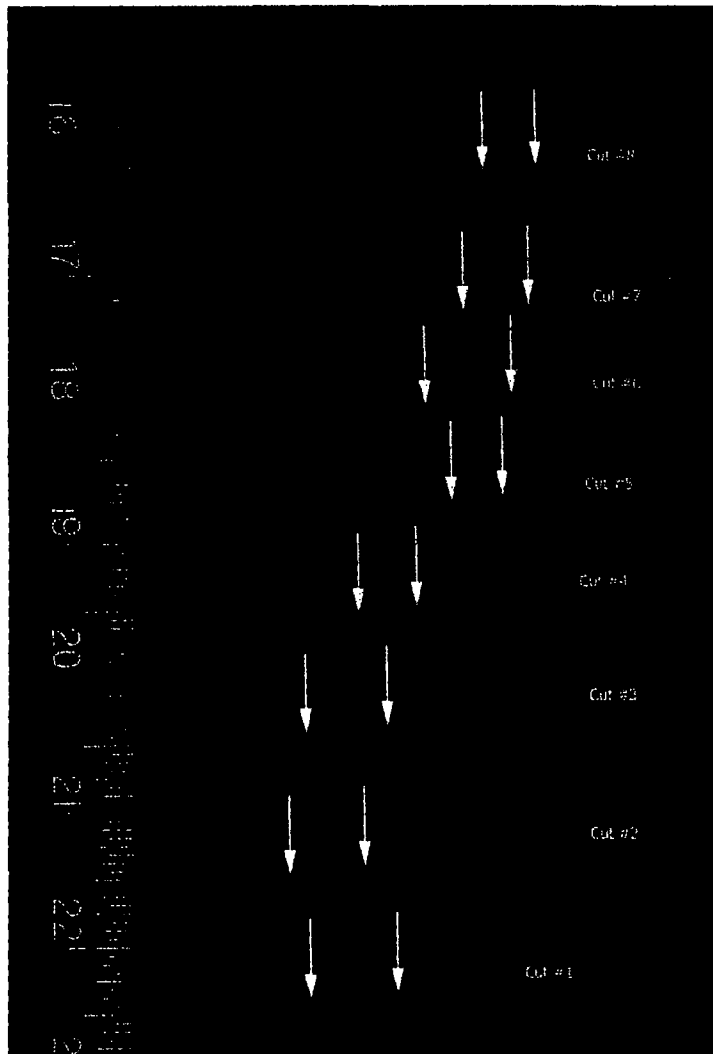
Lastly the replicated surfaces from Figure 9.8 were viewed with a stereomicroscope to better document the surface conditions and to attempt to quantify the corrosion or erosion of the low-alloy steel in the annulus region. Machining marks were observed on the replicated surfaces indicating minimal corrosion, erosion, or wastage throughout the leak path region. Interesting areas are discussed.

**Figure 9.8 Leak Path Replica with Cuts and Pieces Identified. The interference fit region is noted with the black line and is contained in pieces 4 through 9.**
