March 13, 2012

SUBJECT: Review of Draft NUREG/CR – XXXX Entitled, "Ultrasonic Phased Array Assessment of the Interference Fit and Leak Path of the North Anna Unit 2 Control Rod Drive Mechanism Nozzle 63 with Destructive Validation"

**Ultrasonic Phased Array
Assessment of the Interference
Fit and Leak Path of the
North Anna Unit 2 Control Rod
Drive Mechanism Nozzle 63 with
Destructive Validation**

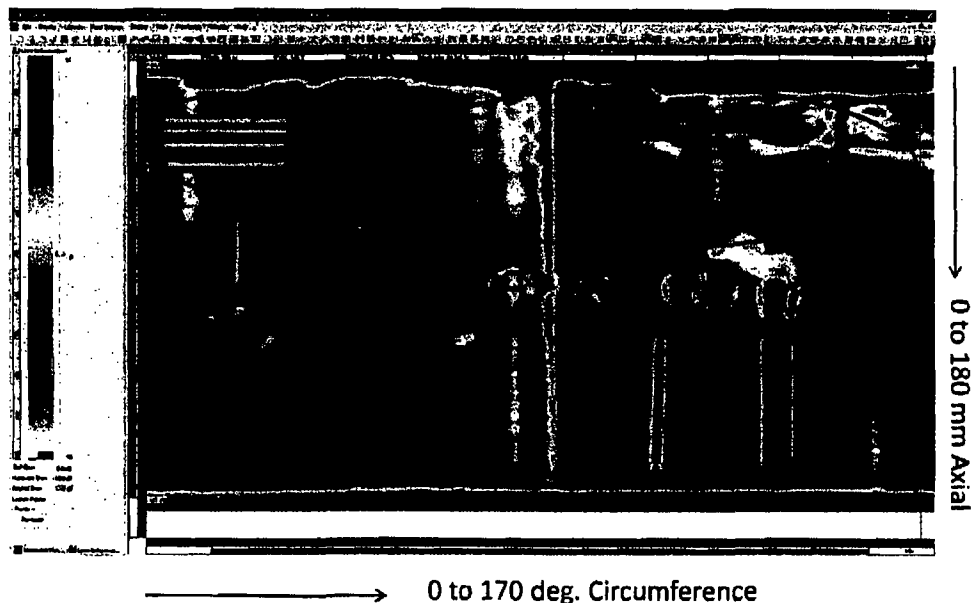
Figure 4.10 Top View, Plan View, or C-scan Ultrasonic Image of the Upper Interference Fit Region Containing Calibration Notches in the Alloy 600 Tube. Calibration notches are circled.

The set of notches in the upper right portion of the scanned image in Figure 4.10 varied in depth but had constant width. These very shallow notches were recognized because their shape and location were known, but they could have been missed based on amplitude response alone. Machining marks on the tube as well as variations in the interference fit produced a non-uniform background response for the fit region, complicating the detection. The center-to-center separations of these notches as ultrasonically measured were 23.84, 24.29, and 23.61 mm (0.939, 0.956, and 0.930 in.), respectively, whereas the actual spacing was 25.4 mm (1.0 in.) between each notch. Flaw depth information was not discernible in the first interference fit echo, but the second echo gave some indication of a flaw tip as noted by the red arrows in the upper part of Figure 4.13. This image represents the B-scan side view of the data while the lower image is a C-scan top view. A higher inspection frequency could have better resolved the small depth variations in these notches. The current second-echo ultrasonic data showed an approximate depth of 0.15 mm (0.006 in.) for all four notches, whereas the actual depths were 0.028, 0.051, 0.76, and 0.13 mm (0.001, 0.002, 0.003, and 0.005 in.), respectively. While these very shallow notches each presented a discontinuity that was ultrasonically detected, their depths were below the system depth or range resolution. For a greater than 50% bandwidth probe, the range resolution is on the order of one wavelength, which in Alloy 600 is approximately 1.1 mm (0.043 in.) at a 5-MHz inspection frequency.

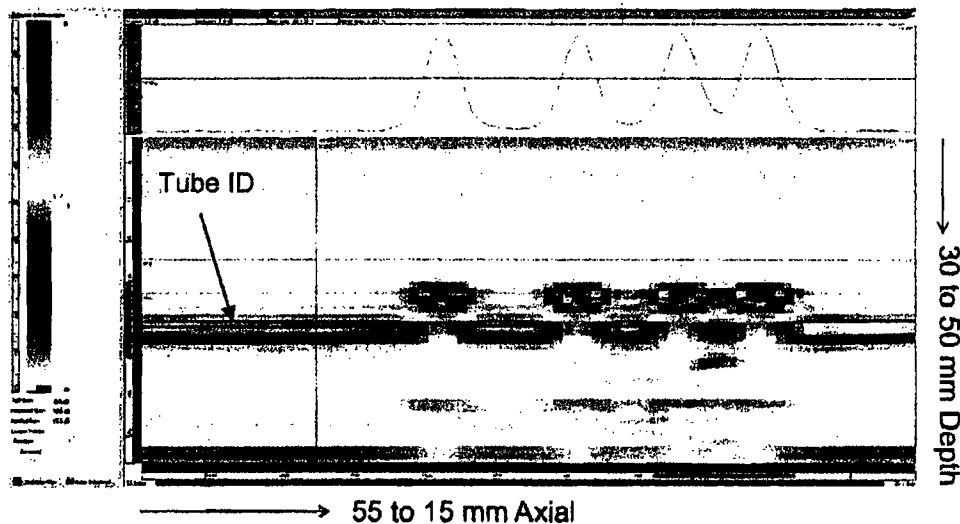
The data analysis software allowed electronic gating of signals in the time or depth dimension as well as positional dimensions Z and theta (axial and circumferential, respectively). The axial resolution notches were first gated or selected for analysis. An enlarged D-scan end view, as depicted in Figure 4.11 was used to measure the center-to-center spacing of the notches. This image was taken as viewed from the left edge of the image in Figure 4.10 and depicts depth into the material (along the sound path) in the vertical axis and the scanner index or nozzle axial direction in the horizontal axis. From this end view, an "echodynamic" curve or profile was generated along the red horizontal line drawn through the responses from the notches, and was plotted above the image. The measured notch widths, from left to right, as measured at the half-amplitude points, were 2.0, 2.0, 2.5, and 2.5 mm (0.08, 0.08, 0.10, and 0.10 in.), respectively. This represents only 4 or 5 pixels with each pixel equal to 0.5 mm (0.02 in.). The actual notch widths were 2.08, 2.06, 2.16, and 2.11 mm (0.082, 0.081, 0.085, and 0.083 in.), respectively. Notch depths were measured as 2.06, 2.06, 2.03, and 2.03 mm (0.081, 0.081, 0.080, and 0.080 in.), respectively. Actual depths were 2.06, 1.95, 2.00, and 2.00 mm (0.081, 0.077, 0.079, and 0.079 in.), respectively. The data suggested that cracks as small as approximately 1 mm (0.04 in.) in depth could be accurately measured. Also, the notches could be clearly distinguished from each other, providing an indication of lateral probe resolution in the nozzle axial direction. In this set of notches, the actual center-to-center separations were 7.11,

5.08, and 4.06 mm (0.28, 0.20, and 0.16 in.), respectively. The measurements from the ultrasonic data gave separations of 7.0, 5.5, and 4.0 mm (0.28, 0.22, and 0.16 in.), respectively. These highly correlated data values and the data image indicated that an axial resolution of better than 4.0-mm (0.16-in.) was achievable.

Figure 4.11 D-scan End View of the Axial Resolution Notches in the Inconel Tube

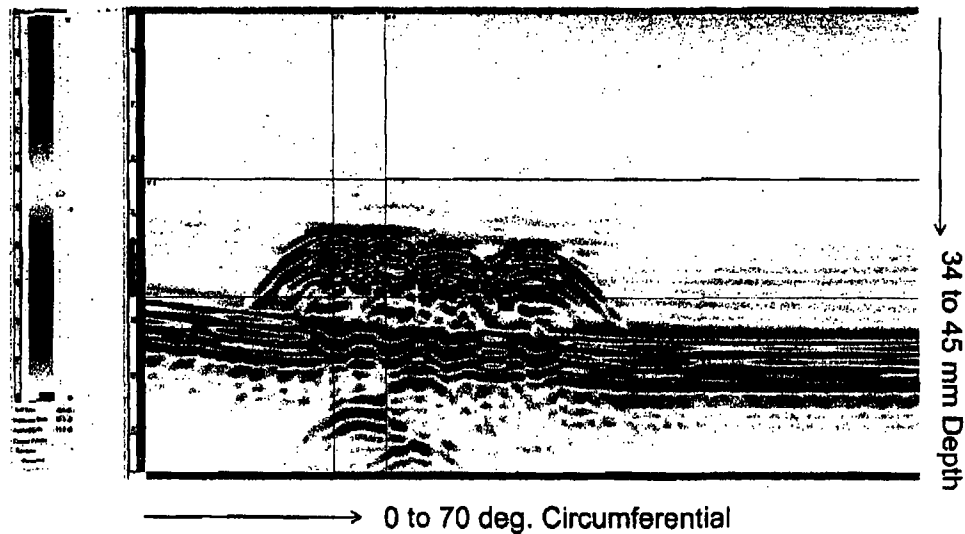
The gated circumferential resolution notch set is shown in Figure 4.12. This image was taken as viewed from the bottom edge in Figure 4.10. Notice that the closely spaced two notches on the left are overlapping but they are still resolvable. Peak-to-peak values gave measured notch separations of 4.36, 5.18, and 6.82 mm (0.17, 0.20, and 0.27 in.), respectively. The actual separations were 4.06, 5.08, and 7.11 mm (0.16, 0.20, and 0.28 in.), respectively. This is greater error than was observed for the axial direction. This test demonstrated a circumferential probe resolution of approximately 4.4 mm (0.17 in.).

Figure 4.12 B-scan Side View of the Circumferential Resolution Notches in the Inconel Tube

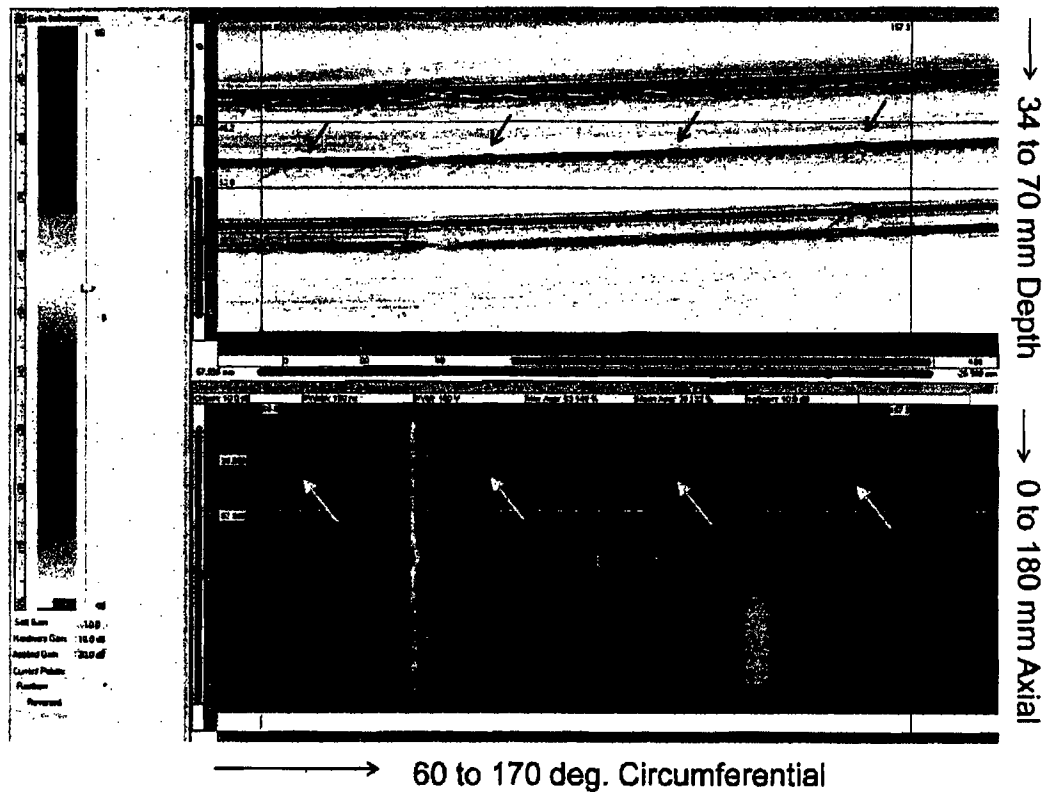
Figure 4.13 The Second Echo Is Gated in the Side View Image in the Top of Figure with the Horizontal Lines. The corresponding C-scan top view is displayed in the bottom image. This second echo captures a disturbance in the back-wall echo showing some depth information, noted by the red arrows at top. The yellow arrows note the depth-varying notches.

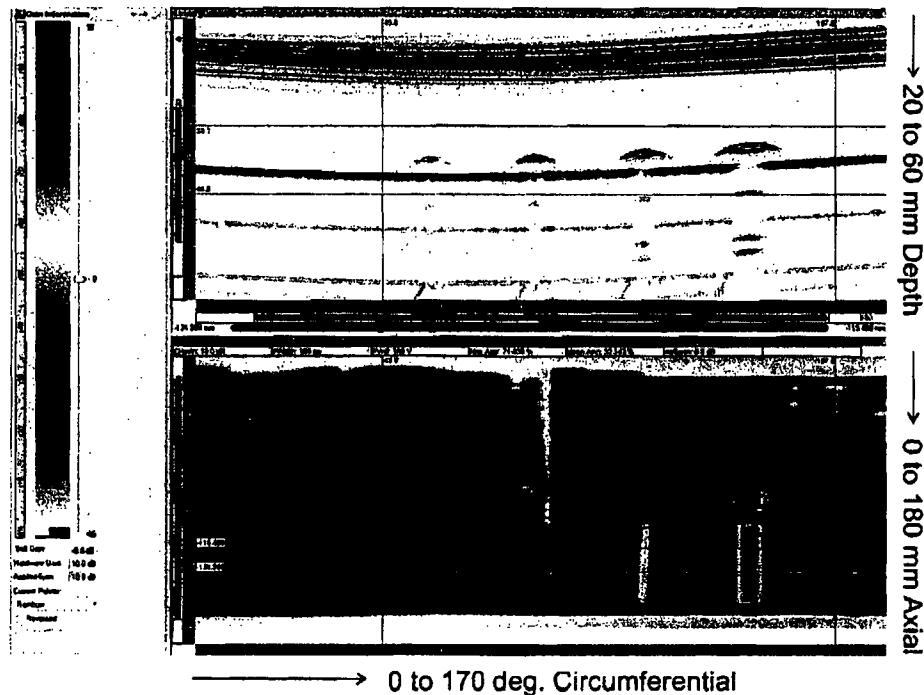
The final set of notches contained width variations and are shown in Figure 4.14. These flaws were ultrasonically measured with depths of 2.2, 2.5, 2.7, and 2.9 mm (0.09, 0.10, 0.11, and 0.11 in.), respectively, left to right in the image, while the actual depth was 2.53 mm (0.10 in.) for all notches. The measured center-to-center spacings were 23.1, 24.8, and 23.8 mm (0.91, 0.98, and 0.94 in.), respectively, while actual spacings were all 24.5 mm (1.00 in.). Finally, the widths of the flaws were measured in two ways. The first method used the width of the upper part of the flaw response, and the second method used the width of the loss of back-wall signal. The loss of back-wall signal technique was more accurate with measured widths of 3.91, 3.36, 5.00, and 8.82 mm (0.099, 0.126, 0.154, and 0.298 in.), respectively. Actual widths were 0.80, 1.61, 3.24, and 6.42 mm (0.031, 0.063, 0.127, and 0.253 in.), respectively. When measured from the second ultrasonic back-wall echo, the loss of signal measurements gave notch widths of 1.36, 2.73, 3.82, and 7.00 mm (0.054, 0.107, 0.150, and 0.276 in.), which were closer to the actual values. The probe spot size when focused at the interference fit, or 15 mm (0.59 in.) into the Alloy 600, was modeled at 1.2 x 1.2 mm (0.047 x 0.047 in.) at the -6 dB points. Flaw width

Figure 4.14 B-scan Side View on Top and C-scan Plan View on Bottom of the Width Varying Notches in the Inconel Tube

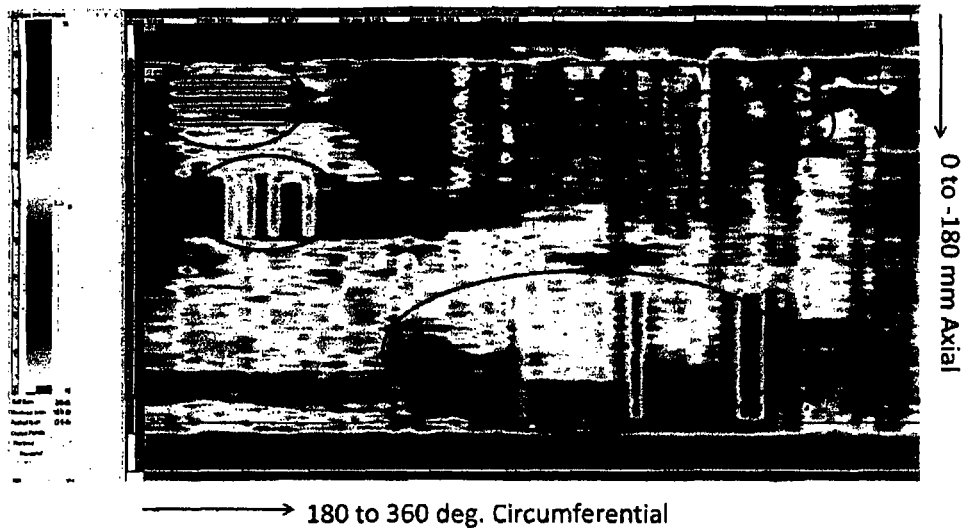
The 180–360 degree portion of the upper fit region in the CRDM mockup contained notches in the carbon steel block to simulate degradation or wastage of the RPV head material. These notches were on the far side of the interference fit relative to the location of the probe. Because the interference fit was not uniform, the notch responses were not as clear as those for notches in the tube, as evident in Figure 4.15.

Figure 4.15 C-scan Plan View of the Notches in the Carbon Steel from the First Ultrasonic Echo. The calibration notches are circled.

The axial resolution notches in the top left of the figure were resolved, but the lower notch was on the edge of a high-amplitude region. The measured center-to-center spacings were 3.90, 4.58, and 6.88 mm (0.15, 0.18, and 0.27 in.), respectively, while actual spacings were 4.06, 5.08, and 7.11 mm (0.16, 0.20, and 0.28 in.), respectively. Axial resolution was therefore approximately 4 mm (0.16 in.) or better.

Measurements from the circumferential resolution notch pattern showed center-to-center spacings of 3.82, 5.00, and 7.54 mm (0.15, 0.20, and 0.30 in.), respectively, with actual spacings of 4.06, 5.08, and 7.11 mm (0.16, 0.20, and 0.28 in.). Circumferential resolution was also approximately 4 mm (0.16 in.) or better.

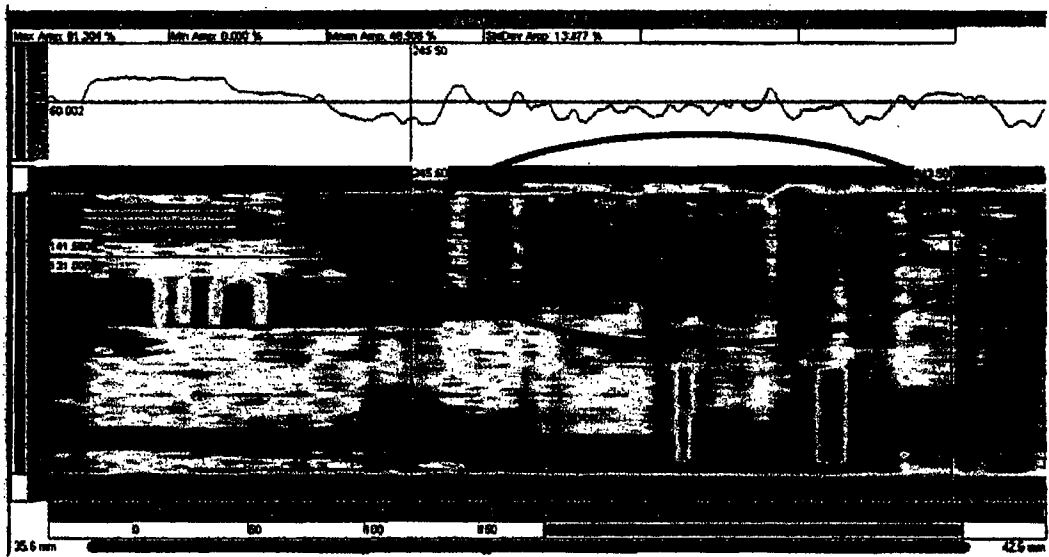
The variable depth notches in the top right of Figure 4.15 were detected but depths could not be measured. First and second echo images are shown in Figures 4.16 and 4.17, respectively. Center-to-center spacing was ultrasonically measured at 23.9, 22.4, and 24.4 mm (0.94, 0.88, and 0.96 in.), respectively, with an actual spacing of 25.4 mm (1.00 in.) for all notches.

Figure 4.16 C-scan Plan View of the Depth Notches in Carbon Steel, Circled on the Upper Right. This image was acquired from the first ultrasonic echo.

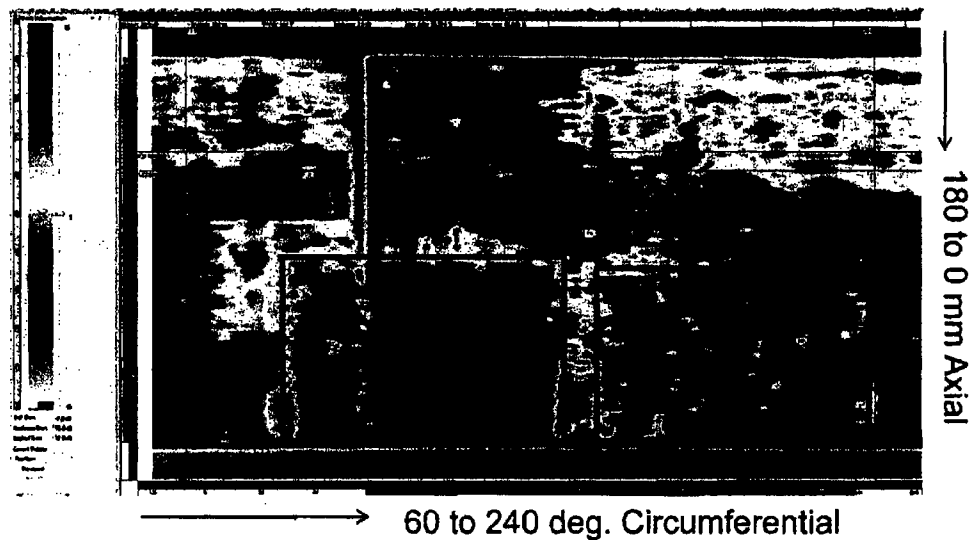
The top view, C-scan images from the mockup with boric acid deposits in the interference fit region are displayed in Figures 4.19 and 4.20. The first image represents the 60 to 240 degree circumferential region and the second image represents the 240 to 60 degree circumferential region, both as captured by the first echo. The boric acid regions were readily detected as lower amplitude response and are outlined with red boxes. Again, notice machining marks and non-uniformity in the interference fit response. The amplitude relevance is discussed in the next section.

Figure 4.19 C-scan Plan View of the Boric Acid Deposits, Boxed in Red, in the Lower Interference Fit Region. The horizontal axis represents the circumferential range of 60–240 degrees. This image is from the first ultrasonic echo.

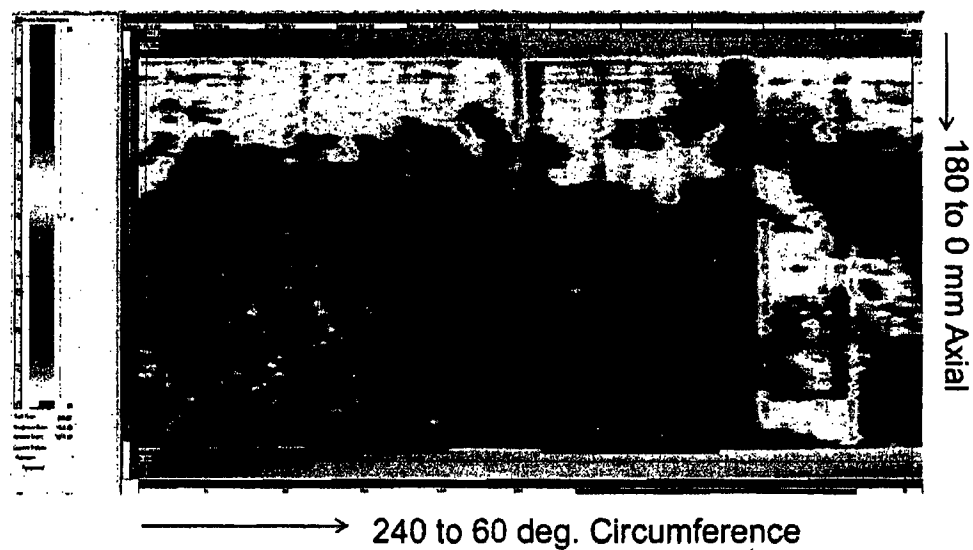
Figure 4.20 C-scan Plan View of the Boric Acid Deposits, Boxed in Red, in the Lower Interference Fit Region. The horizontal axis represents the circumferential range of 240–60 degrees. This image is from the first ultrasonic echo.

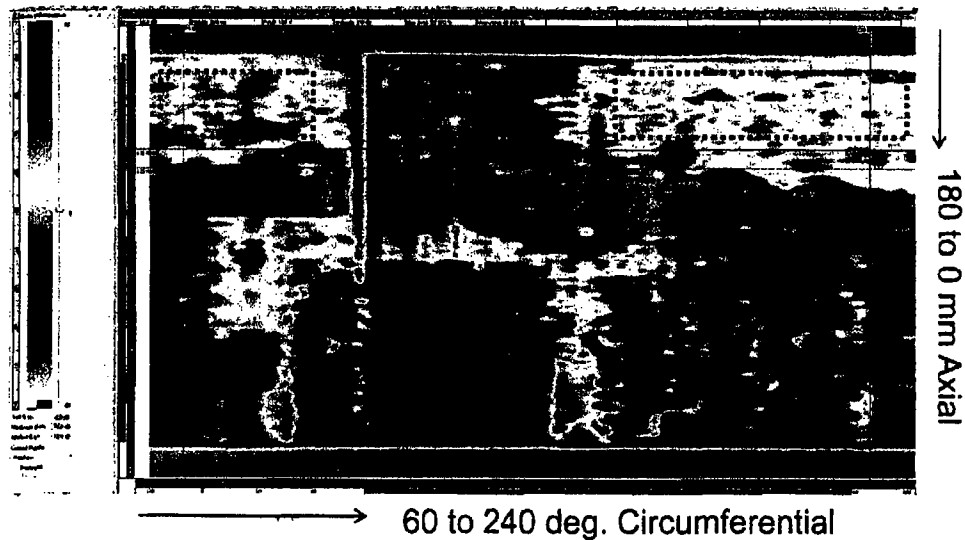
Figure 4.21 The Interference Fit Region Containing Boric Acid is Subdivided into Three Regions. The red box represents the presence of boric acid in the interference fit region, the black dashed boxes represent the tube region, and the black dotted boxes represent the interference fit region.

The data images were analyzed with a total image gain of 12 dB. This represented 10 dB of hard gain applied during acquisition and 2 dB of soft gain applied during analysis. The mean responses from the interference fit regions without boric acid deposits were in the range of 40 to 55 percent of full-screen amplitude. This range of values was due to the variability in the fit itself. Some regions of the fit were tight, giving lower reflected amplitude and more transmitted energy. This condition is represented by the green color in the image. Other regions of the fit showed higher reflected energy (not tight), thus less transmitted energy, and this state is represented by the yellow-to-orange colors. Machining marks were evident and also lead to

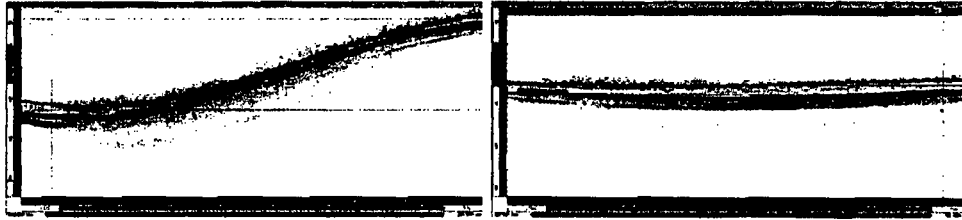
Figure 5.1 Alloy 600 Tube ID Response Before (left) and After (right) Centering the Scanner on the Nozzle. The horizontal axis represents approximately 180 degree and the vertical axis 20 mm (0.79 in.).

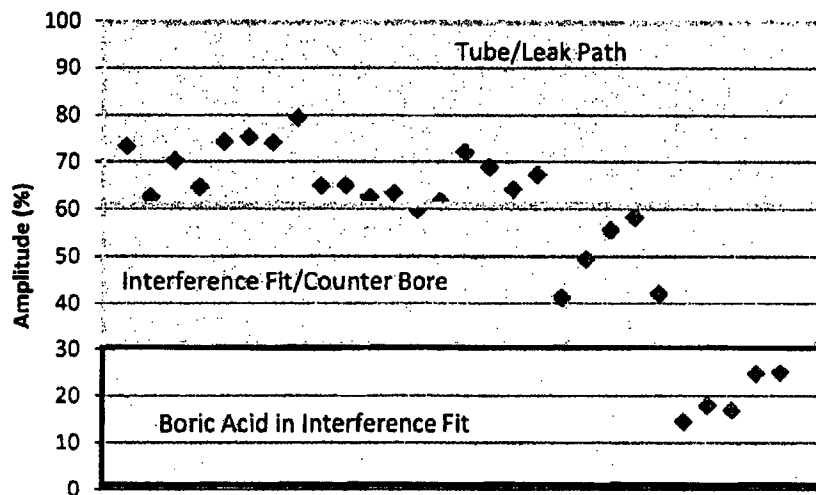
Figure 5.6 Mean Amplitude Response from the Regions Indicated in Figures 5.4 and 5.5

In summary, the mean amplitude responses from the different regions in the data image were measured. Based on this analysis, the regions are separable and compare favorably to the responses measured previously on the calibration mockup specimen. A comparison of the responses is presented in Table 5.1. Note that the Nozzle 63 data were acquired with 1 dB

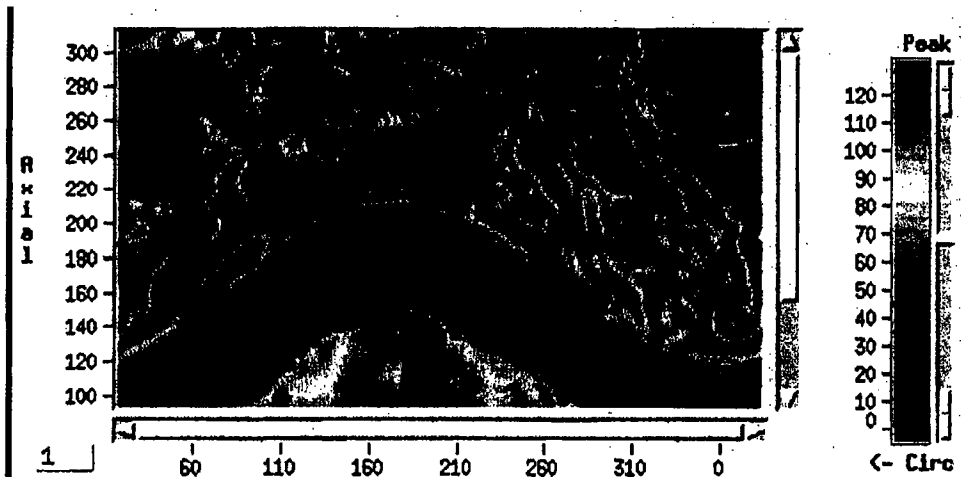
Figure 5.9 Ultrasonic Data from Nozzle 63 as Obtained by WesDyne International. The image was acquired with a 2.25-MHz probe. The horizontal axis represents the nozzle circumference in units of degrees. The vertical axis represents the nozzle axis in units of millimeters.

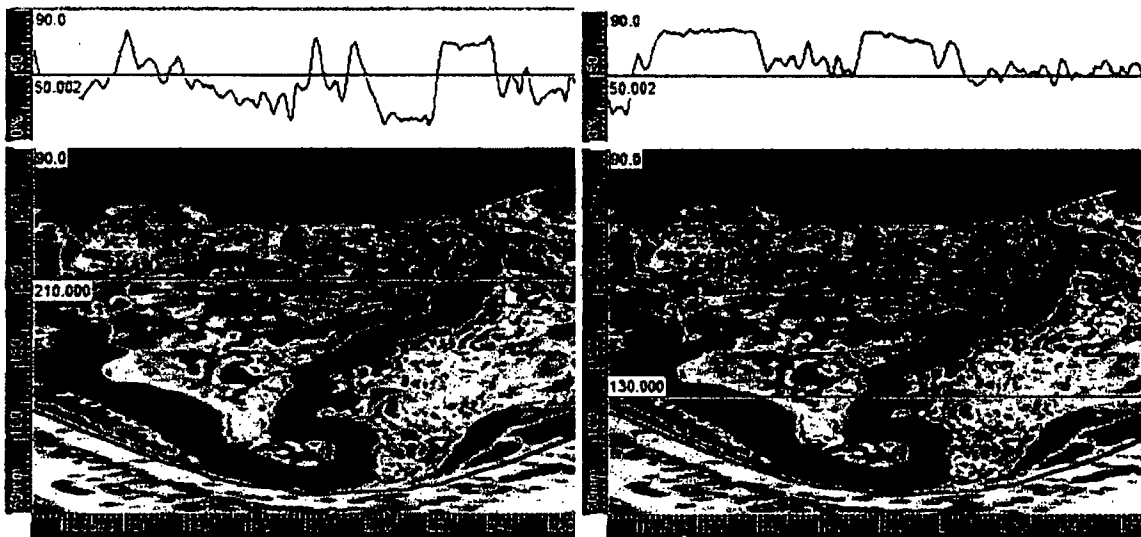
The relationship between the ultrasonic response values and eddy current (EC) thickness values was explored in more detail. As was previously demonstrated in the mockup evaluation, the large-amplitude ultrasonic data represent a gap in the interference fit. These data regions are represented by the color orange in the rainbow color bar previously shown in Figure 5.3, for example. Two horizontal profiles that display ultrasonic amplitude variations along the selected measurement line in the image are shown in Figure 8.3. The left image displays a profile taken along the red horizontal line located in the interference fit region. Clearly the high ultrasonic response is evident across the main leak path and then the response falls off on either side, of the leak path. The left side drop off is more severe in the profile and is associated with the blue color in the image, while the right side drop off is moderate and is associated with the yellow color in the image. The right image displays a profile taken along the red horizontal line in the image below the interference fit. The profile as well as the data image, again, shows a high-amplitude ultrasonic response for the leak path regions with signal drop off on both sides of the leak paths. At this axial position in the annulus, the drop off is smaller than that observed in the data from within the interference fit on the left.

Figure 8.3 Ultrasonic Response Profile at Top, Acquired Along the Red Horizontal Line in the Image Below. The left image profile is in the interference fit and the right image profile is outside of the interference fit.

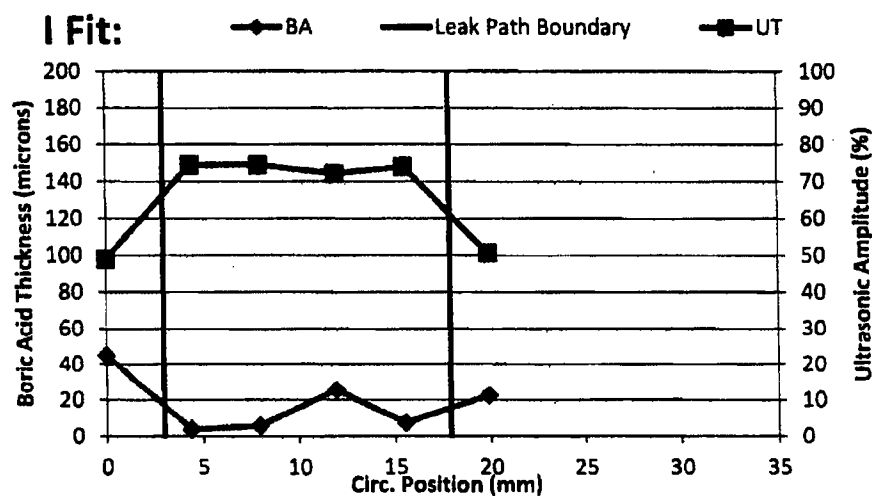
The inherent characteristic of a leak path in the ultrasonic image was suggested and verified as that of a high-amplitude response that traversed the entire interference fit (I fit) region. The primary leak path boric acid measurements obtained with the eddy current probe further show that the leak path was characterized by a region with a minimal or no boric acid/corrosion layer. This inverse relationship is represented in Figures 8.4 and 8.5. Eddy current data obtained at the red points spanning the primary leak path in Figure 8.1 are plotted as boric acid (BA) data in blue diamonds. The corresponding ultrasonic data at those same points are plotted as ultrasonic test (UT) data in red squares. Figure 8.4 represents data obtained in the interference

fit region and Figure 8.5 represents data outside of the interference fit from the primary leak path points, red in Figure 8.1. In each figure below, the leak path boundary is noted by two black horizontal lines. Both figures show that leak path data points are represented by this characteristic high ultrasonic response (above 70%) and low boric acid/corrosion layer thickness (approximately below 20 microns [0.79 mils]). More specifically, the BA/corrosion layer thickness within the interference fit is below 7 microns (0.28 mils) with the exception of the data point acquired at the island position in the main leak path. Here a larger thickness value of 25.5 microns (1.0 mils) was measured. Similarly, for data outside of the interference fit but still in the primary leak path, the layer thickness values were below 12 microns (0.47 mils) except for the data point at the rust-colored streak in the middle at 16 microns (0.63 mils). Moving outside of the leak path, the ultrasonic response drops and the BA/corrosion layer increases. Within the interference fit, Figure 8.4, this increase in BA/corrosion layer thickness is much smaller as can be expected. The interference fit region has little to no gap between the nozzle and RPV head but this condition is variable throughout the fit (Hunt and Fleming 2002). Boric acid presence in this region would likely be a thin layer and more compacted as noted by the low (blue-colored) ultrasonic response. Outside of the interference fit, the BA/corrosion layer increases more dramatically on either side of the main leak path, to nominally 185 microns (7.28 mils). A wider gap was present in the annulus region outside of the interference fit due to a machined counter bore (refer to Figure 1.1). The data suggest that this gap fills with boric acid. Note that the ultrasonic response shows a smaller drop on either side of the leak path possibly indicating that the boric acid was less compacted in this region.

Figure 8.4 Ultrasonic and Boric Acid/Corrosion Layer Thickness Along a Line Across the Main Leak Path in the Interference (I) Fit

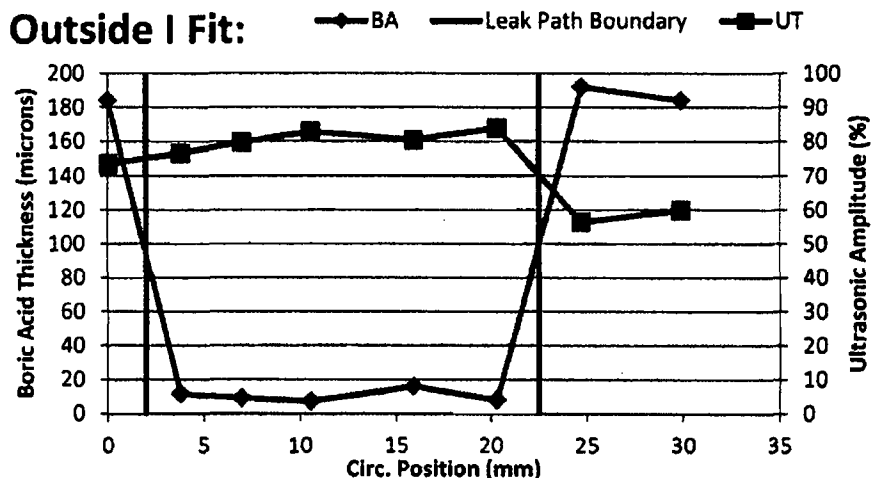
Figure 8.5 Ultrasonic and Boric Acid/Corrosion Layer Thickness Along a Line Across the Main Leak Path Outside the Interference Fit

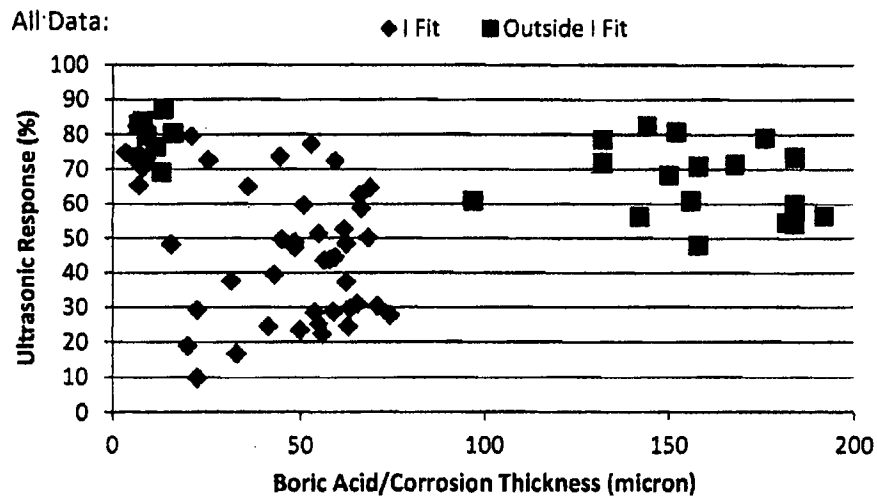
Lastly, an attempt was made to correlate the ultrasonic and eddy current measurements at all 70 data points. In this analysis, the data points were segregated as the interference fit region and outside of the interference fit region. Initially, all of the points were plotted with results shown in Figure 8.6. Points with high ultrasonic response and BA/corrosion thickness, upper left, are primarily associated with the main leak path region and represent areas where any potential deposits are flushed out and not allowed to remain. In addition to the primary leak path, other partial leak paths and regions with possible bare metal, lacking deposits, were identified. All of these leak path and bare metal points are plotted in Figure 8.7. These points represent a gap in the annulus, noted by the high ultrasonic response. Deposits as measured with the EC probe could be present but are not compacted throughout the annulus thickness. The remaining points (70 original points minus the leak path and bare metal points) represent the nominal annulus condition and are plotted in Figure 8.8. An ultrasonic amplitude level of approximately 50% divides the data between an interference fit response and one outside the interference fit region. For this nozzle, the BA/corrosion layer thickness values in the interference fit are less than 75 microns (3.0 mils), and outside the interference fit are greater than 130 microns (5.12 mils). The center point, with a layer thickness of 97 microns (3.82 mils) in Figure 8.8, can be excluded as it was obtained at a location where there is a noticeable boric acid deposit on the nozzle side. This additional deposit, though not quantitatively known, would increase the layer thickness value moving the point to the right and likely in the range of the other "Outside I Fit" data points. The other outlier point (EC value of 9 microns [0.35 mils] and UT value of 73%) is from the interference fit data and was obtained at a rust-colored region so it was not included in the bare metal points. This outlier is possibly explained by positional registration error of the data points. For example, ultrasonic data in a narrow secondary leak path varied from a value of 83 to 44% within and outside the leak path, respectively. Also the accuracy in acquiring EC data at the exact points specified on the photograph varied as definitive local boundary markers on the component were not always present. This is to say that these measurements have some positional error that cannot be eliminated. Nevertheless,

- Leak paths
 - a. High UT response, >60%
 - b. Minimal boric acid/corrosion layer EC measurement, <16 microns (0.63 mils)
- Outside the leak path
 - a. Inside the interference fit region
 - i. UT response <50%
 - ii. EC measurement low, 15–75 microns (0.59–3.0 mils)
 - b. Outside the interference fit region
 - i. UT response >50%
 - ii. EC measurement larger, 130–190 microns (5.12–7.48 mils)

Figure 8.6 Comparison of Ultrasonic Response and Boric Acid/Corrosion Layer Thickness at all 70 Acquired Data Points
