STATUS REPORT ON THE
INVESTIGATION OF THE DEWATERING SYSTEM
OCTOBER 27, 1978

The purpose of this report is to document the status of the investigation and actions being performed on the dewatering system at the San Onofre Units 2 and 3 construction site. This report provides a summary of work accomplished during the month of September 1978.

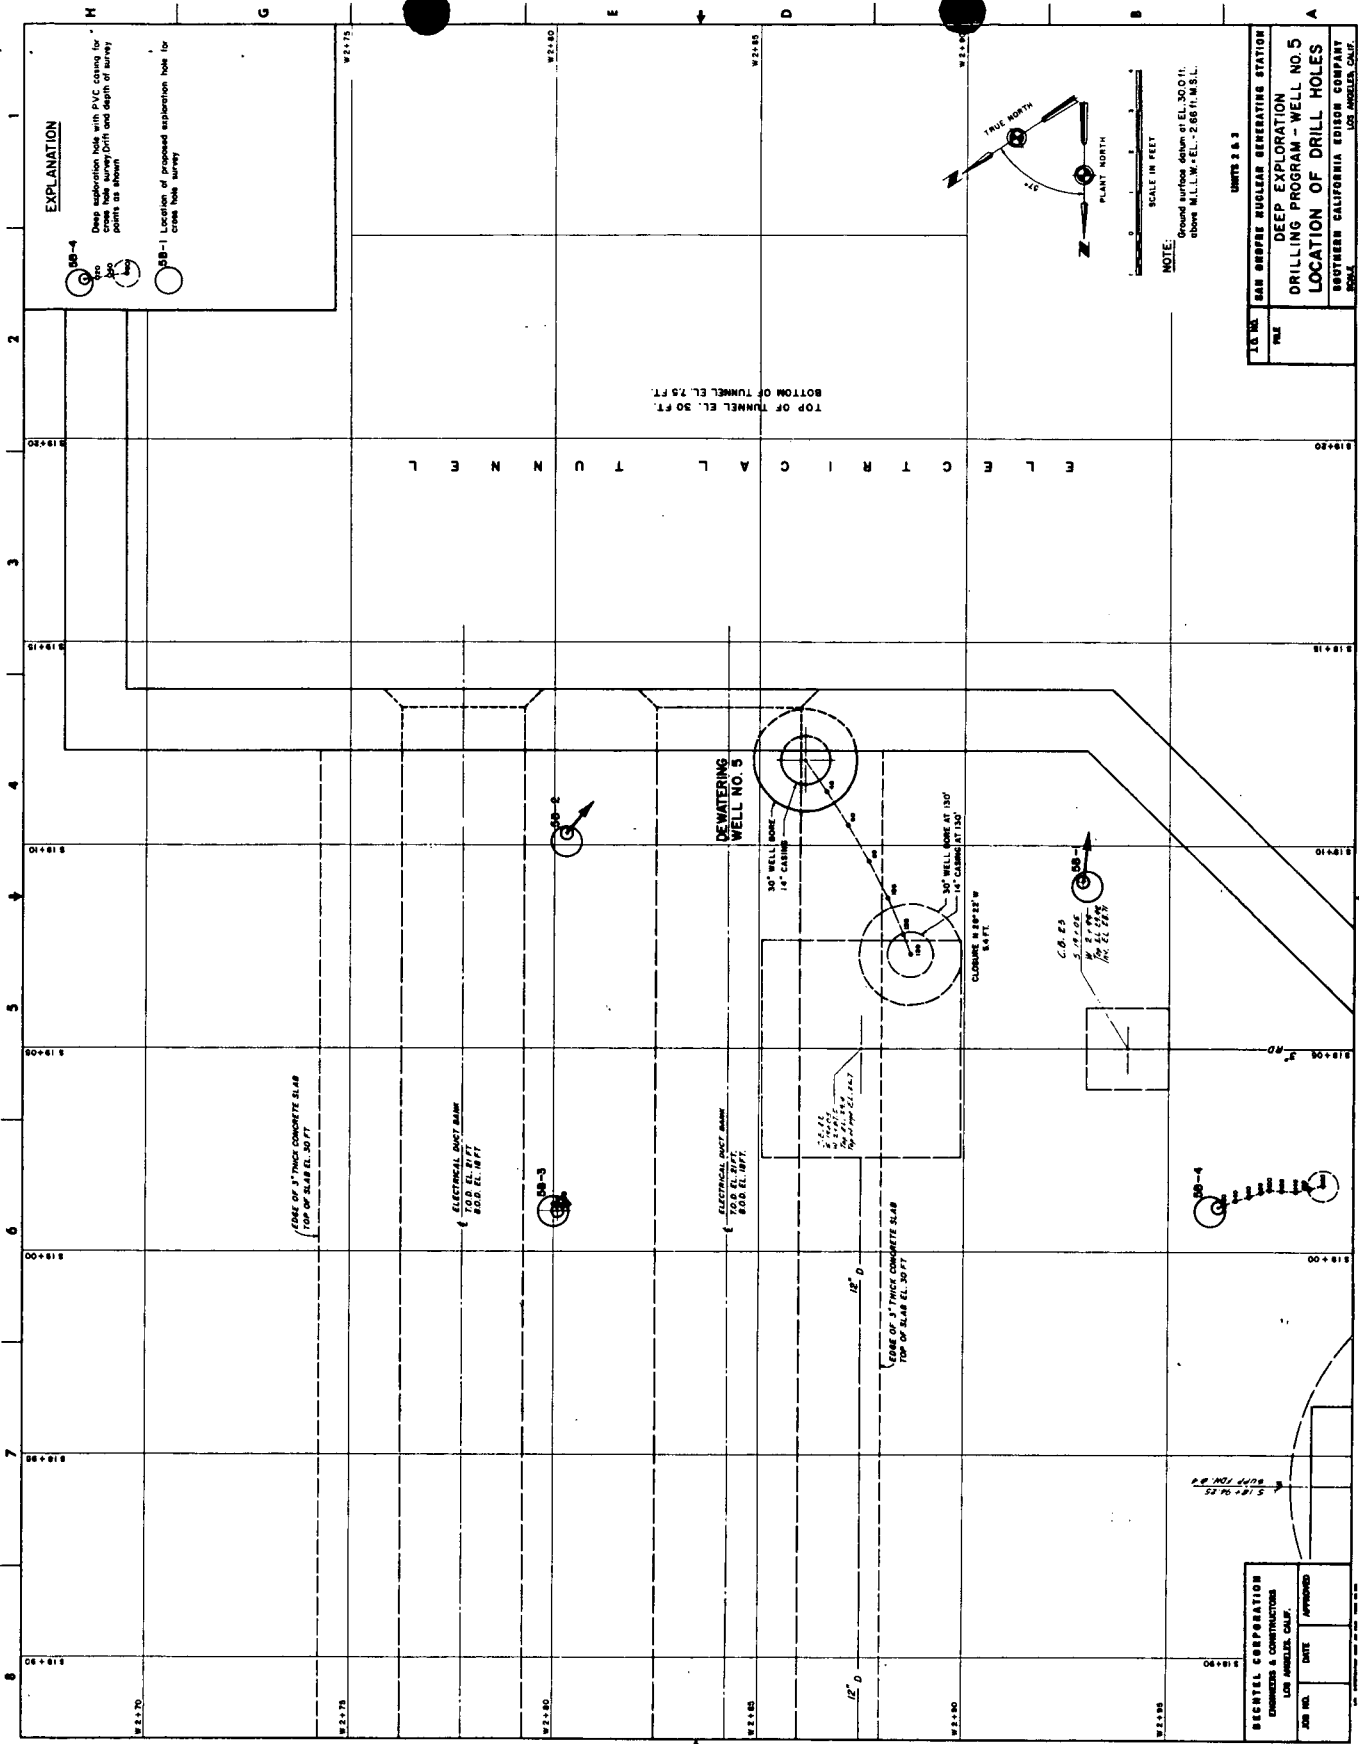
Fig. 1 - STATUS SUMMARY OF INVESTIGATION / DEMOBILIZATION OF WELLS AS OF 1 OCTOBER 1978

3A	Offline, Test Well Demobilized	None	Casing in place, TV to 296'	Lightly Encrusted some corrosion	No	No	Yes	No	No	None	Well operated a few days as test well; only 6' fill in bottom of well. TV showed minor encrustations and some lower corrosion, gravel pack visible where J-louvers were enlarged; well completely demobilized by gravity grouting the casing.
4	Offline, Very Low Maint.	—	Casing in place, TV to 198'	Heavily Encrusted	Yes	Yes (inside casing)	—	—	—	—	Well initially demobilized by cutting off top, filling with sand, and welding steel cap on top. Presently uncovered, larger (4" diameter) working casing set, accessible for investigation/demobilization. Inclination of well bore was measured.
5	Offline, High Maint.	21 borings to El. -20 to -175'	Casing in place, TV to 141'	Heavily Encrusted below 50'	Yes	Yes	—	Yes, Cement to El. -23'	—	Yes	Cavity detected near working surface by borings; 30' casing placed around well casing to El. -25' and cavity pressure grouted. Large diameter working casing set for investigation/demobilization. Casing cleaned to 141'. Inclination of well bore was measured.

6	Offline, High Maint.	35 borings to El. -20 to -170' (19 slope indicators) 21 deep borings to El. -29 to -170'	Casing 200' removed, TV to 200'	Bad Deterioration below 115'	Yes	Yes Casing backfilled w/sand	Yes	Yes	Mech. & Sonar	Yes	Cavity detected by borings, inside casing cleaned by airlift and photographed, annulus and cavity partially cleaned of gravel and loose sand by airlift, cavity measured by mechanical caliper and sonar. Below 143' casing is almost non-existent but gravel pack and asphalt coating in place. (NOTE: Bailing tried in early stages but caused too much disturbance in well and was discontinued). A 36" casing was redriven from 108 to 118'. The casing weld broke at about 43', with about a 3" horizontal offset. Seals for the offset have been placed and airlift cleaned to 128-1/2'. The casing filled to 124', airlifted to 134-1/2' for bottom camera inspection. Casing filled to 125'. Open cavity filled with gravity grout. Deep exploration drilling has been completed. The gravel hole drilling and grouting is presently in progress.

7	Offline, Very High Maint.	54 borings to El. -18 to -170' (19 slope indicators) 26 deep borings to El. -20 to -170'	Casing 199' removed, TV to 199', 199'10" removed	Bad Deterioration 10" casing also bad	No	Yes	Partial Fill	—	Limited Sonar	Yes	New 10" casing placed early in operation inside original 14" casing because well filled with sand (removed by bailing). Cleaned inside 14" and 10" casing to bottom of hole. Attempted cleaning of annulus around 14" casing, but unable to advance because of volume of material. Filled 119' of 10" casing. Attempted retrieval of remainder of 10" casing by tool. The tool became lodged in the 14" casing at 132'. Partial concrete and sand filling of the open cavity on east side and a portion of west side has been completed. Well is presently accessible for investigation/demobilization. Cavity detected by borings. The deep exploration drilling is presently in progress.

8	Offline, Demobilized, High Maint.	66 borings to El. -5 to -25' (12 slope indicators) 18 deep borings to El. -142 1/2 to -172 1/2'	142' Casing removed, TV from 142 to 185' through telescope casing	Minor Corrosion 100-120' highly corroded below 120'	Yes	Yes	Yes	Yes	Mech.	Yes above a depth of 115'	Casing and annulus was cleaned with airlift with casing lagging cleaning; casing removed and cavity calipered, boreholes drilled to define plan size and depth of cavity, central access casing set, grout pipe set through cavity and cavity filled with grout (gravity), subsidence occurred at west end due to local water rise during gravity grouting, area below pressure grouted, telescoping casing set and airlift operation resumed. Casing had to be telescoped to a 160' depth due to casing. Positive head airlifted to 192' and TV logged to 183'. The cavity was gravity grouted and excavation of the Unit 3 P&S Tunnel to El. 47' completed. The deep drilling exploration has been completed. The gravel hole drilling and grouting has been completed. The well was demobilized August 1978.

9	Offline, Demobilized, High Maint.	None	200' Casing removed, TV to 200' in casing	Heavily Encrusted with some corrosion below 90'	No	Yes	Yes	No	Mech.	No	Annulus around casing and 46' of fill in casing cleaned, casing removed in good structural condition with some minor corrosion below 90' (no holes larger than J-louvers), caliper indicated no borehole enlargement indicative of erosion, well completely demobilized by gravity grouting.
10	Operational, Avg. to Low Maint.	—	200' Casing TV to 189'	Heavily Encrusted	No	—	—	—	—	—	Presently accessible for investigation/demobilization, currently in operation, lost visibility on TV below 150'.
11	Operational, Avg. Maint.	—	200' Casing TV to 200'	Very Heavily Encrusted	No	—	—	—	—	—	Outside Plant area, no investigation work planned.
12	Operational	—	—	—	No	—	—	—	—	—	Outside Plant area, no investigation work planned.
