SUBJECT: Forwards info summarizing feedwater ring damage, discussed at NRC 810731 meeting. Proposed feedwater ring mods render auxiliary feedwater initiation test unnecessary. Final design details for repair will be provided.

Subject: Docket Nos. 50-361 and 50-362  
San Onofre Nuclear Generating Station  
Units 2 and 3

SAN ONOFRE UNIT 2 FEEDWATER RING DAMAGE

PRELIMINARY REPORT OF CONDITION OF  
FEEDWATER PIPE ASSEMBLY  
IN  
SAN ONOFRE UNIT 2, NO. 2  
STEAM GENERATOR

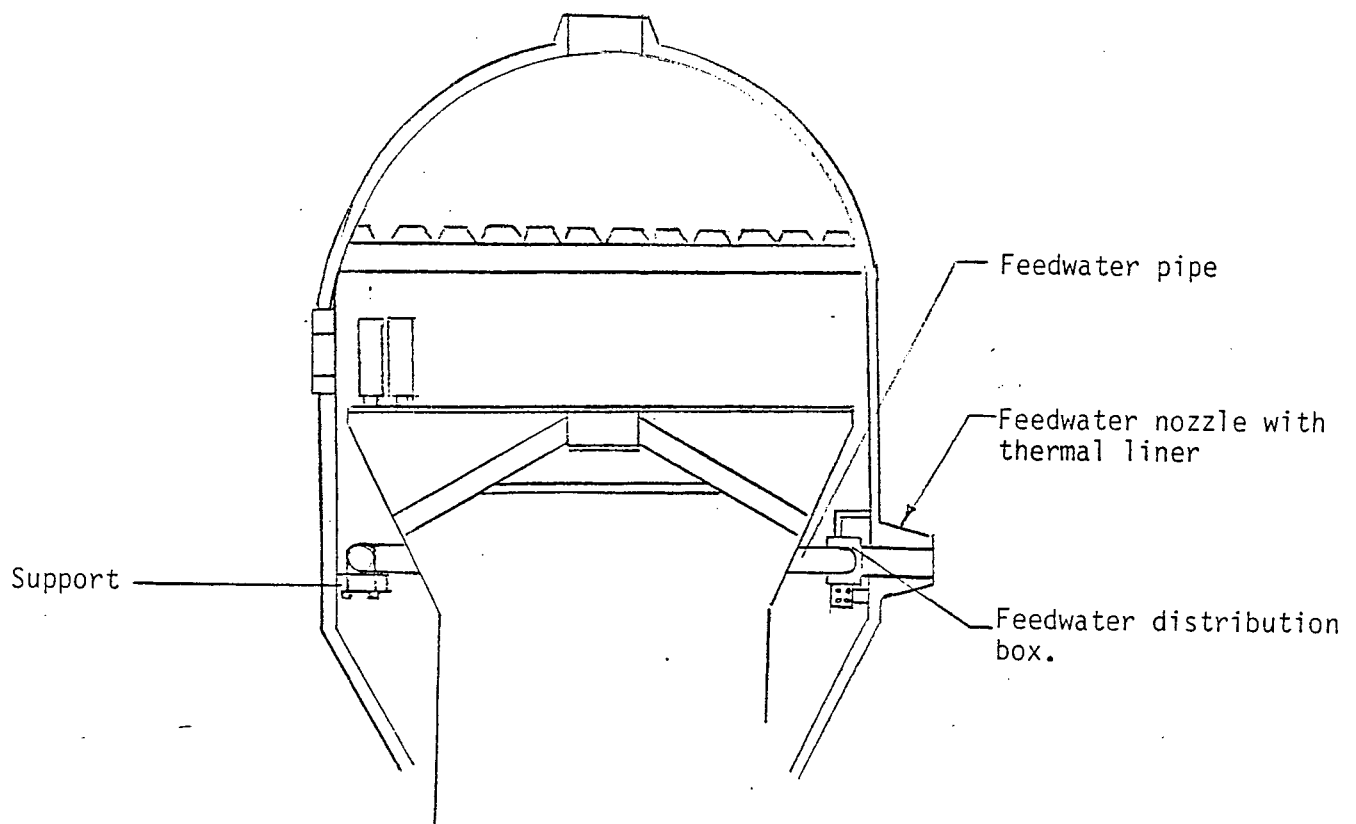
The feedwater pipe is located in the down comer approximately 75" below the Steam Separator Support Deck (Can Deck).

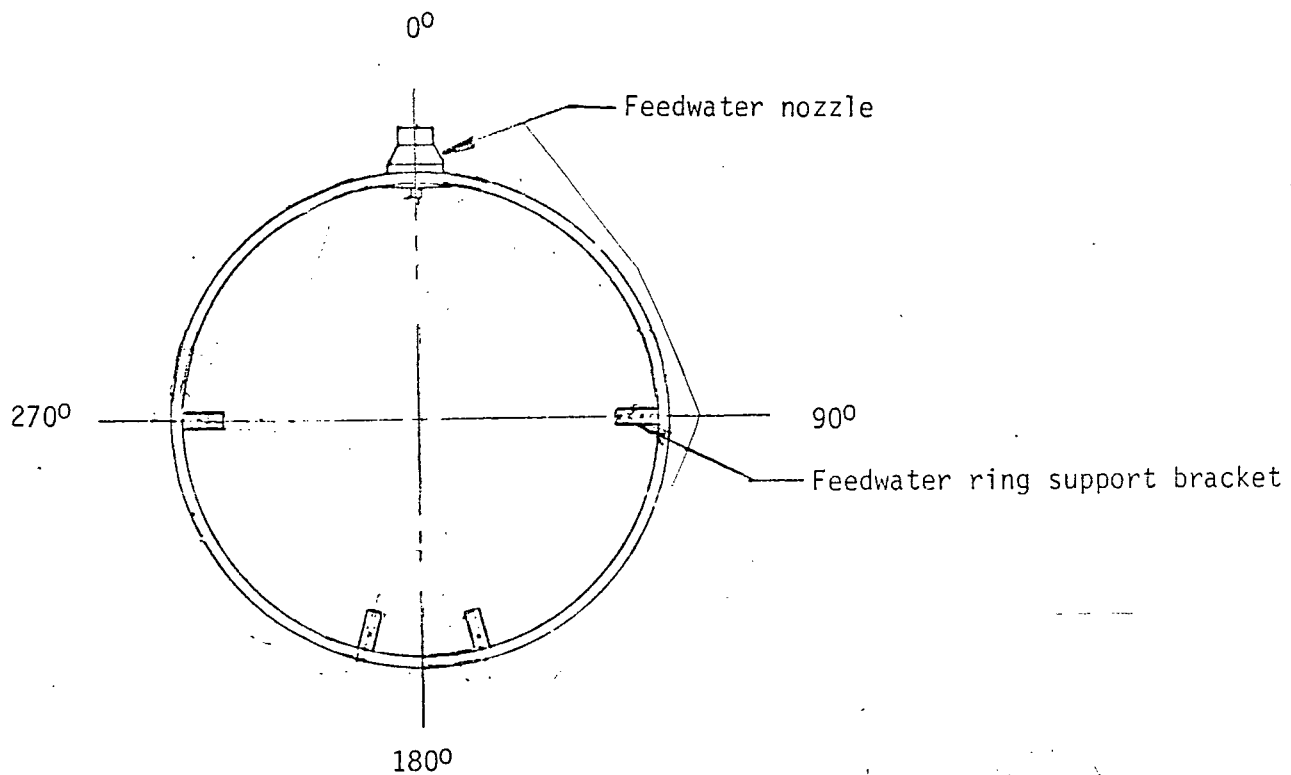
Detail of Feedwater ring  
Support bracket

The feedwater pipe assembly is supported on four (4) brackets. These brackets are welded to the pressure boundary with full penetration welds. The brackets are located at the 90°, 166°, 194° and 270° locations. The feedwater nozzle and water distribution box is located at the 0° position.

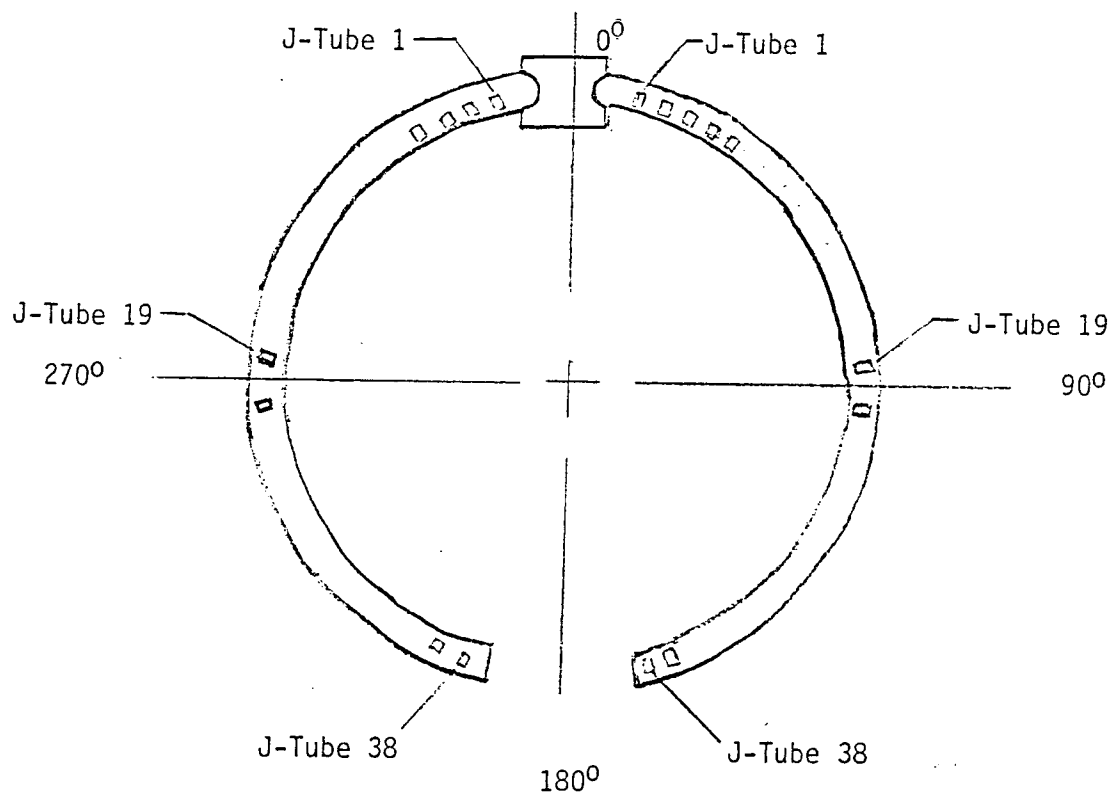
The feedwater pipe is fabricated from SA-106-Grade B, 12" schedule 40 pipe (nominal wall thickness 0.406"). The feedwater pipe assembly is made in two sections. These sections are referred to herein as the 0-90° section and the 0-270° section. The 0-90° section is supported at the feedwater distribution box and on brackets located at the 90° and 166° positions. The 0-270° section is supported at the feedwater distribution box and on brackets located at the 270° and 194° position.

The discharge nozzles on top of the feedwater pipe are referred to as J-Tubes. There are 38 J-Tubes in each section of the feedwater pipe assembly. The J-Tubes are numbered starting at the feedwater distribution box. In the 0-90° section the numbering system is clockwise (as viewed from top of ring) and counter clockwise in the 0-270° section.

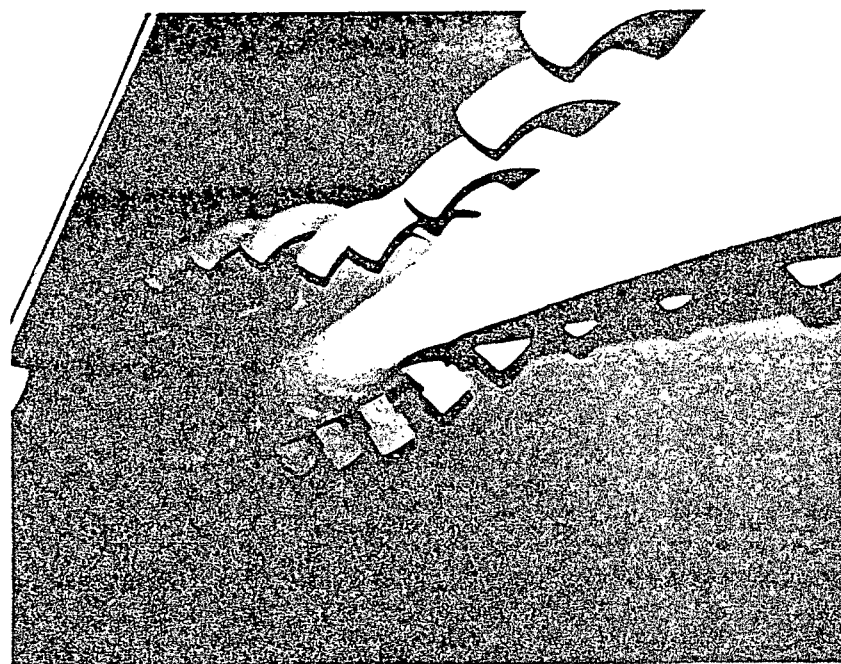
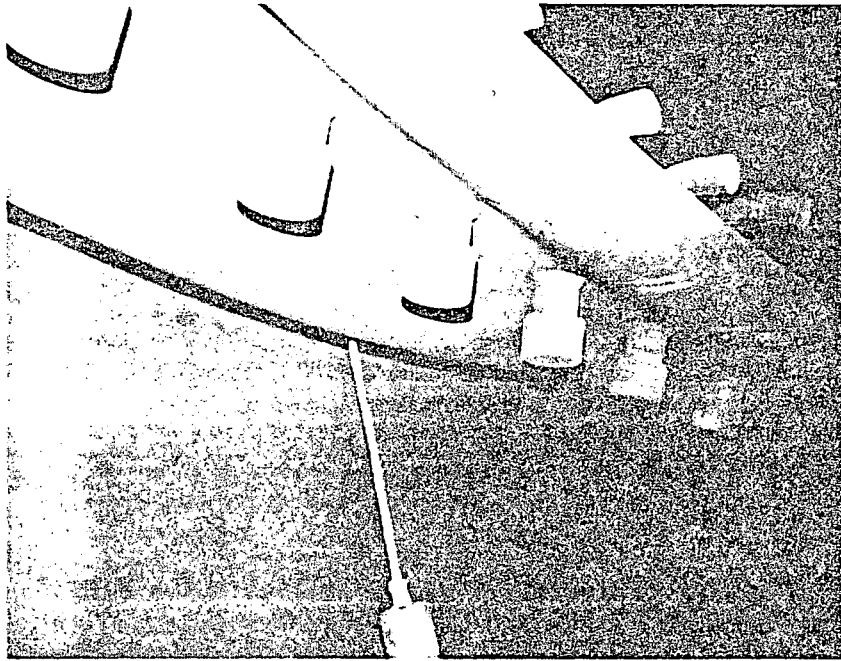
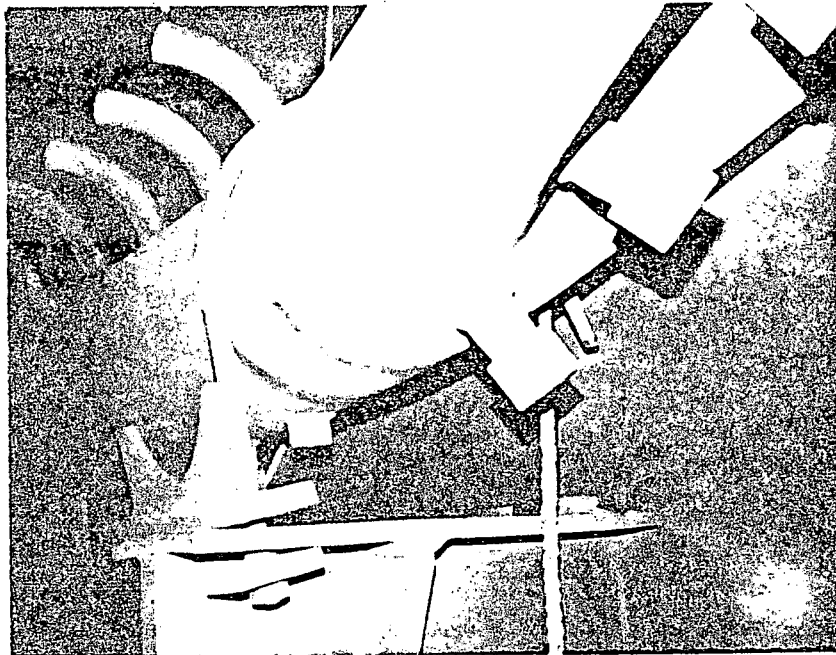
- a) (@ 90° bracket). U-bolts were stretched upward beyond the elastic limit. Bolts did not fail but assembly loose.
- b) (@ 166° bracket). Condition is the same as described in 5(a) above.
- c) (@ 270° brackets).

Both U-bolts failed at the threads. U-bolts deformed beyond elastic limit.

- d) (@ 194° bracket).  
Condition is the same as described in 5-(c) above.

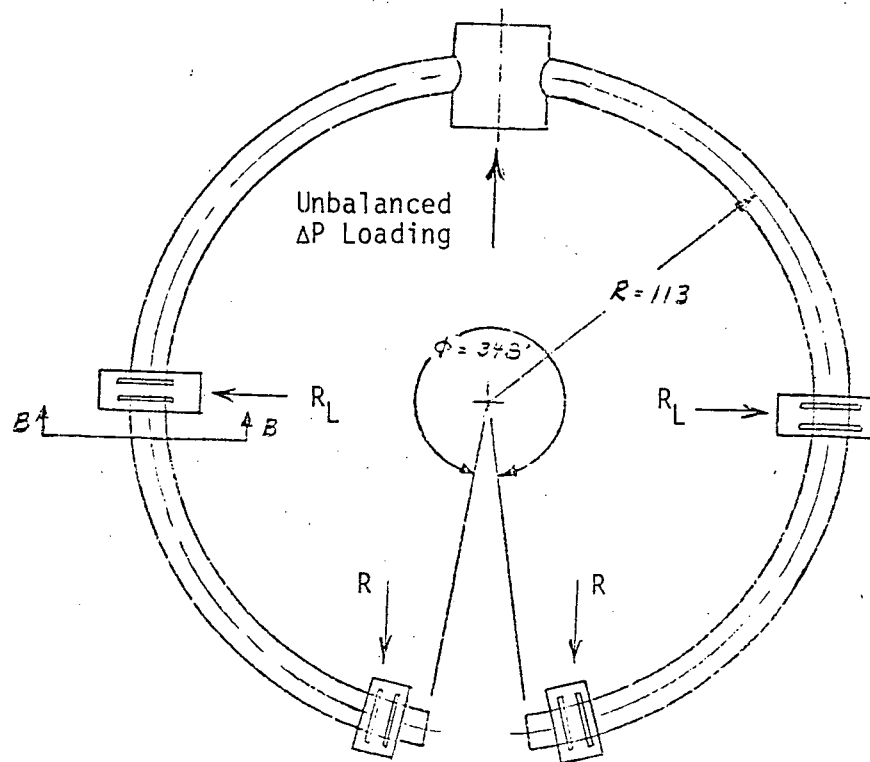
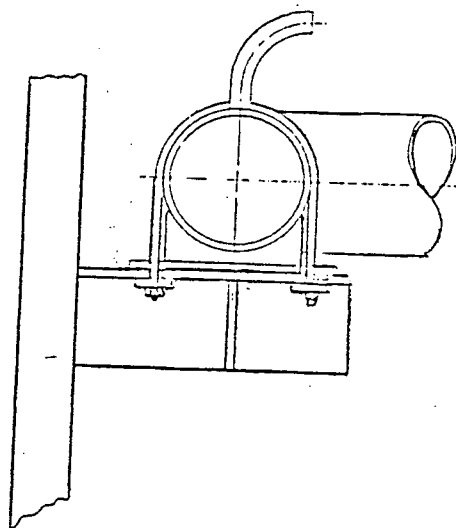
SECTION VIEW BB

# FEEDWATER SPARGER SUPPORTS AND SUPPORT LOADING
