SUBJECT: Forwards list of attendees & handouts from util 810915 meeting w/NRC re final design for feedwater ring mods & basis for not repeating feedwater hammer test & procedure for feedwater ring/auxiliary piping integrity test.

September 16, 1981 meeting - San Onofre Units 2 and 3 Steam Generator
Feedwater Ring Modifications

SAN ONOFRE 2 STEAM GENERATOR FEEDWATER SPARGER DAMAGE MECHANISM

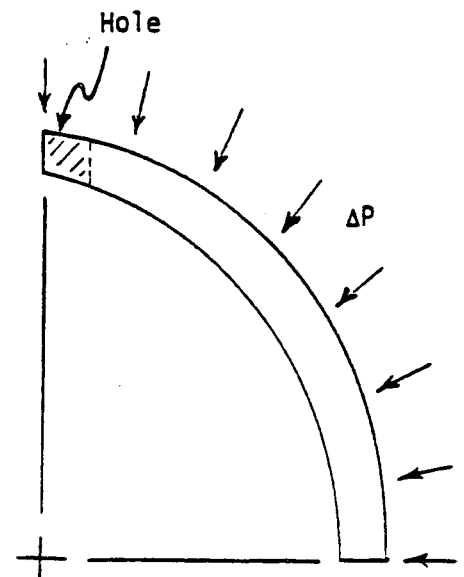
BUCKLING MODE 1

An external pressure differential which was "suddenly" applied to the sparger, as a result of rapid steam condensation occurring inside the sparger, was the principal cause of sparger damage. Other factors which reduced the load carrying capacity of the 12 inch schedule 40 pipe were ovality, variation in thickness, the holes in both the top and bottom of the pipe and the unbalanced differential pressure loading across the back of the feedwater distributor box.

The presence of 78 two-inch diameter holes periodically spaced in both the top and bottom of the sparger pipe (bottom holes are capped), provide preferential locations for two of the four plastic hinges required to form before the pipe can collapse. This is substantiated by observing the principal collapse modes of the damaged pipe in the north SONGS 2
