Monticello Nuclear Generating Plant
2807 W County Road 75
Monticello, MN 55362

Subject: 10 CFR 50.55a Request RR-008 Associated with the Fifth Ten-Year Inservice Inspection (ISI) Interval

**PROPOSED ALTERNATIVE IN ACCORDANCE WITH 10 CFR 50.55a(a)(3)(ii)
10 CFR 50.55a REQUEST RR-008**

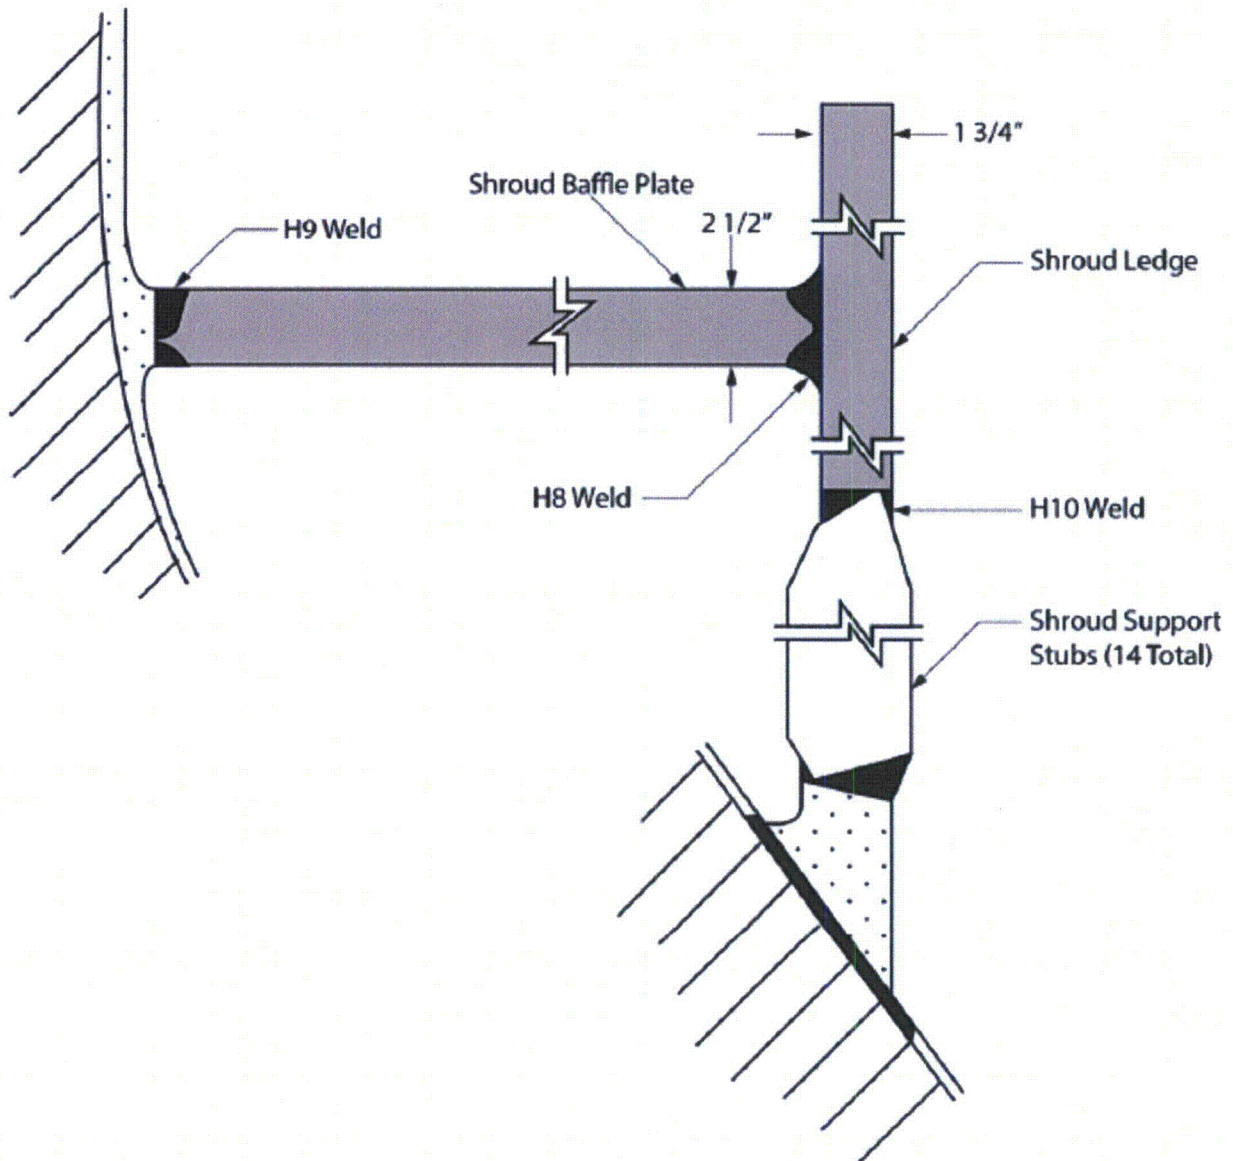
Attachment D – Monticello Shroud Support Structure Illustration

Since 2011, when the flaws in the H8 and H9 welds were initially discovered, extensive analysis was performed regarding the flaws and how they may affect the structural integrity of the shroud support assembly. These analyses demonstrated that the flaws in the H8 and H9 welds have a negligible effect on the ability of the shroud support assembly to perform its design and safety functions during normal and accident conditions.

The primary concern related to the H8 and H9 welds is uplift of the plate in the event of a design basis LOCA event. The uplift of the shroud support plate would be driven by the vertical seismic loads and reactor internal pressure differences across the plate. The evaluations done in 2011 and 2013 assume very conservative flaw profiles including complete circumferential cracking of both the

H8 and H9 flaws with cracking in the depth direction of approximately 75% through the weld thickness (through-wall). In the 2013 evaluation, using conservative flaw profiles and consideration of the loading acting upon the shroud support plate in the reactor vessel, only 18% of the total weld surface is required to be free of through-wall indications to overcome the uplift loads acting on the shroud support plate. Considering such extensive flaw profiles, the evaluations demonstrate that the structural integrity of the shroud support plate and its ability to resist uplift remain intact for at least 12 years and maintain the core coolant envelope. See Enclosure 2 for additional details of evaluations performed to date.

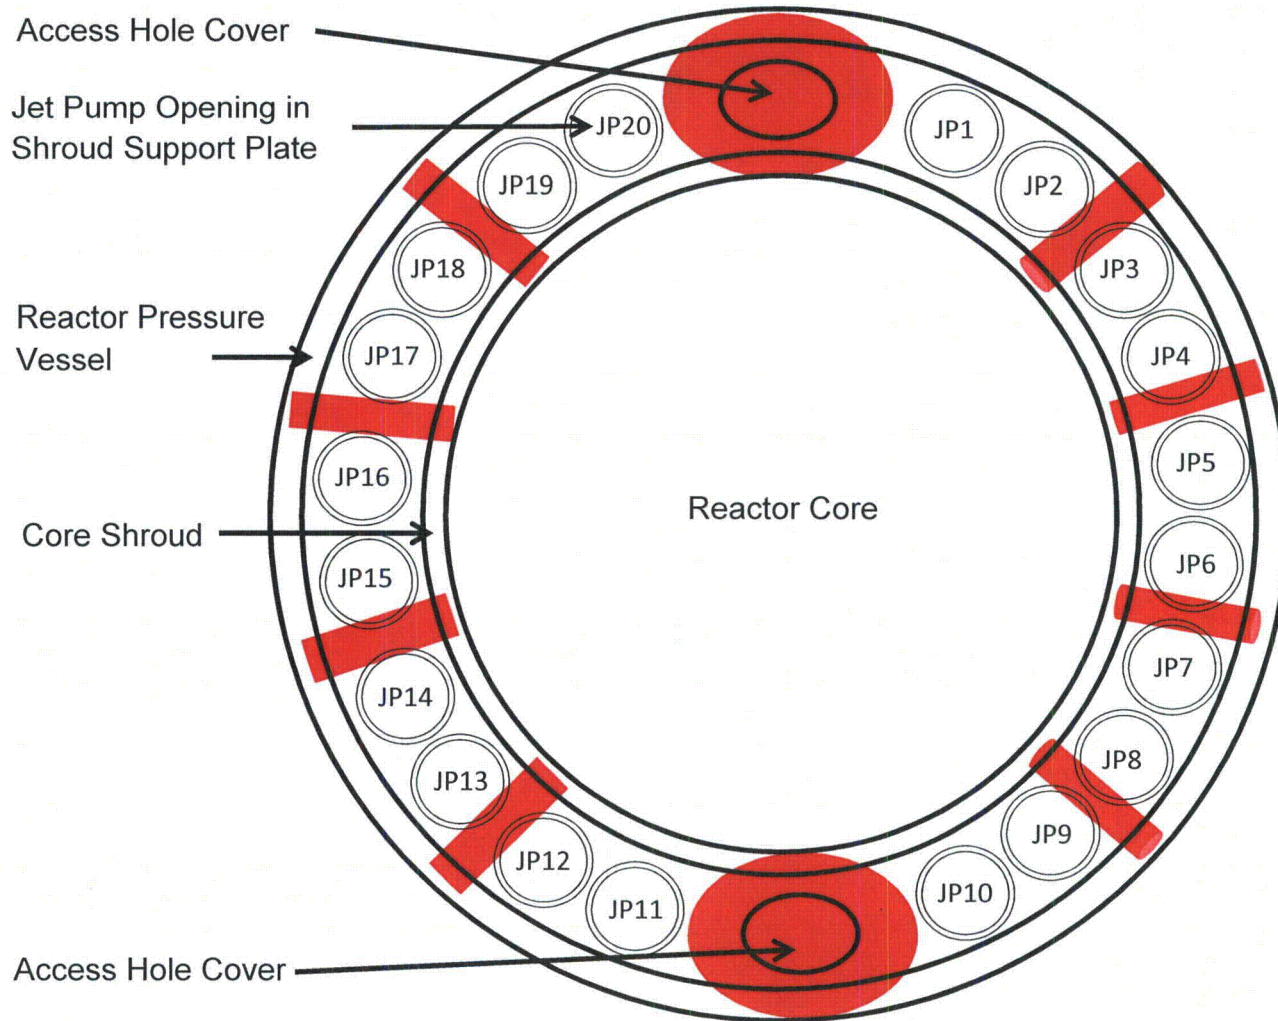
Attachment E – Monticello Shroud Support Plate Underside Illustration
(Shroud Support Legs Not Illustrated)

Note that in 2013, Monticello was able to inspect 32% of the topside of the H8 weld and 35% of the topside of the H9 weld with no relevant indications. Based on a review of previously inspected regions on the underside of the H8 and H9 welds, the areas accessed through the jet pump inlets, will be used to meet the 5% coverage recommendation.
