PNNL-22553

# Final Assessment of Manual Ultrasonic Examinations Applied to Detect Flaws in Primary System Dissimilar Metal Welds at North Anna Power Station

March 2014

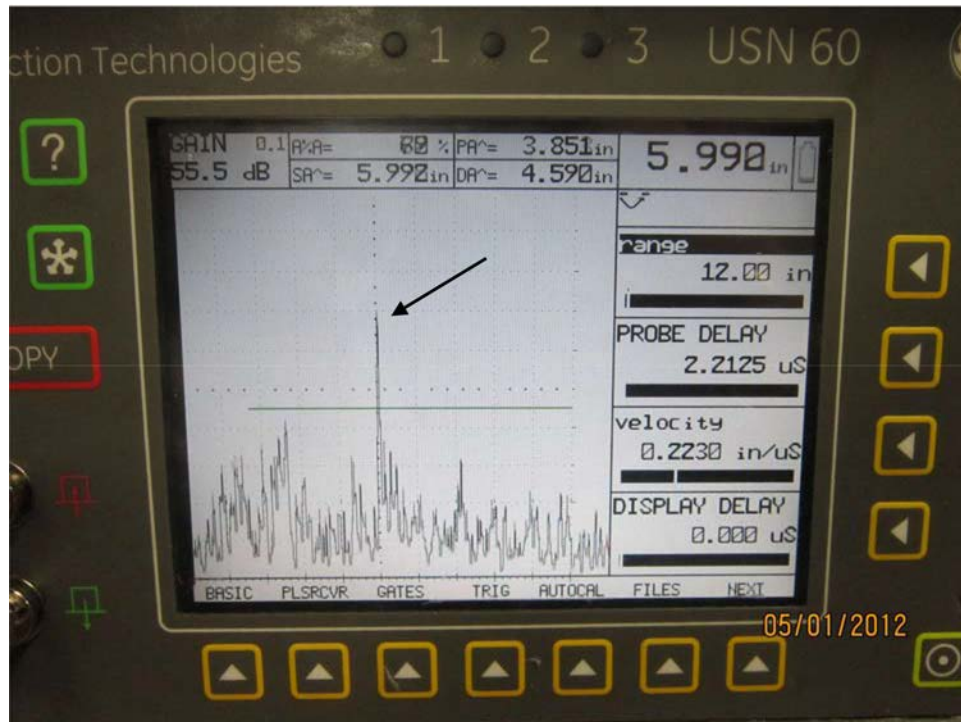
This mock-up has one axial flaw that is reported to be approximately 32% in through-wall depth. The flaw was ultrasonically located in near proximity to the side-drilled holes (SDHs) with the “LR” probe at a 2:1 signal-to-noise ratio (SNR). This flaw was also detected in the opposite scan direction with the “RR” probe, but with much less than a 2:1 SNR. Several other mid-to-upper wall ultrasonic responses were observed along the weld length; these are potentially welding fabrication or, based on the location detected, implantation artifacts from circumferentially oriented flaws in the mock-up. The presence of these “spurious indications” in near vicinity to axial flaws is somewhat unusual for a demonstration mock-up and makes manual UT detection more challenging, even when the locations of the targeted axial flaws are known. Figure 4.2 provides an example of the A-scan results showing typical mid-wall indications. Figures 4.3 through 4.6 provide additional pictorial support of the discussion in this section.

**Figure 4.3.** DM-05 32% Through-Wall Axial Flow with LR Probe

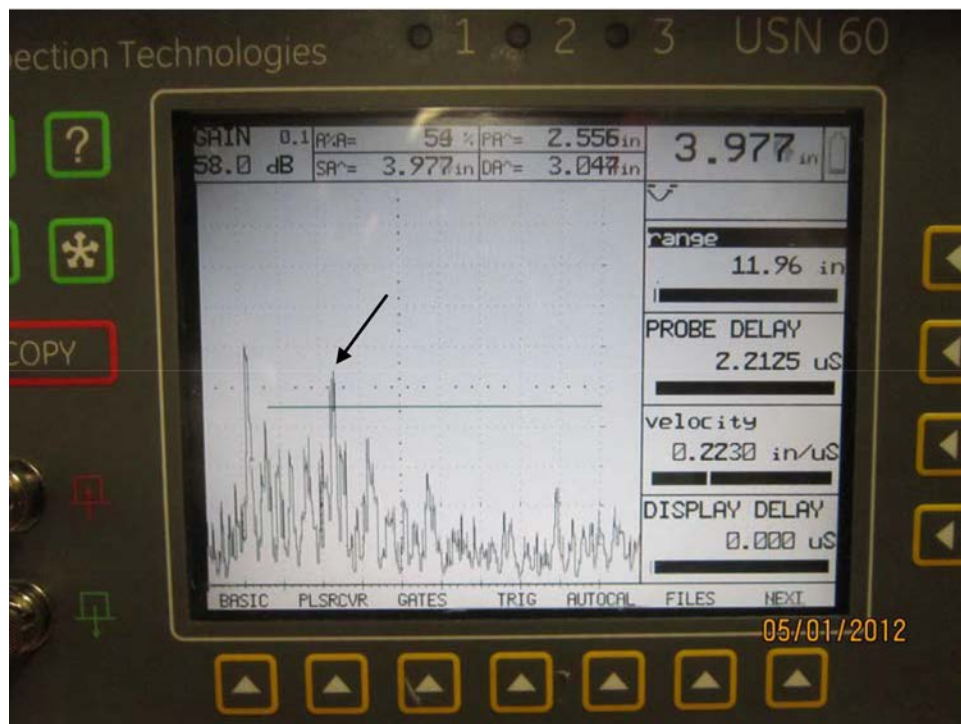
**Figure 4.4.** DM-05 Fabrication/Implantation Flaws

As a general observation, one would expect fewer inadvertent fabrication flaw, or implantation artifact, signal responses to be present. The UT responses from these imperfections impede detection and characterization of the axial flaws as cracks. Based on the site observations using the tandem probe configurations, there are many transient indications detected on the NAPS-1 mock-ups that interfere with targeted flaws; this makes it especially difficult for one to unequivocally determine the effectiveness of the inspection system to detect cracks. The placement of the axial flaws, in relative proximity to the locations of the circumferential flaws in these mock-ups results in challenging detection conditions because of implantation or fabrication artifacts.

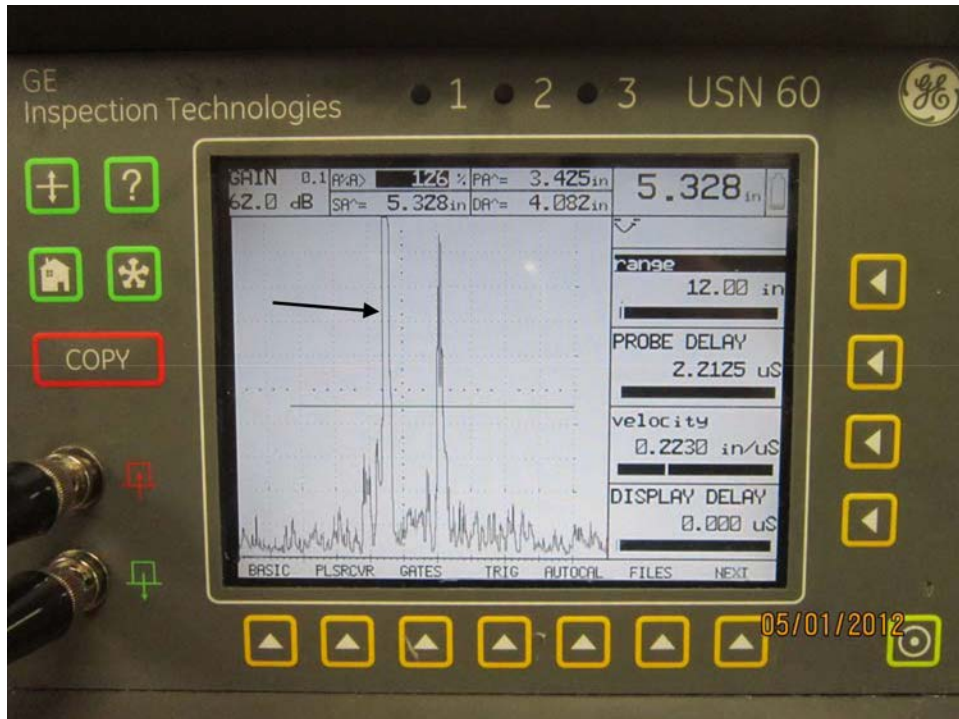
**Figure 4.5.** DM-05 End-of-Block through Safe End

The end-of-block response from the mock-up, which represents a 100% through-wall smooth reflecting surface, was very easy to detect when scanning from the wrought safe end, but exhibited a significantly lower response when scanning through the weld material. In addition, the UT response from the end-of-block appeared to be slightly shifted out in time, indicating that the weld microstructure may be re-directing the primary sound beam “upward” or at a higher inspection angle. There was a noticeable difference in sensitivity between the LR and RR tandem probes—this was on the order of 4 to 6 dB—and each set of probes exhibited a high-pitched “whining” sound. It should be noted that this repetitive “whining” noise occurred while exciting the probes with the USN60 in the “High” square-wave mode setting (while at North Anna and during assessments at PNNL). The USN60 contains two square wave mode pulser voltage settings – high and low. The USN60 low voltage setting was not applied, as this evaluation was aimed at assessing the field operation at NAPS-1. However, when lower voltage settings were subsequently applied to the tandem probes using instrumentation at PNNL, no audible “whine” was observed.

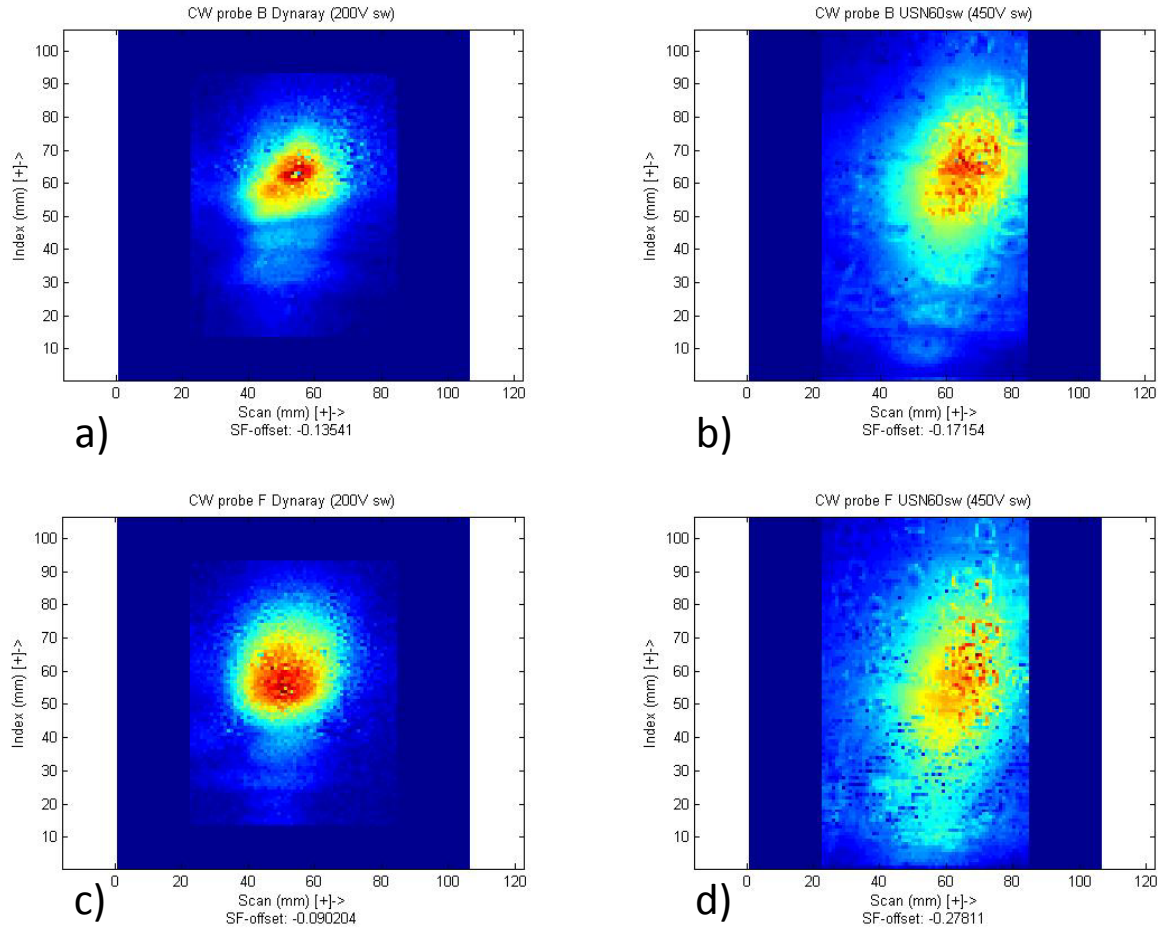
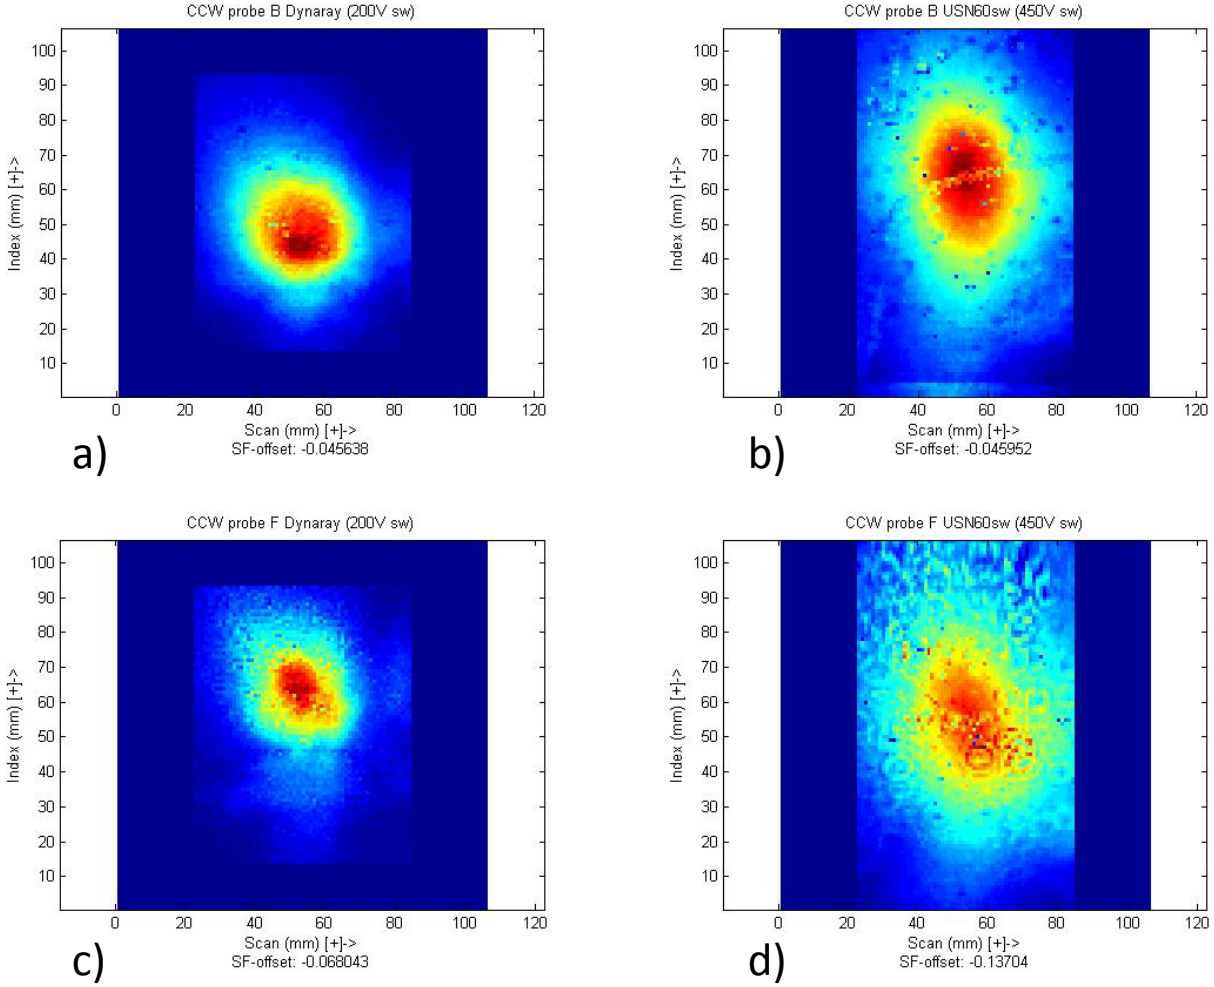
**Figure 5.8.** Sound Field (MatLab) Images from the CW Tandem Probe: a) back element DYNARAY square wave pulser at 200V; b) back element USN60SW square wave pulse at 450V; c) front element DYNARAY square wave pulser at 200V; d) front element USN60SW square wave pulse at 450V

**Figure 5.9.** Sound Field (MatLab) Images from the CCW Tandem Probe: a) back element DYNARAY square wave pulser at 200V; b) back element USN60SW square wave pulse at 450V; c) front element DYNARAY square wave pulse at 200V; d) front element USN60SW square wave pulse at 450V

To assess the images in a quantitative sense, the beam sizes at the  $-6$  dB level were measured using the sound field data in Figures 5.8 and 5.9. The DYNARAY and the USN60SW square waves were tuned to the same pulse duration so that the voltages of 200 and 450 could be compared. The results are listed in Table 5.2. Also listed are the ratios of the beam sizes in the scan (image horizontal) direction relative to the beam in the index (image vertical) direction. The DYNARAY pulser produces a more focused and symmetric beam in all scenarios. Symmetry variations in the DYNARAY system are as much as 17% from an ideal (ratio of 1); whereas, the USN60SW shows a deviation of up to 38%. The USN60SW beam size is approximately 20% to 2 times larger in the scan direction (horizontal) and 2 to 2.5 times greater in the index direction (vertical) than the DYNARAY beam. A metric to measure scatter is discussed in the following paragraph.

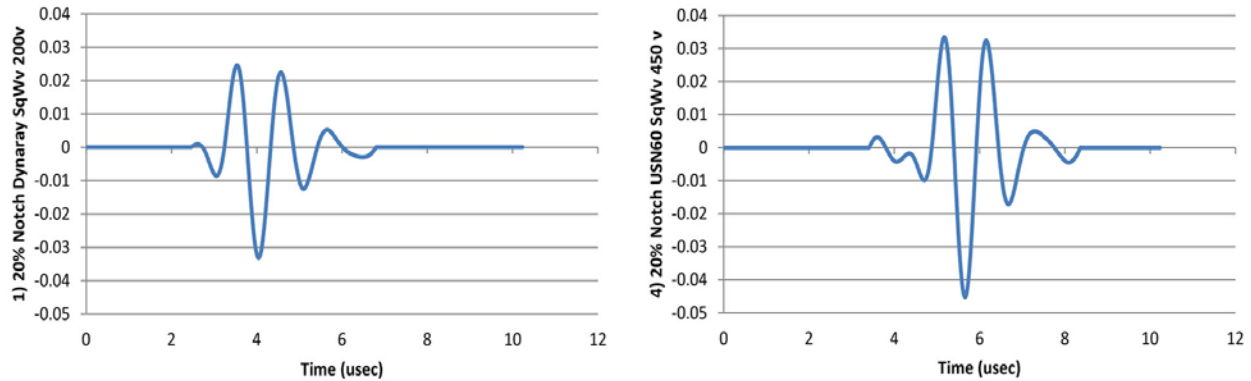
All of the notch responses were received and recorded with the DYNARAY system. The A-scan waveforms from the notch are displayed in Figure 5.10 with the response from the DYNARAY on the left and USN60SW on the right. The peak responses were measured as 0.033 and 0.045 volts for the DYNARAY and USN60SW pulsers, respectively (an increase of 36%).

**Figure 5.10.** Ultrasonic Responses from a 20% Through-wall Deep Notch: DYNARAY square wave pulser at 200V on the left; USN60SW square wave pulser at 450V on the right

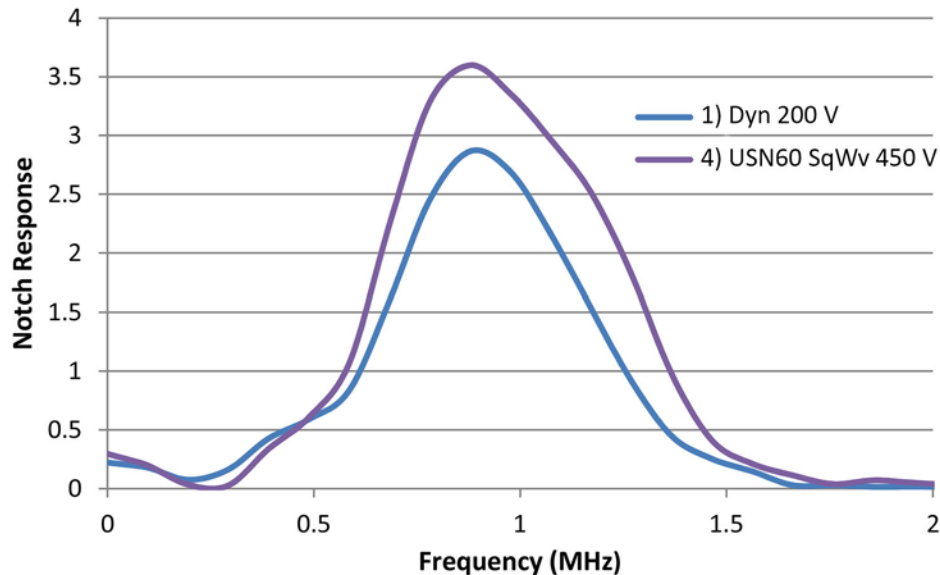
The frequency content of these waveforms was obtained through spectral analyses, with the results shown in Figure 5.11. As expected, the 200-volt DYNARAY response has less energy than the 450-volt USN60SW pulse. Center frequencies are similar for either pulser at 0.92 MHz for the DYNARAY system and 0.96 MHz for the USN60SW system. The bandwidth of the USN60SW pulse response was slightly greater (by 14%) at 65% as compared to the 57% bandwidth of the DYNARAY pulse response. Finally, the SNRs from the reflected notch waveforms were calculated at 22.4 and 24.2 dB for the DYNARAY and USN60SW pulsers, showing minimal to no variation. These SNRs were calculated from the A-scans and represent a peak signal to mean noise value. Peak signal to peak noise values were 8.7 and 9.6 dB for the DYNARAY and USN60SW pulsers.

**Figure 5.11.** Frequency Content of the Notch Response Waveforms Obtained with Two Pulse Excitation Scenarios

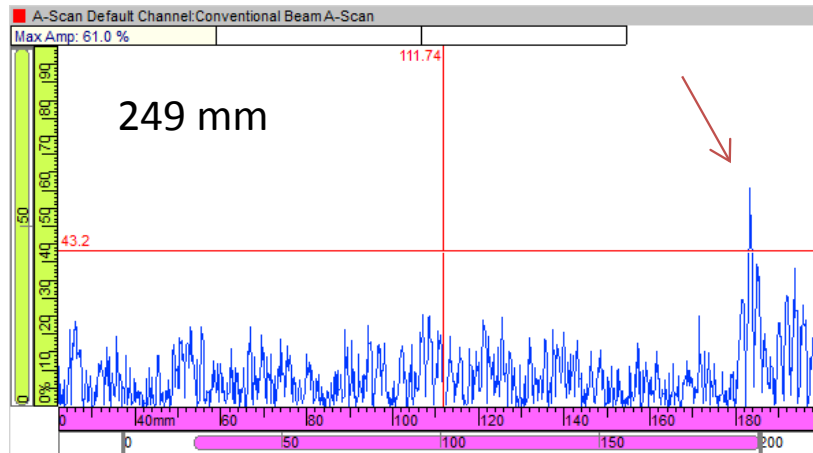
In order to measure persistence, the scan position was moved forward (toward the flaw) until the signal dropped to a 50% amplitude level (−6 dB, or about 30% FSH) and then backward (away from the flaw) to a 50% amplitude level. This full scan distance between −6 dB points was measured to be approximately 26.0 mm (1.02 in.), which represents the flaw persistence while scanning. The A-scan data are displayed in Figure 5.16 for the peak response at the 249-mm scan position. Figure 5.17 shows the two positions where the signal drops to the 50% level at 243 and 269 mm in the scan axis. The flaw signals at this 50% (−6 dB) level are comparable to ambient peak noise responses in the A-scan; thus, at these points, the flaw is essentially undetectable.

**Figure 5.16.** Peak Response from Axial Flaw 1

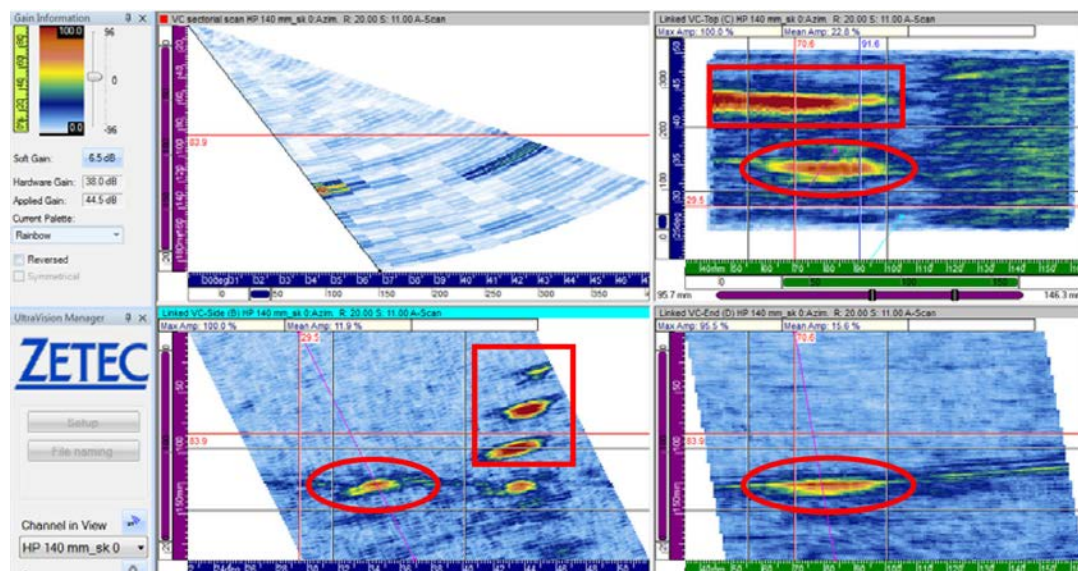
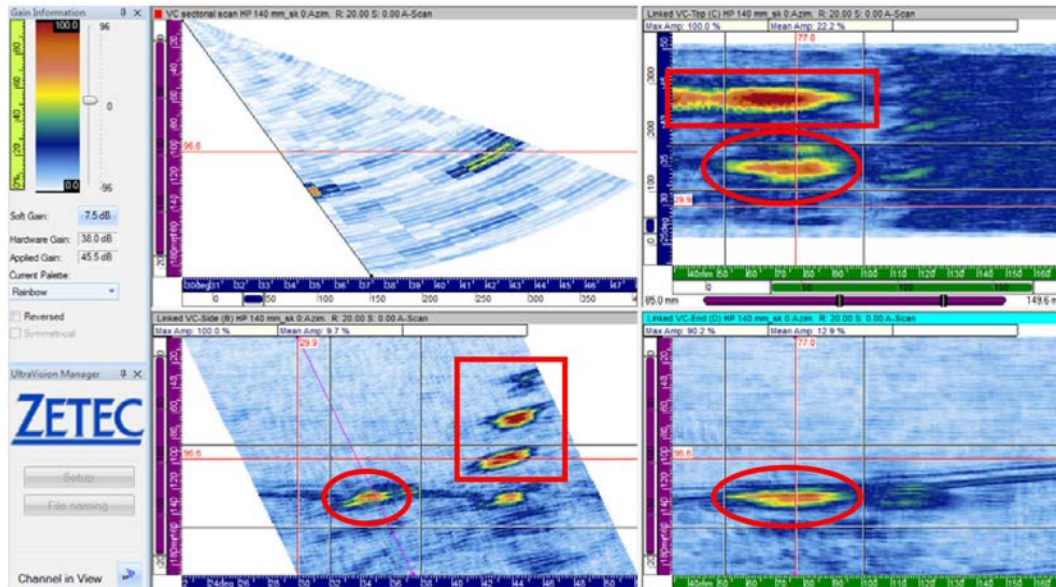
After initial reviews of a portion of the data, the half-path focusing was found to produce images with similar or slightly better (1 dB) SNRs. Figures 6.8 and 6.9 show the true-depth and half-path images from axial flaw 1 and three SDHs in DM-05. This presentation of data will be the standard format for the 0.5-MHz PA data in this report. The sector scan is displayed in the upper left, the C-scan top view in the upper right, the B-scan side view in the lower left, and the D-scan end view in the lower right. Electronic gating is accomplished with the black horizontal and vertical lines. Because the half-path focusing produced similar or marginally better SNRs, only the half-path data were analyzed to expedite the data review.

**Figure 6.8.** Mock-up DM-05 Axial Flaw 1 (circled) and Three SDHs (boxed) with a True-Depth Focus at 125 mm (4.92 in.). The scan is in the CW direction with a 0-degree skew.

**Figure 6.9.** Mock-up DM-05 Axial Flaw 1 (circled) and Three SDHs (boxed) with a Half-path Focus at 140 mm (5.51 in.). The scan is in the CW direction with a 0-degree skew.

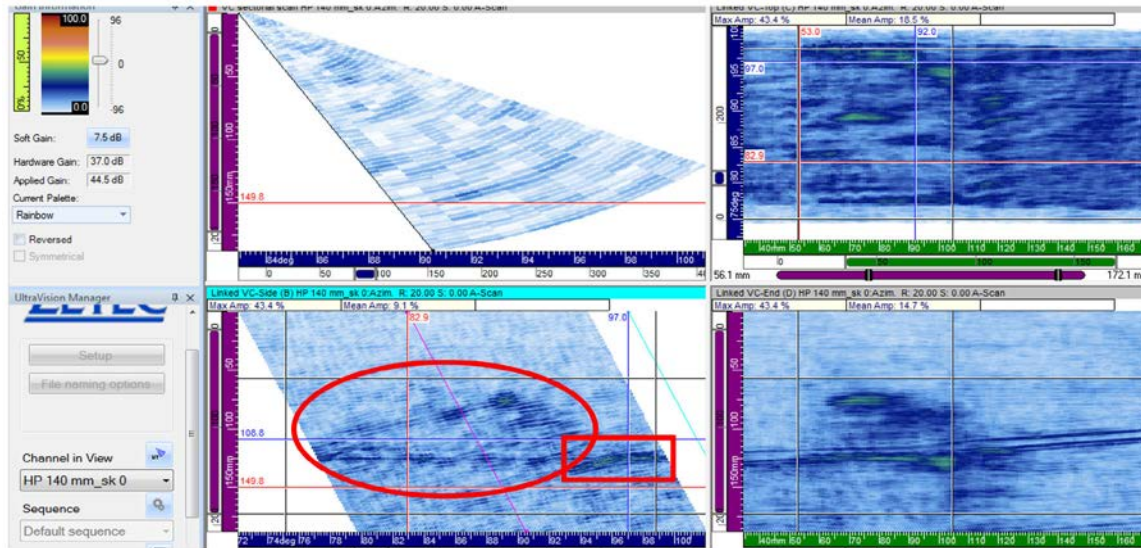
Implantation artifacts are evident in the region of circumferential flaw 2 as shown in Figure 6.14, also circled in red. This flaw is reported at the circumferential region between 83 and 97 degrees. While a strong ID corner response is not visible, except possibly to the right at 94 to 98 degrees (in the red boxed region) with a peak response of 28.7%, there is a noticeable upper flaw signal response. This upper signal

has a peak response of 29.0%, well over the mid-wall peak and average baseline noise levels determined earlier. The flaw depth is measured at 50.5 mm (2.00 in.) while the true depth is reported at 62.0 mm (2.44 in.). This nearly 50% through-wall deep circumferential flaw is thus detected by a mid-wall response outlining the upper part of the flaw and by possible stronger ID signal responses at the extremities of the flaw.

**Figure 6.14.** DM-05 B-scan Side View (bottom left) Depicts an Implantation Artifact from Circumferential Flaw 2 (circled) and ID Corner Response (boxed)

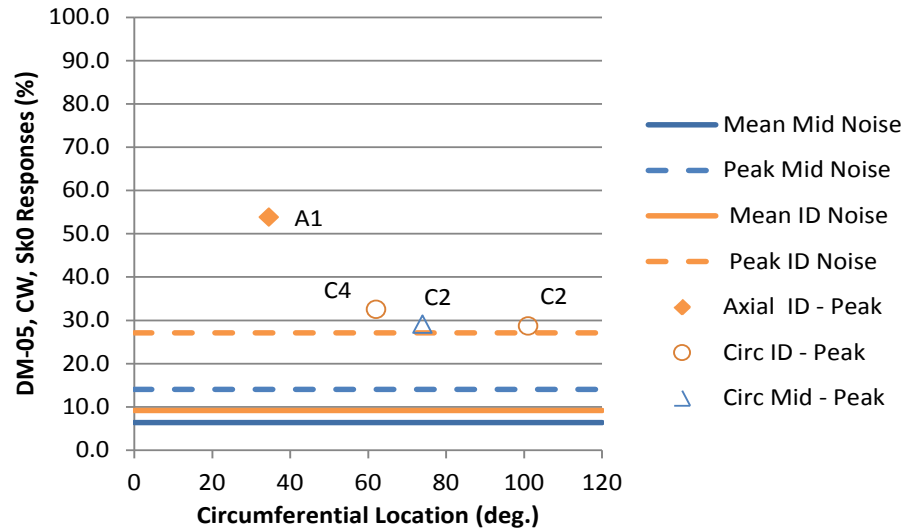
A summary plot of the CW data responses obtained with a skew angle of 0 degrees is shown in Figure 6.15. The mean and peak ID noise values are represented by the solid and dashed orange horizontal lines, respectively. The noise from the mid-wall region as measured by the mean and peak values is represented by the blue solid and dashed lines, respectively. In general the color orange denotes ID signals and blue denotes mid-wall signals. Further, the axial flaw response (A1) is plotted as a filled diamond symbol. These signals, noise and axial flaw responses, establish a baseline to which all unknown signals may be compared. Based on the comparison, it is believed that all of the artifact responses can be attributed to circumferential flaw implantation and are plotted with hollow markers (except for circumferential flaw 2 in the DM-05 mock-up which shows an artifact at 10 degrees, which is not a documented flaw implantation site). The horizontal axis represents the circumferential position of the peak response. Indication length and proximity of indications will be presented later. The peak ID artifact or circumferential flaw 4 (C4) signal observed at 62 degrees is plotted as well as the circumferential flaw 2 (C2) artifact peak responses from the ID and mid-wall regions. Clearly the peak mid-wall response from circumferential flaw 2 is much greater than the peak noise value in the mid-wall region of the mock-up as was seen in the data image. The ID response of circumferential flaw 2 is not noticeably larger than the peak ID response in the mock-up but is well above the mean ID noise. This flaw might not be detected based solely on its ID response amplitude, but the ID signal was wider (in time or depth) than the baseline noise and the large mid-wall indications clearly show the presence of an implantation artifact in this location.

**Figure 6.15.** Summary of Noise and Signal Responses for DM-05 Scanning CW with a Skew Angle of 0 Degrees. The normalized gain setting is 41 dB.

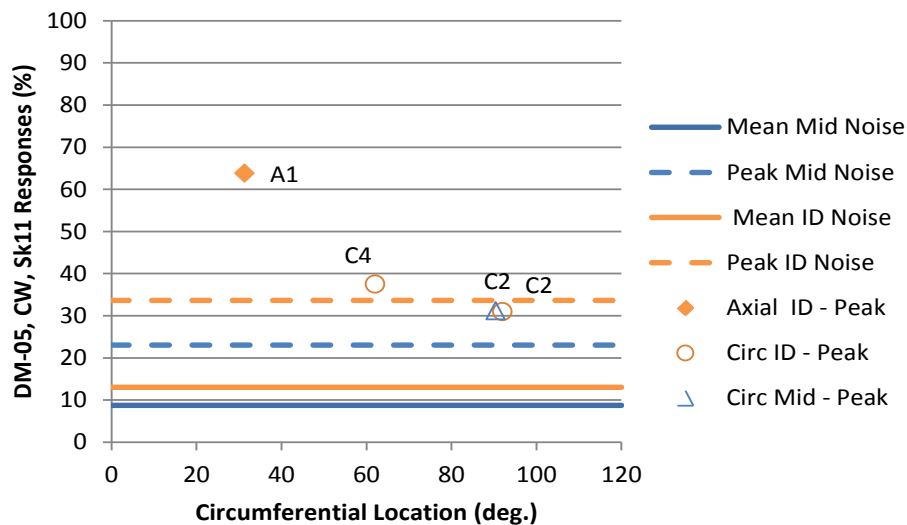
The DM-05, CW data with a skew angle of 11 degrees were similarly analyzed for noise, known signals, and artifact responses. A summary of these results is plotted in Figure 6.16 and is comparable to the skew 0-degree data in Figure 6.15. Within measurement error, the true state location is the same as what is plotted. The axial flaw response is well above the noise levels and the mid-wall signal from the circumferential flaw 2 stands out along with the artifact or circumferential flaw 4 signal observed at the ID (at 62 degrees). Artifacts from circumferential flaw 3 implantation were not detected in either of the CW data sets.

**Figure 6.16.** Summary of Noise and Signal Responses for DM-05 Scanning CW with a Skew Angle of 11 Degrees. The normalized gain setting is 41 dB.

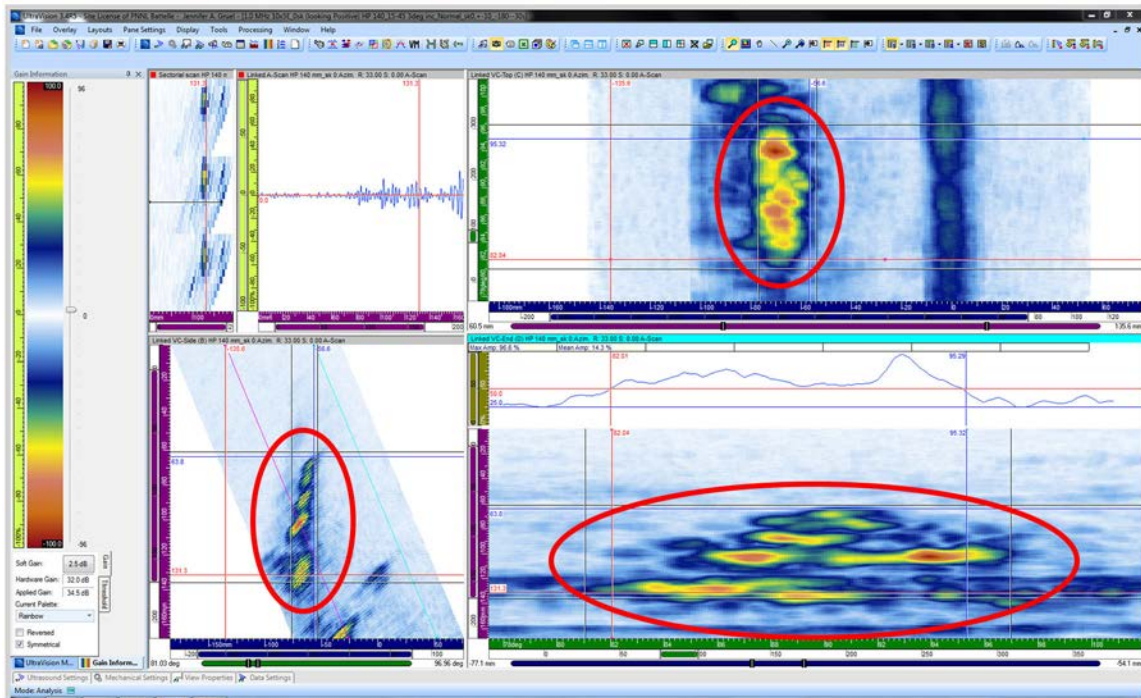
**Figure 6.33.** 1.0-MHz Axial Scan, Circumferential Flaw 2 in DM-05 Circled in Red

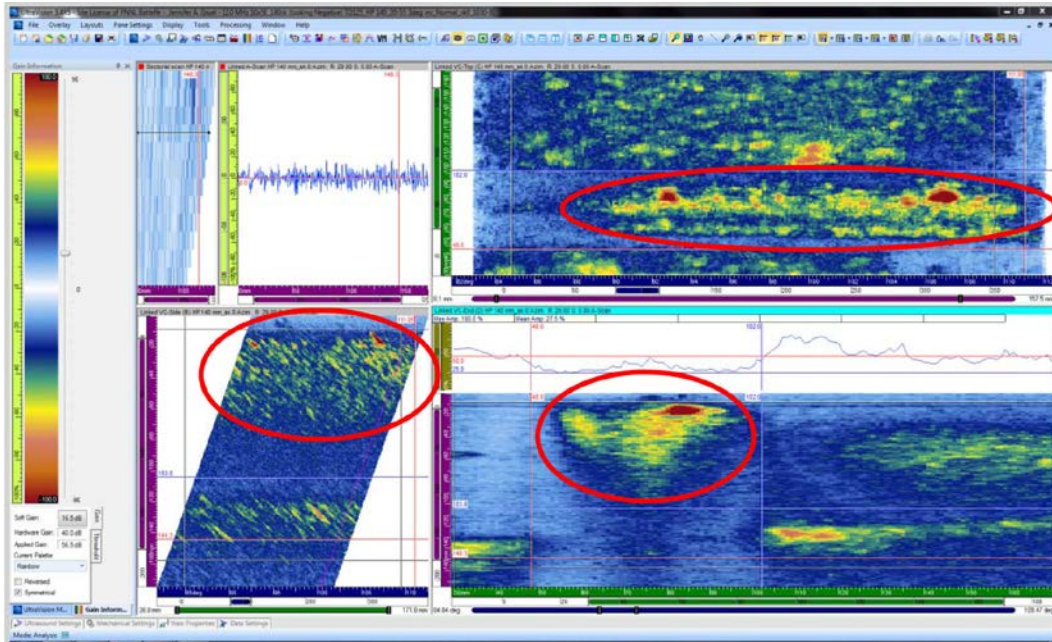
Analysis of 2.0-MHz circumferential scan data included an assessment of artifacts previously seen that were neither intentional flaws nor geometric responses. As with the 1.0-MHz data, the 2.0-MHz data scans only covered regions containing the implanted flaws and not the full 120-degree circumference of the mock-ups. Unlike the 0.5 MHz and 1.0-MHz data that displayed several ID response artifacts in regions of, or adjacent to, the intentional flaws, the 2.0-MHz data exhibit a lack of signal response at the ID flaw/weld region, but the presence of a significant number of weld fabrication flaws that begin in mid-wall and extend to the OD were observed. Figure 6.35 shows a cluster of weld fabrication flaws circled in red in the C-scan, B-scan, and D-scan views from the CCW data in the flaw 2 region of DM-10. The fabrication flaws are located directly in the weld region of the component with volumetric-like responses indicative of slag or porosity as a result of the welding process.

**Figure 6.35.** DM-10 CCW Skew 0 View of Axial Flaw 2 Region (flaw not detected) with Weld Fabrication Flaws Circled in Red

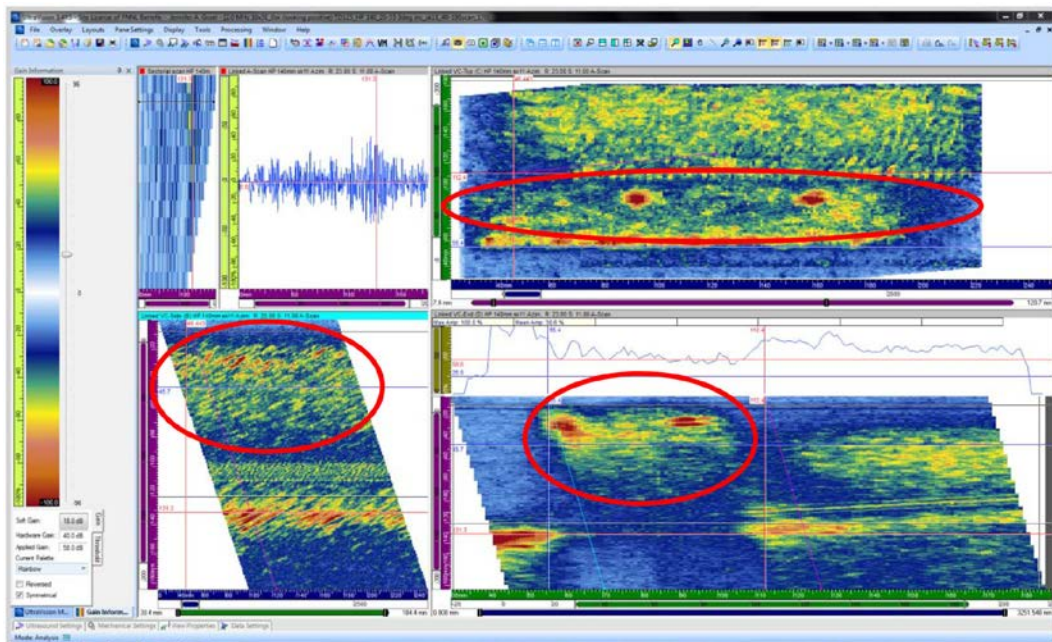
Data from the axial flaw 3 region of DM-10 also has a significant population of fabrication flaws in the weld region as circled in red on Figure 6.36. The responses again appear volumetric.

**Figure 6.36.** DM-10 CW Skew 10 View of Axial Flaw 3 Region (flaw not detected) with Weld Fabrication Flaws Circled in Red

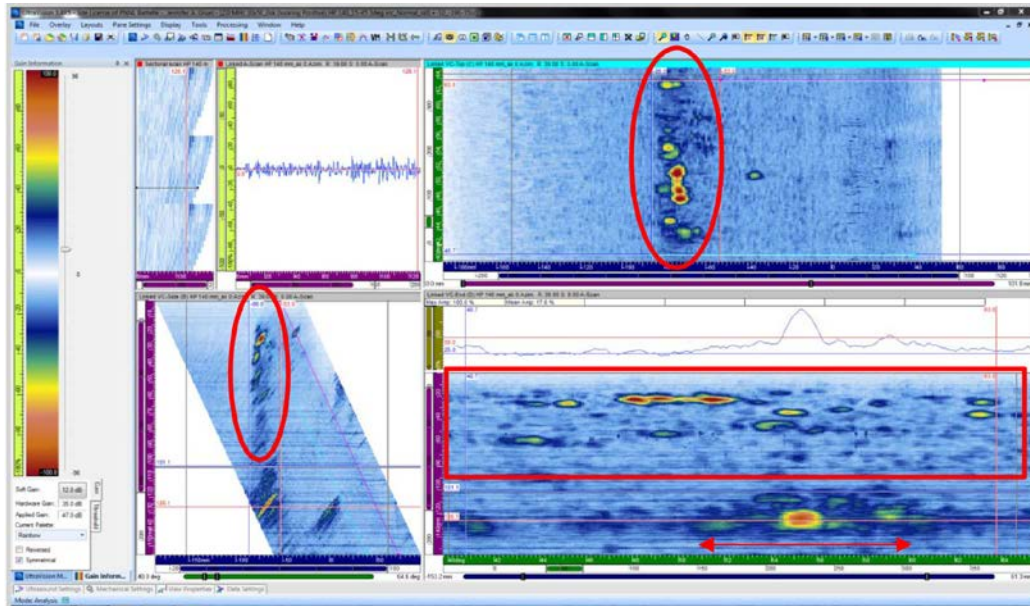
Figure 6.37 shows the CW view of the circumferential flaw 3 region in DM-05. The data gates have been applied to isolate the region above the ID region. The C-scan view shows the many indications in the weld region (circled in red) that are likely a result of the welding process. The B-scan view shows the depth variation of the indications. Similarly, Figure 6.38 shows the CW view of circumferential flaw 4 with similar strings of indications found mid-wall.

**Figure 6.38.** Looking Positive Skew 0 View of Circumferential Flaw 4 (indicated by red arrow) DM-05 with Weld Fabrication Flaws Circled and Boxed in Red

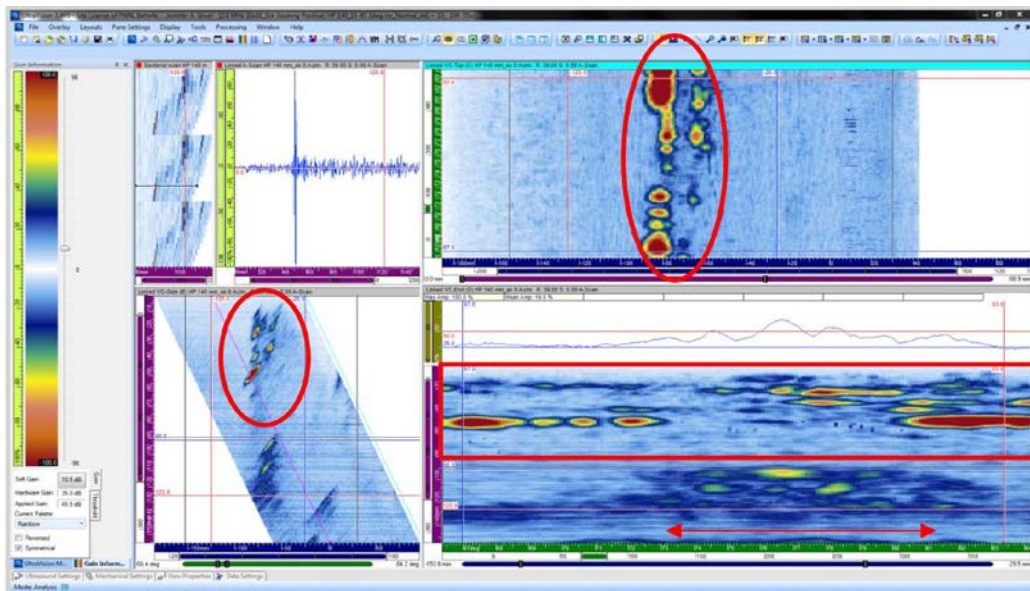
Specimen DM-10 also presented a range of fabrication flaws present in the weld region of the specimen. The circumferential flaw 4 region depicted in Figure 6.39 highlights some of the stronger, more detectable strings of fabrication indications present. Here, the fabrication flaws (circled and boxed) are actually stronger than the intentional flaw of the region, marked by the red arrow.

**Figure 6.39.** Looking Positive Skew 0 View of Circumferential Flaw 4 (indicated by red arrow) DM-10 with Weld Fabrication Flaws Circled and Boxed in Red

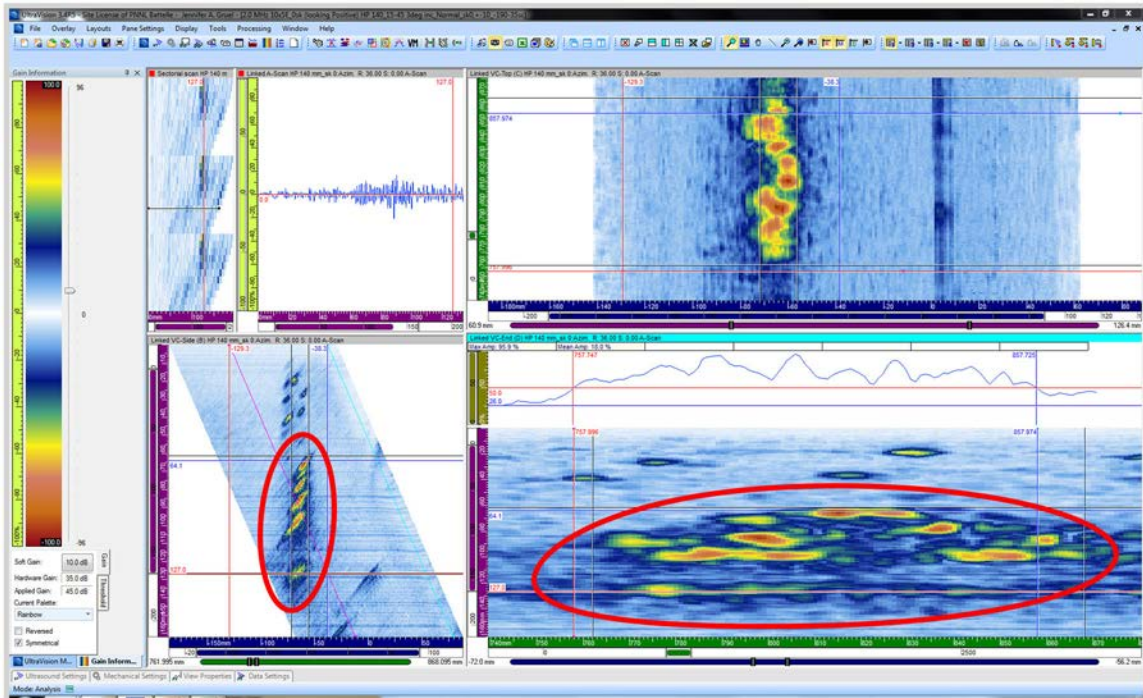
The mock-ups were scanned in the axial direction for the detection of the five implanted circumferential flaws. Results of the data analyses are listed in Table 6.7 and include the measured flaw length, depth, and SNR. Figure 6.40 shows circumferential flaw 1 (circled) from DM-10 examined at the refracted angle of 36 degrees. This flaw also has strong specular reflections from multiple locations along its through-wall extent that facilitate characterization. All of the circumferential flaws were detected; however, occasionally it was difficult to separate flaw ID corner responses from weld geometrical signals. The SNRs as measured at the ID were between 13.6 and 18.6 dB. The full set of data images are presented in Appendix E.

**Figure 6.40.** 2.0-MHz Axial Scan, Circumferential Flaw 1 (circled in red) in DM-10

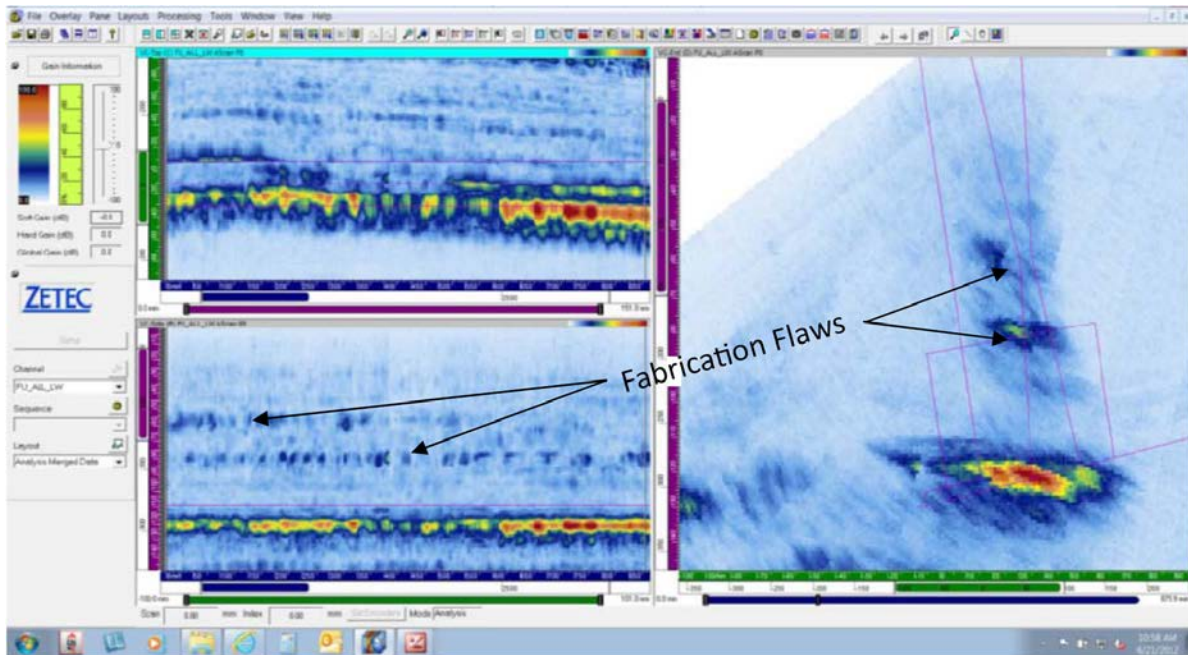
One cold leg weld was fully evaluated while individual quadrants of the remaining two cold leg welds were selected to assess trends seen in the primary weld that was initially examined. In addition, data from hot leg welds were provided by Dominion and a review and screen capture exercise was conducted on those components as well. Figures 6.42 and 6.43 show example data containing fabrication flaws and general weld 'noise' from the field welds.

**Figure 6.42.** Axial Scan Data from a Field Weld

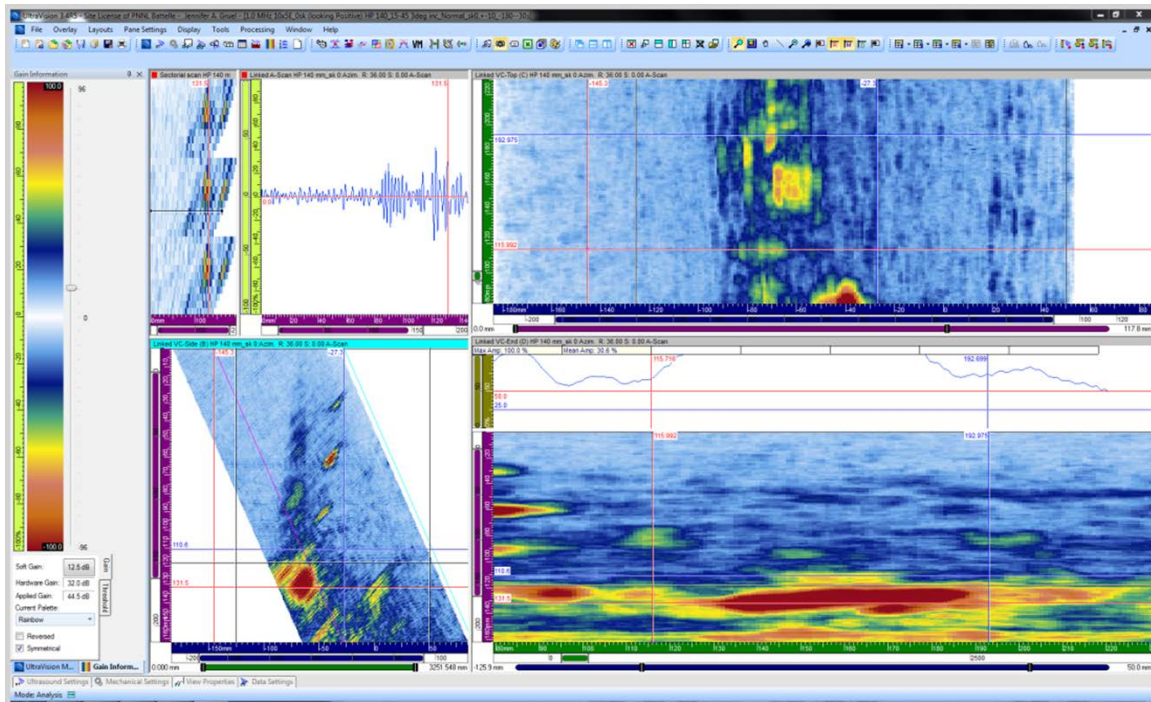
**Figure A.5.** CW Probe, DM-10 Axial Flaw 2 Circled in Red

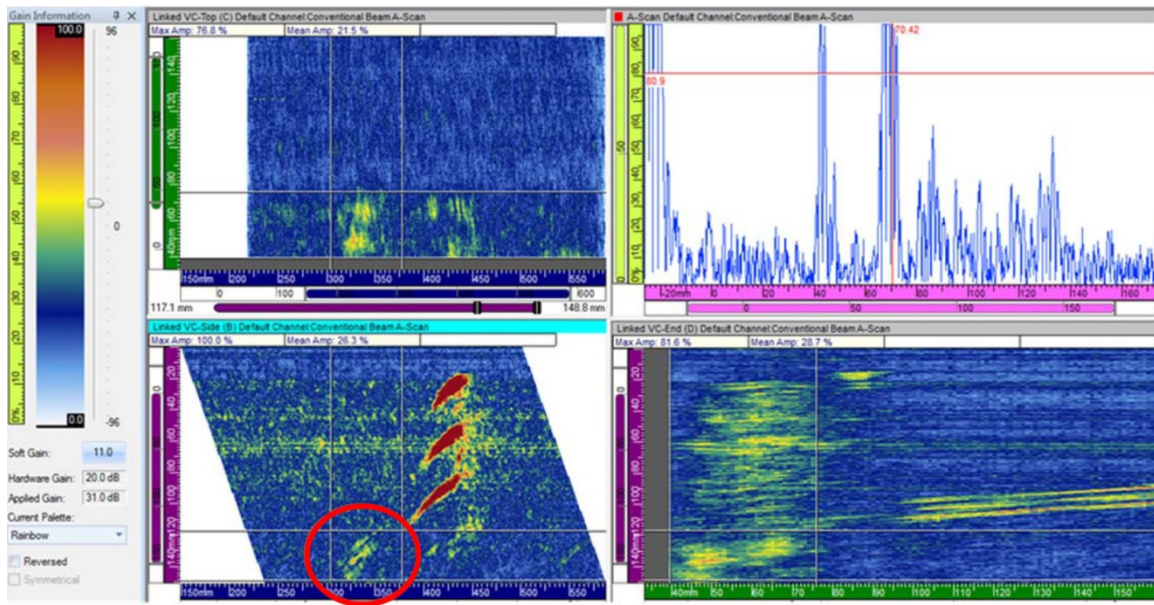
**Figure B.3.** CW Probe, DM-05 Axial Flaw 1 Circled in Red

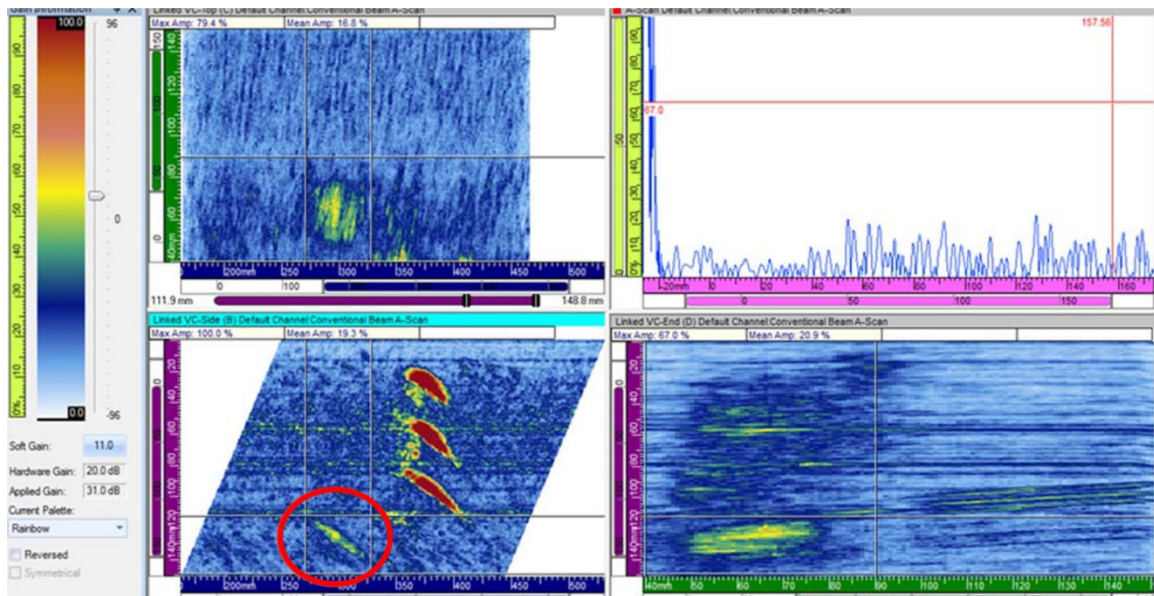
**Figure B.4.** CCW Probe, DM-05 Axial Flaw 1 Circled in Red

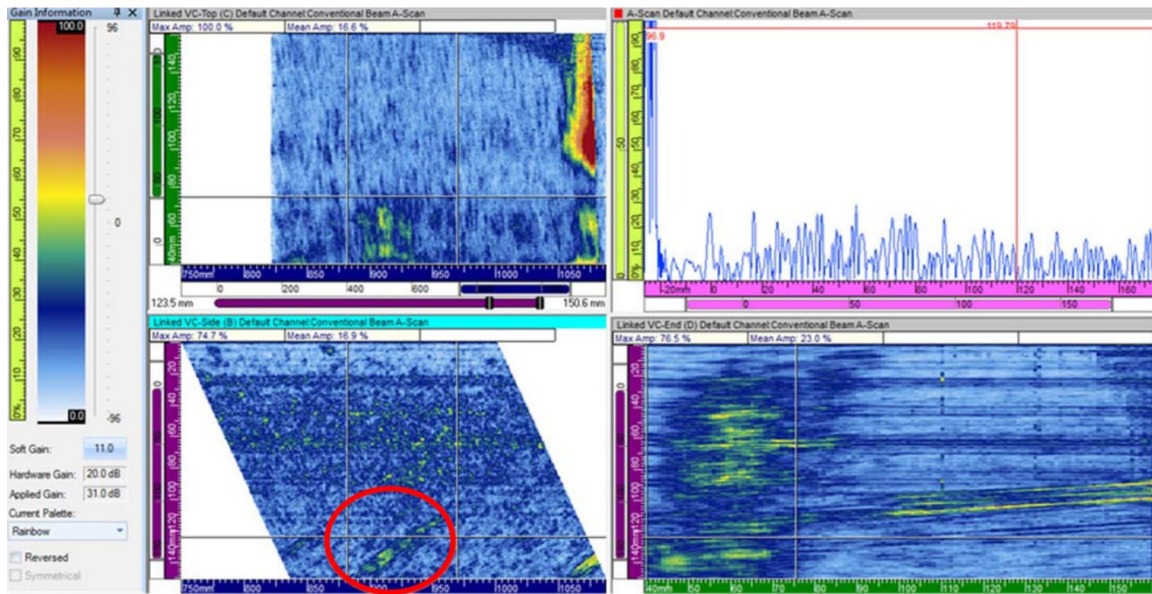
**Figure B.5.** CW Probe, DM-10 Axial Flaw 2 Circled in Red

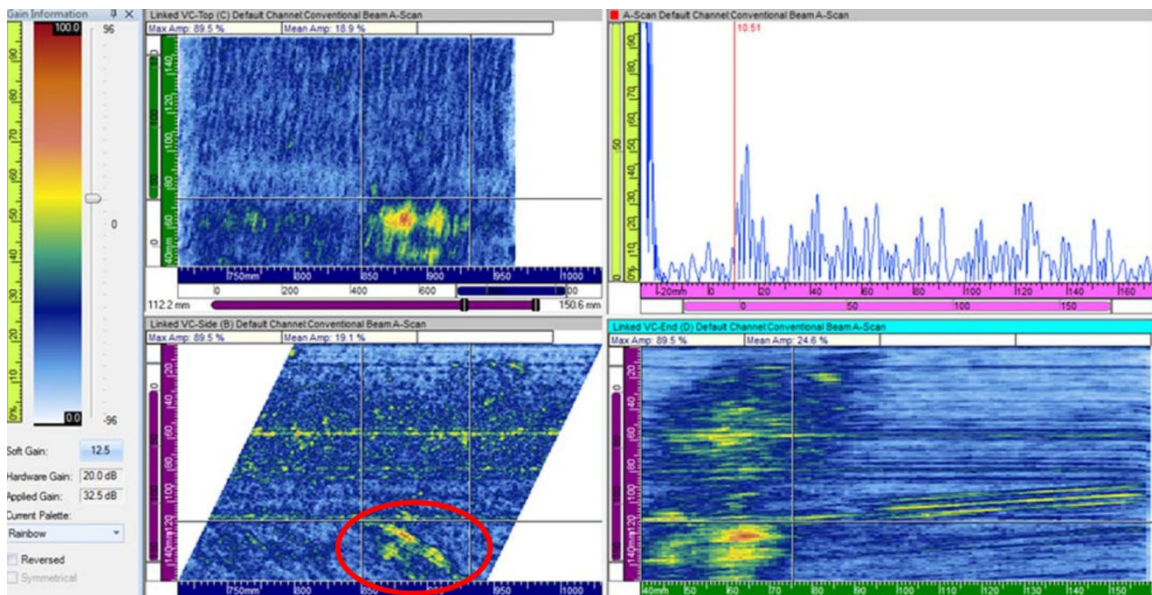
**Figure B.6.** CCW Probe, DM-10 Axial Flaw 2 Circled in Red

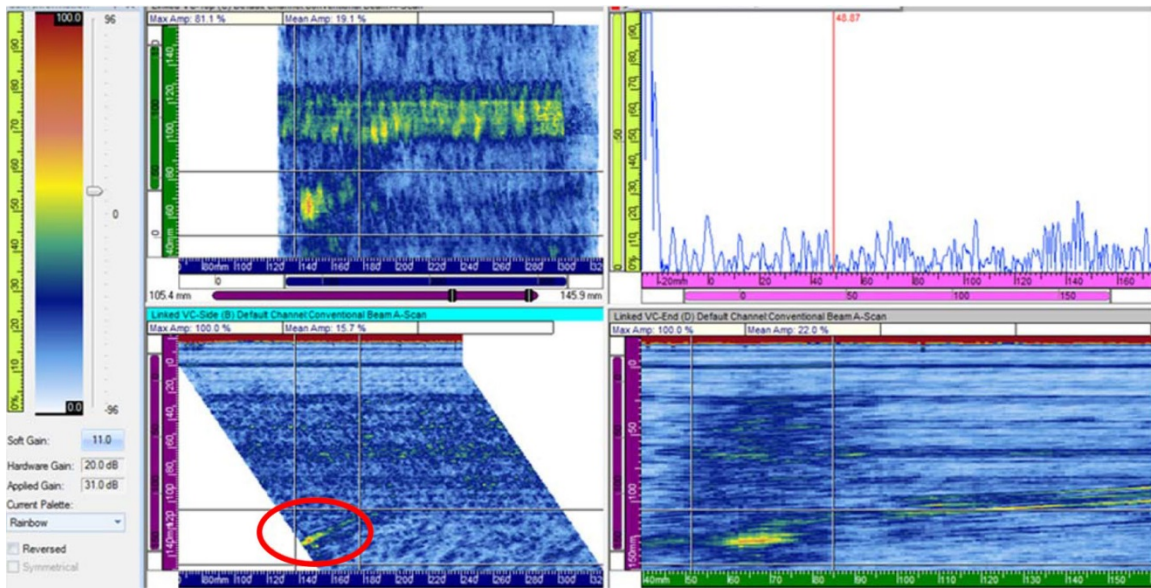
**Figure B.7.** CW Probe, DM-10 Axial Flaw 3 Circled in Red
