PNNL-22553

# Final Assessment of Manual Ultrasonic Examinations Applied to Detect Flaws in Primary System Dissimilar Metal Welds at North Anna Power Station

March 2014

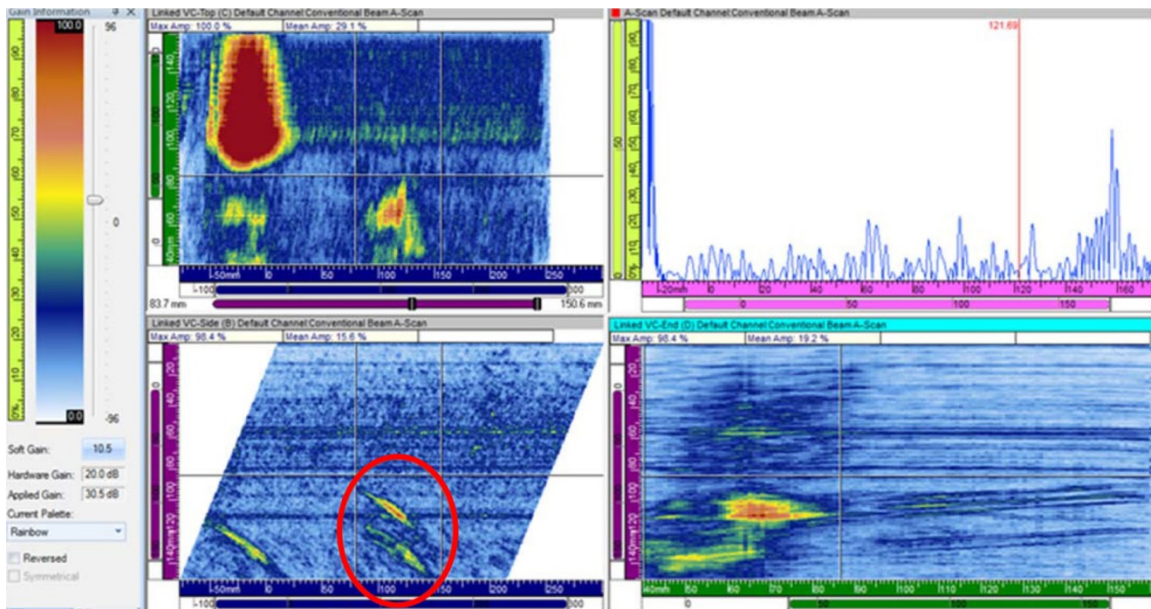
**Figure B.8.** CCW Probe, DM-10 Axial Flaw 3 Circled in Red

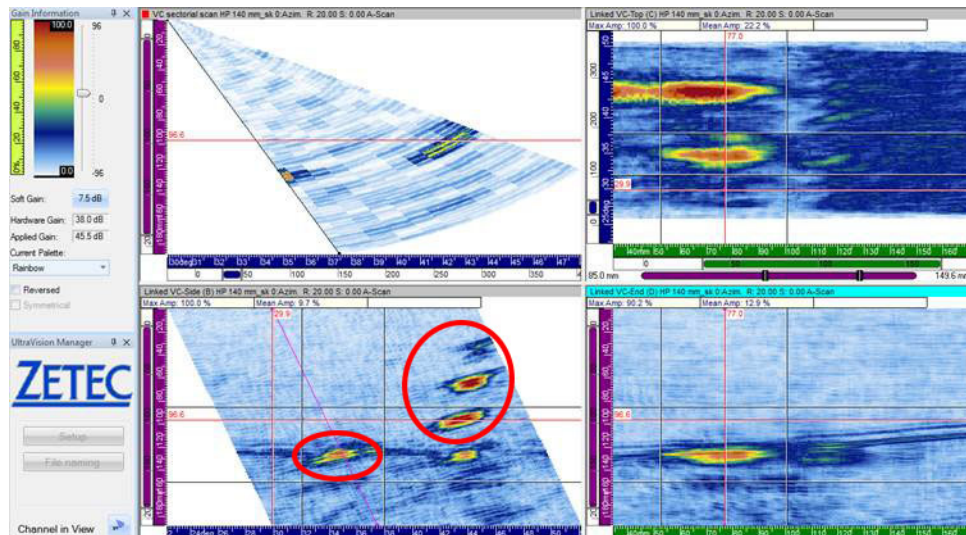
Figure C.2. CW, Skew 0, File 240 to 440 (mm). Axial flaw 1 (left) and three side-drilled holes (right) are circled in red.

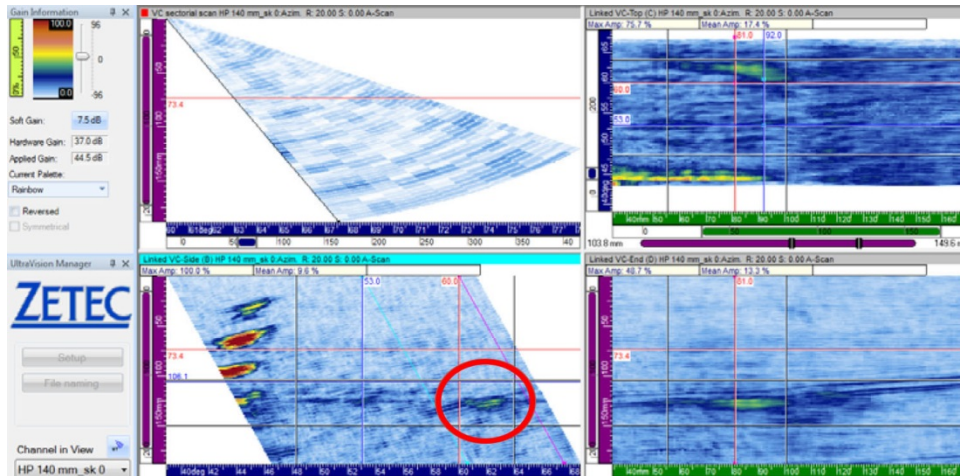
**Figure C.3.** CW, Skew 0, File 390 to 590 (mm). Artifact is visible at 62 degrees (circumferential flaw 4) and circled in red.

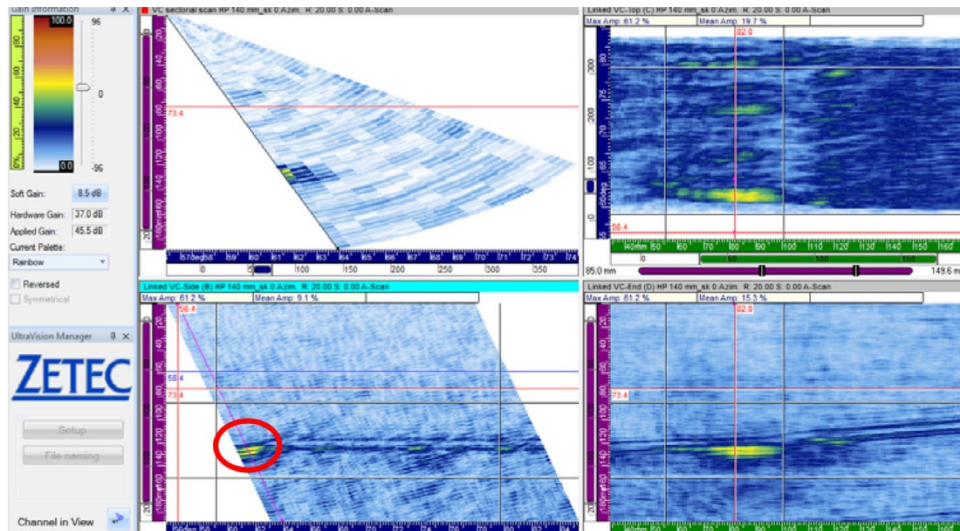
**Figure C.4.** CW, Skew 0, File 540 to 740 (mm). Artifact is visible at 62 degrees (circumferential flaw 4) and circled in red.

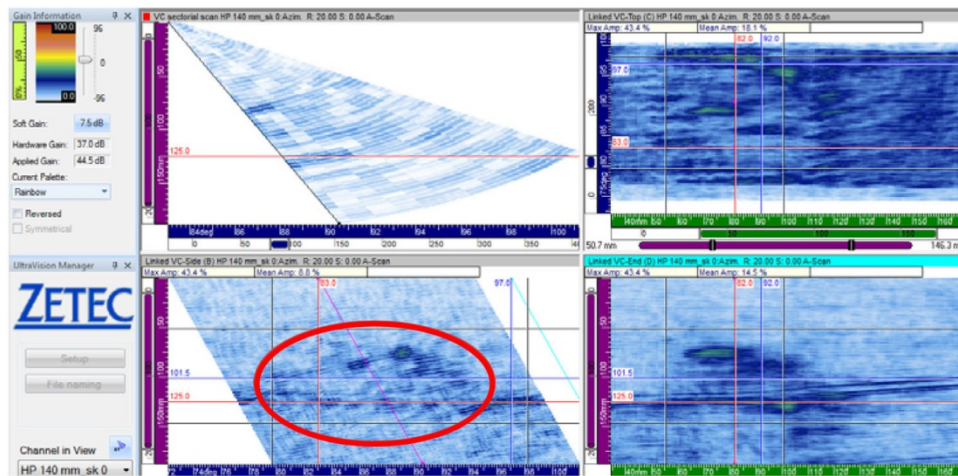
**Figure C.5.** CW, Skew 0, File 690 to 890 (mm). Circumferential flaw 2 implantation artifact is visible and circled in red.

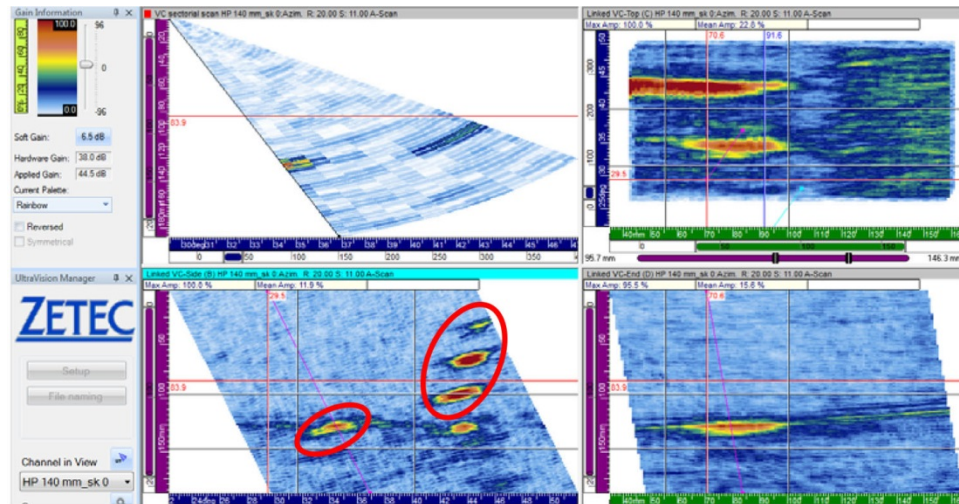
**Figure C.8.** CW, Skew 11, File 240 to 440 (mm). Axial flaw 1 (left) and the three side-drilled holes (right) are visible and circled in red.

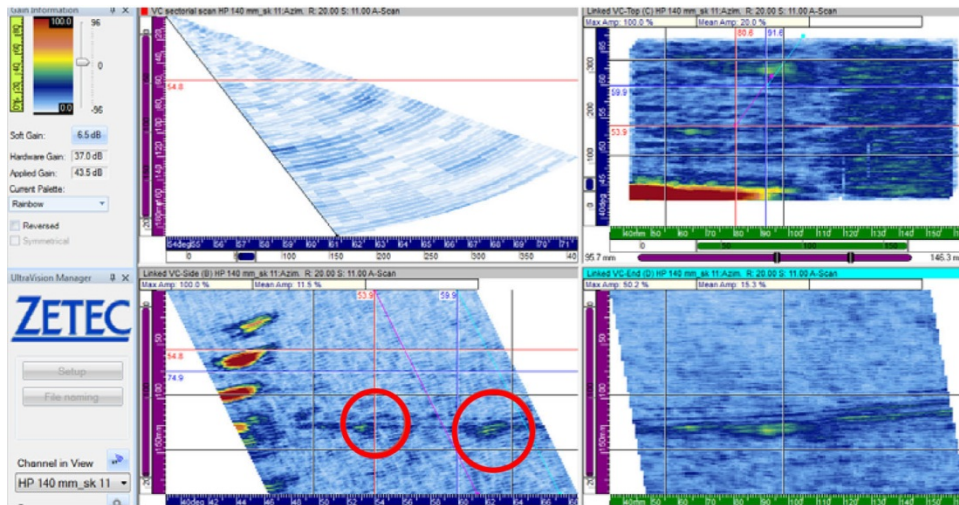
**Figure C.9.** CW, Skew 11, File 390 to 590 (mm). Possible implantation artifacts at 53 and 62 degrees are visible from circumferential flaw 4 and circled in red.

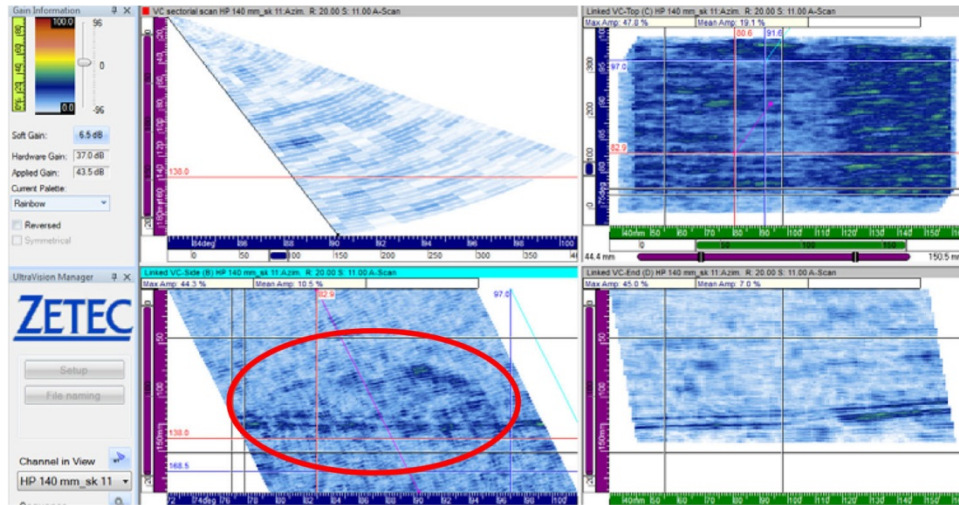
**Figure C.11.** CW, Skew 11, File 690 to 890 (mm). Possible implantation artifact from circumferential flaw 2 is visible and circled in red.

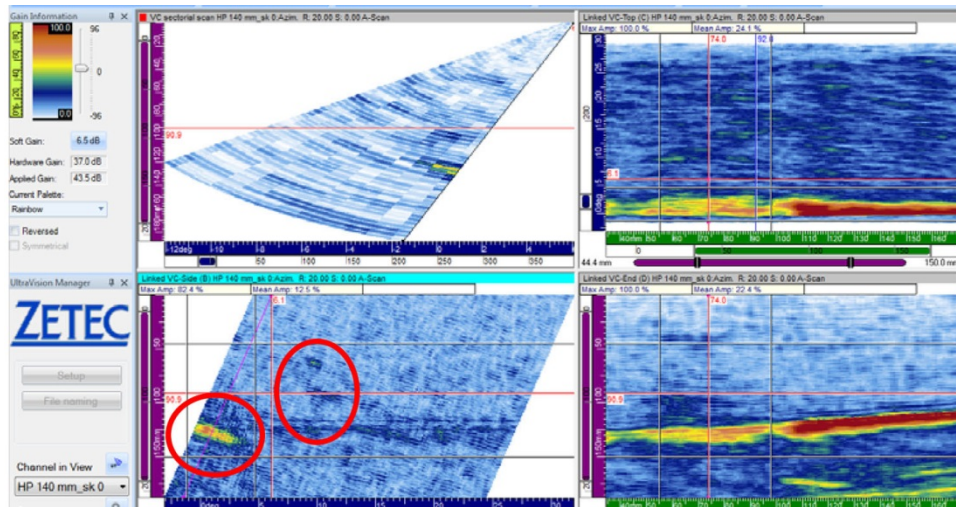
**Figure C.13.** CCW, Skew 0, File 250 to -3 (mm). The end of the specimen (left) is visible as well as mid-wall circumferential flaw 3 artifacts (right) and circled in red.

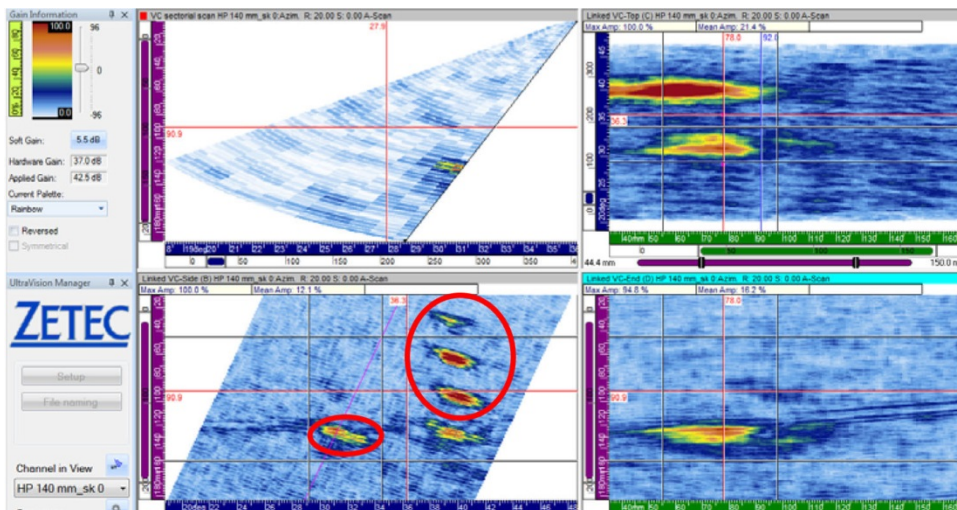
**Figure C.14.** CCW, Skew 0, File 400 to 200 (mm). Axial flaw 1 (left) and the three side-drilled holes (right) are visible and circled in red.

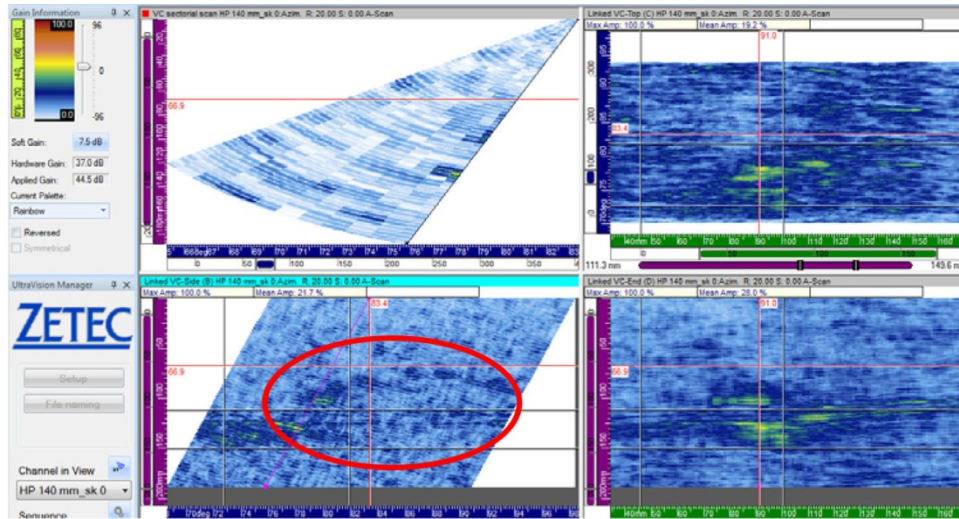
**Figure C.17.** CCW, Skew 0, File 850 to 650 (mm). Possible artifact from circumferential flaw 2 is visible and circled in red.

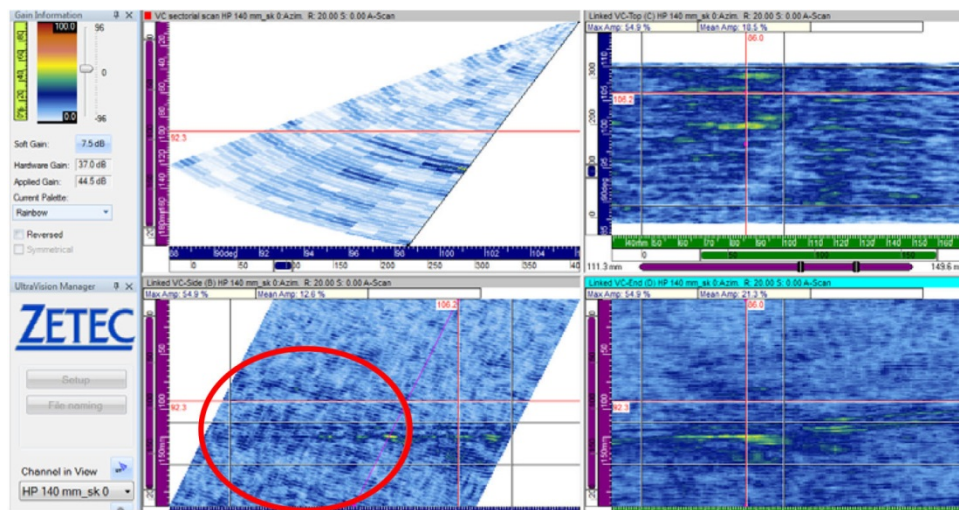
**Figure C.18.** CCW, Skew 0, File 1000 to 800 (mm). Possible artifact from circumferential flaw 2 is visible and circled in red.

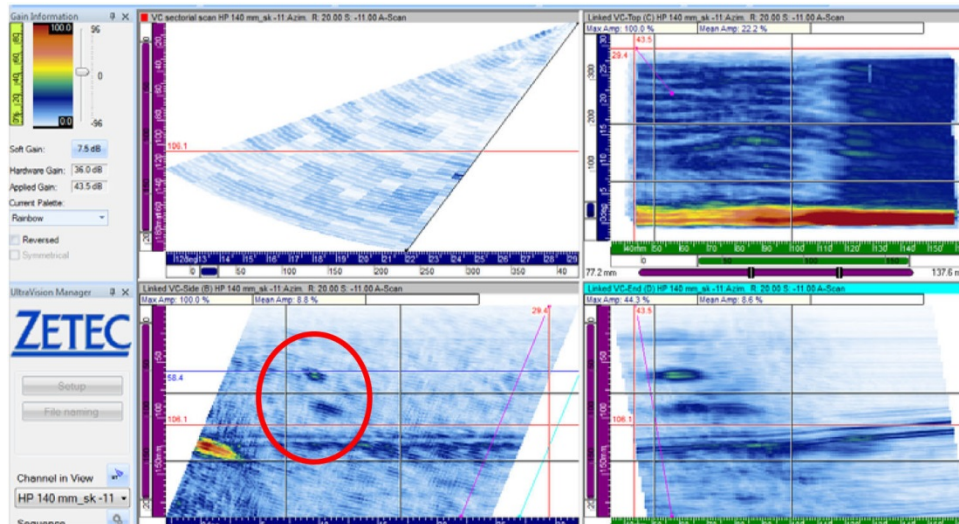
**Figure C.19.** CCW, Skew 11, File 250 to -3 (mm). Possible circumferential flaw 3 artifact at 10 degrees is visible and circled in red.

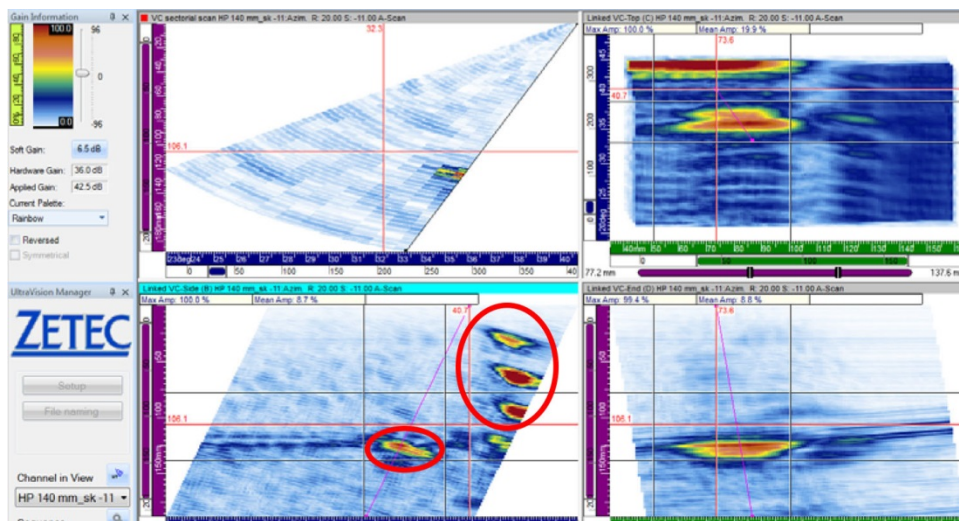
**Figure C.20.** CCW, Skew 11, File 400 to 200 (mm). Axial flaw 1 (left) and three side-drilled holes (right) are visible and circled in red.

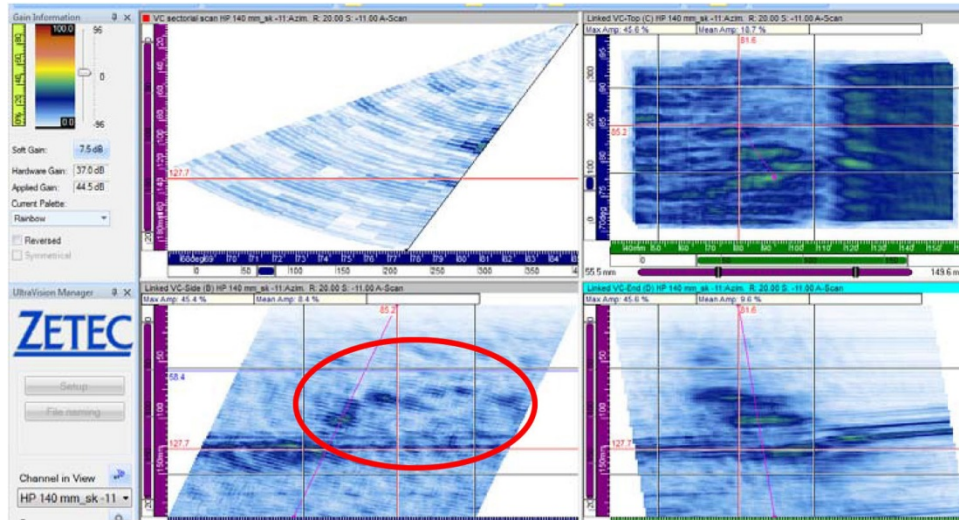
**Figure C.23.** CCW, Skew 11, File 850 to 650 (mm). Possible implantation artifact from circumferential flaw 2 is visible and circled in red.

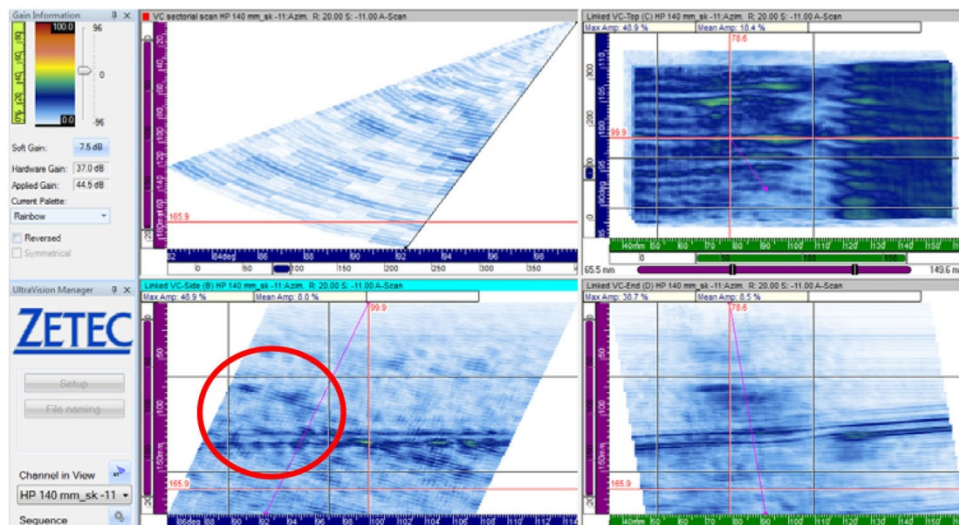
**Figure C.24.** CCW, Skew 11, File 1000 to 800 (mm). Possible implantation artifact from circumferential flaw 2 is visible and circled in red.

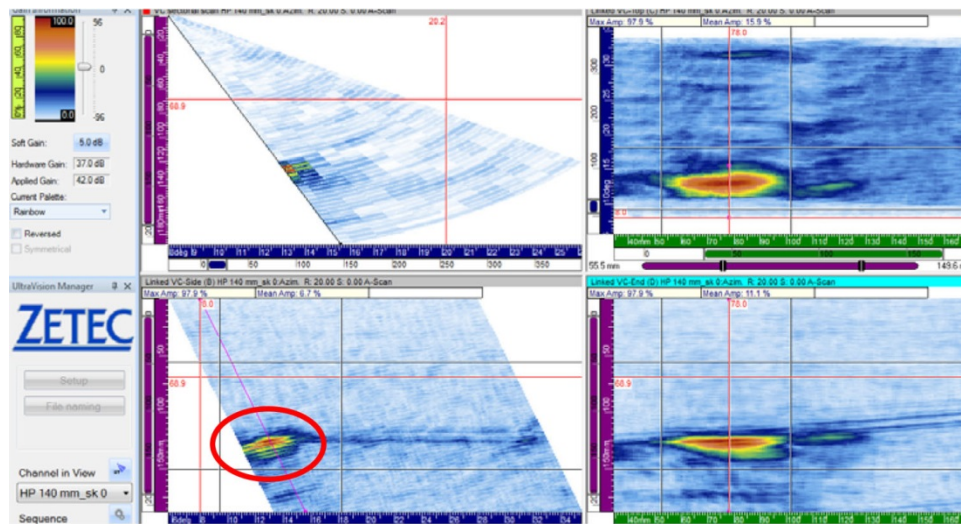
**Figure C.25.** CW, Skew 0, File 90 to 290 (mm). Axial flaw 3 is visible and circled in red.

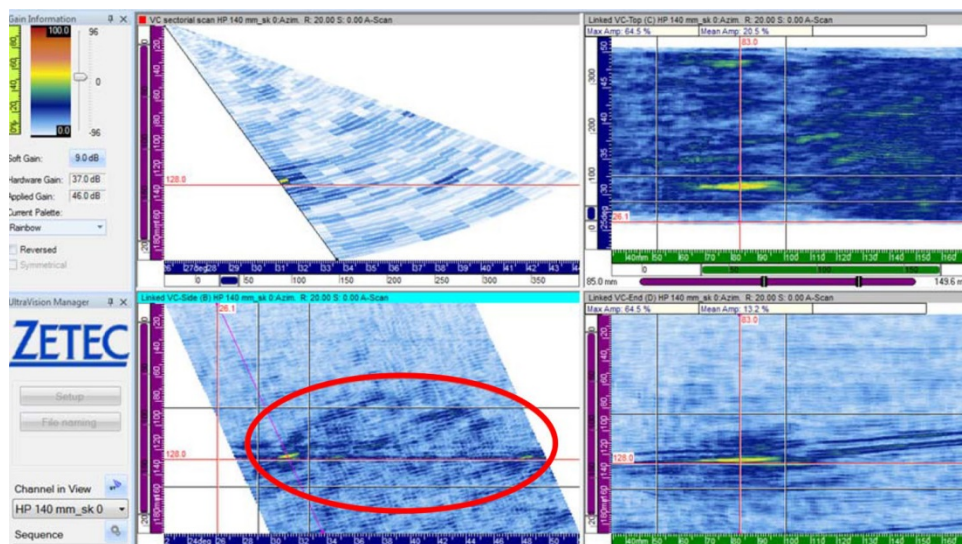
**Figure C.26.** CW, Skew 0, File 240 to 440 (mm). Possible implantation artifact from circumferential flaw 1 is visible and circled in red.

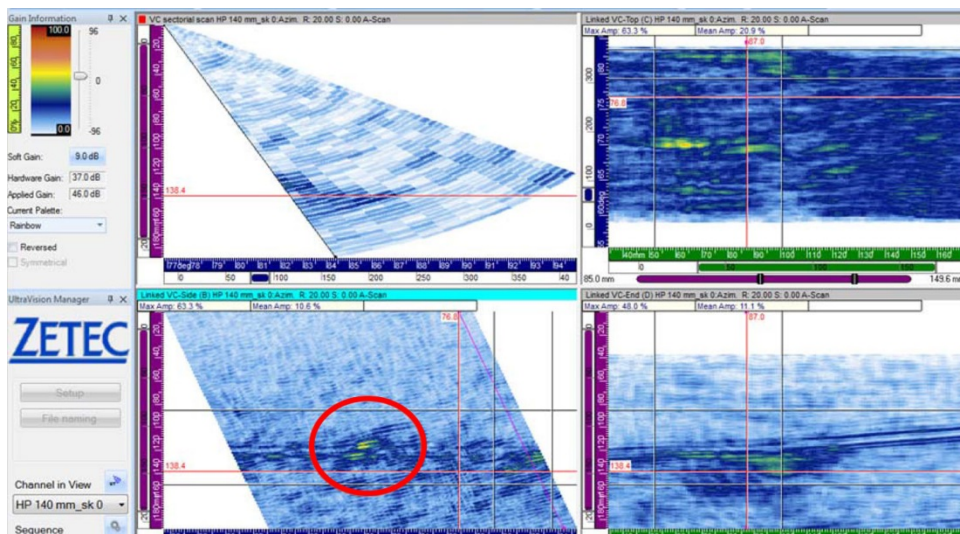
**Figure C.28.** CW, Skew 0, File 540 to 740 (mm). Possible flaw implantation artifact from circumferential flaw 4 is visible and circled in red.

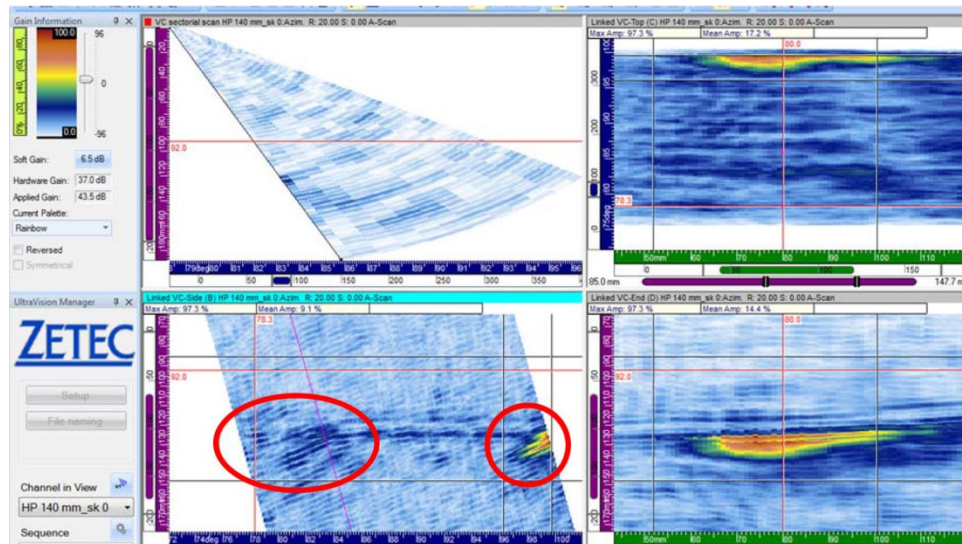
**Figure C.29.** CW, Skew 0, File 690 to 890 (mm). Circumferential flow 4 implantation artifact (left) and axial flow 2 (right) are visible and circled in red.

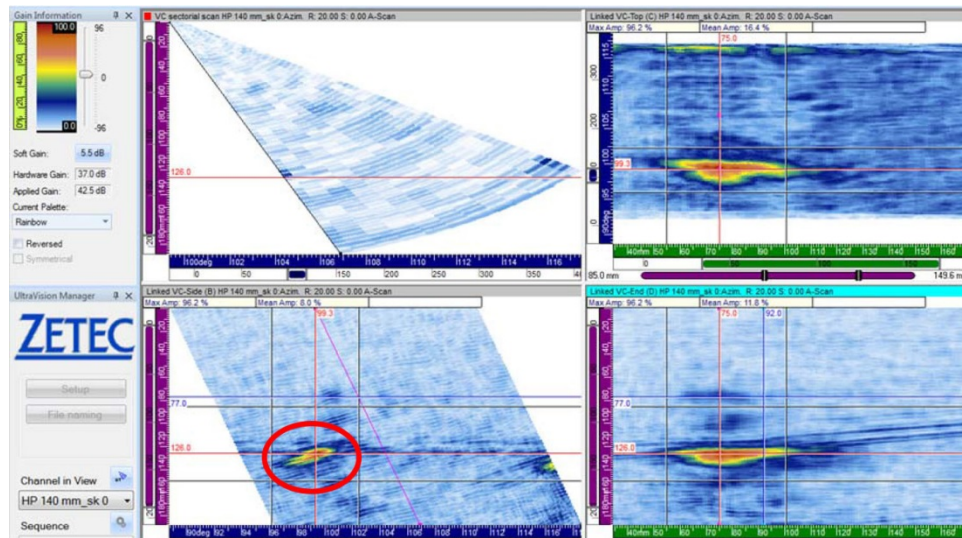
**Figure C.30.** CW, Skew 0, File 840 to 1040 (mm). Axial flow 2 is visible and circled in red.

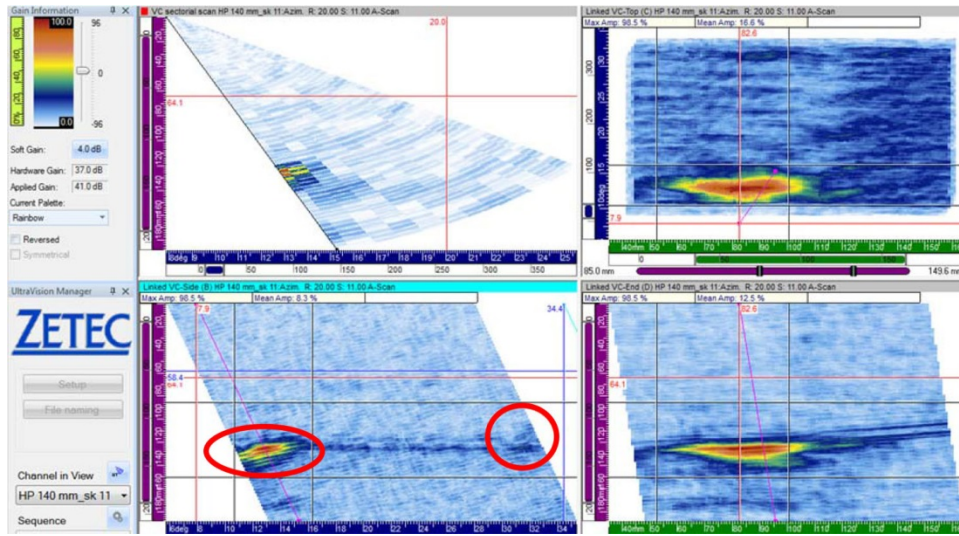
**Figure C.31.** CW, Skew 11, File 90 to 290 (mm). Axial flaw 3 (left) and possible implantation artifact from circumferential flaw 1 (right) are visible and circled in red.

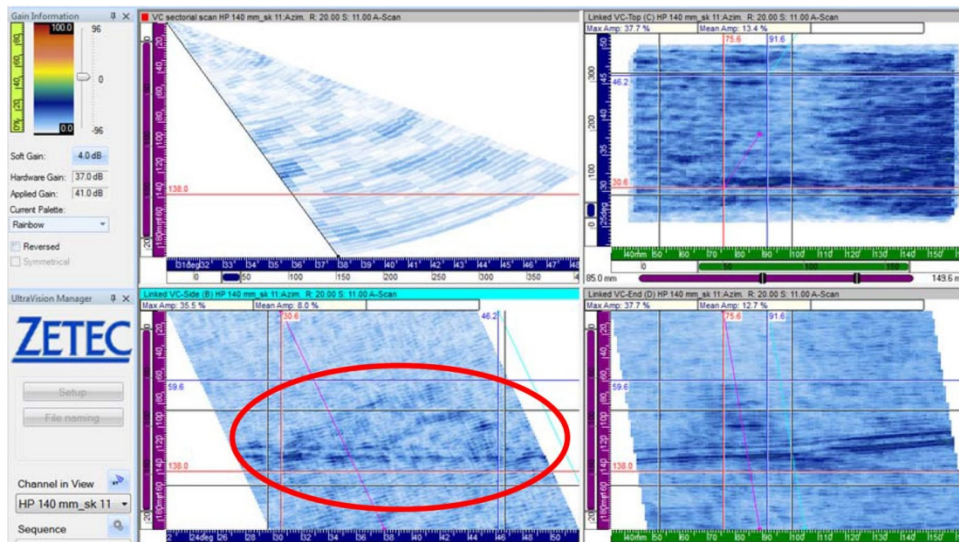
**Figure C.32.** CW, Skew 11, File 240 to 440 (mm). Possible implantation artifact from circumferential flaw 1 is visible and circled in red.

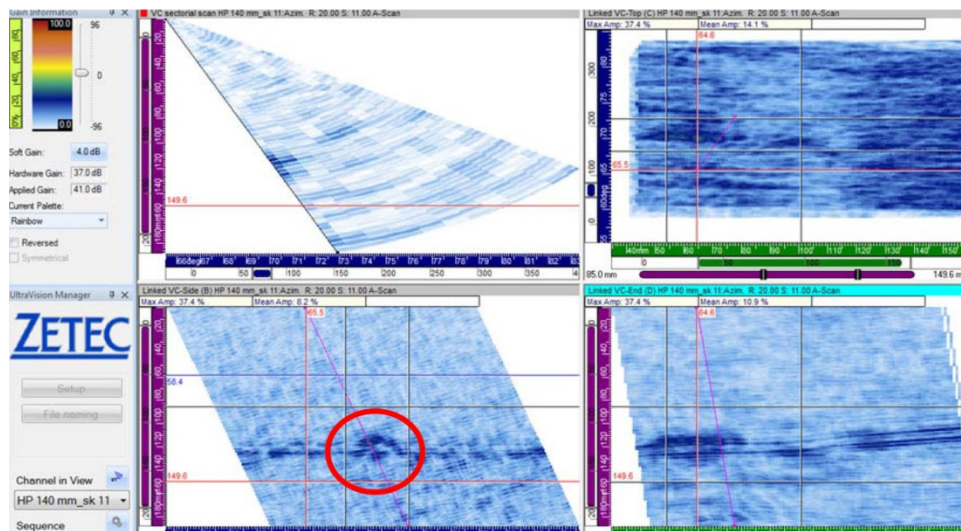
**Figure C.34.** CW, Skew 11, File 540 to 740 (mm). Possible implantation artifact from circumferential flaw 4 is visible and circled in red.

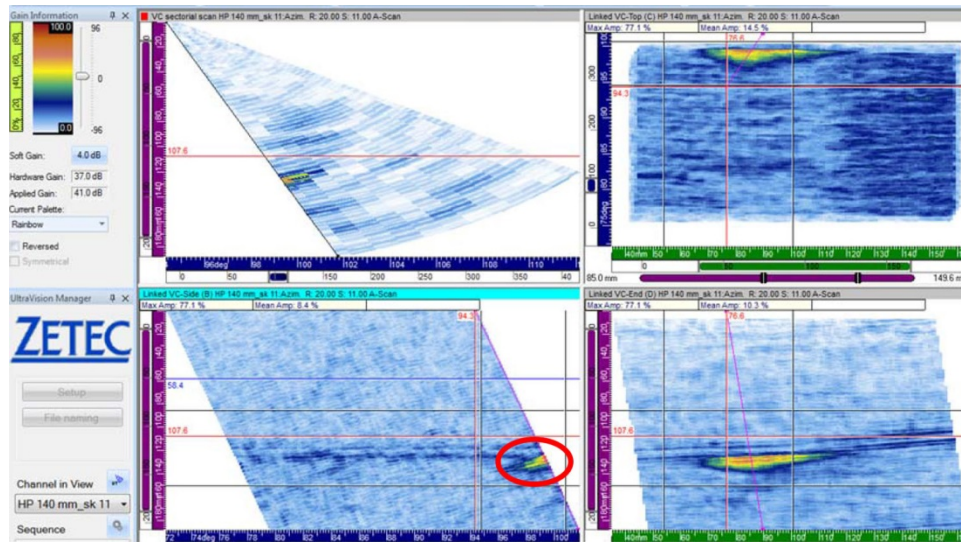
**Figure C.35.** CW, Skew 11, File 690 to 890 (mm). Axial flaw 2 is on the edge of the scanned aperture and circled in red.

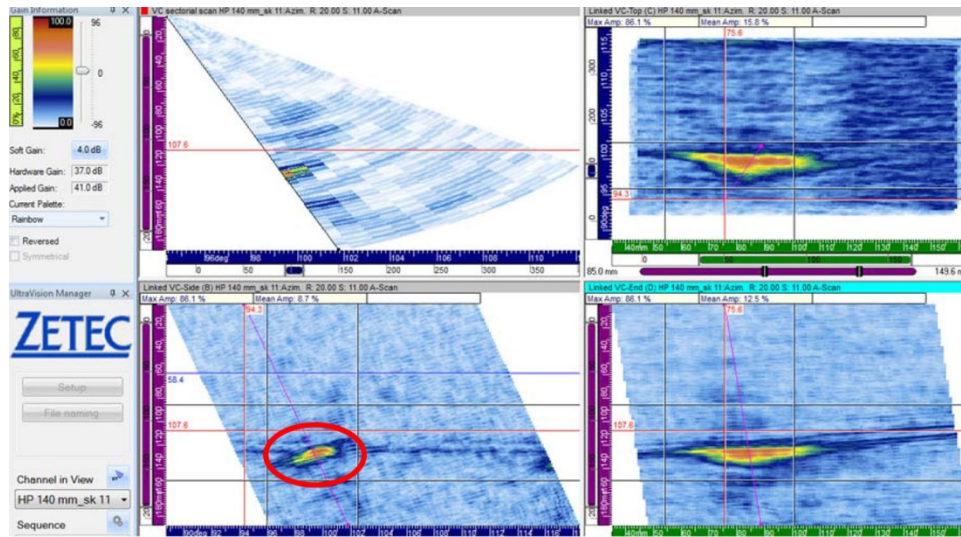
**Figure C.36.** CW, Skew 11, File 840 to 1040 (mm). Axial flaw 2 is visible and circled in red.

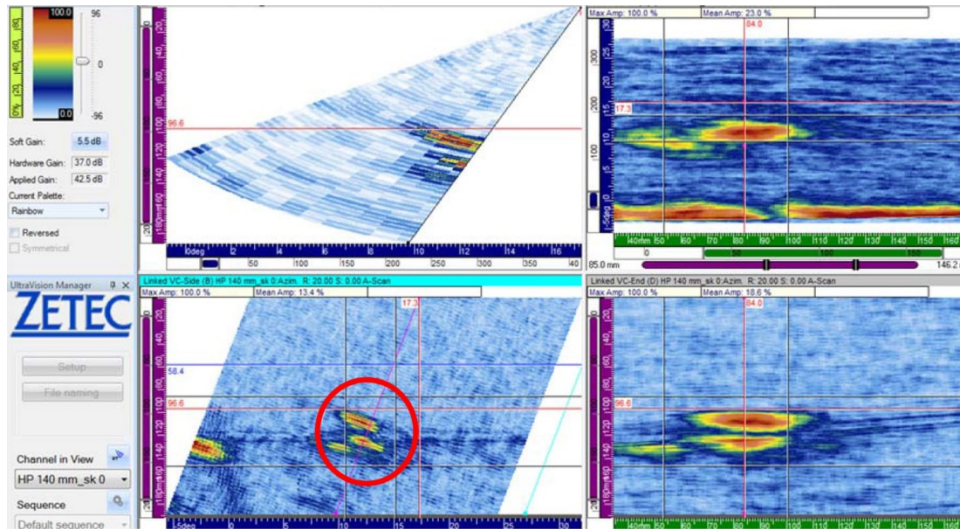
**Figure C.37.** CCW, Skew 0, File 250 to -20 (mm). Axial flaw 3 is visible and circled in red.

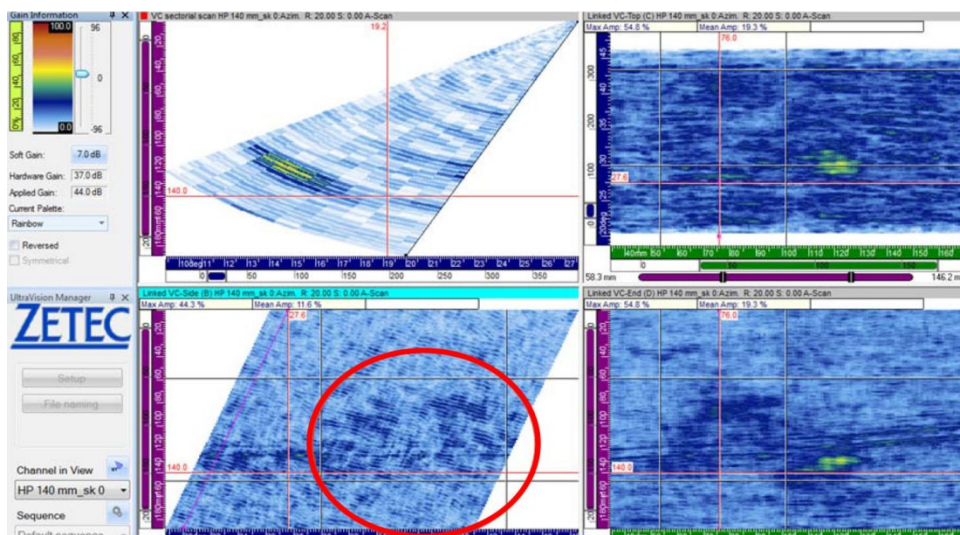
**Figure C.38.** CCW, Skew 0, File 400 to 200 (mm). Possible implantation artifacts from circumferential flaw 1 are visible and circled in red.

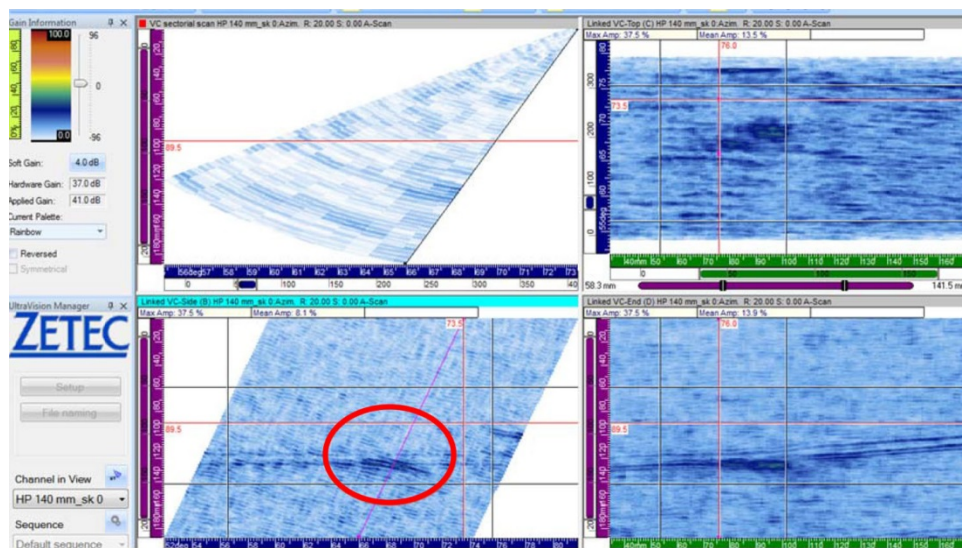
**Figure C.40.** CCW, Skew 0, File 700 to 500 (mm). A possible implantation artifact from circumferential flaw 4 is visible and circled in red.

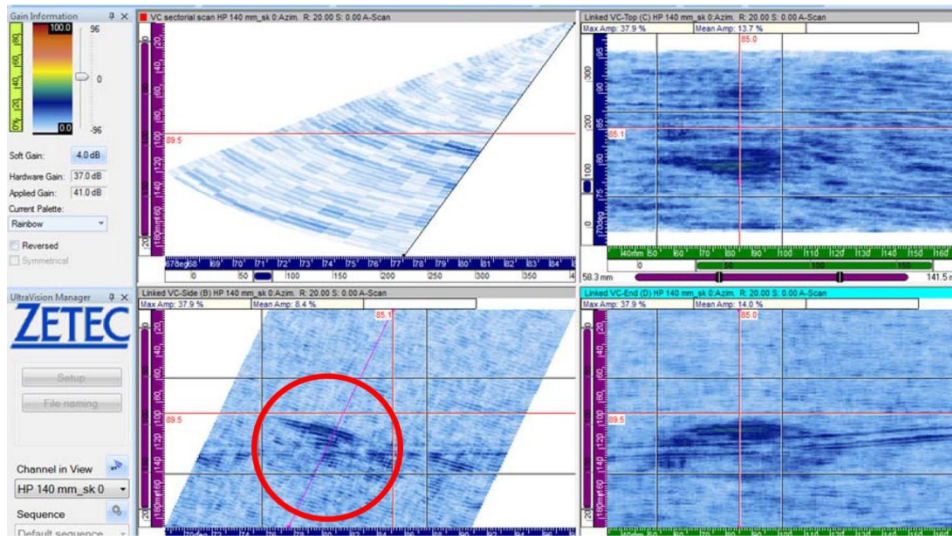
**Figure C.41.** CCW, Skew 0, File 850 to 650 (mm). Possible artifact from circumferential flow 4 is visible and circled in red.

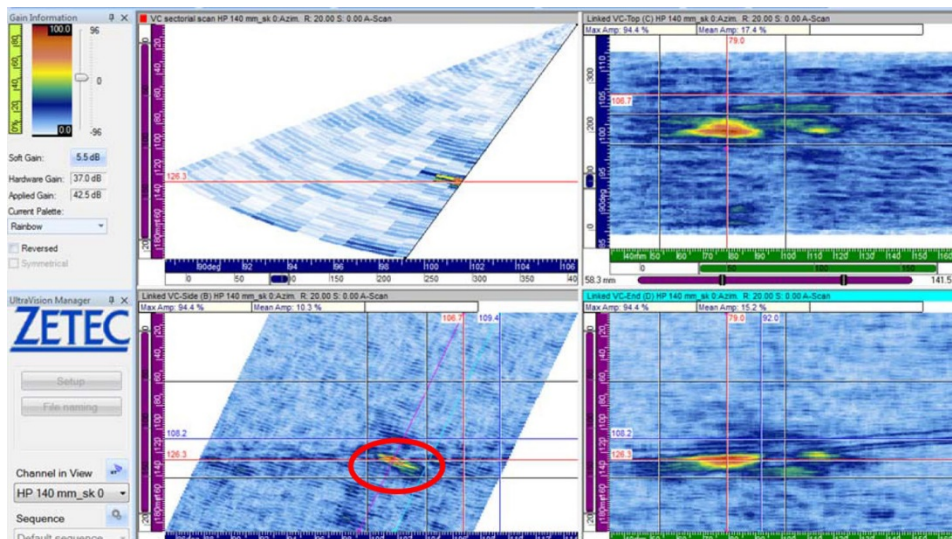
**Figure C.42.** CCW, Skew 0, File 1000 to 800 (mm). Axial flaw 2 is visible and circled in red.

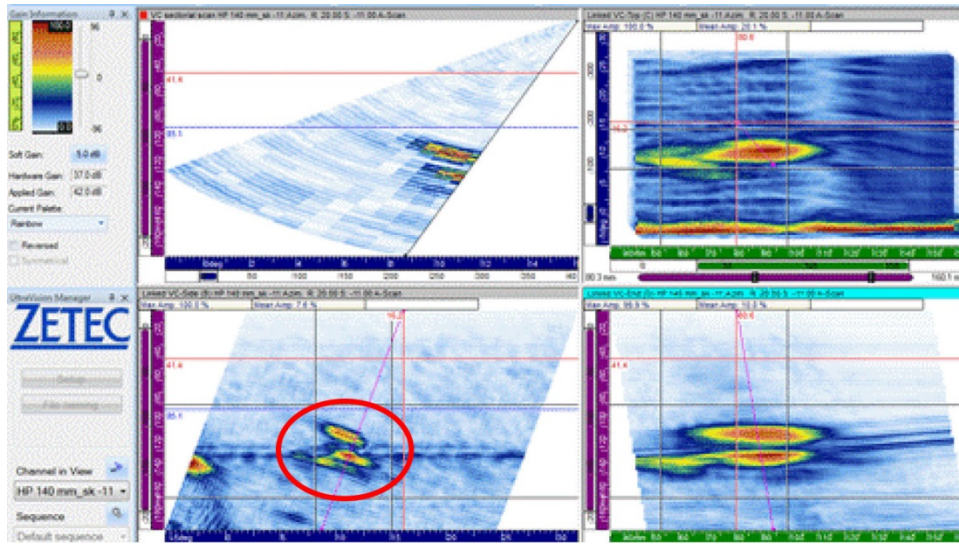
**Figure C.43.** CCW, Skew 11, File 250 to -20 (mm). Axial flow 3 is visible and circled in red.

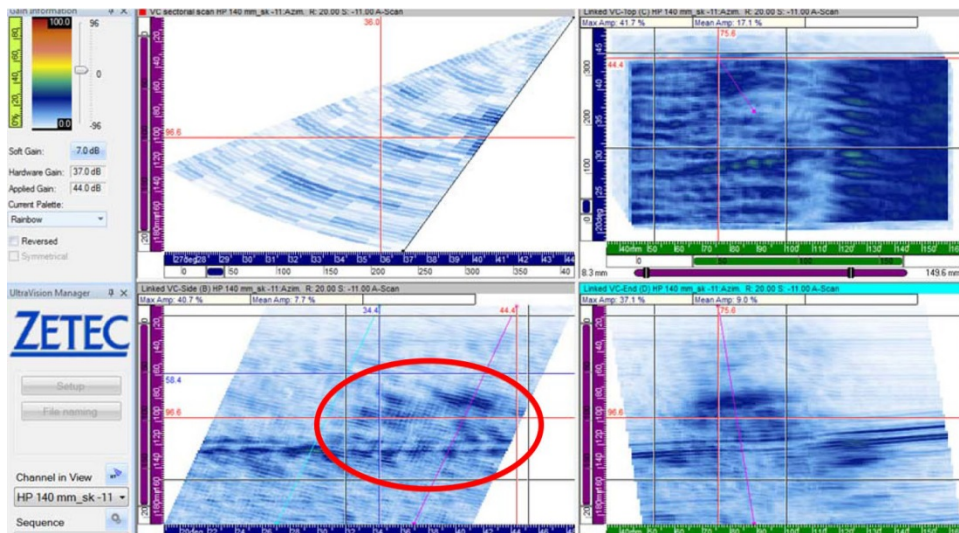
**Figure C.44.** CCW, Skew 11, File 400 to 200 (mm). Possible implantation artifacts from circumferential flaw 1 are visible and circled in red.

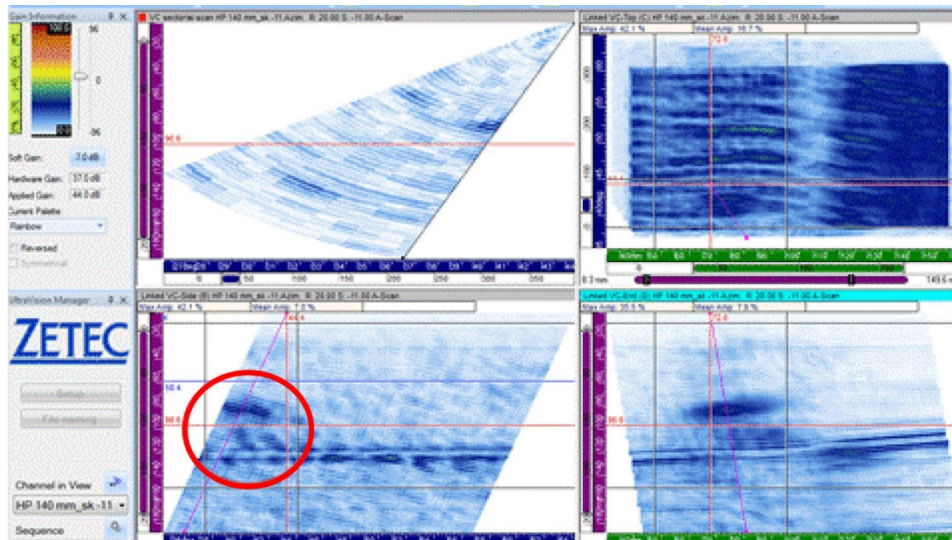
**Figure C.45.** CCW, Skew 11, File 550 to 350 (mm). Possible implantation artifacts from circumferential flaw 1 are visible and circled in red.

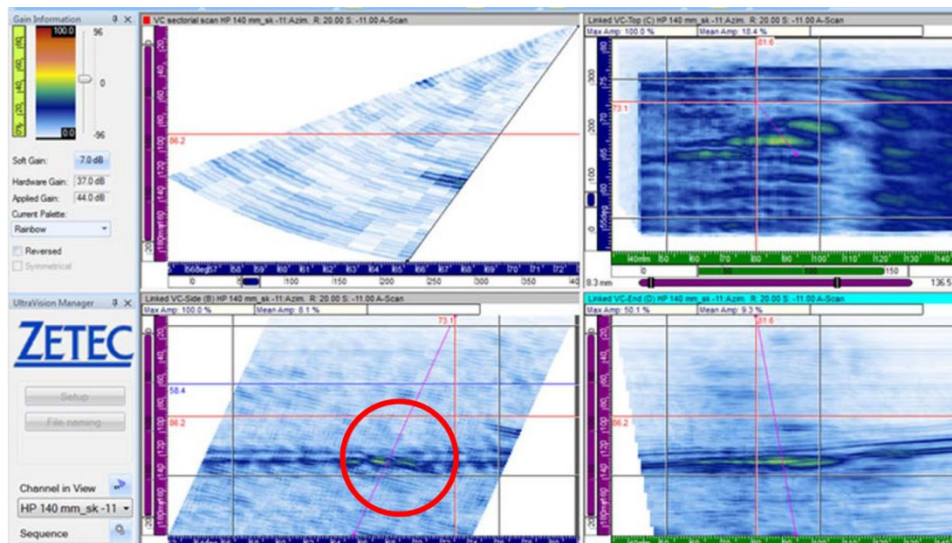
**Figure C.46.** CCW, Skew 11, File 700 to 500 (mm). A possible implantation artifact from circumferential flaw 4 is visible and circled in red.

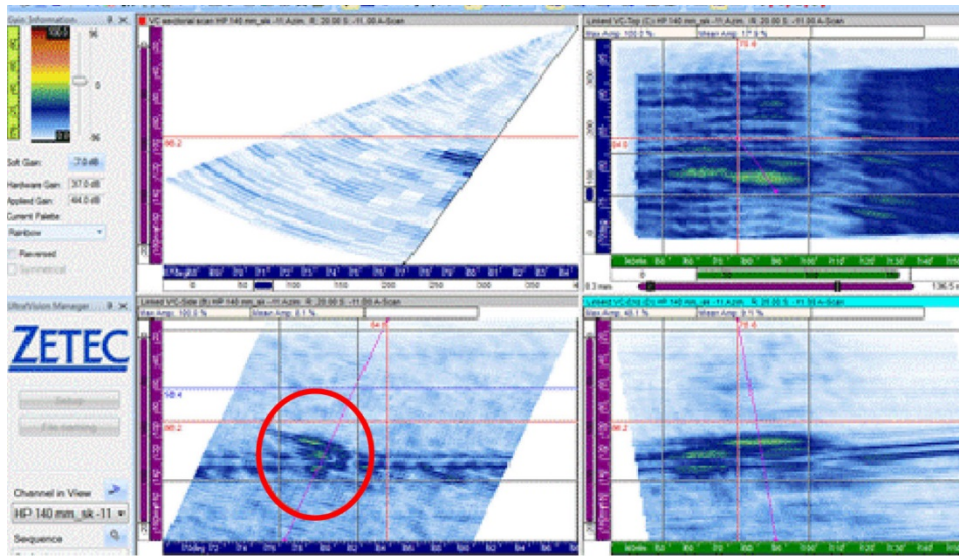
**Figure C.47.** CCW, Skew 11, File 850 to 650 (mm). Possible implantation artifact from circumferential flaw 4 is visible and circled in red.

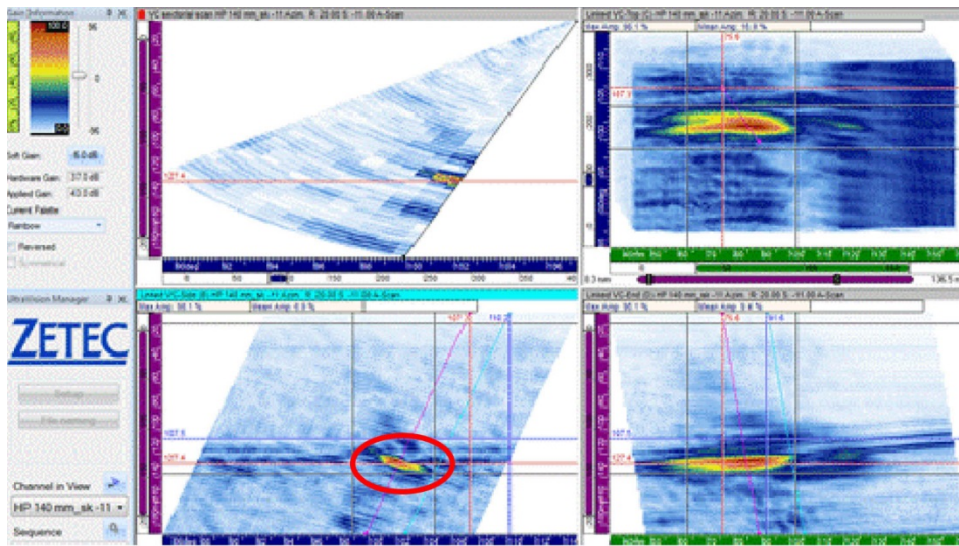
**Figure C.48.** CCW, Skew 11, File 1000 to 800 (mm). Axial flaw 2 is visible and circled in red.

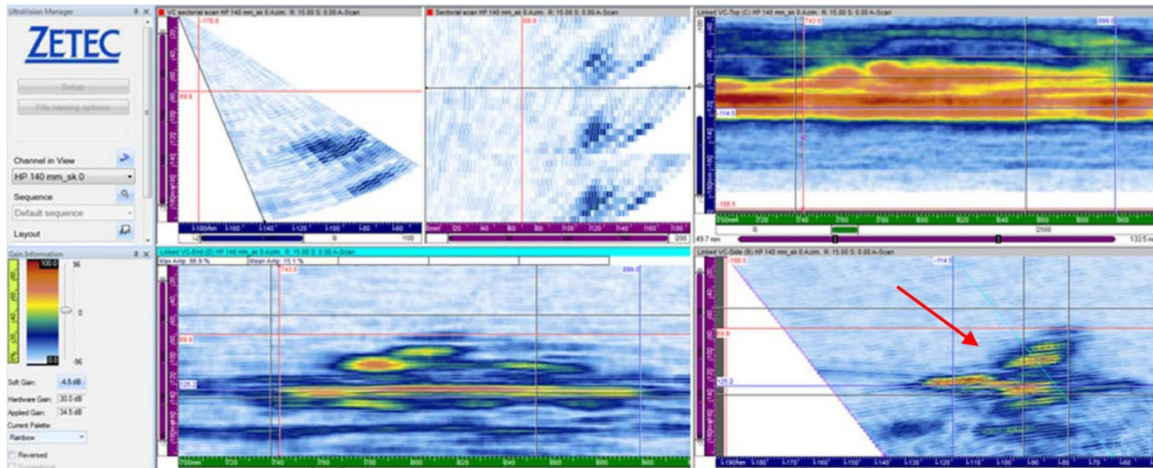
**Figure C.49.** DM-05 Flaw 2, Noted by Red Arrow

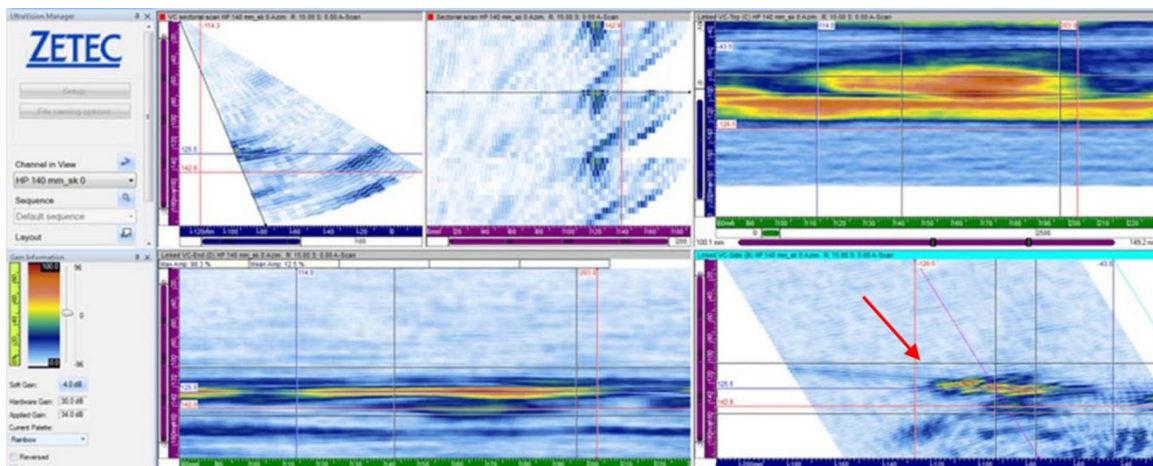
**Figure C.50.** DM-05 Flaw 3, Noted by Red Arrow

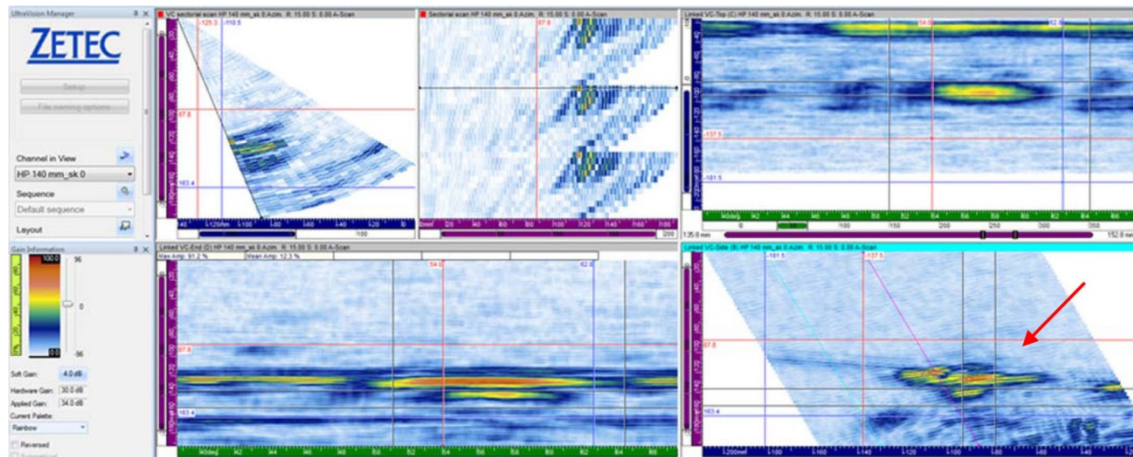
**Figure C.51.** DM-05 Flaw 4, Noted by Red Arrow

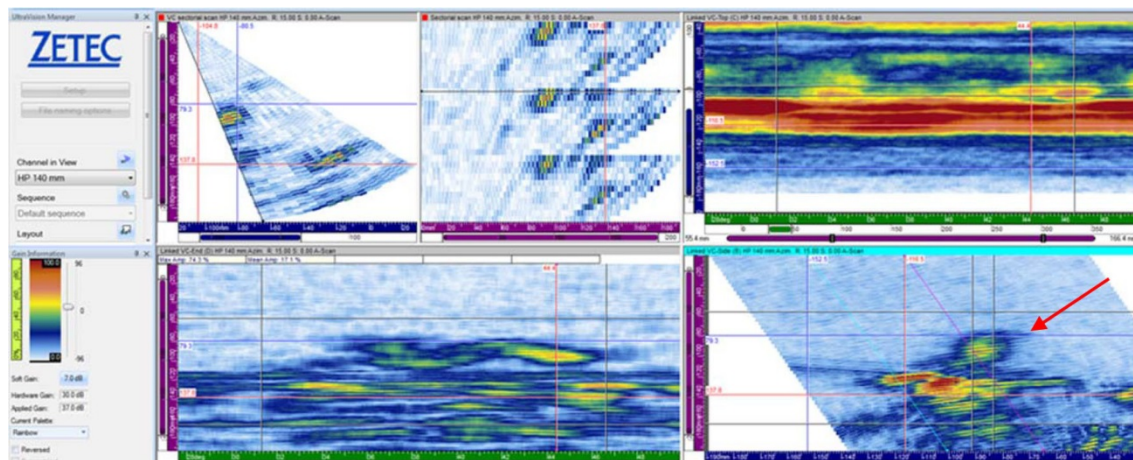
**Figure C.52.** DM-10 Flaw 1, Noted by Red Arrow

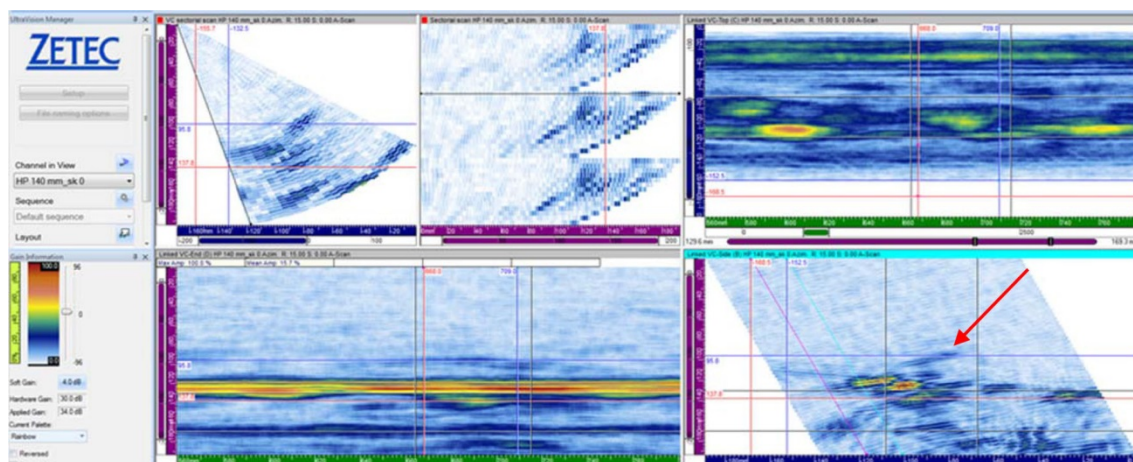
**Figure C.53.** DM-10 Flaw 4, Noted by Red Arrow
