PNNL-22553

# Final Assessment of Manual Ultrasonic Examinations Applied to Detect Flaws in Primary System Dissimilar Metal Welds at North Anna Power Station

March 2014

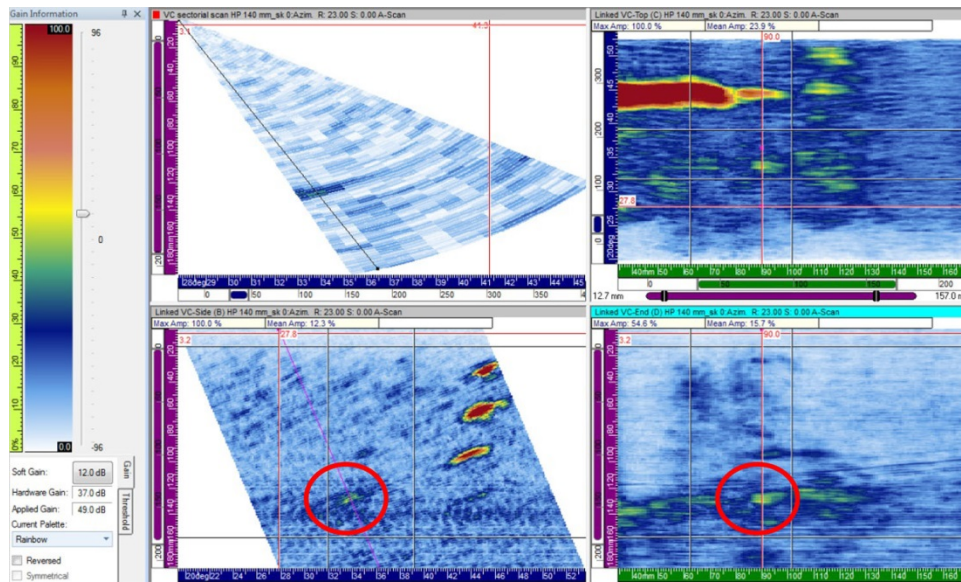
**Figure D.1.** CW, Skew 0, Axial Flaw 1, Circled in Red

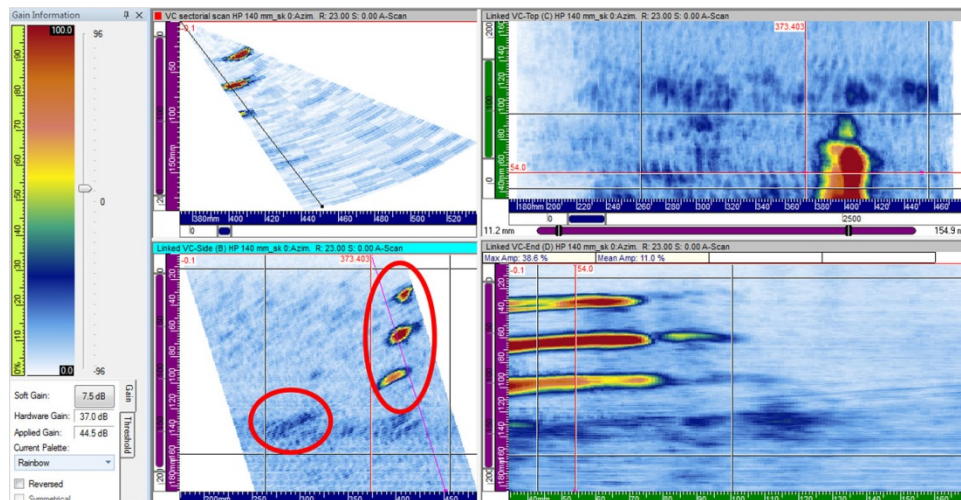
**Figure D.2.** CW, Skew 0 (reduced gain). Axial flaw 1 (left) and three side-drilled holes (right) are visible and circled in red.

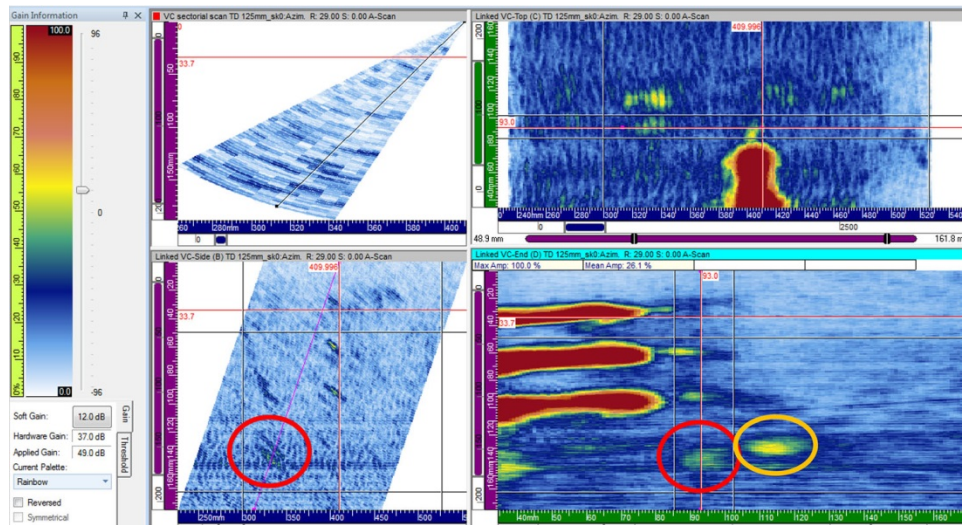
**Figure D.3.** CCW, Skew 0, Axial Flaw 1, Circled in Red. An artifact extending into the safe end is circled in orange.

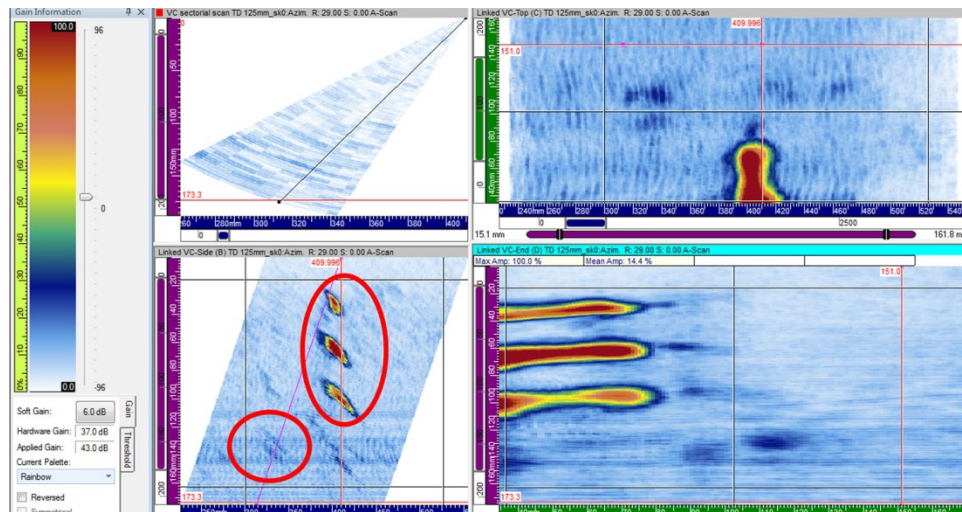
**Figure D.4.** CCW, Skew 0, Reduced Gain. Axial flaw 1 (left) and three side-drilled holes (right) are visible and circled in red.

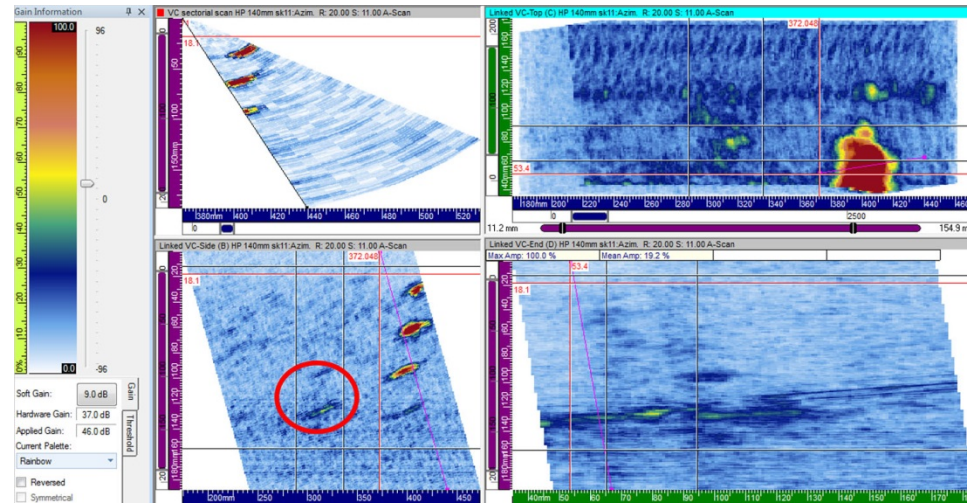
**Figure D.5.** CW, Skew 11, Axial Flaw 1, Circled in Red

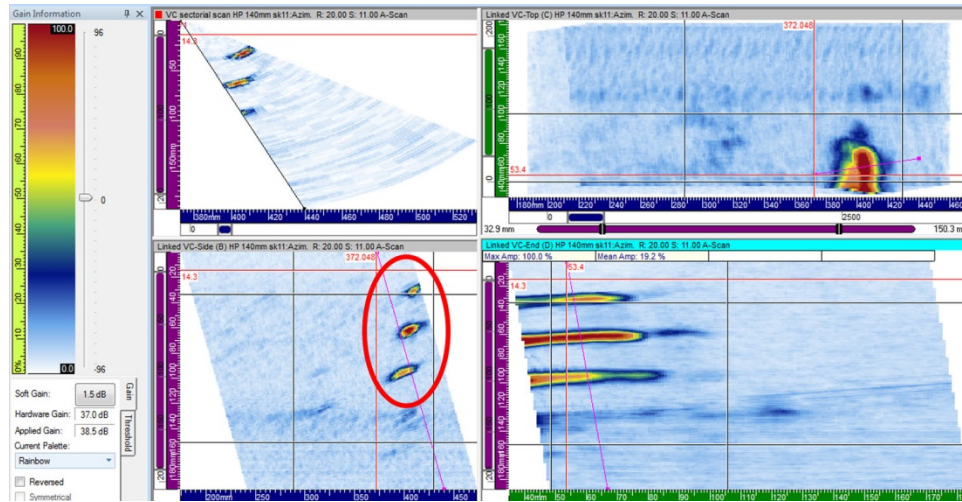
**Figure D.6.** CW, Skew 11, Reduced Gain. Three side-drilled holes are visible and circled in red.

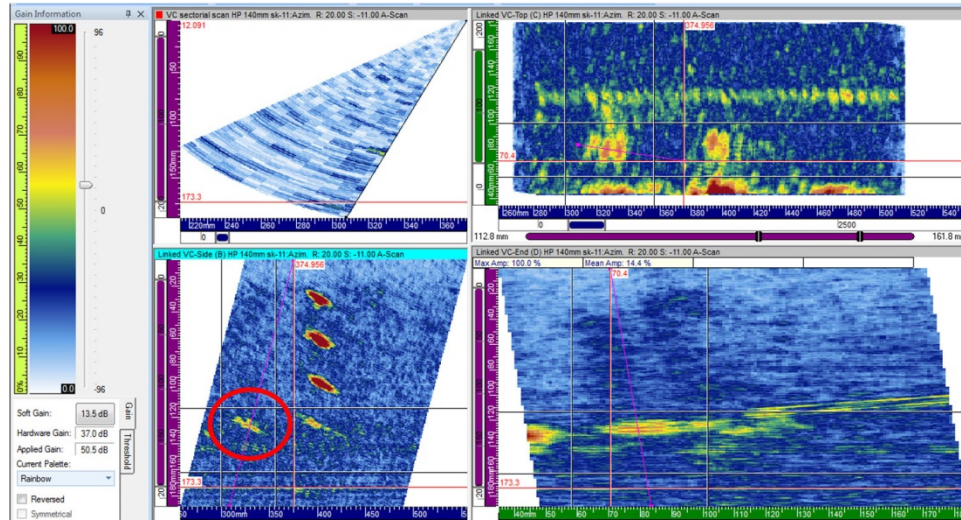
**Figure D.7.** CCW, Skew 11, Axial Flaw 1, Circled in Red

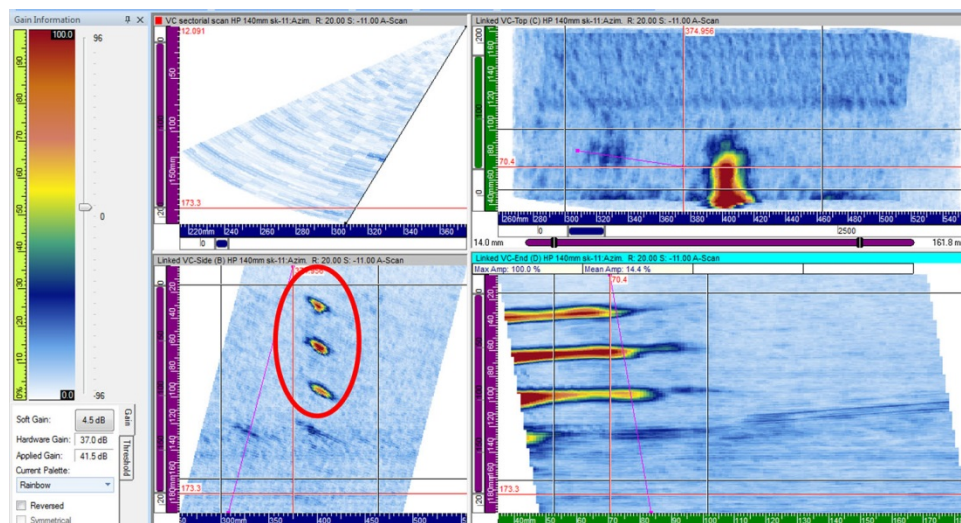
**Figure D.8.** CCW, Skew 11, Reduced Gain. Three side-drilled holes are visible and circled in red.

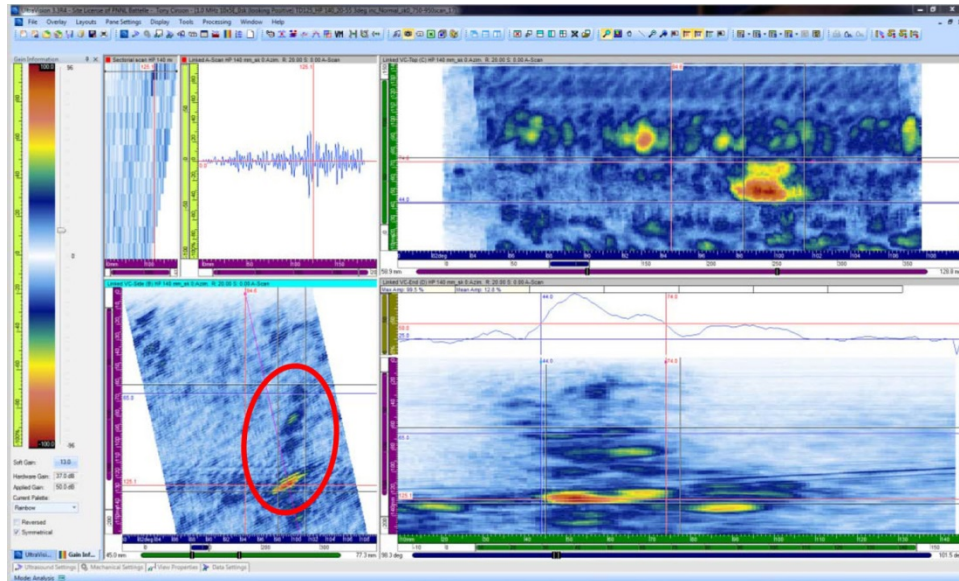
Figure D.9. CW, Skew 0, Axial Flaw 2, Circled in Red

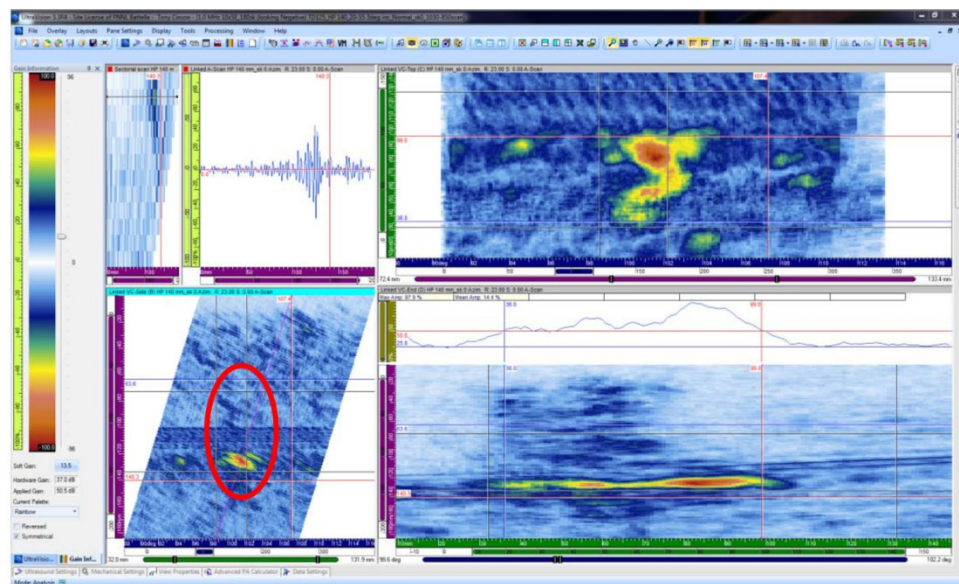
Figure D.10. CCW, Skew 0, Axial Flaw 2, Circled in Red

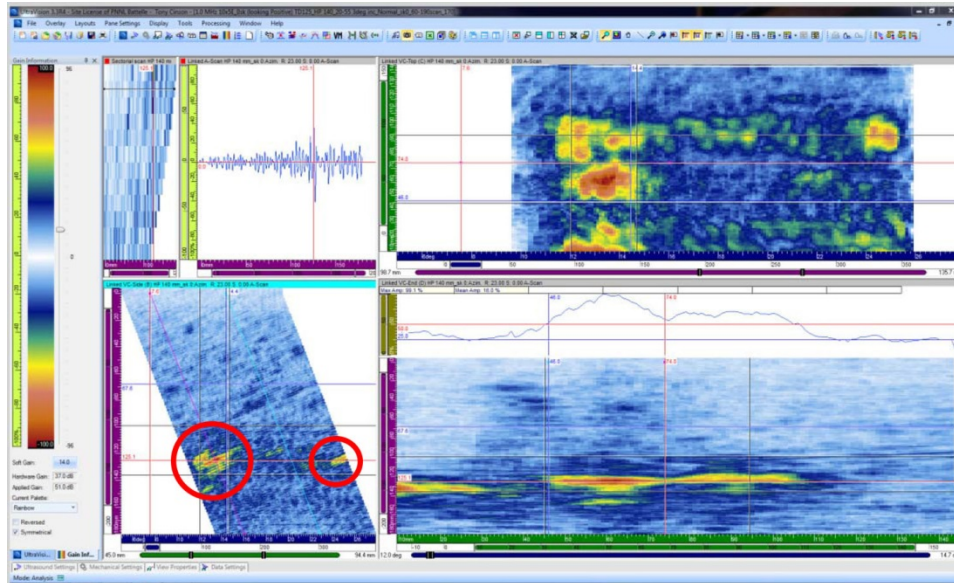
**Figure D.11.** CW, Skew 0. Axial Flaw 3 (left) and artifact (right) are visible and circled in red.

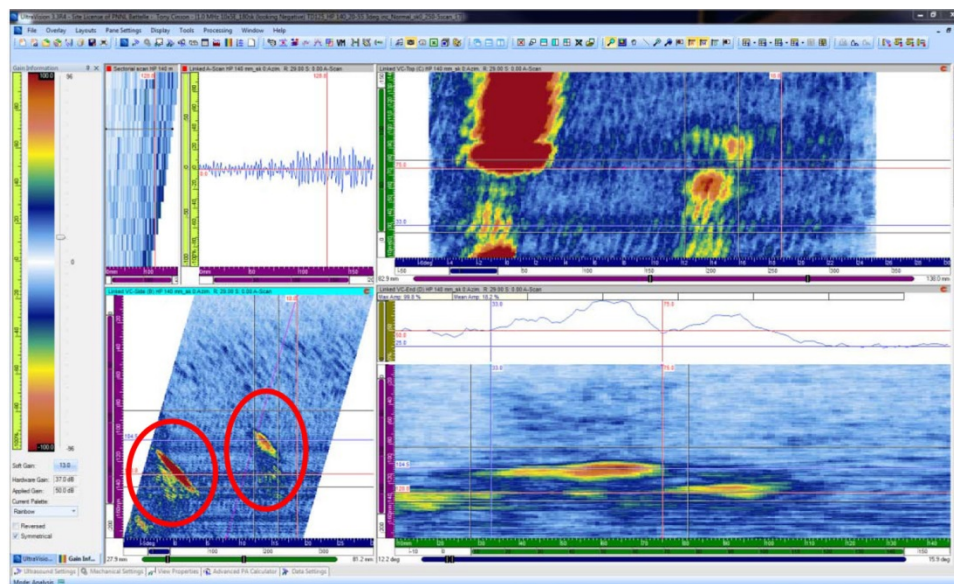
**Figure D.12.** CCW, Skew 0. Axial Flaw 3 and artifact (right), and end-of-specimen (left) are visible and circled in red.

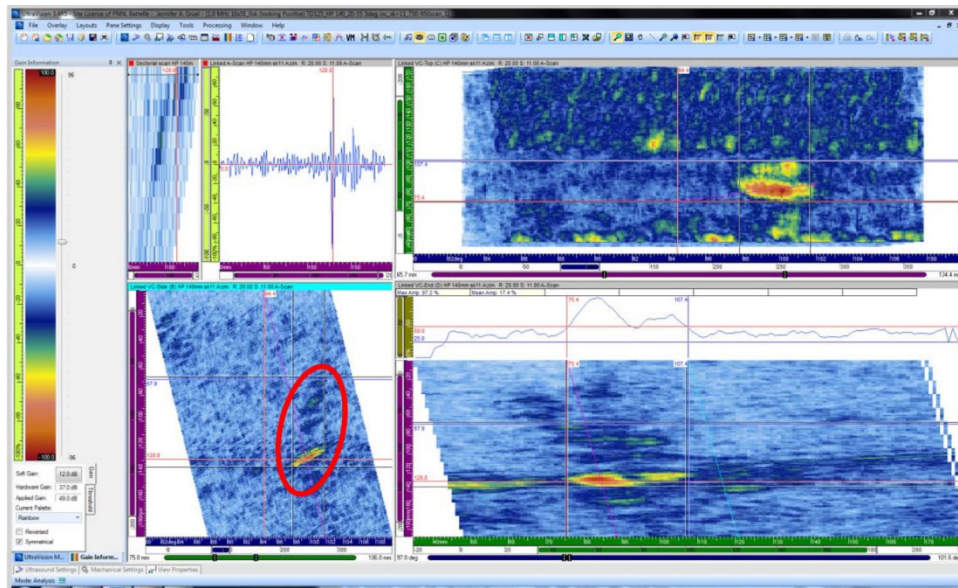
**Figure D.13.** CW, Skew 11, Axial Flaw 2, Circled in Red

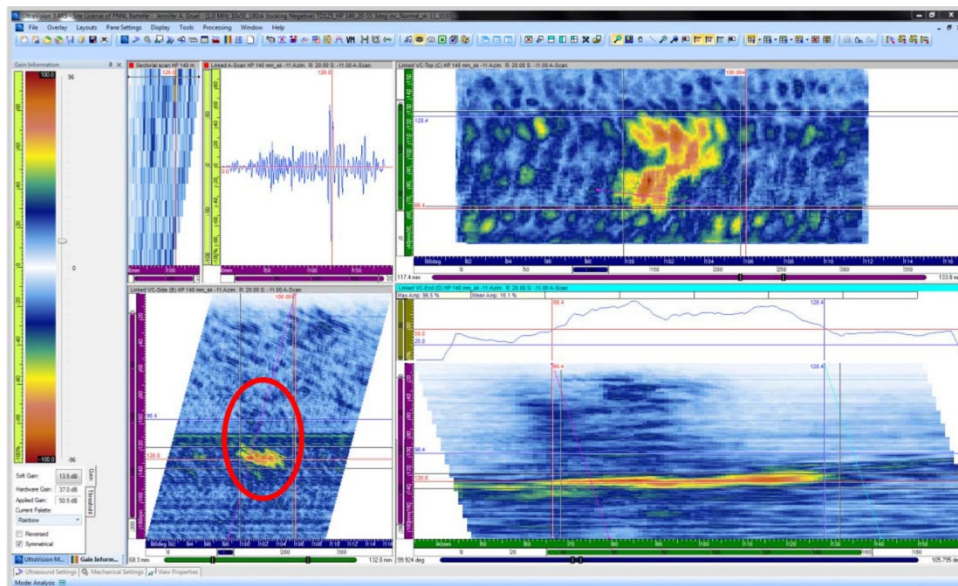
**Figure D.14.** CCW, Skew 11, Axial Flaw 2, Circled in Red

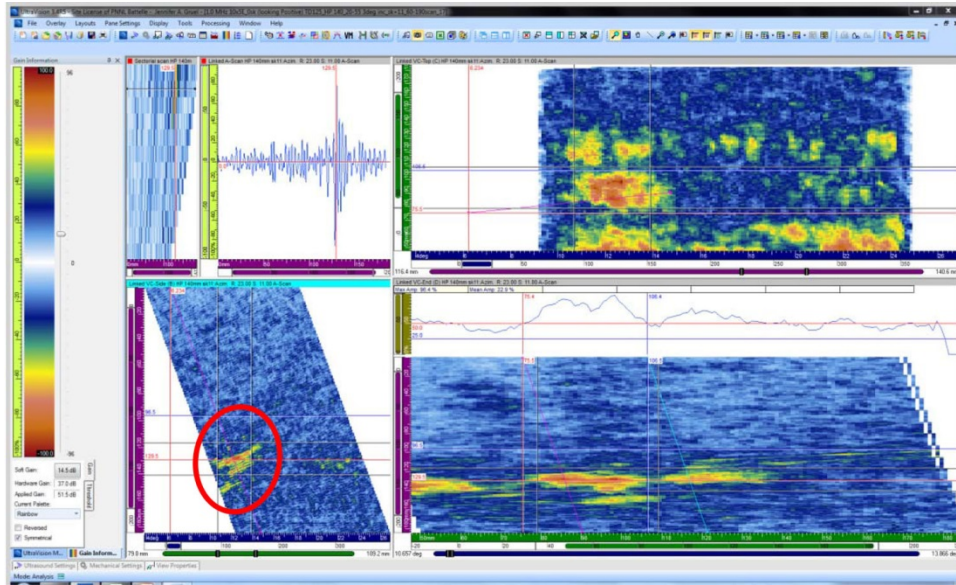
**Figure D.15.** CW, Skew 11, Axial Flaw 3, Circled in Red

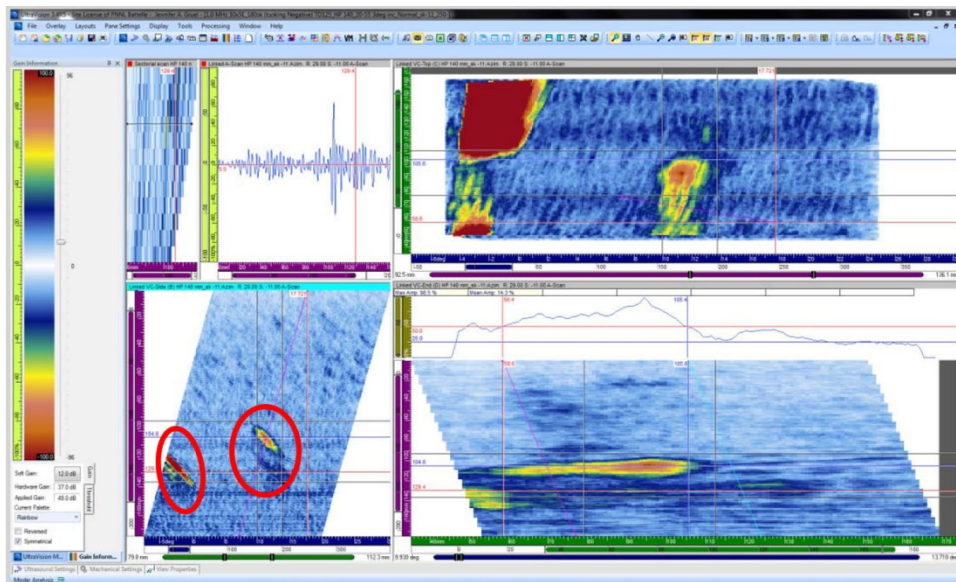
**Figure D.16.** CCW, Skew 11. Axial flaw 3 (right) and end-of-specimen (left) are visible and circled in red.

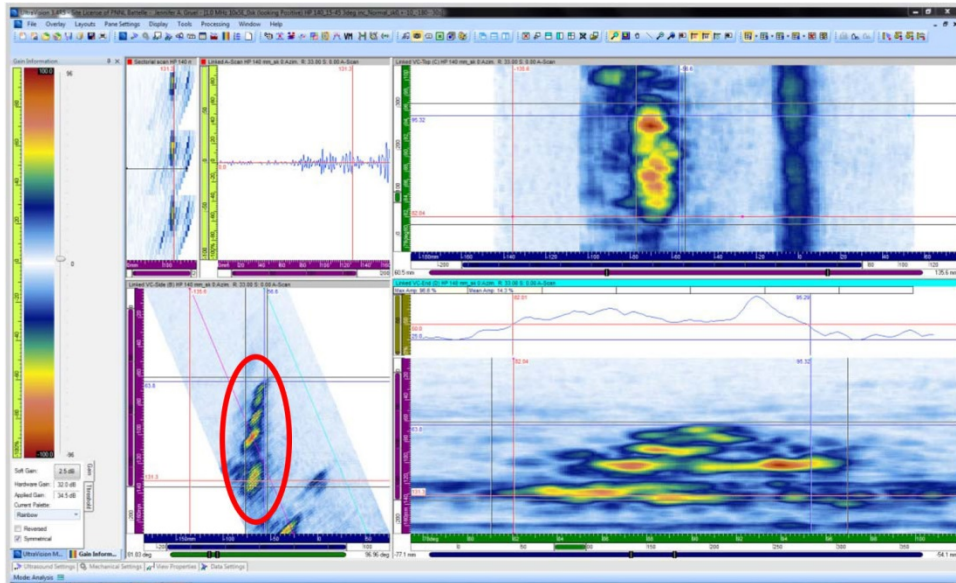
Figure D.17. DM-05 Flaw 2 Circled in Red

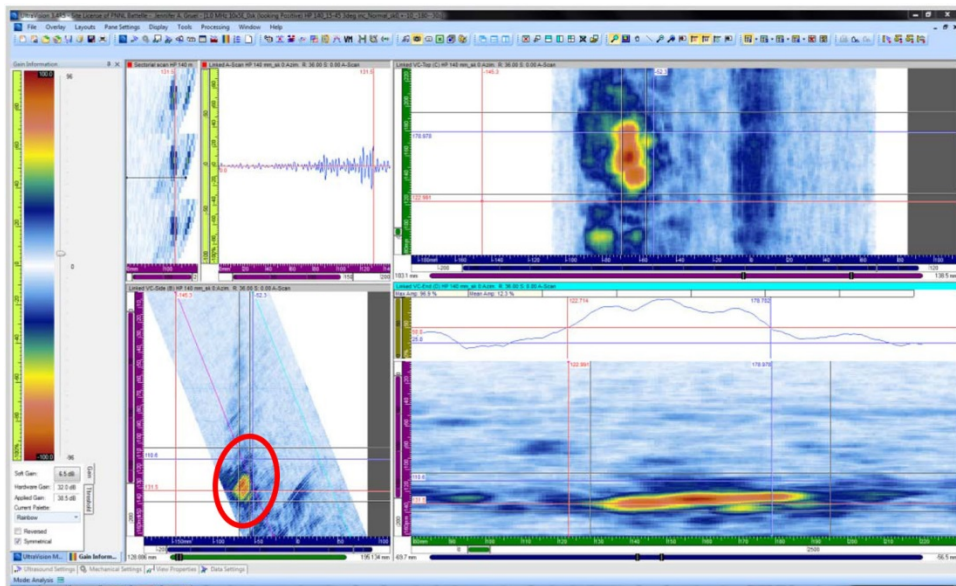
Figure D.18. DM-05 Flaw 3 Circled in Red

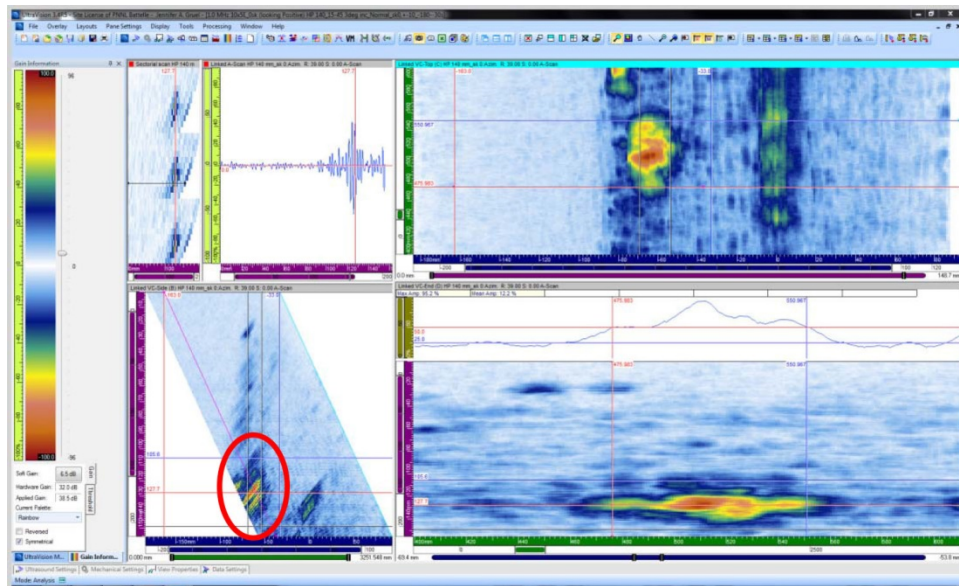
**Figure D.19.** DM-05 Flaw 4 Circled in Red

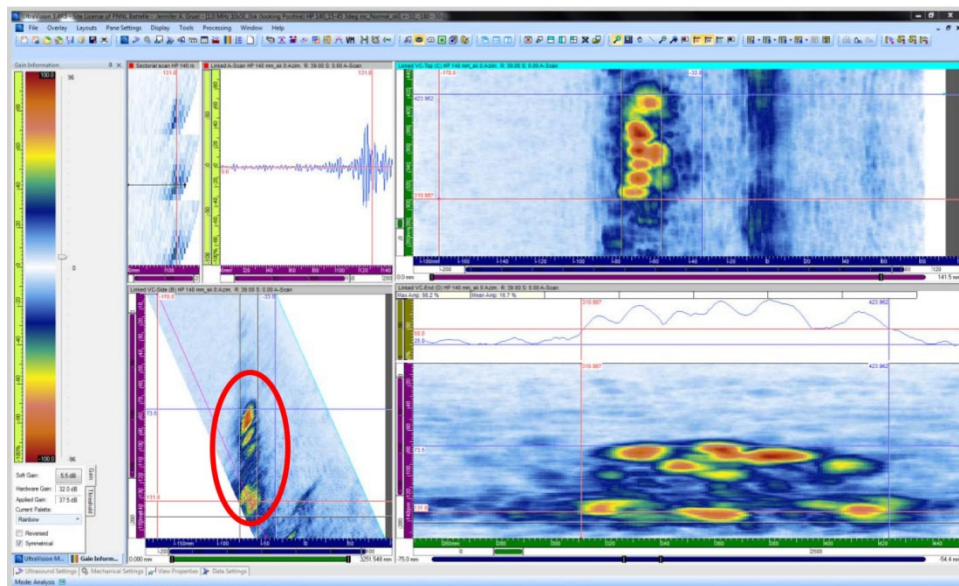
**Figure D.20.** DM-10 Flaw 1 Circled in Red

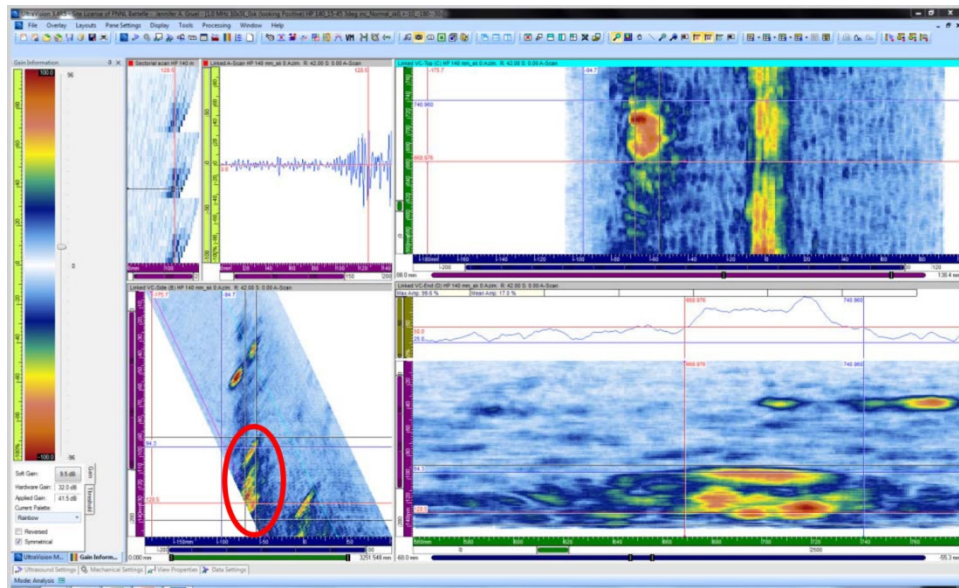
**Figure D.21.** DM-10 Flaw 4 Circled in Red

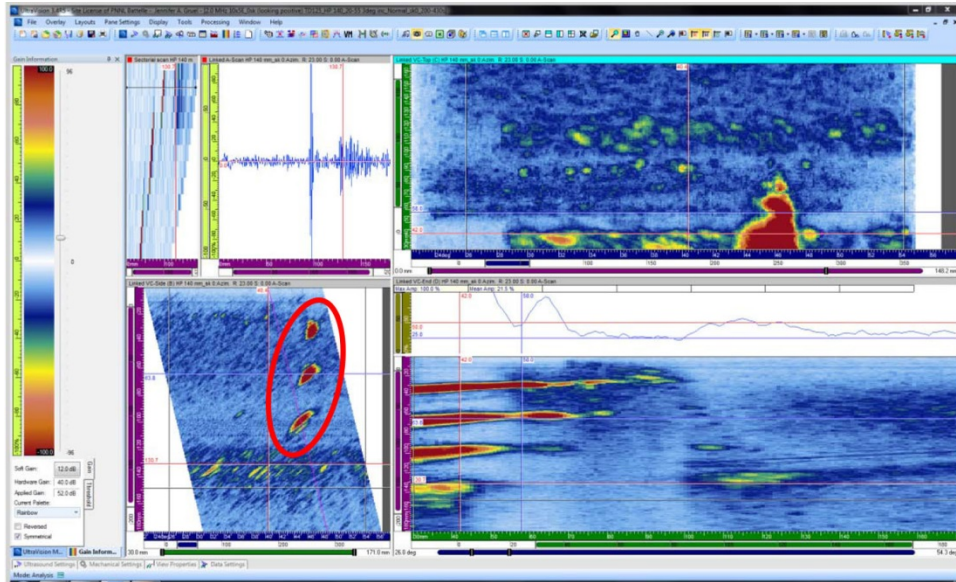
**Figure E.1.** CW, Skew 0, Axial Flaw 1 Region. Flaw not detected. Three side-drilled holes are visible and circled in red.

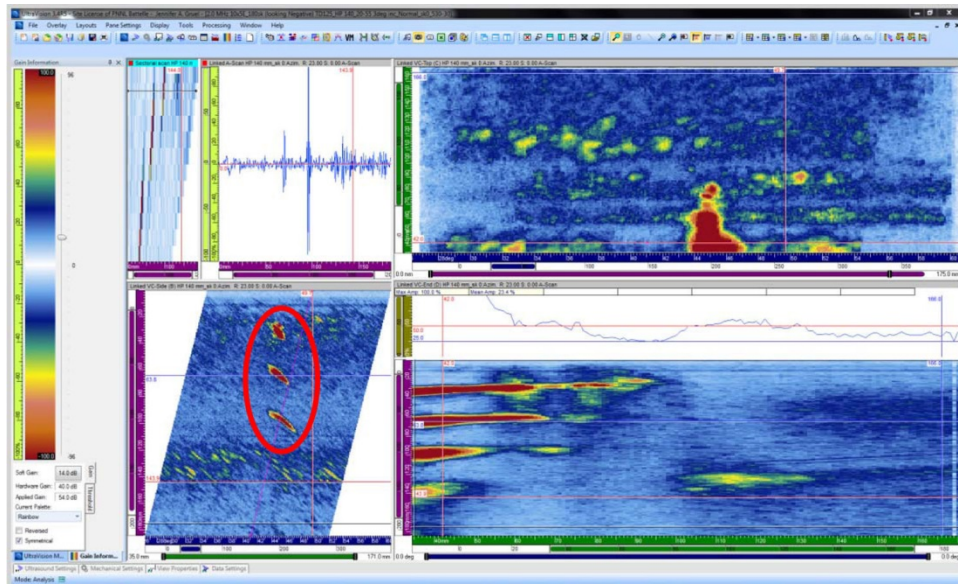
**Figure E.3.** CCW, Skew 0, Axial Flaw 1 Region. Flaw not detected. Three side-drilled holes are visible and circled in red.

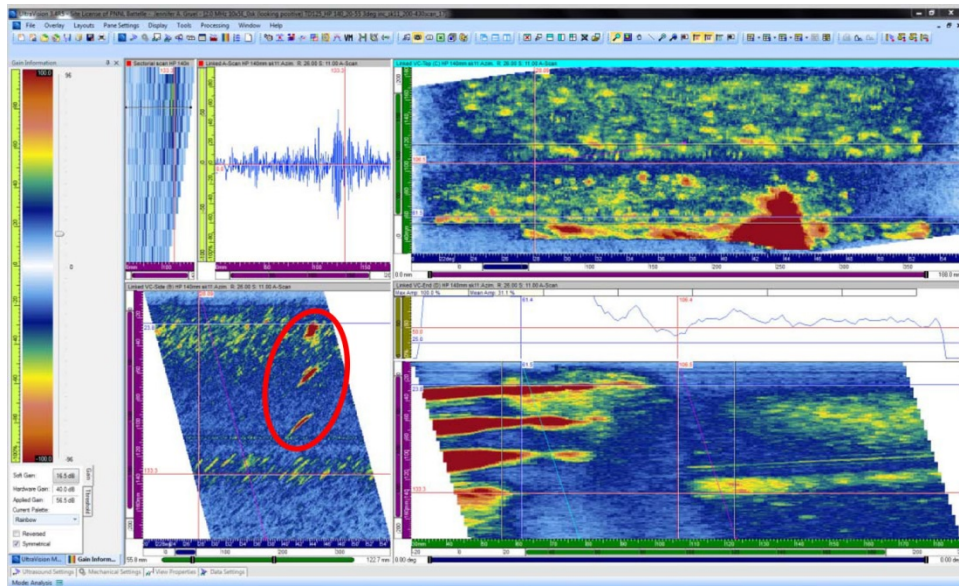
**Figure E.5.** CW, Skew 11, Axial Flaw 1 Region. Flaw not detected. Three side-drilled holes are visible and circled in red.

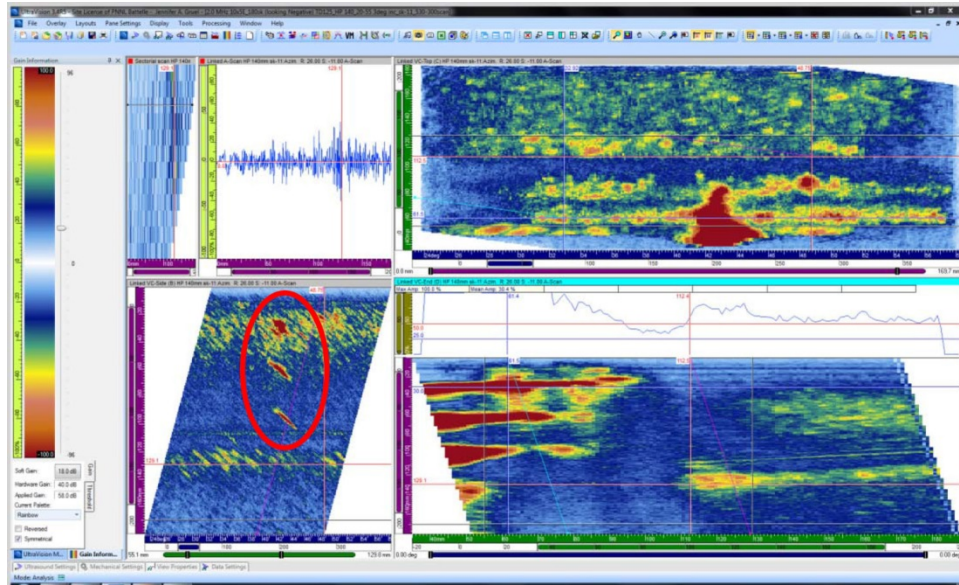
**Figure E.7.** CCW, Skew 11, Axial Flaw 1 Region. Flaw not detected. Three side-drilled holes are visible and circled in red.

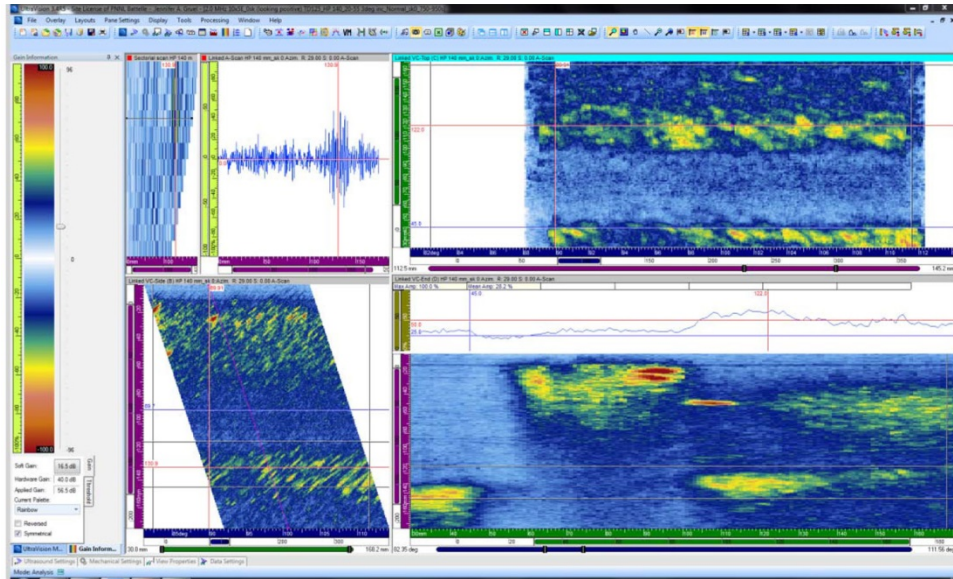
**Figure E.9.** CW, Skew 0, Axial Flow 2 Region. Flaw not detected.

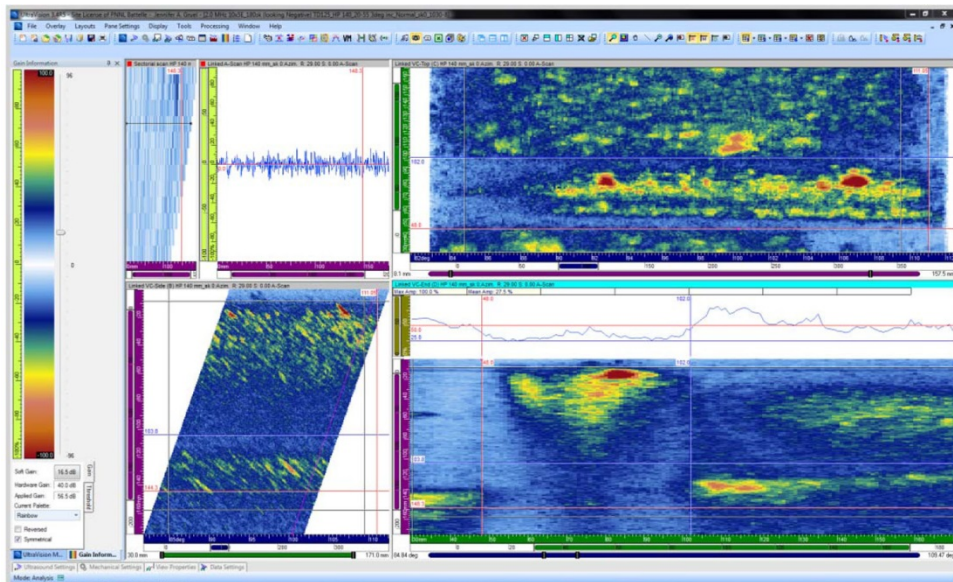
**Figure E.10.** CCW, Skew 0, Axial Flow 2 Region. Flaw not detected.

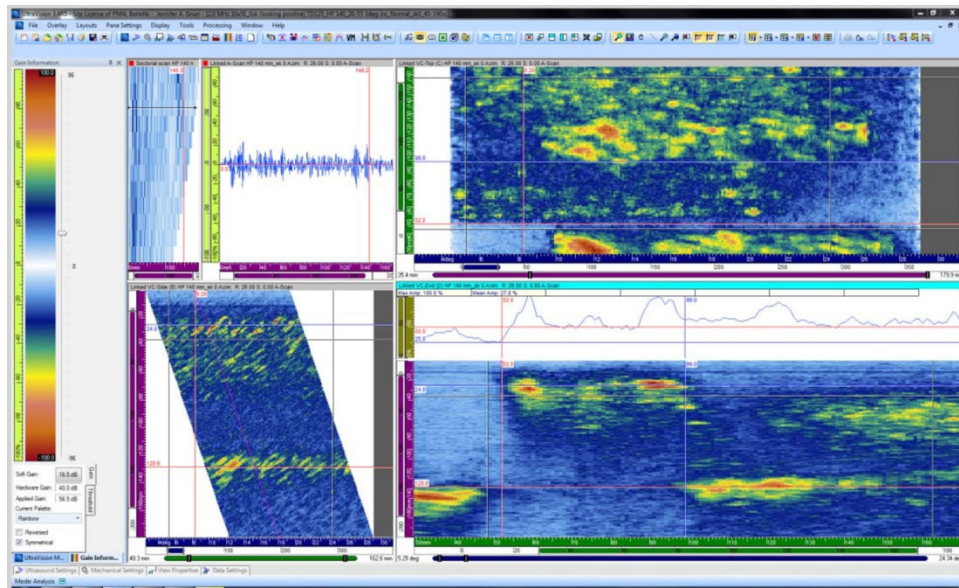
**Figure E.11.** CW, Skew 0, Axial Flaw 3 Region. Flaw not detected.

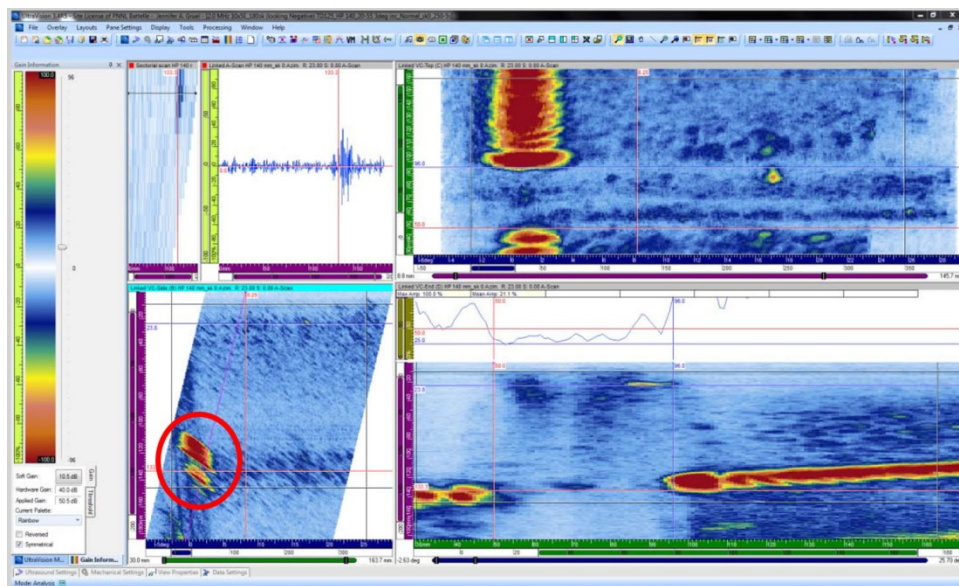
**Figure E.12.** CCW, Skew 0, Axial Flaw 3 Region. Flaw not detected; end-of-specimen is visible and circled in red.

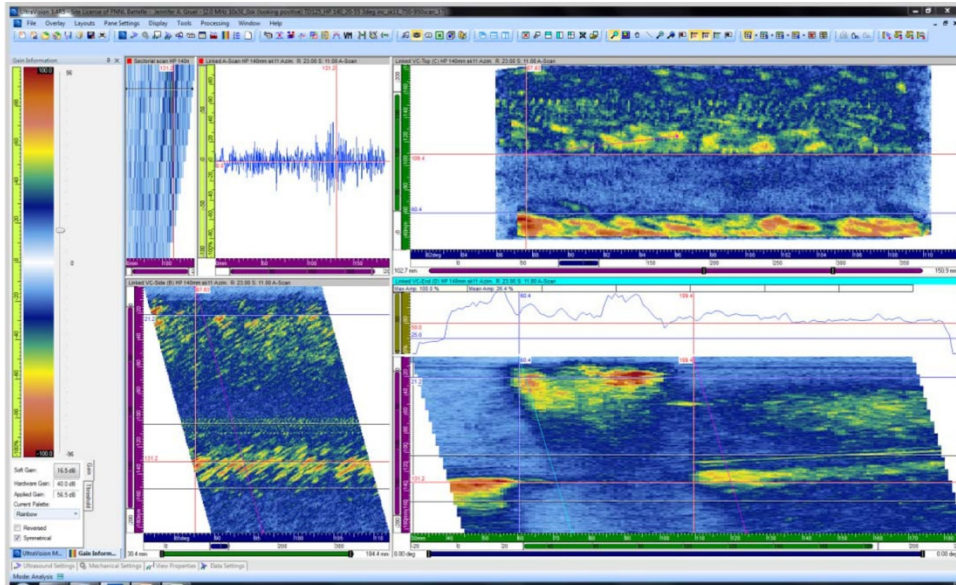
**Figure E.13.** CW, Skew 11, Axial Flaw 2 Region. Flaw not detected.

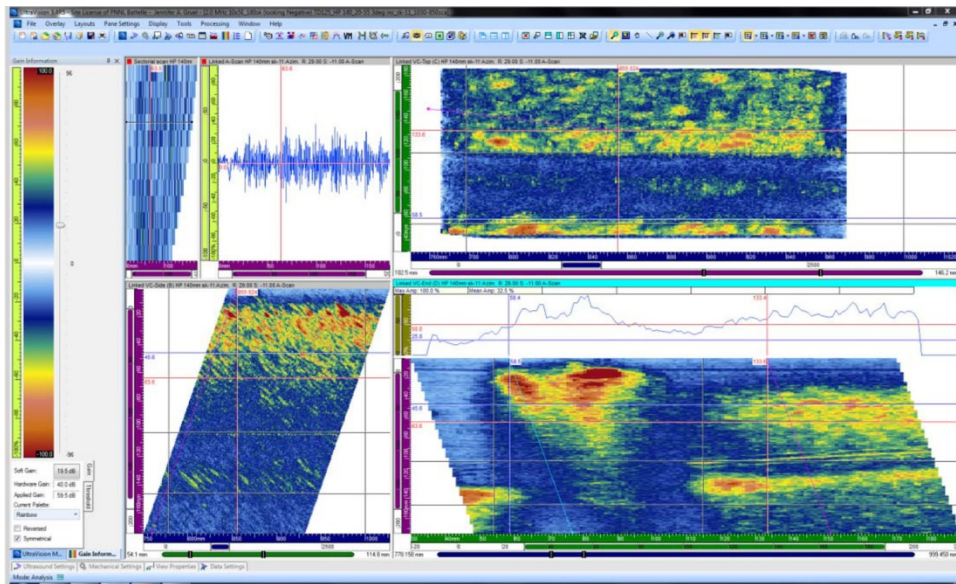
**Figure E.14.** CCW, Skew 11, Axial Flaw 2 Region. Flaw not detected.

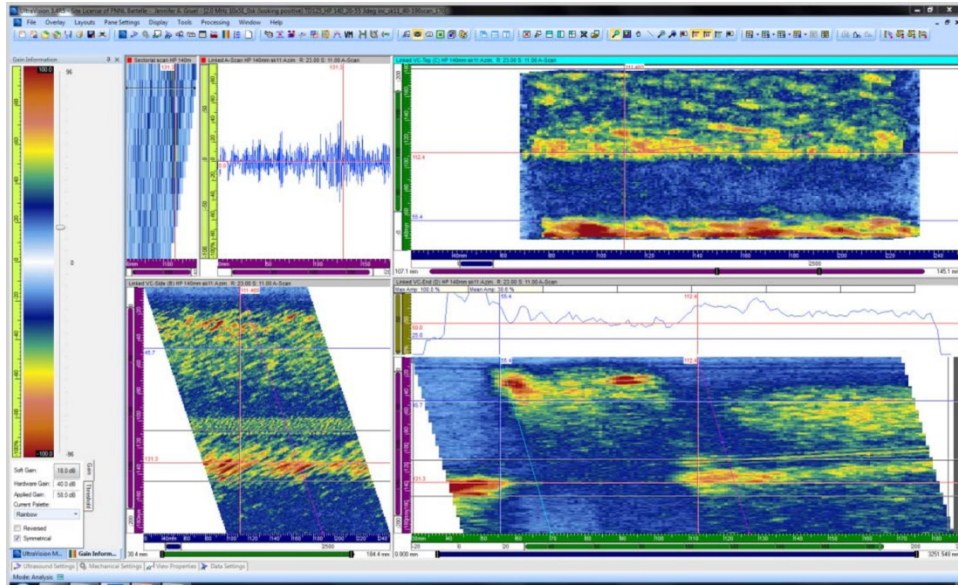
**Figure E.15.** CW, Skew 11, Axial Flaw 3 Region. Flaw not detected.

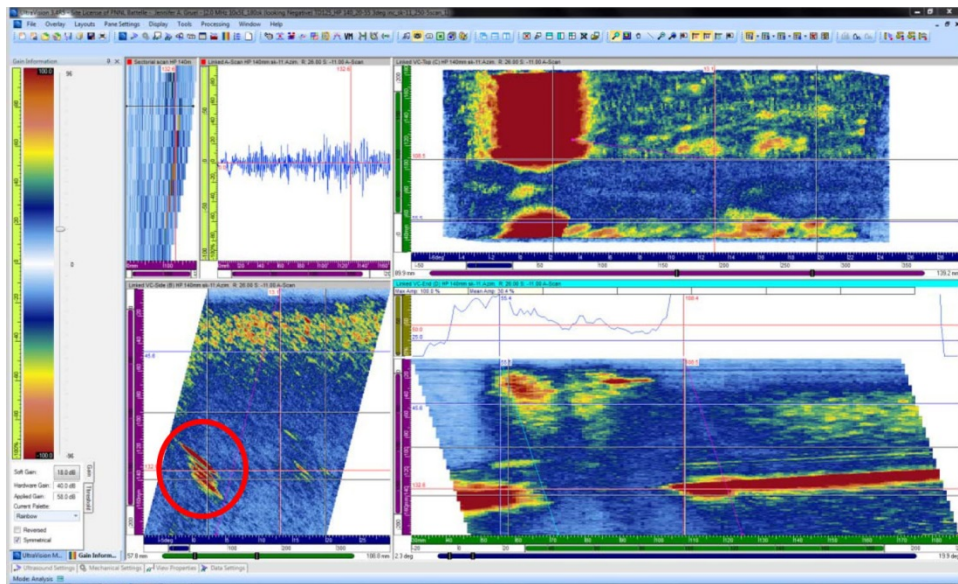
**Figure E.16.** CCW, Skew 11, Axial Flaw 3 Region. Flaw not detected; end-of-specimen is visible and circled in red.

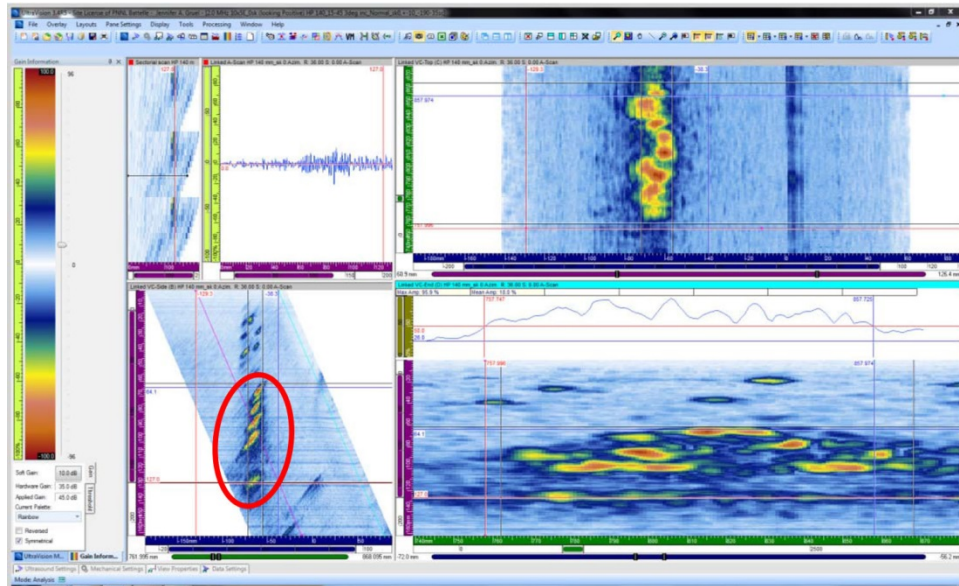
Figure E.17. DM-05 Flaw 2 Circled in Red

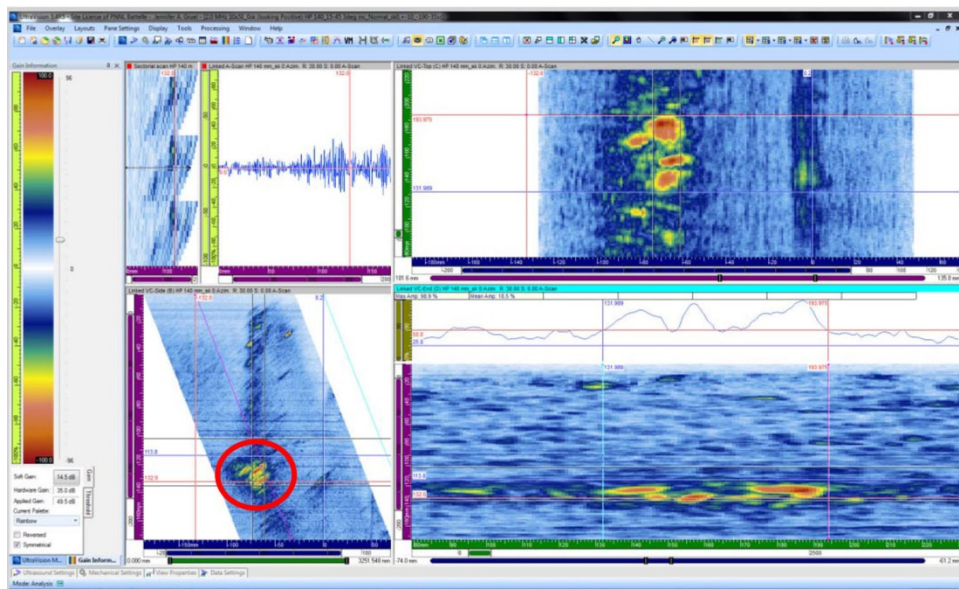
Figure E.18. DM-05 Flaw 3 Circled in Red

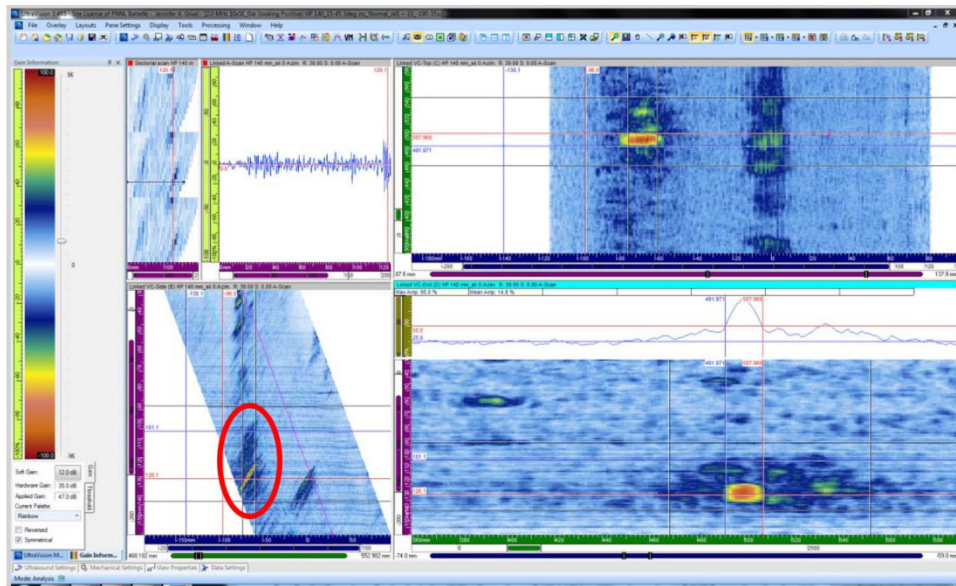
**Figure E.19.** DM-05 Flaw 4 Circled in Red

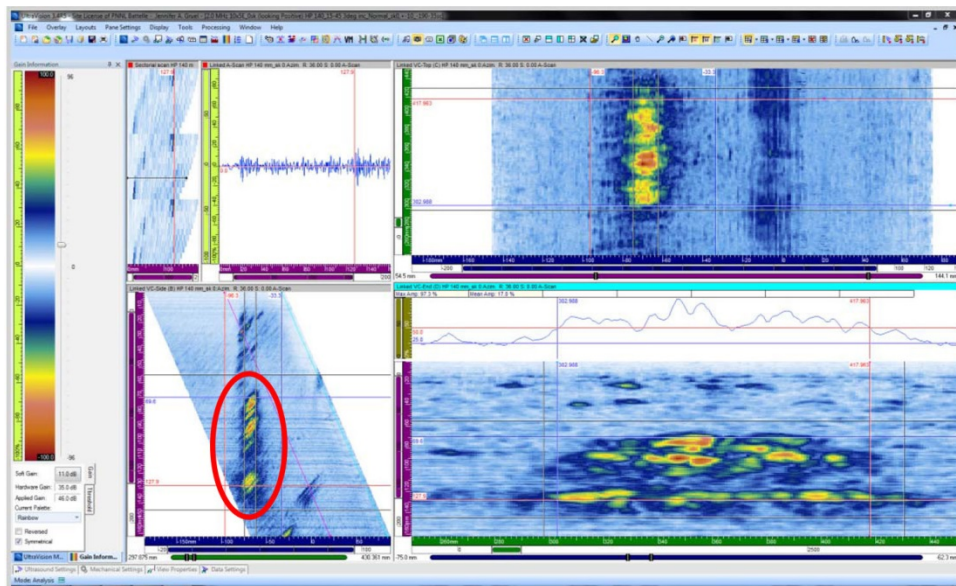
**Figure E.20.** DM-10 Flaw 1 Circled in Red

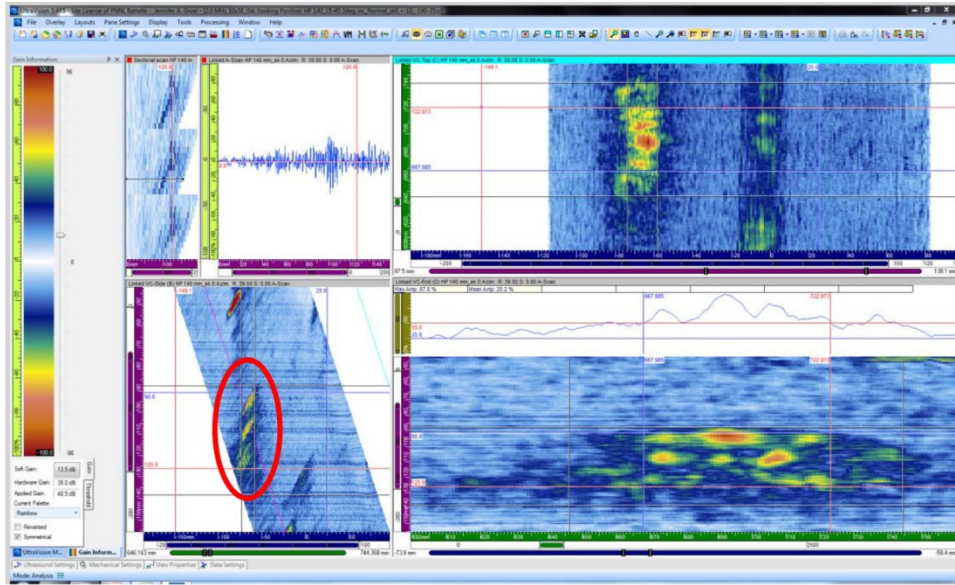
**Figure E.21.** DM-10 Flaw 4 Circled in Red

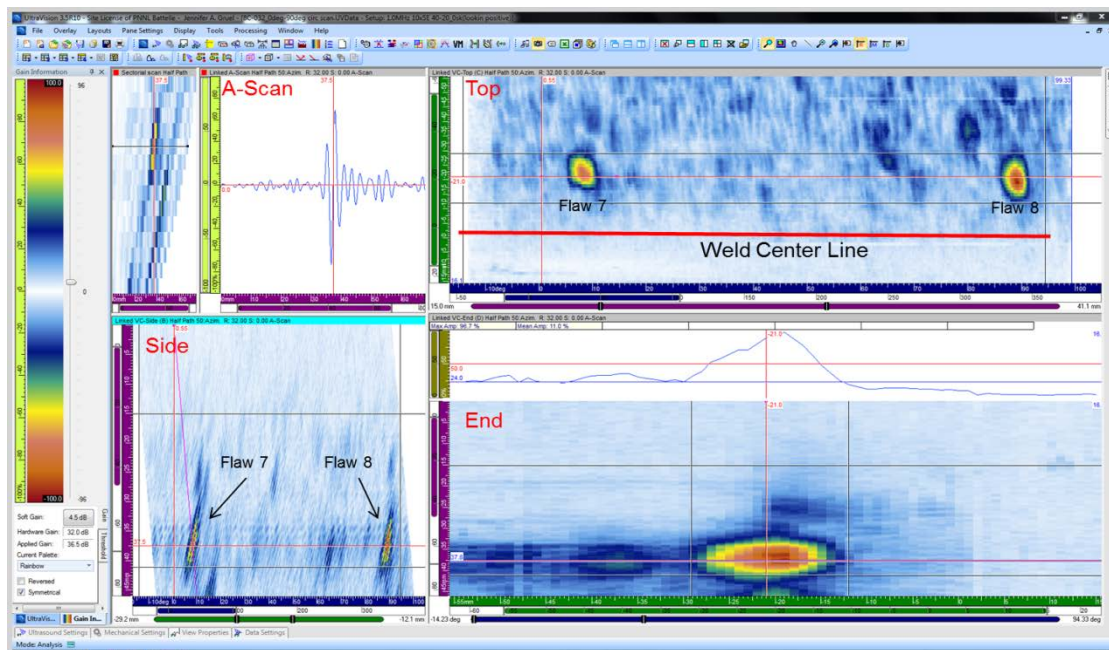
Circumferential scan quadrant #1 of 8C-036 extended from approximately  $-10$  degrees to  $100$  degrees in length from the reference '0' position and contained both axially orientated flaws (for reference, flaw numbers 7 and 8). Figure F.9 shows the PA-UT data for quadrant #1 at an inspection angle of  $32$  degrees ( $43$ -degree impingement angle). The selected angle resulted with the largest response from both flaws and established the applied gain setting to be  $36.5$  dB for subsequent analyses. Flaws #7 and #8 were easily detected (indicated by the black arrows) at the true-state locations of  $9$  and  $90$  degrees circumferentially in the scan axis and adjacent to the weld (in the weld/butter region) in the top and side views. Signal-to-noise ratio (SNR) values for flaw #7 and #8 were  $21.7$  and  $23.0$  dB, respectively. Note: The data layout format will remain consistent for the remainder of the section.

**Figure F.9.** 8C-036 Quadrant #1: Detection of Axially Orientated Flaws #7 and #8
