PNNL-22553

# Final Assessment of Manual Ultrasonic Examinations Applied to Detect Flaws in Primary System Dissimilar Metal Welds at North Anna Power Station

March 2014

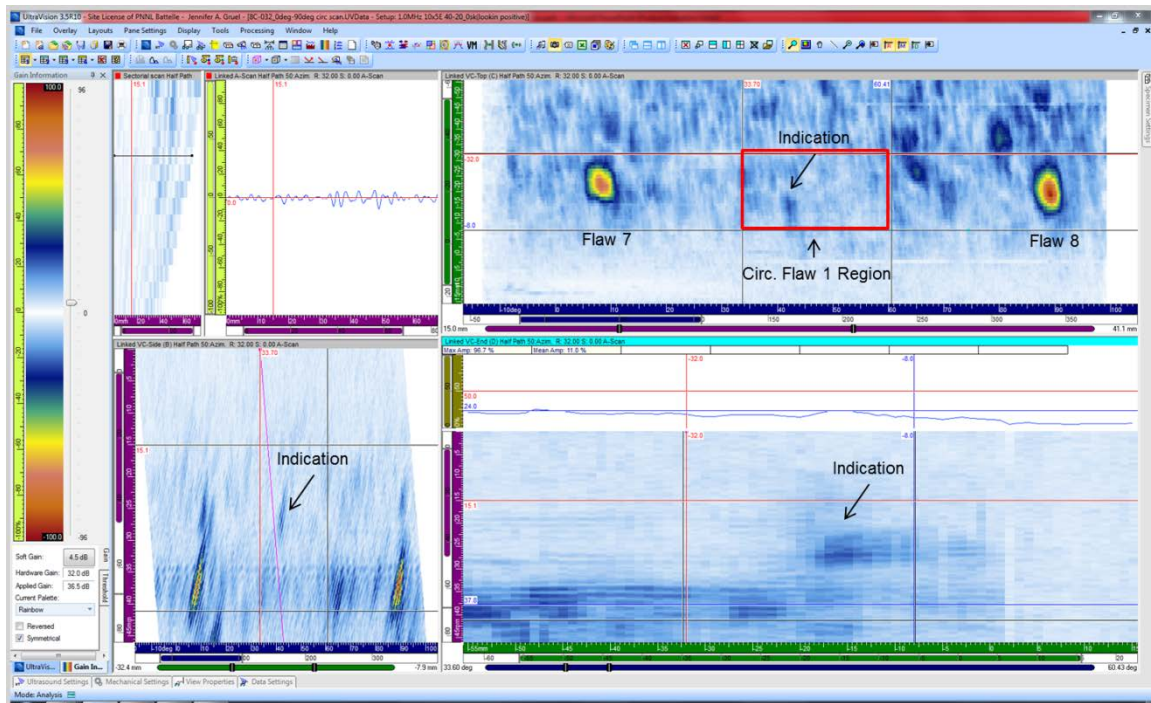
In addition to the two axially orientated flaws, quadrant #1 contained the 58% through-wall circumferentially orientated flaw #1 between scan locations of  $33.7$  and  $60.3$  degrees circumferentially. The flaw #1 region of interest is boxed in red and shown in Figure F.10. At the same  $32$ -degree inspection angle and applied gain settings, a mid-wall indication was identified and highlighted by the black arrows in the figure. Figure F.11 shows a mid-wall gate applied excluding ID responses, and sensitivity was increased displaying the through-wall extents of flaws #7 and #8 as well as the indication in the circumferential flaw region (boxed in red). Here it is shown that the indication is located closer to the weld center line and is detected with a SNR of  $12.9$  dB.

**Figure F.10.** 8C-036 Circumferential Flaw #1 Region Boxed in Red

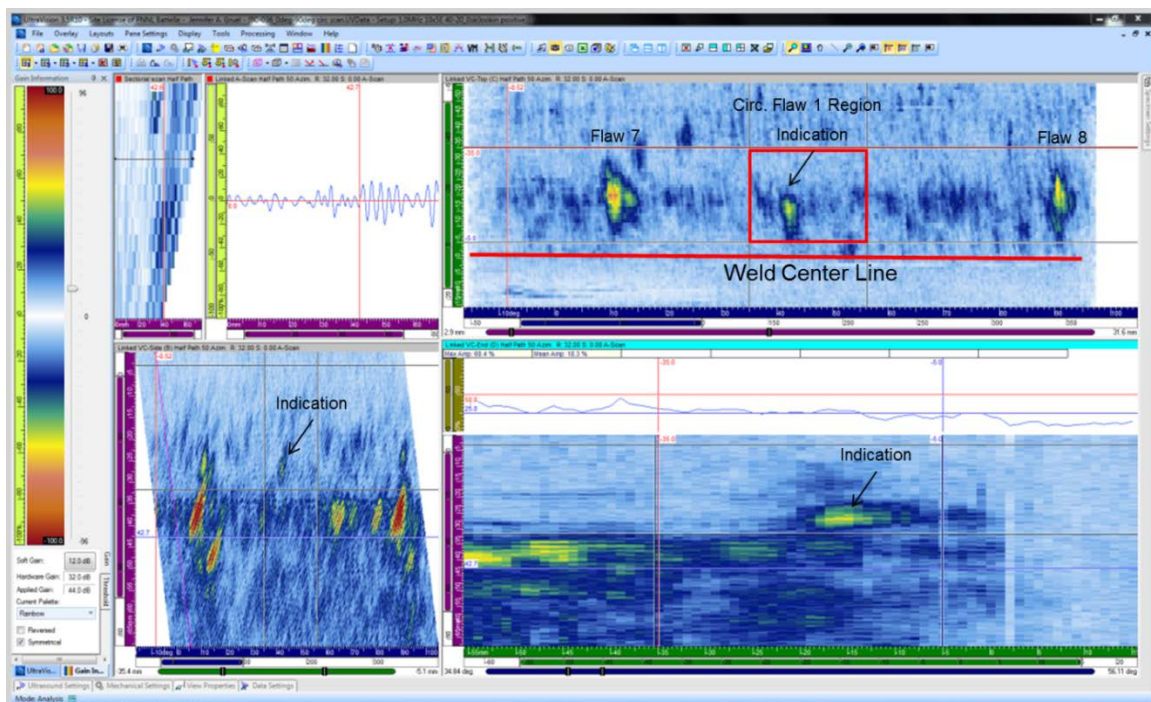
**Figure F.11.** 8C-036 Circumferential Flaw #1 Region Boxed in Red. Mid wall data gates are applied.

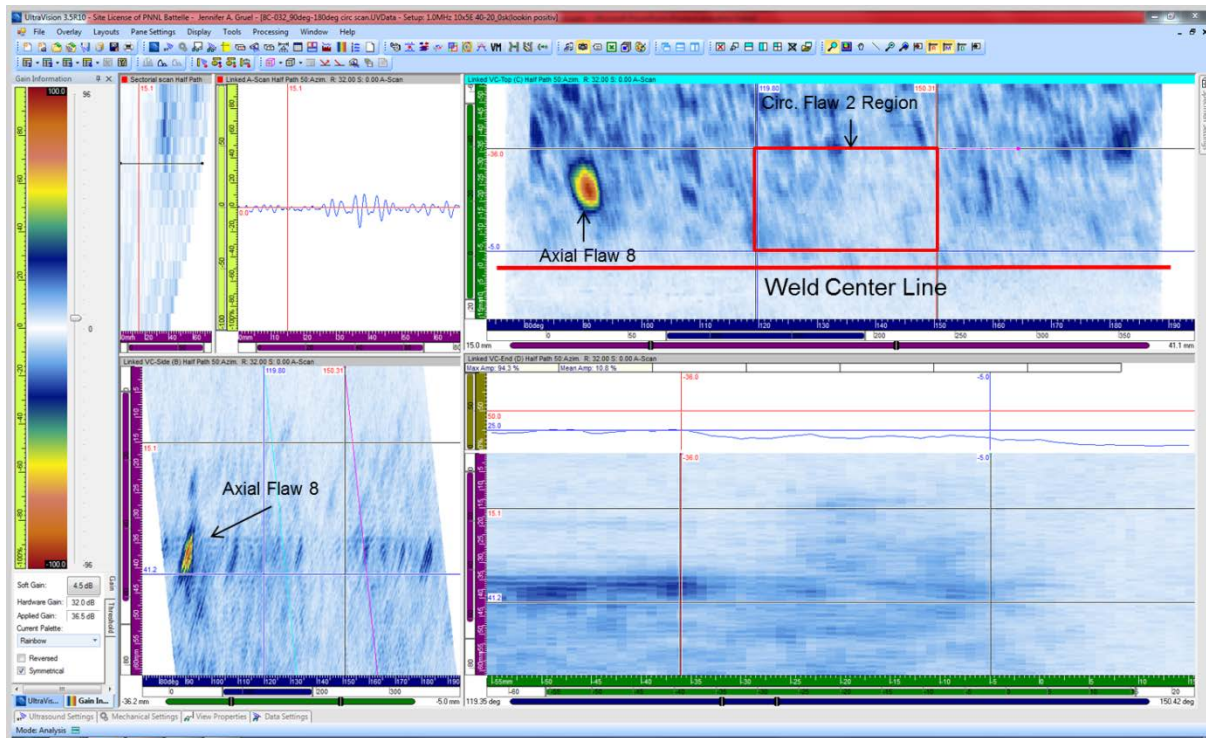
Subsequently, quadrants #2, #3, and #4 of the 8C-036 DMW component were analyzed. Figures F.12, F.13, and F.14 show data screenshots highlighting the circumferential flow regions of interest boxed in red. In addition, the axial flaws are indicated where applicable. Quadrants #2, #3, and #4 did not show any discernable indications above background noise in the regions of circumferentially oriented flaws.

**Figure F.12.** 8C-036 Circumferential Flaw #2 Region Boxed in Red. No indications.

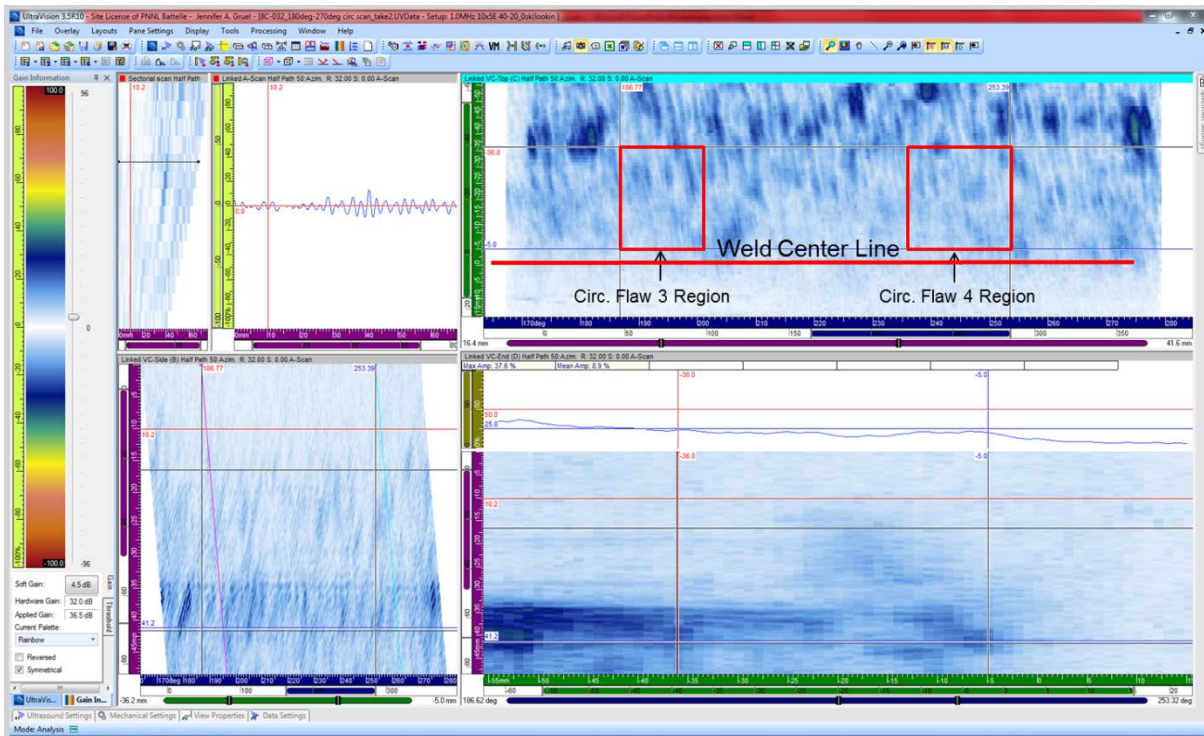
**Figure F.13.** 8C-036 Circumferential Flaw #3 and #4 Region Boxed in Red. No indications.

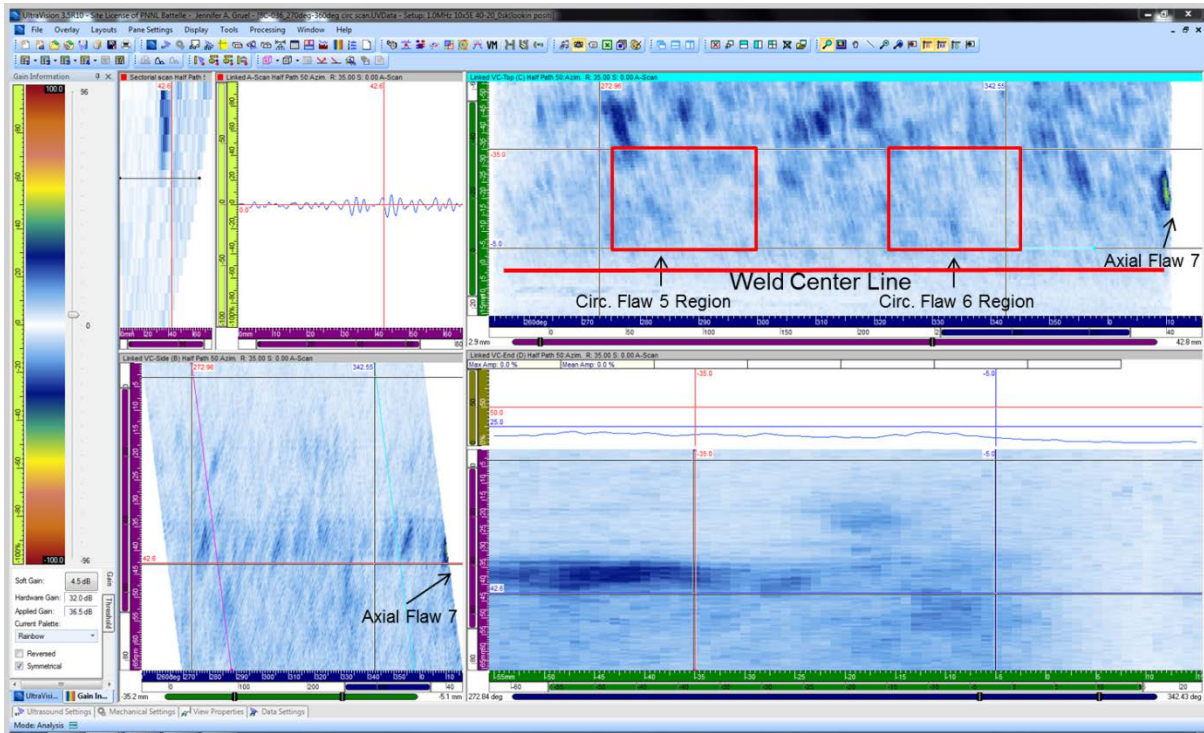
**Figure F.14.** 8C-036 Circumferential Flaw #5 and #6 Region Boxed in Red. No indications.

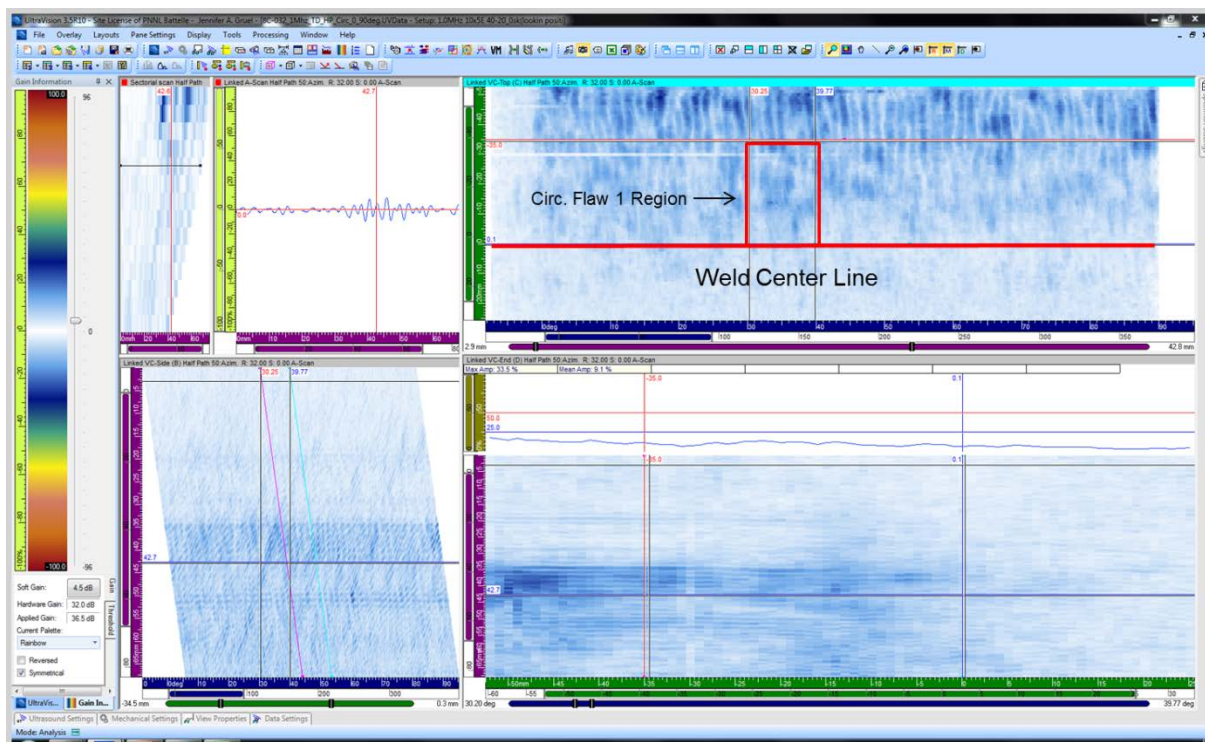
Circumferential scans were also performed on the 8C-032 DMW component in quadrant fashion with reference to the '0' position stamped on the specimen. The 8C-032 component only contains implanted circumferential flaws. For calibration purposes, a sensitivity setting of 36.5 dB at a 32-degree inspection angle was applied to all 8C-032 data—as established from the axial flaw responses #7 and #8 in the 8C-036 component. The red boxed region in Figure F.15 illustrates the circumferential flaw #1 region in quadrant #1 that extends from 30.2 to 39.8 degrees circumferentially. No indications above background noise are detected in this region.

**Figure F.15.** 8C-032 Circumferential Flaw #1 Region Boxed in Red. No indications.

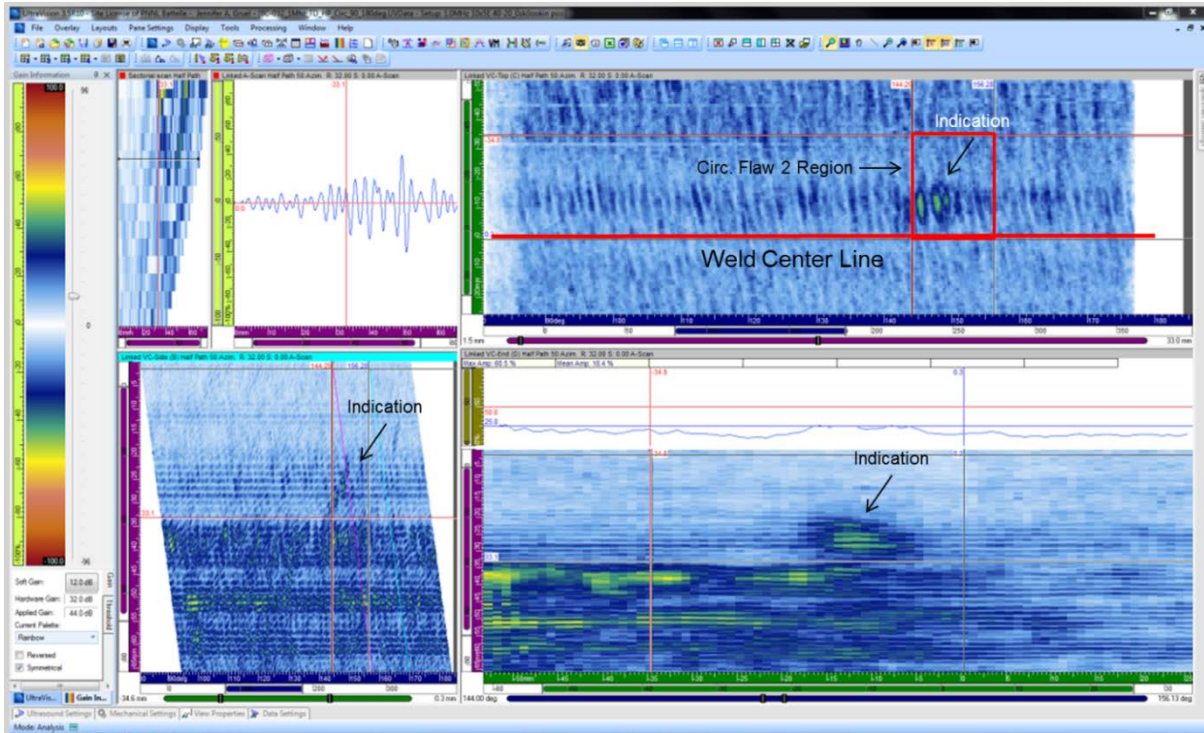
The quadrant #2 scan of the 8C-032 specimen contains circumferential flaw #2 between 144 and 156 degrees circumferentially. An indication above background noise levels was detected in the mid-wall region of circumferential flaw #2. The mid-wall gated view of the data is shown in Figure F.16 with increased sensitivity. The indication was detected with a SNR of 9.5 dB.

**Figure F.16.** 8C-032 Circumferential Flaw #2 Region Boxed in Red. Mid-wall data gates are applied.

Considering the ten opportunities for detection of circumferential-flaw-related indications, only two regions of circumferential flaw locations presented indications above background noise from each DMW component. Circumferential flaw #1 region in 8C-036 contained an implanted TFC that was 58% through-wall and extended 26.6 degrees in the circumferential axis. This flaw also was specified to have a 30-degree tilt away from the weld with respect to radial. The detectable mid-wall indication from this flaw region had a SNR of 12.9 dB. The second indication was found in the circumferential flaw #2 region of 8C-032. Similarly, this was a 40% through-wall implanted TFC with a radial tilt of 19 degrees. This flaw was detected in the mid-wall region with a SNR of 9.5 dB.

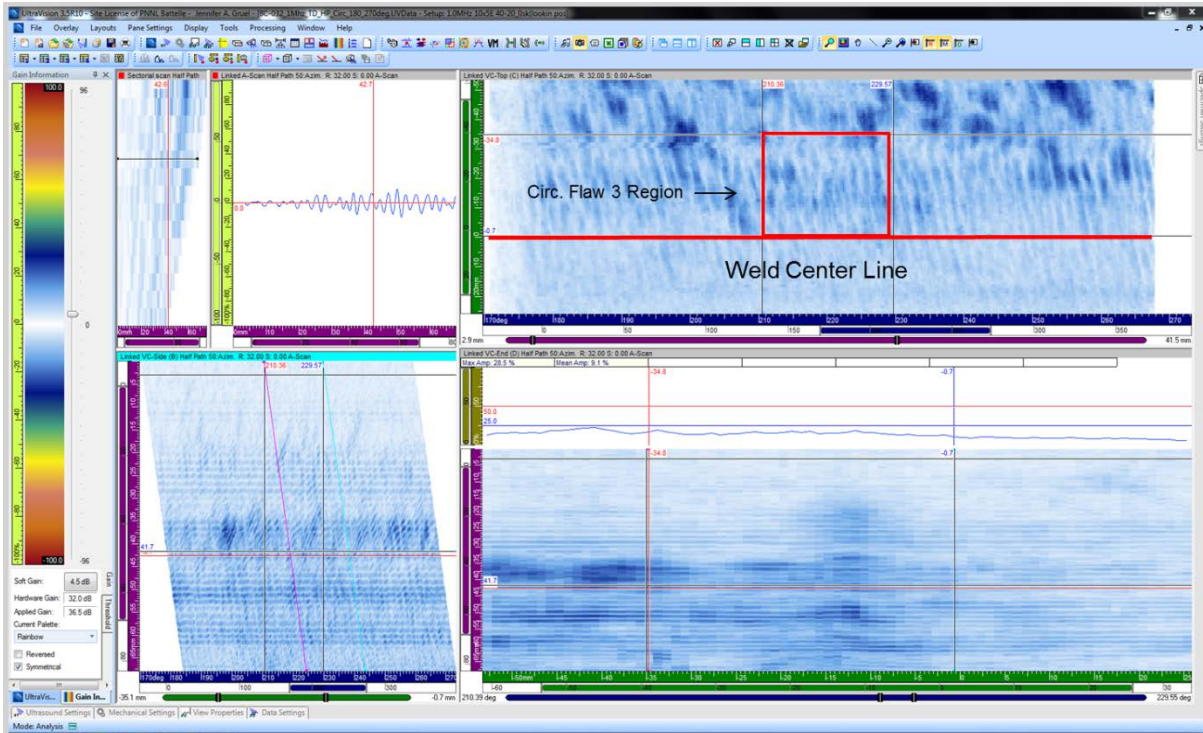
Quadrants #3 and #4 of 8C-032 containing circumferential flaws #3 and #4, respectively, were also fully evaluated for detection of indications in the flawed regions. Figures F.17 and F.18 show data from each quadrant with the circumferential flaw regions boxed in red. Neither quadrant had indications above noise levels.

**Figure F.17.** 8C-032 Circumferential Flaw #3 Region Boxed in Red. No indications.

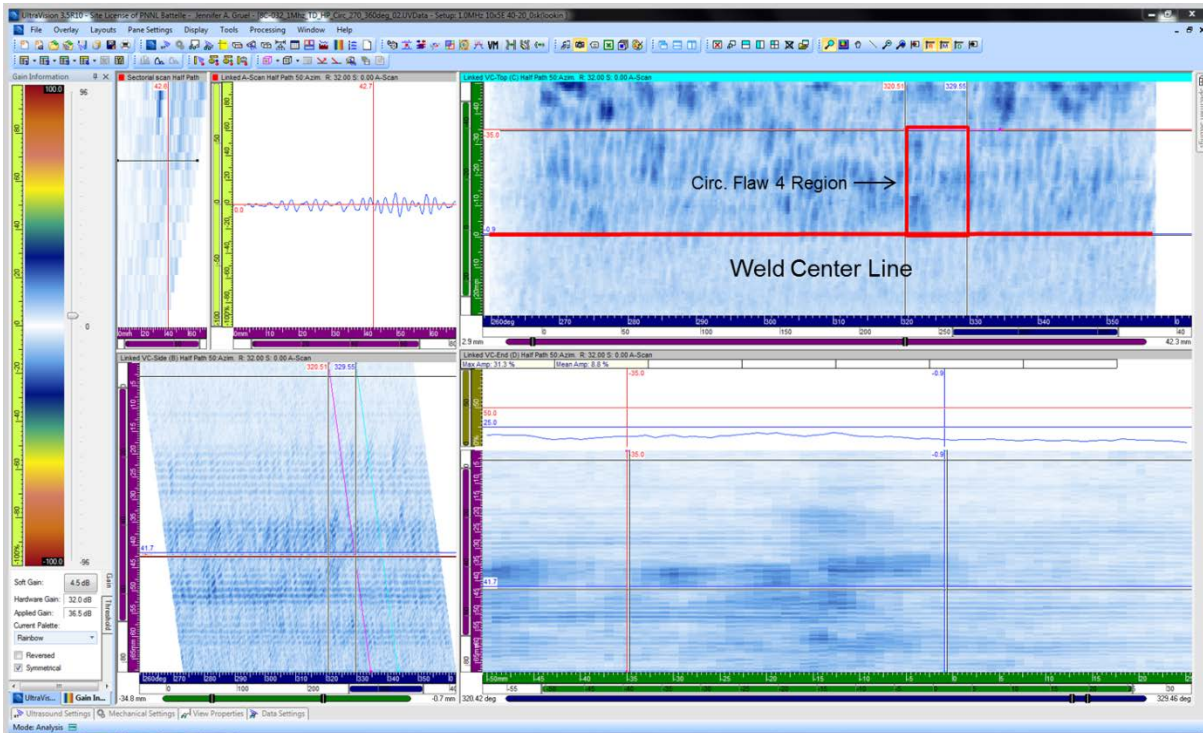
**Figure F.18.** 8C-032 Circumferential Flaw #4 Region Boxed in Red. No indications.
