Calc. Pkg No. VSC-04.3101
File No.: VSC-04.3101
Revision: 3

VSC-04 / VSC-24 General Licensees

VSC-24 CoC Renewal Aging Management Review

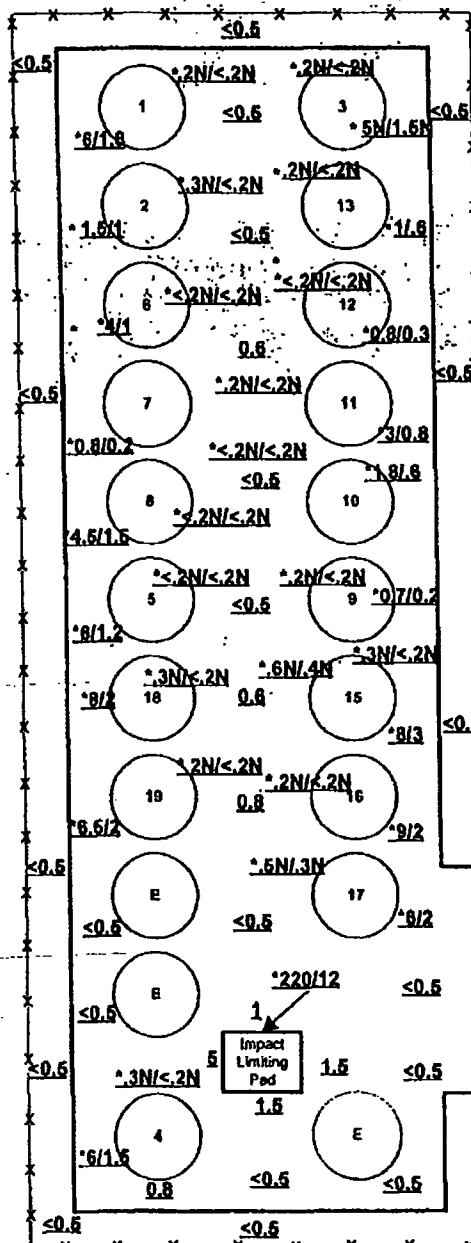
Neutron=(N) dose rates
Neutron Dose rates performed annually.
Neutron dose rates performed on 08-16-08 by VEM (ASP-1#2573)

Old Impact Limiting Pad labeled-
800 mrem/hr contact
16 mrem/hr @ 12'
(bottom of box)
09-08-07 1640

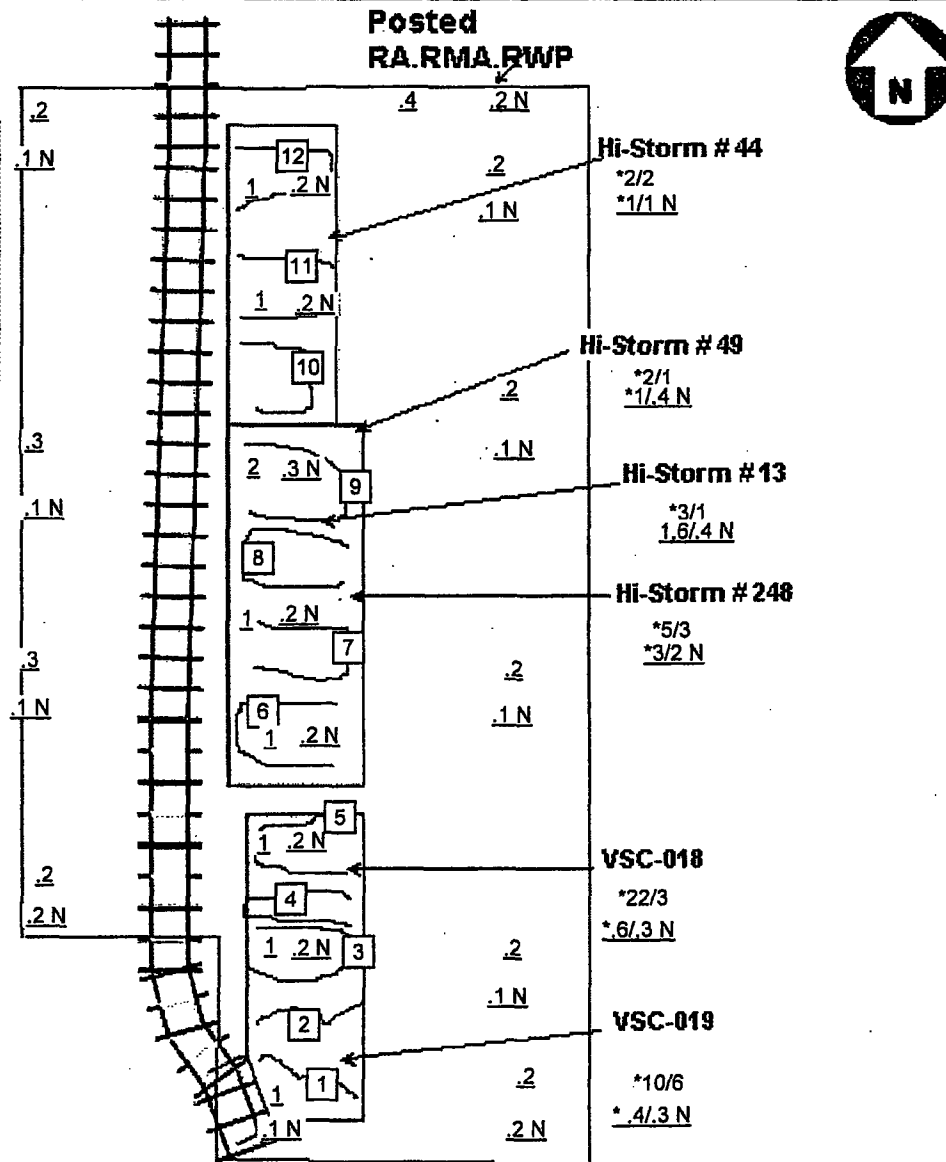
Appendix B, Attachment 3

Note: All postings, rad rope and tags are in satisfactory condition.
