CENSEE EVENT REPORT

SERIAL: RSEP/79-1133

SUPPLEMENTAL INFORMATION  
FOR  
LICENSEE EVENT REPORT 79-26 REV. 1

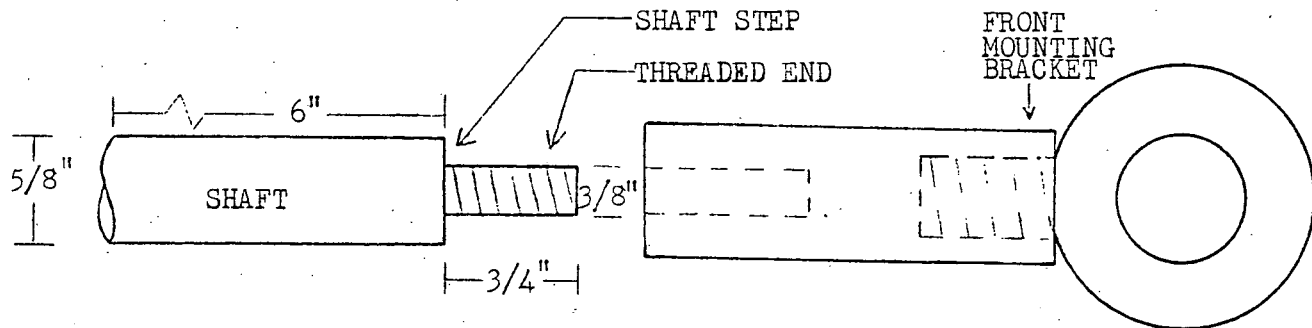
POSITION PRIOR TO FAILURE

Following the failure, it was noticed that the snubber's front mounting piece had not been threaded fully onto the front end of the shaft (see attached drawing). This resulted in the threaded end being subjected to loads much higher than normal. Angular loads are generated at the time of compression lockup due to the inherent flexibility of the 5/8 inch diameter, 6 inch stroke shaft. If the front mounting bracket had been seated against the shaft step, the threaded end would not have been exposed to these loads. Thus, the rigidity and strength of the shaft as a whole would have been enhanced to the extent that the failure probably would not have occurred.

Since the threaded end is exposed, it must act as a load supporting part of the shaft. Due to its smaller diameter it is much more vulnerable to failure than the shaft when exposed to angular loading.

Precautionary instructions will be added to both the functional test procedure and the reinstallation instructions to ensure that the front mounting bracket is seated against the shaft step. This action should eliminate further occurrences during either testing or while the snubber is in service.
