H. B. ROBINSON UNIT NO. 2

SEMI-ANNUAL OPERATING REPORT NO. 6

JANUARY 1, 1973 THROUGH JUNE 30, 1973

EQUIPMENT	NATURE OF MAINTENANCE	EFFECT ON SAFE OPERATION	MALFUNCTION		CORRECTIVE/PREVENTIVE ACTION	TIME OUT OF SERVICE
			CAUSE	RESULT		
Audio count rate channel selector switch	Corrective	None	Switch was dirty and needed lubricating	Channel selector switch was frozen	The switch was cleaned and lubricated	1 hr.
"B" boric acid evaporator	Corrective	None	PS-8 switch out of calibration	Feed valve opens at too high tank level	The PS-8 switch was recalibrated	2 hrs.
"A" feedwater pump discharge drain valve	Corrective	None	Defective valve	Excessive leakage	New 1500 lb. valve was installed	2 hrs.
"A" steam generator level transmitter LT-475	Corrective	None	Transmitter out of calibration	Improper indication	The transmitter was calibrated	5 hrs.
R-14 radiation monitor	Corrective	None	The check source, operate alarm had a broken wafer	Defective check source	The wafer was replaced	2 hrs.
Gland steam condenser	Corrective	None	Defective gasket	Excessive leakage	A new gasket was installed	4 hrs.

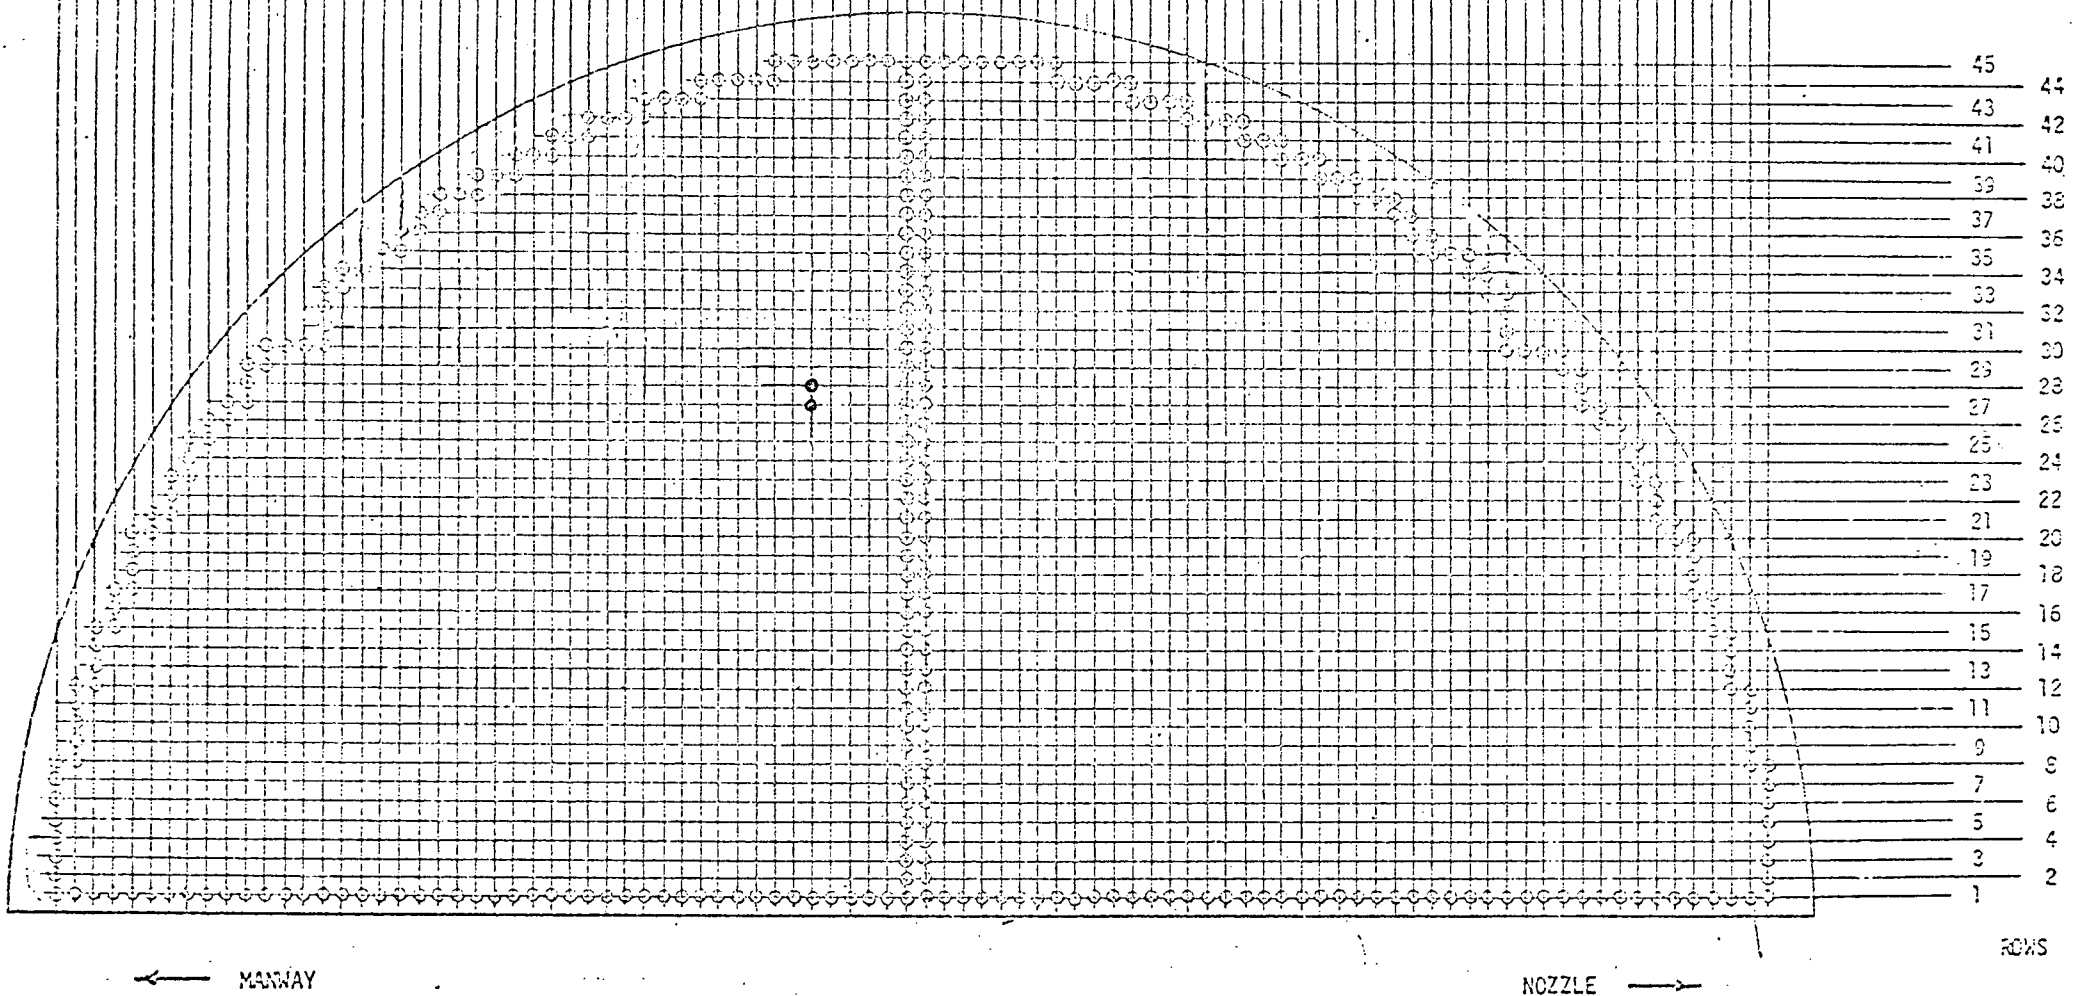
FIGURE NO. 2  
EXPLODED VIEW OF PLUGGED TUBES

● PLUGGED TUBES

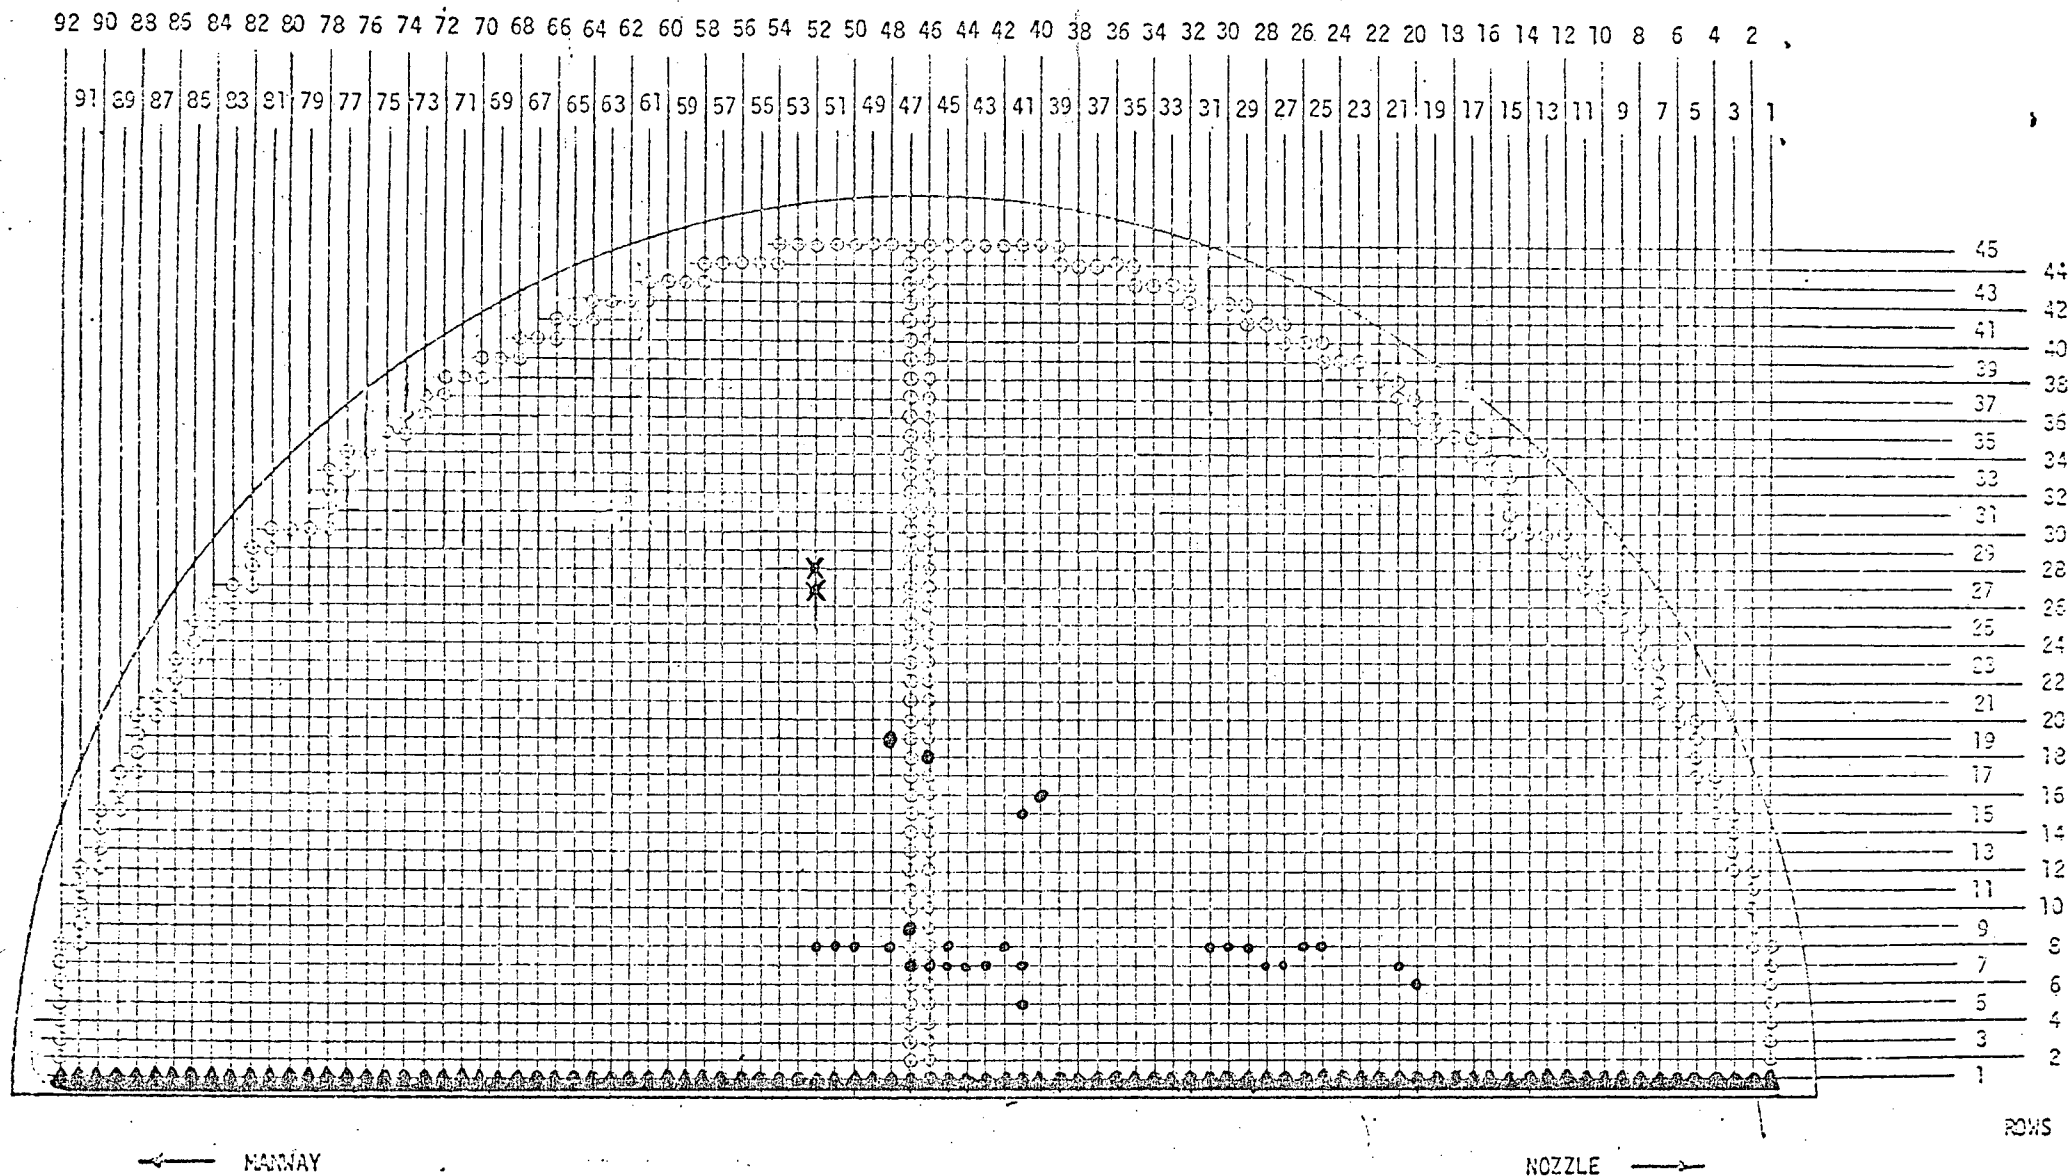
ROW	COLUMN	REMARKS
1	1-92	PLUGGED 1971
5	41	" 1972
6	20	" 1972
7	21, 27, 28	" 1972
7	41	" 1972
7	43 - 47	" 1972
8	25, 26	" 1972
8	29, 30, 31	" 1972
8	42, 45, 48	" 1972
8	50 - 52	" 1972
9	47	" 1972
15	41	" 1972
16	40	" 1972
18	46	" 1972
19	48	" 1972
27	52	" 1973
28	52	" 1973

- ▲ PLUGGED JULY 1971
- PLUGGED JUNE 1972
- × PLUGGED MAY 1973

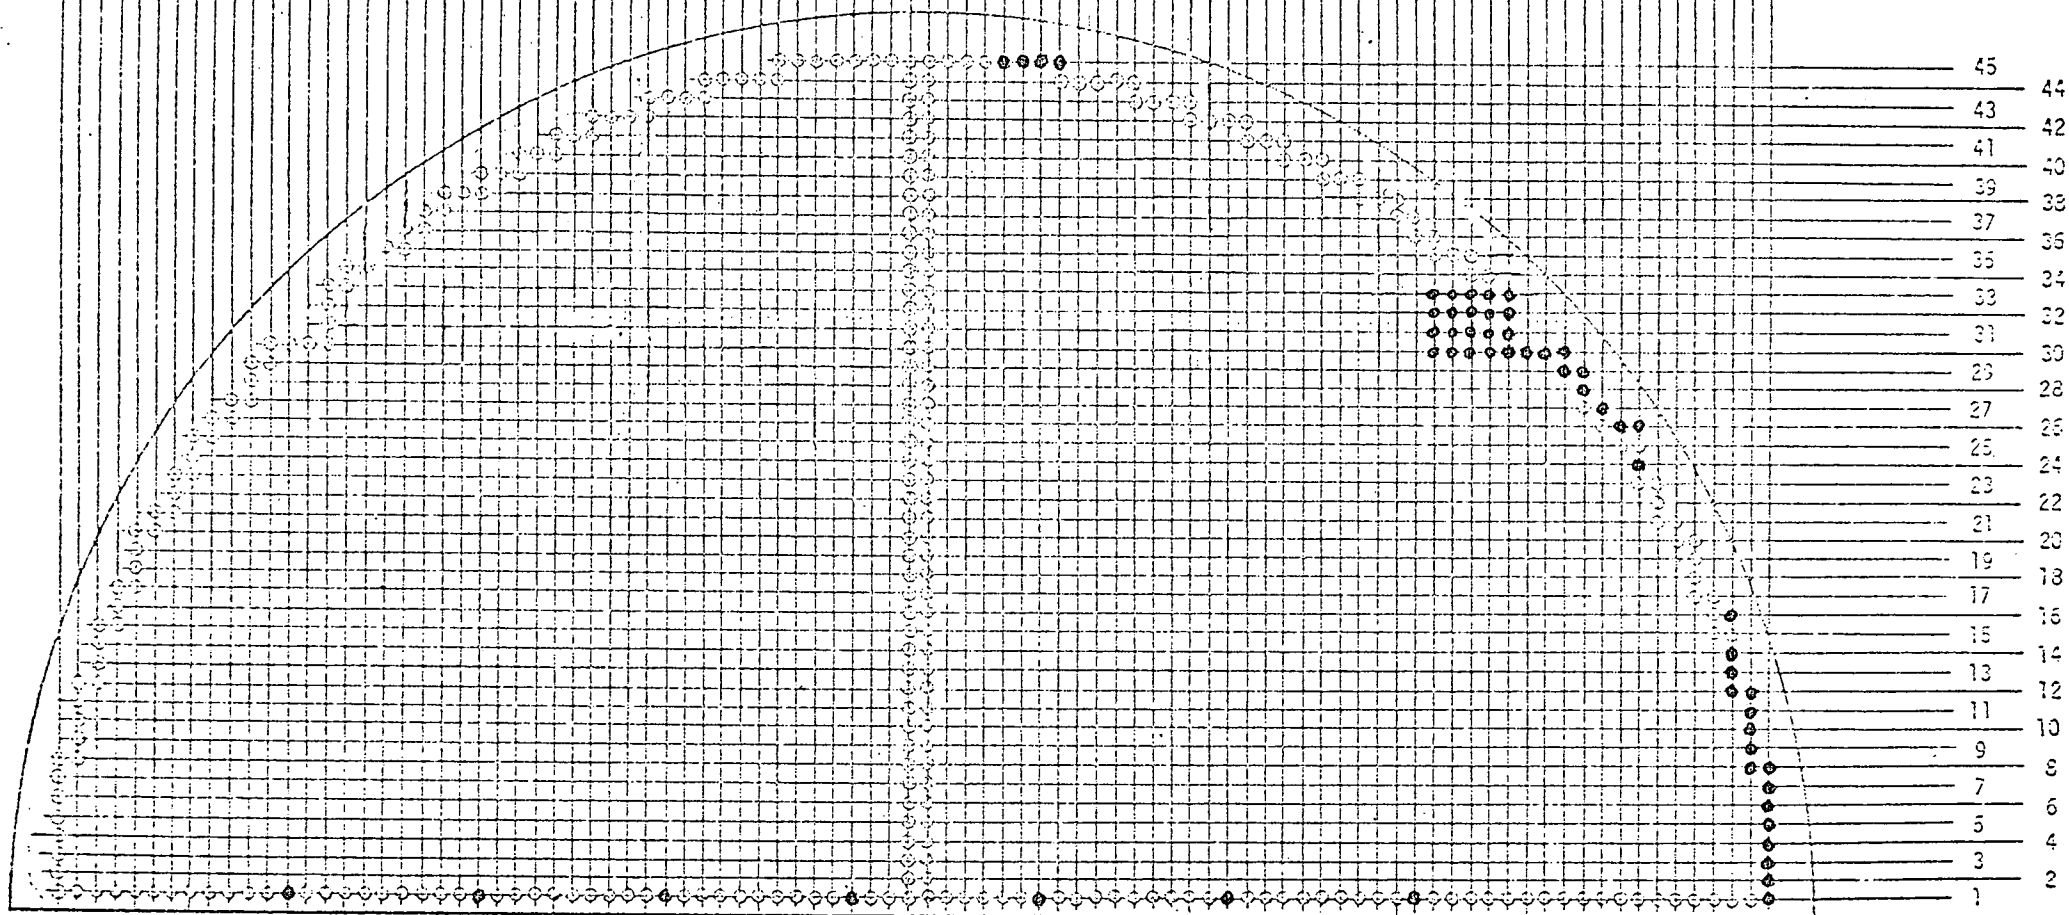
FIGURE 8

STEAM GENERATOR "B"

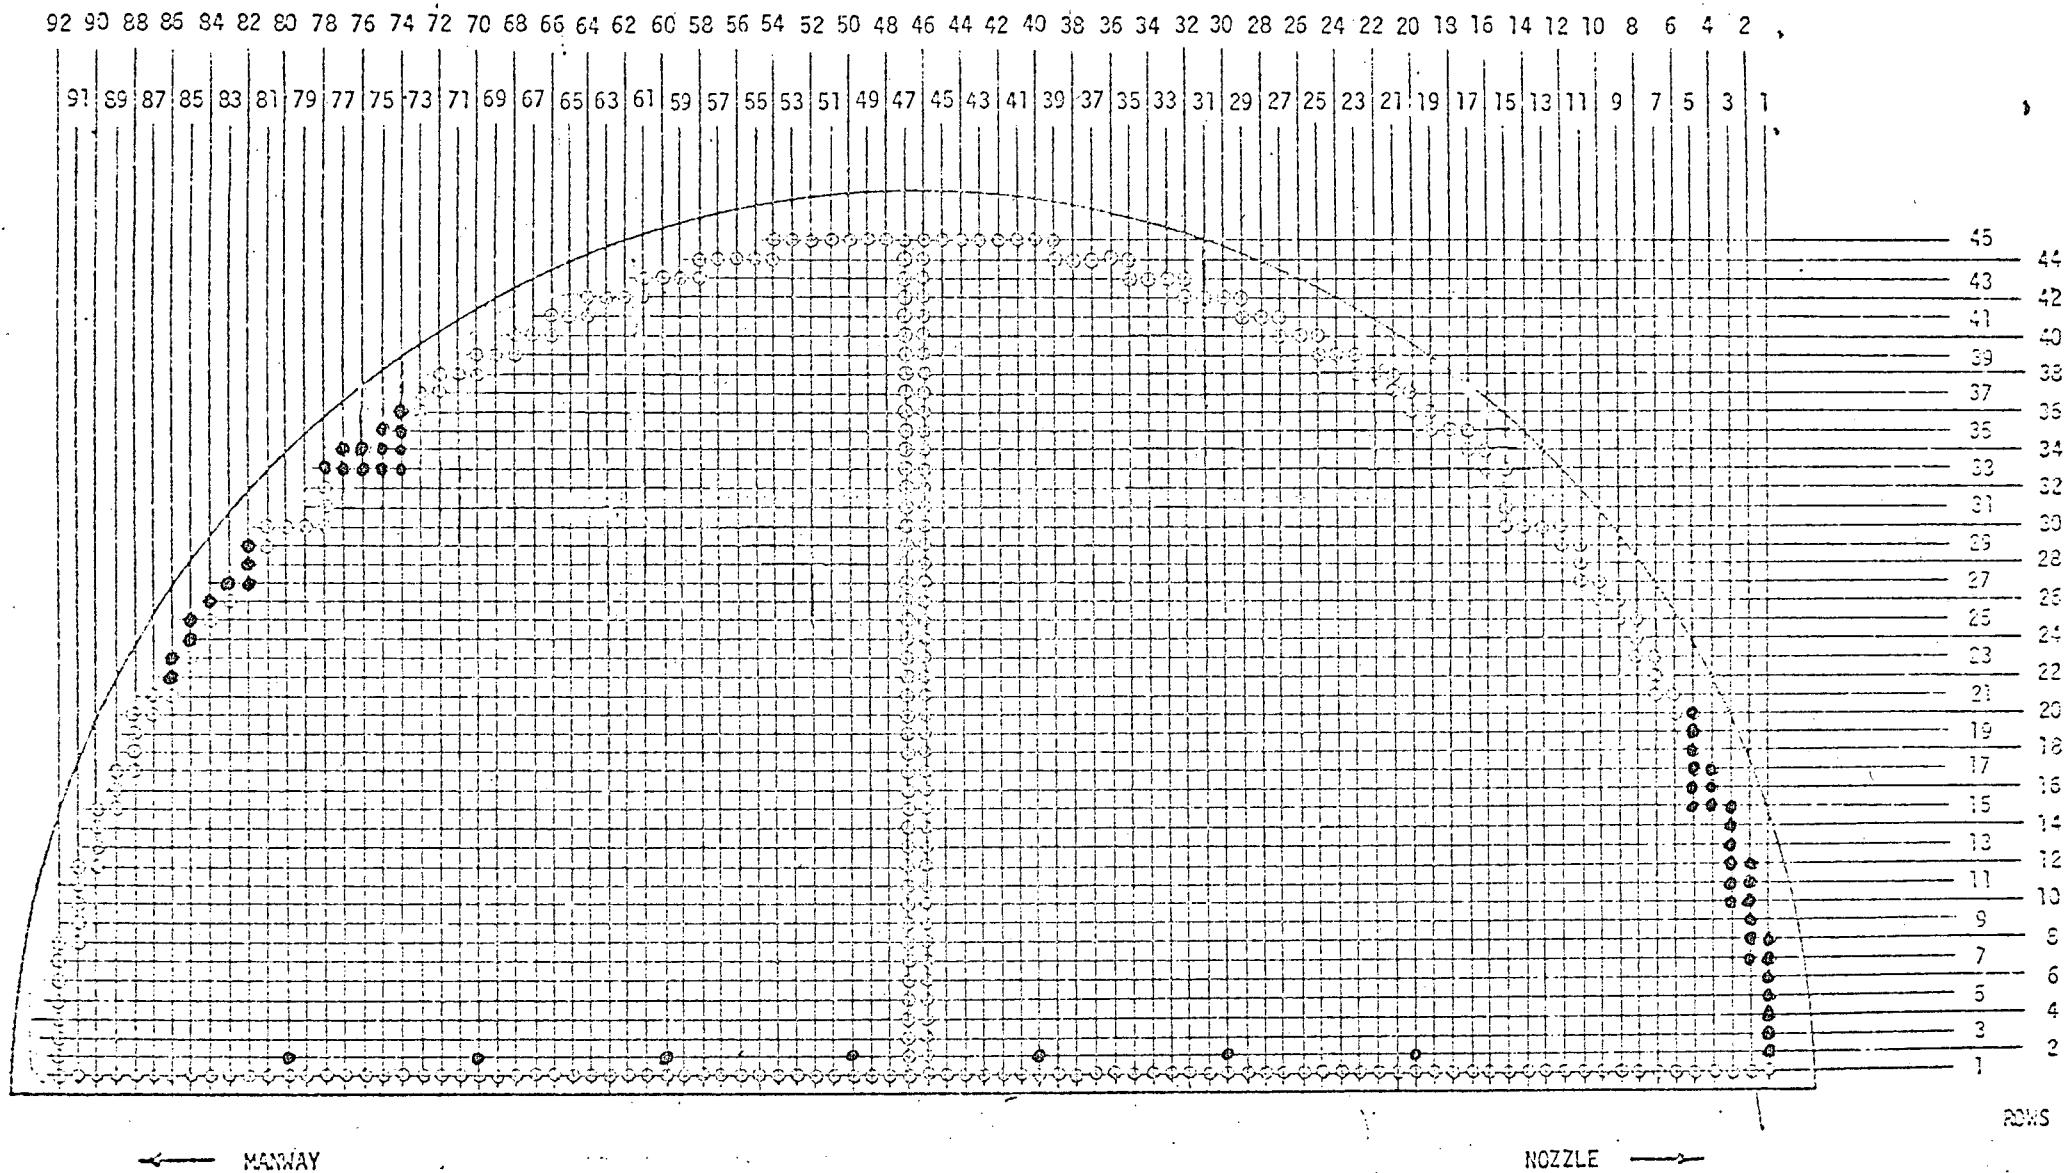
# EXPLODED VIEW OF TUBES NOT INSPECTED

TUBES NOT INSPECTED

STEAM GENERATOR "C"

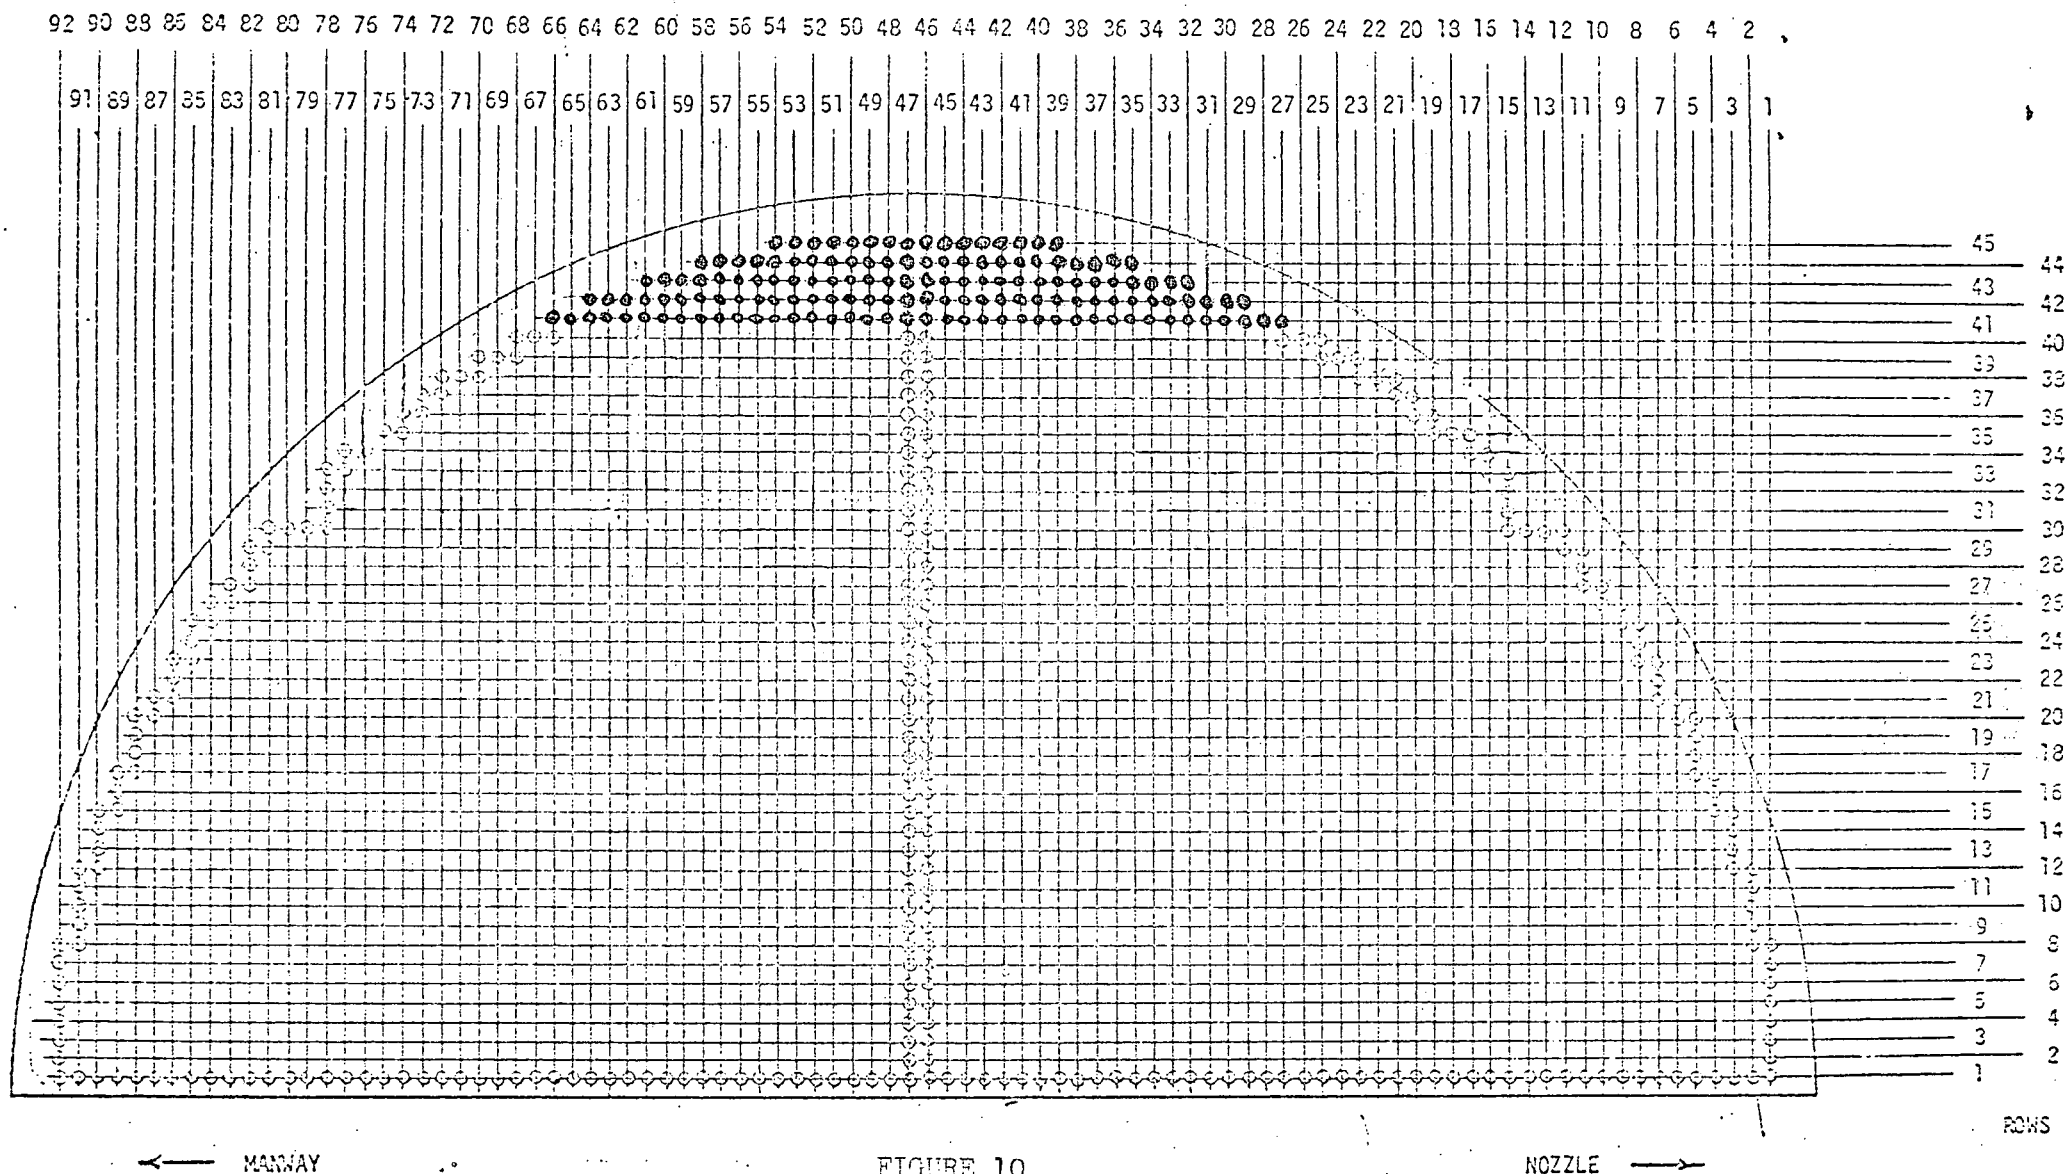
FIGURE 10

A U-bend inspection was performed on steam generator "A" to determine if there was any tube deterioration around the U-bends. All tubes in rows 41 through 45 were inspected totalling 146 tubes. There were no indications of tube deterioration in this area. This test was performed by Westinghouse personnel. See enclosed Figure 10 for view of tubes inspected.

# EXPLODED VIEW OF TUBES U-BEND INSPECTED
