ACCESSION NBR: 8108250441 DOC. DATE: 81/08/21 NOTARIZED: YES DOCKET #  
 FACIL: 50-261 H. B. Robinson Plant, Unit 2, Carolina Power and Light 05000261  
 AUTH. NAME: AUTHORITY AFFILIATION  
 UTLEY, E.E. Carolina Power & Light Co.  
 RECIP. NAME: RECIPIENT AFFILIATION  
 VARGA, S.A. Operating Reactors Branch 1

H. B. ROBINSON STEAM ELECTRIC PLANT, UNIT NO. 2  
DOCKET NO. 50-261  
LICENSE NO. DPR-23  
STEAM GENERATOR RECOVERY PROGRAM

STEAM GENERATOR REPAIR AND PREVENTATIVE  
MEASURES REPORT

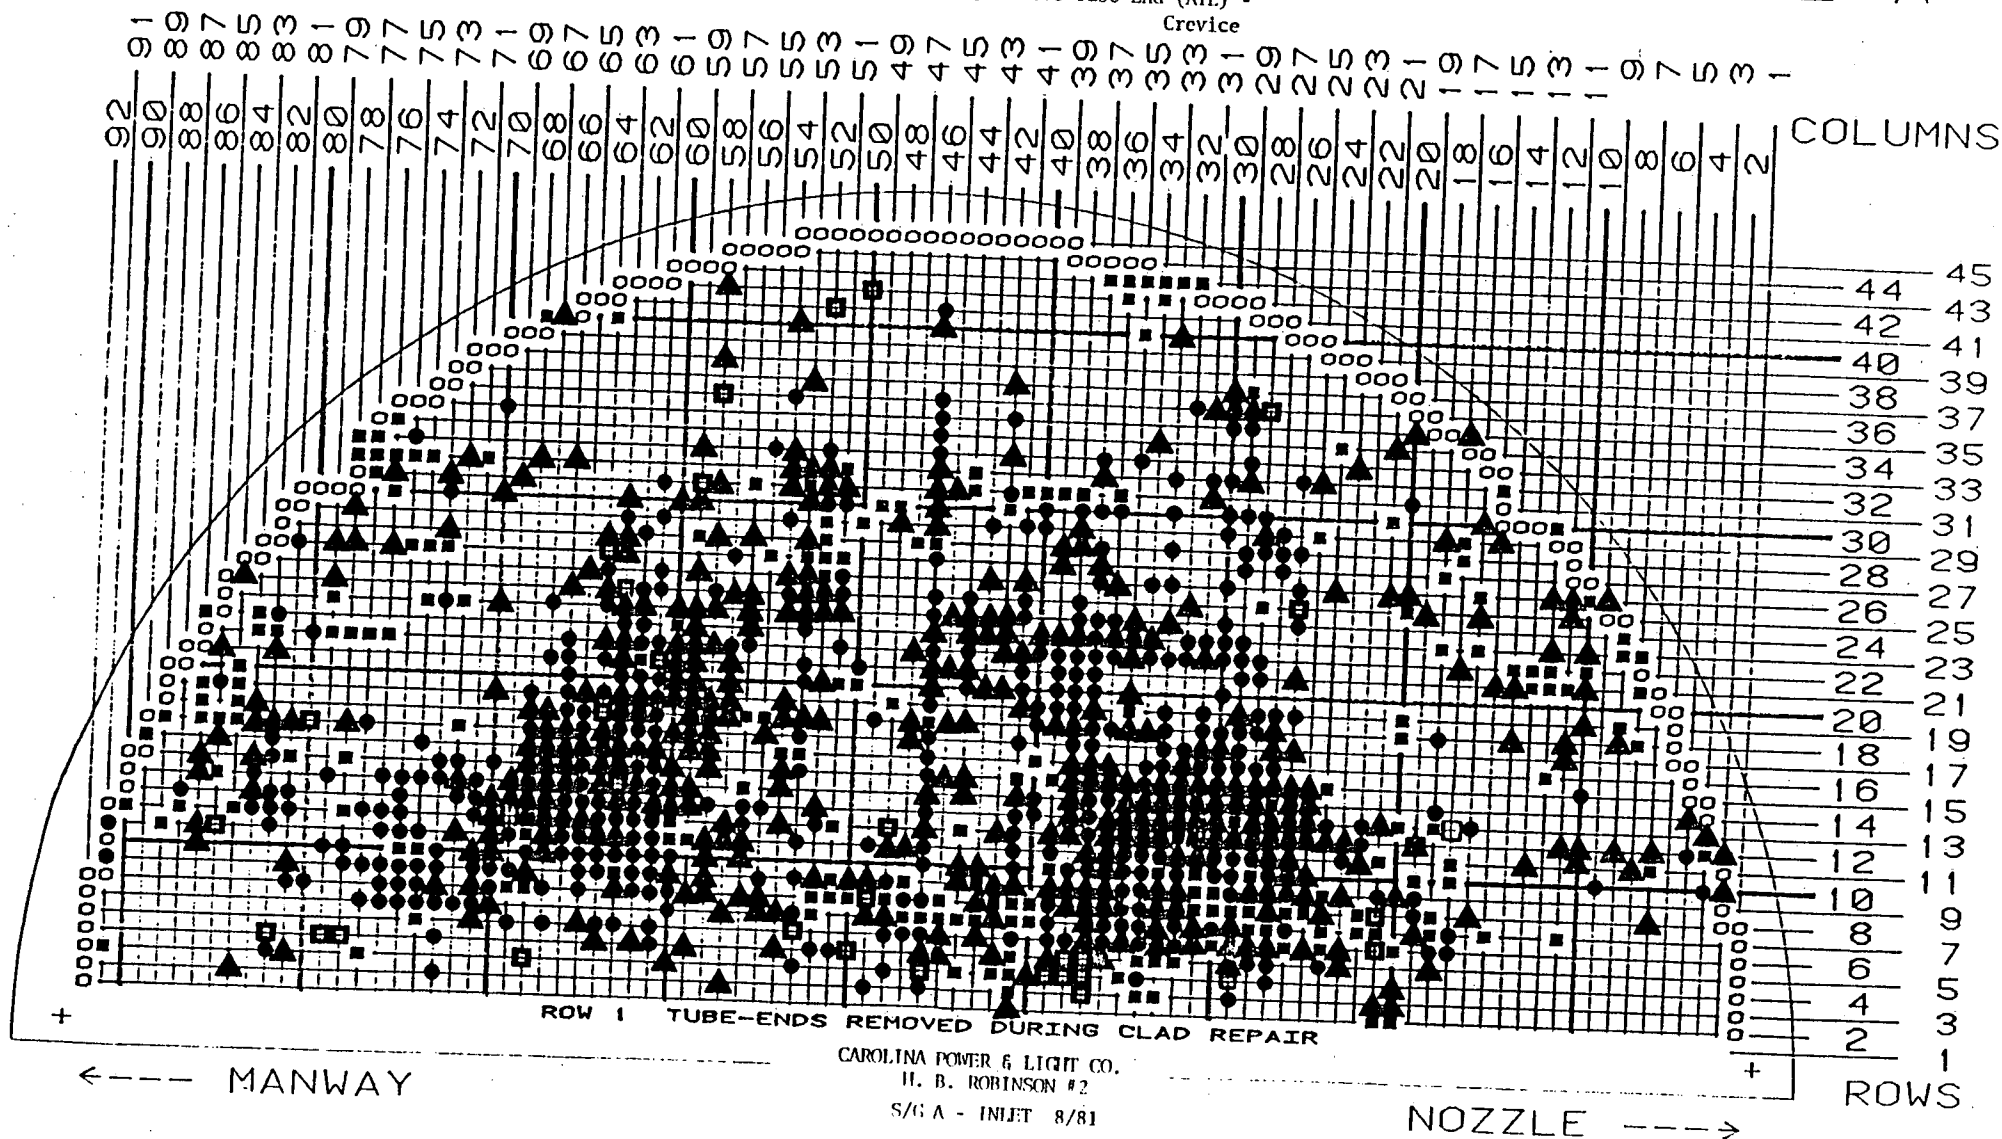
Figure 3.1.11

■ = Above Tubesheet (ATS)  
 ■ = Top Tubesheet (TTS)  
 ■ = Above Tube End (ATE) -  
 Crevice

LEGEND:  $\Delta$  = <20% or Distorted

$\square$  = 20-47%

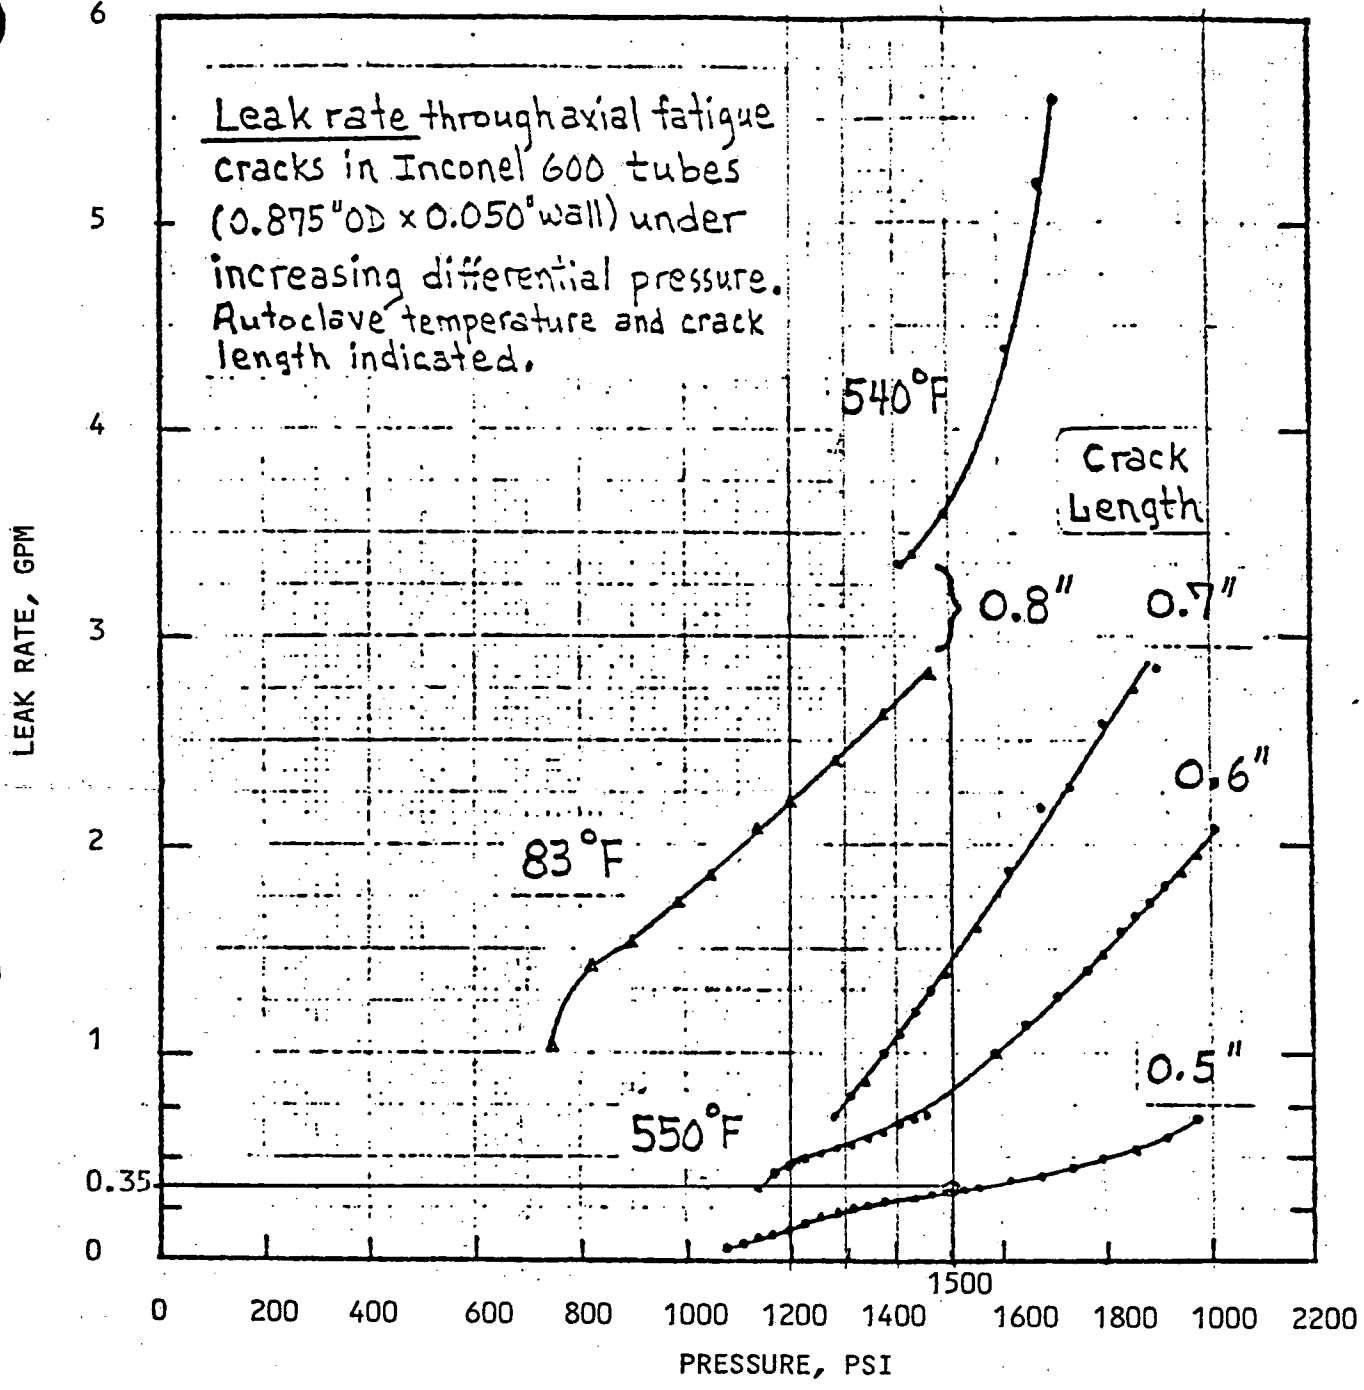
FIGURE 5.1.1

The burst pressure and expected leakage rate at normal operating conditions were determined for the 13/16 crack length. Data for determining these values was presented in "CPL Steam Generator Tube Plugging Criteria Calculations" (WTD-SM-77- 058). Figure 3-1 of the report (attached as Figure 5.1.1) shows curves of leak rate versus pressure for various crack lengths and temperatures. Figure B-1 of the report (attached as Figure 5.1.2) shows a curve of crack length to room temperature burst pressure. Burst pressure at operating temperature is related to room temperature burst pressure via the ratio of material ultimate strengths at room temperature and operating temperature.

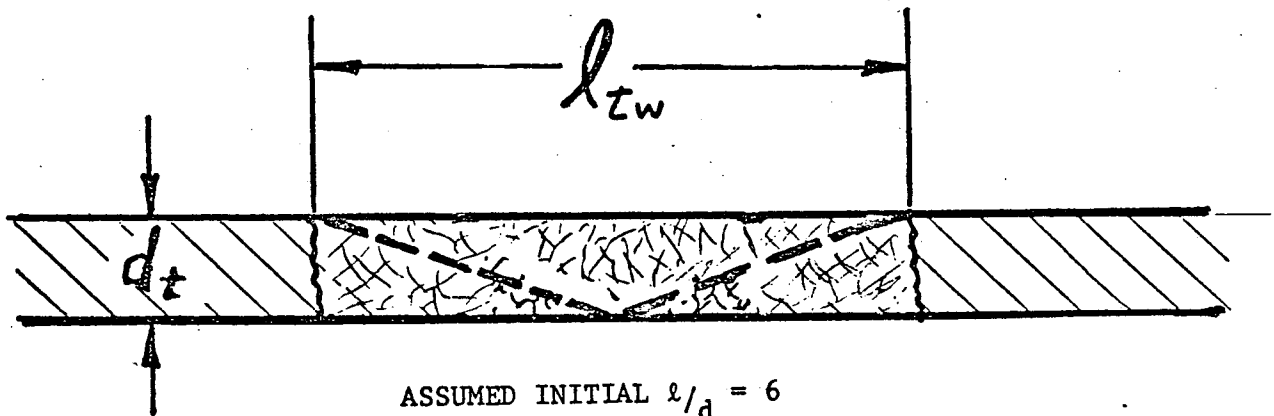
FIGURE 5.1.3

This section addresses the possibility of pre-existing part through wall degradations penetrating the wall as a result of the steam line break accident differential. In this case the tubes have sufficient wall thickness to sustain the normal operating pressure differential. Experience with the propagation of part wall intergranular cracks in Inconel 600 has been that there is an aspect ratio of length (on the initiating surface) to depth of penetration through the wall (Figure 5.1.3). The aspect ratio has been observed to vary between 2 and 5. The most conservative

CRACK ASPECT RATIO
