H. B. ROBINSON STEAM ELECTRIC PLANT, UNIT NO. 2
DOCKET NO. 50-261/LICENSE NO. DPR-23

SUBMITTAL OF CONTAINMENT SURVEILLANCE TENDON TEST RESULTS

TITLE: Inspection and Evaluation of Containment Prestressed Tendon
25-Year Surveillance Block

Document No. 96236-TR-01
Revision 0
Volume 1 of 1

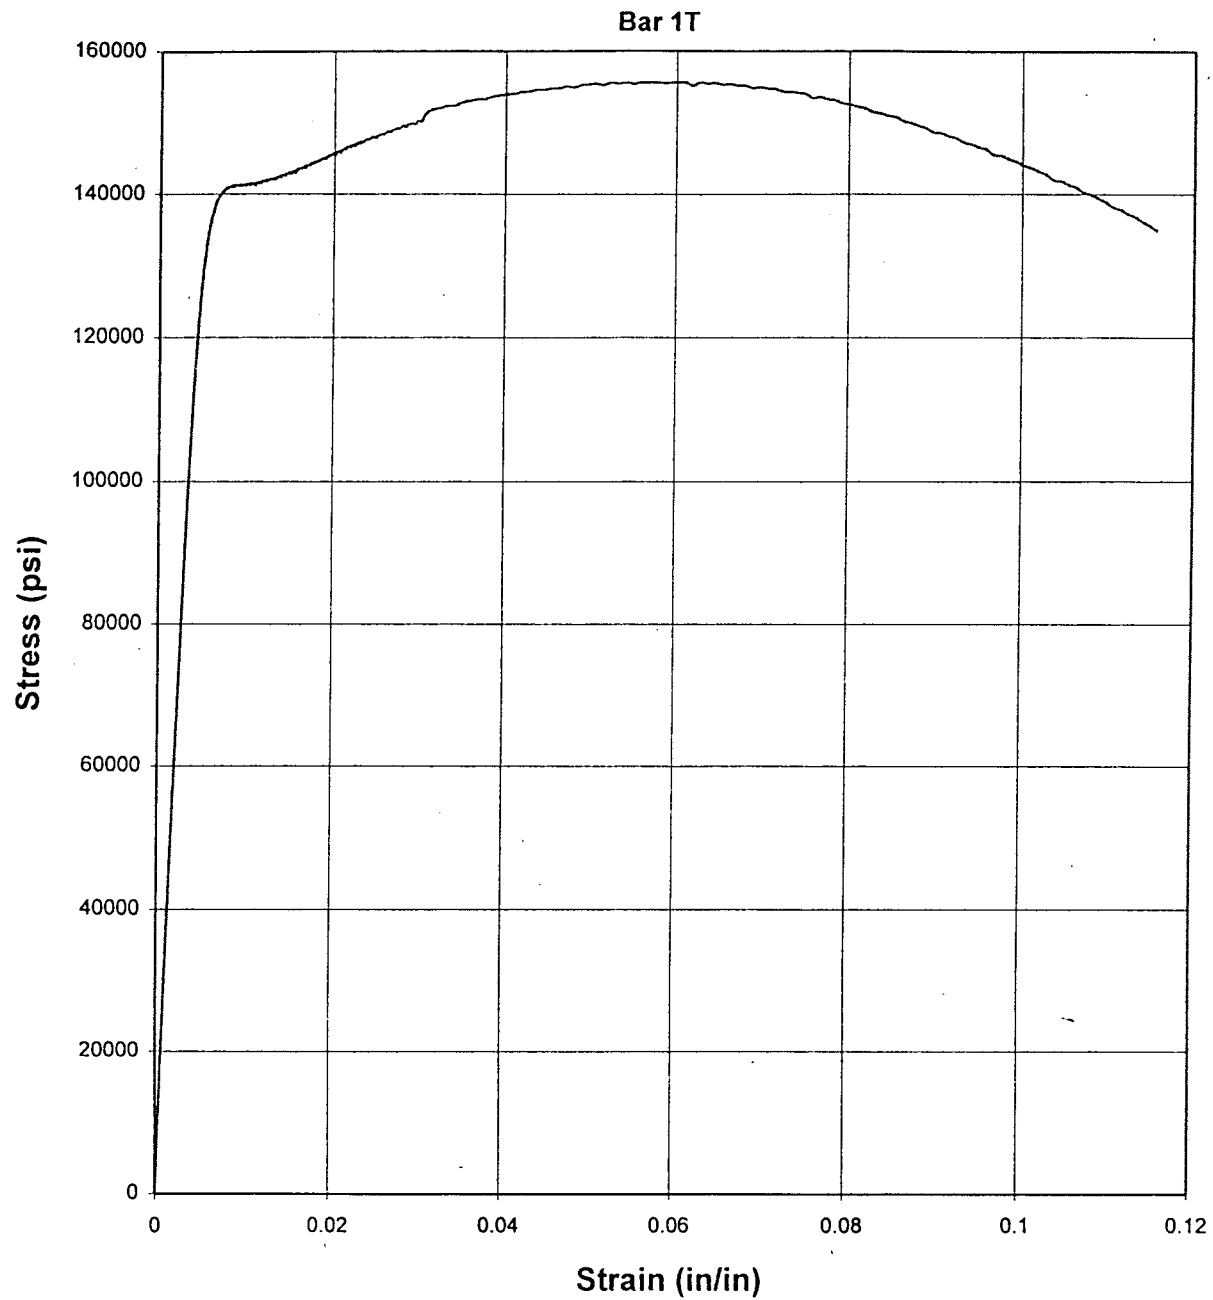
Figure 2 Stress-Strain Curve for Tendon Bar No. 1

One tensile specimen from each bar was cut and tested for tensile strength and mechanical properties. The testing was performed in accordance with the ASTM E8 [2]. Figures 2 to 7 show the stress/strain graphs of the specimens and results are presented in Table 2.

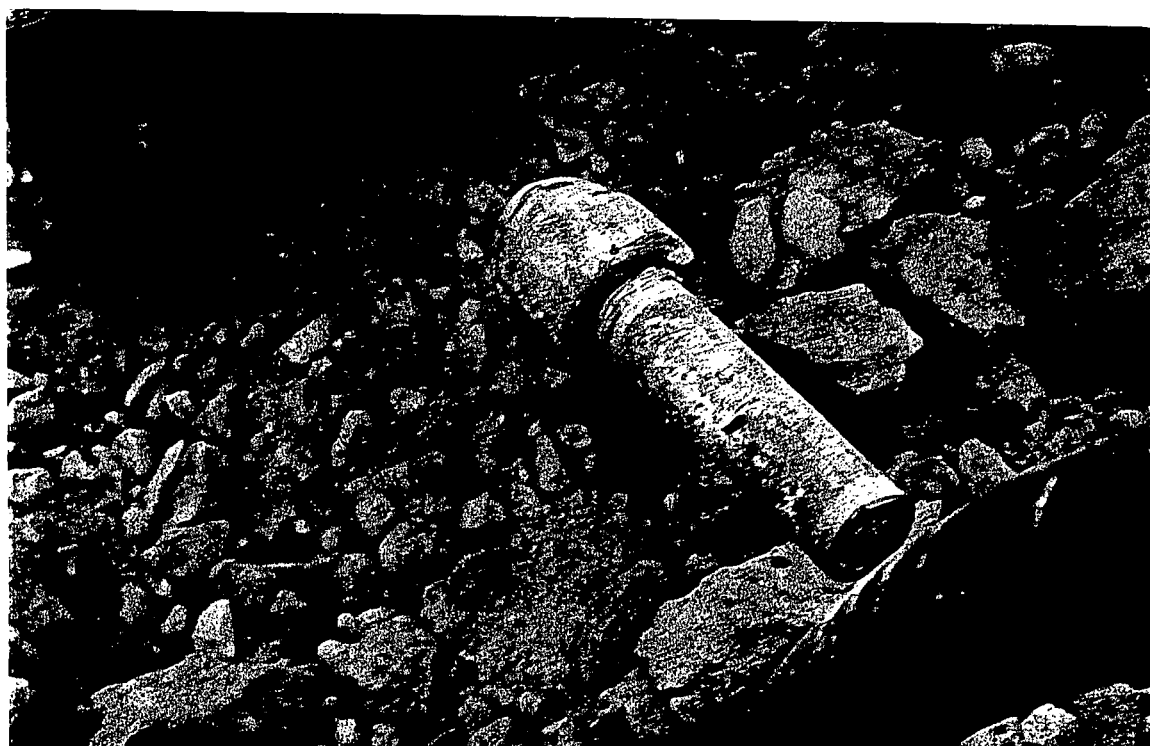
Figures A11 to A19 show the different parts of the tendon assembly immediately after exposure. Figure A11 and A12 show the base plate and a detail view of its bottom side. The superficial corrosion products (stains) on this surface were slightly covered with oil, and corrosion was limited to only the metal surface. The surrounding concrete did not contain any corrosion products. This oily surface indicates that the corrosion had not been active after construction and most likely was present at the time of construction. Figure A13 shows a close-up of the grouting pipe attached to the bottom of the base plate.

Grouting Pipe Attached to the Bottom Base Plate
FIGURE A13.

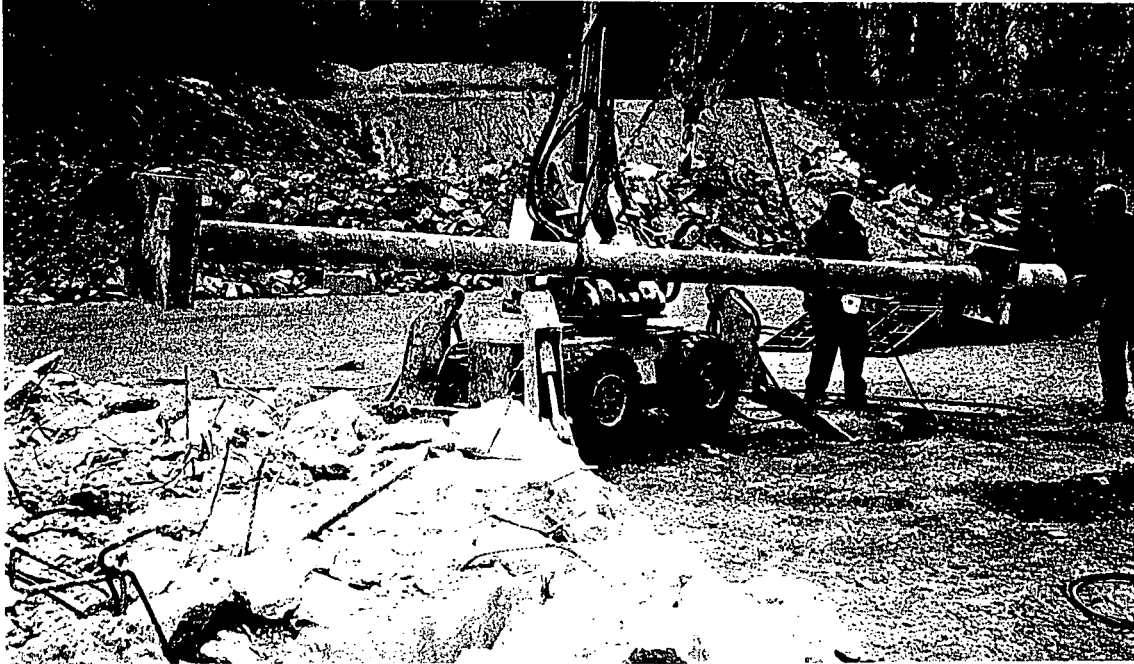
The tendon assembly was removed for a more detailed examination (Figure A21). Except for the superficial oxides mentioned above, no other sign of age related degradation or corrosion was detected on the exterior of the two end plates, galvanized steel pipe, or on the galvanized cap. Figures A22 and A23 show the exterior appearance of the tendon casing. The galvanized tendon cap was removed using a cutting torch by cutting both circumferentially along the base flange and longitudinally down the cap (Figure A24). The cap was pried open and the grout was broken exposing the free ends of the tendons. The internal surface of the cap was free from corrosion (Figure A25). The ends of the tendons were numbered from 1 to 6 (Figure A26). Some reddish oxide was observed on the surface of the tendons and the surrounding grout (Figure A27). No measurable metal loss was associated with this corrosion product which probably existed during construction.

Tendon Assembly after Removal From Cement
FIGURE A21.

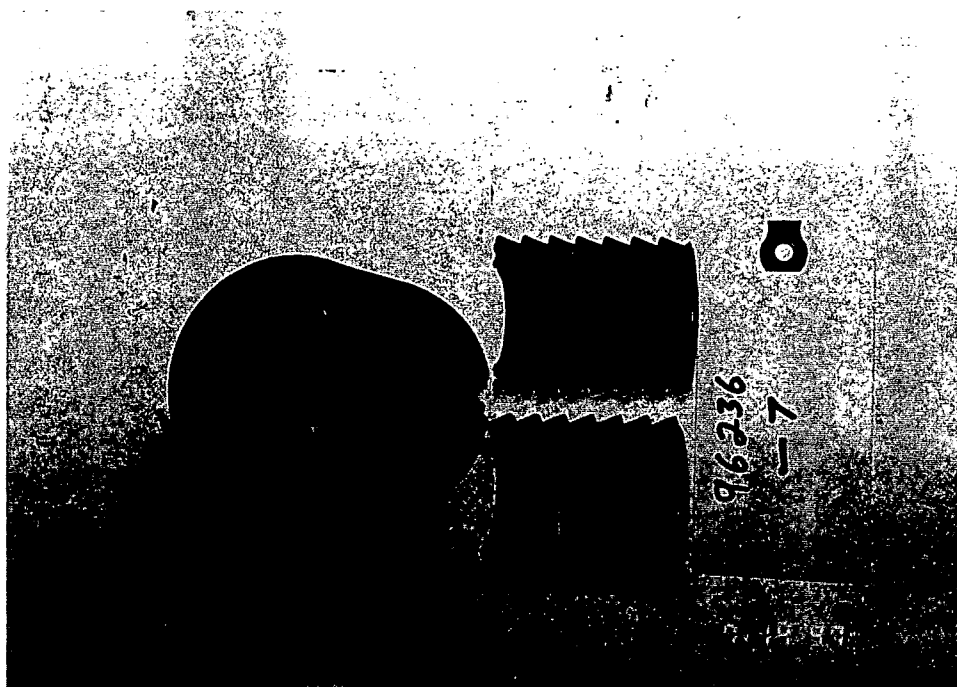
The grip nuts were all in good condition. No sign of corrosion was detected on the outer surface. The grip nut on bar number 4 was randomly selected and cut. Figures A58 to A60 show the components within this grip nut and the area of the bar encased by the nut after cutting. Similar to the external surface, the internal surface was also free from corrosion.

The Cut Grip Nut
FIGURE A58.

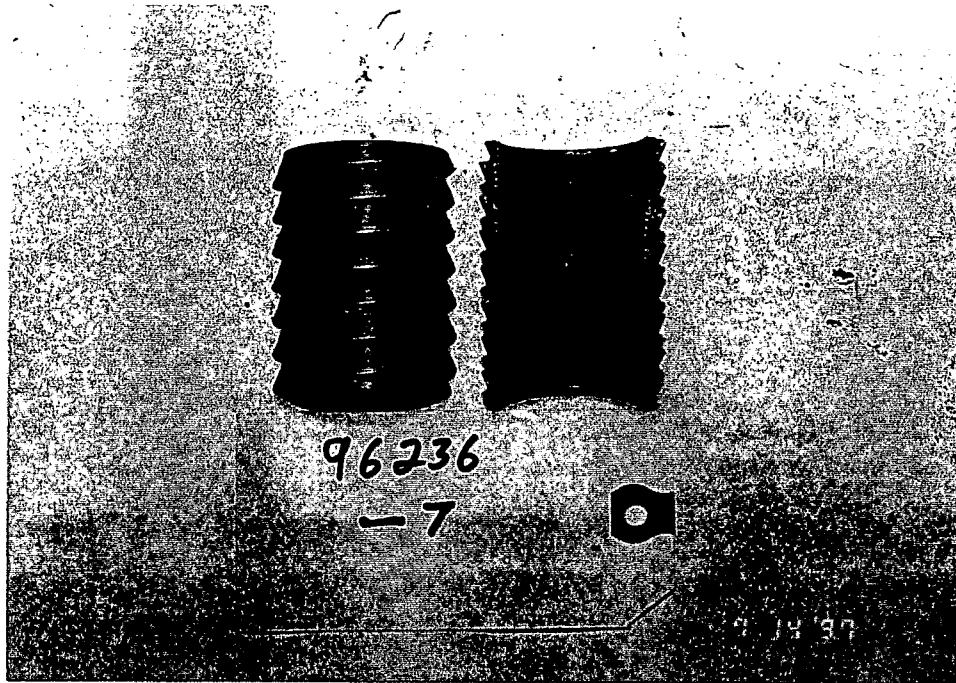
Interior and Exterior View of the Grip Nut
FIGURE A59.

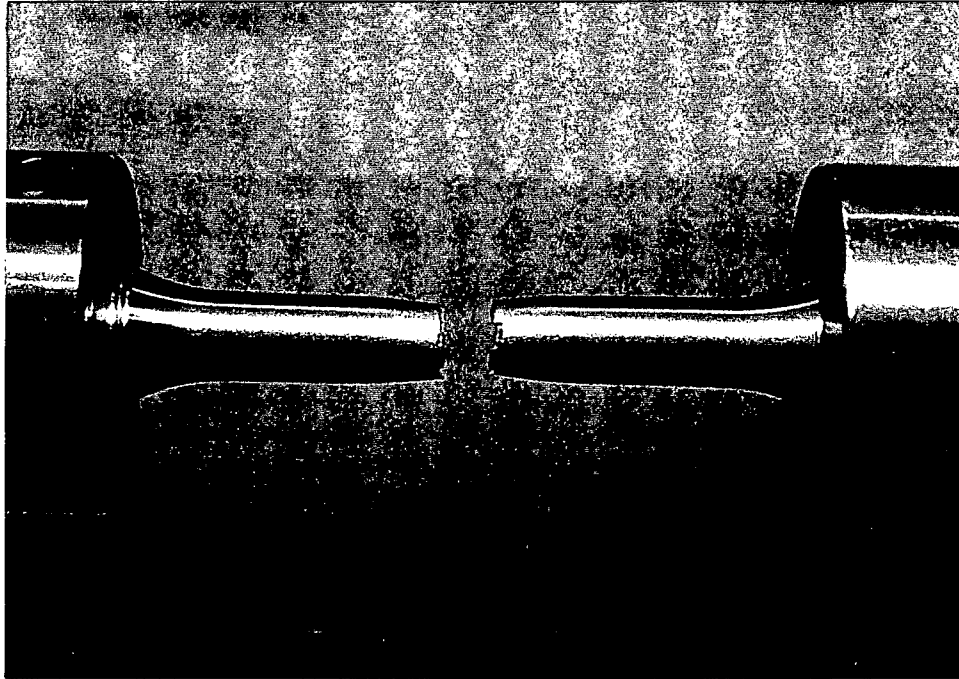
Test Coupon Upon Failure in Tension
FIGURE A69.
