Technical Report

STEAM GENERATOR WATER HAMMER EVALUATION  
H. B. ROBINSON STEAM ELECTRIC PLANT UNIT NO. 2

Report No. 6-2

March 13, 1980

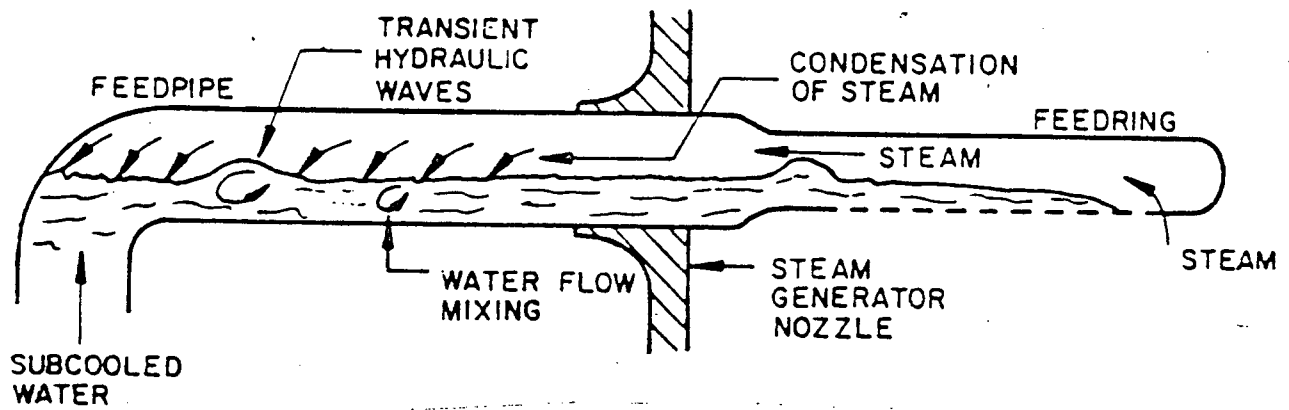
Figure 2. Counter-current Flow into Piping [2]

- (1) The flow of steam into the feedring through the discharge holes which are not flowing water and around the feedring into feedwater piping is counter to the flow of water toward the holes. This counter-current flow can cause waves on the surface which can build up to block the ring and isolate a steam pocket in the upstream portion of piping.
- (2) As the level in the steam generator rises to the bottom of the feedring, an isolation of the steam in the ring occurs.
- (3) Unsteady flow in the horizontal portion of the feedring and feedwater piping can, solely by hydraulic instabilities, cause a sealing off of a steam pocket as the recovering flow nears the top of the piping or as the incoming flow rate is changed by a controlling valve adjustment.

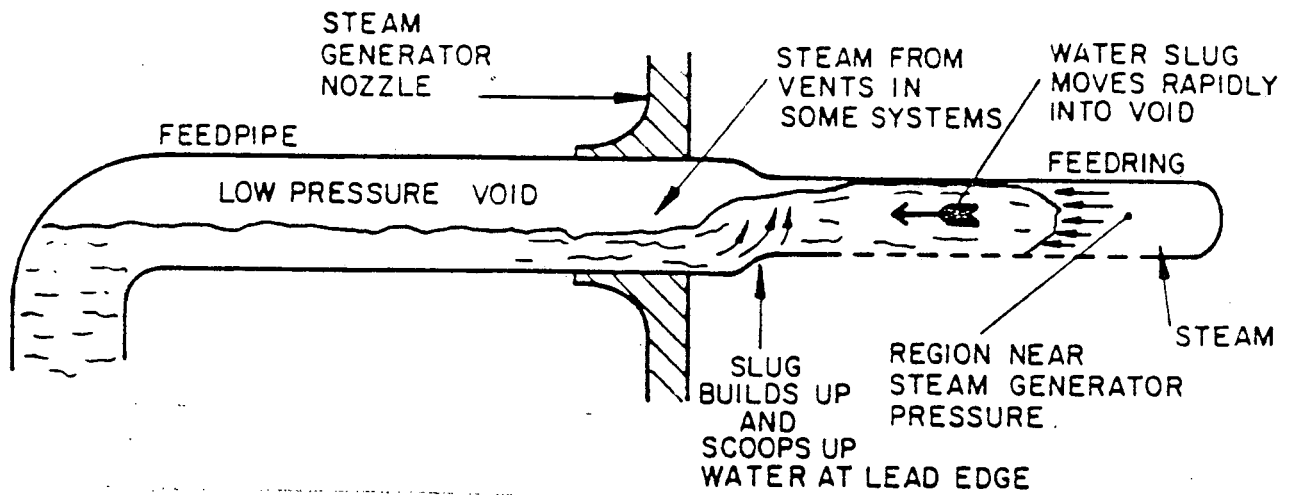
Figure 4. Acceleration of Water Slug [2]

The dynamic event considered here is that occurrence which has been observed several times in PWR's both in the United States and abroad in which a water slug is accelerated by the differential pressure caused by the condensation of an isolated steam pocket. The accelerated water slug can impact the piping or water and cause damage to the piping system. Reported cases in other units (there have been no reported cases at HBR) have led to associated damages such as bent piping supports and a cracked feedwater line.
