CAROLINA POWER AND LIGHT COMPANY
H. B. ROBINSON SEG PLANT, UNIT NO. 2

1982 REFUELING OUTAGE
STEAM GENERATOR INSPECTION
REPORT

SEPTEMBER, 1982

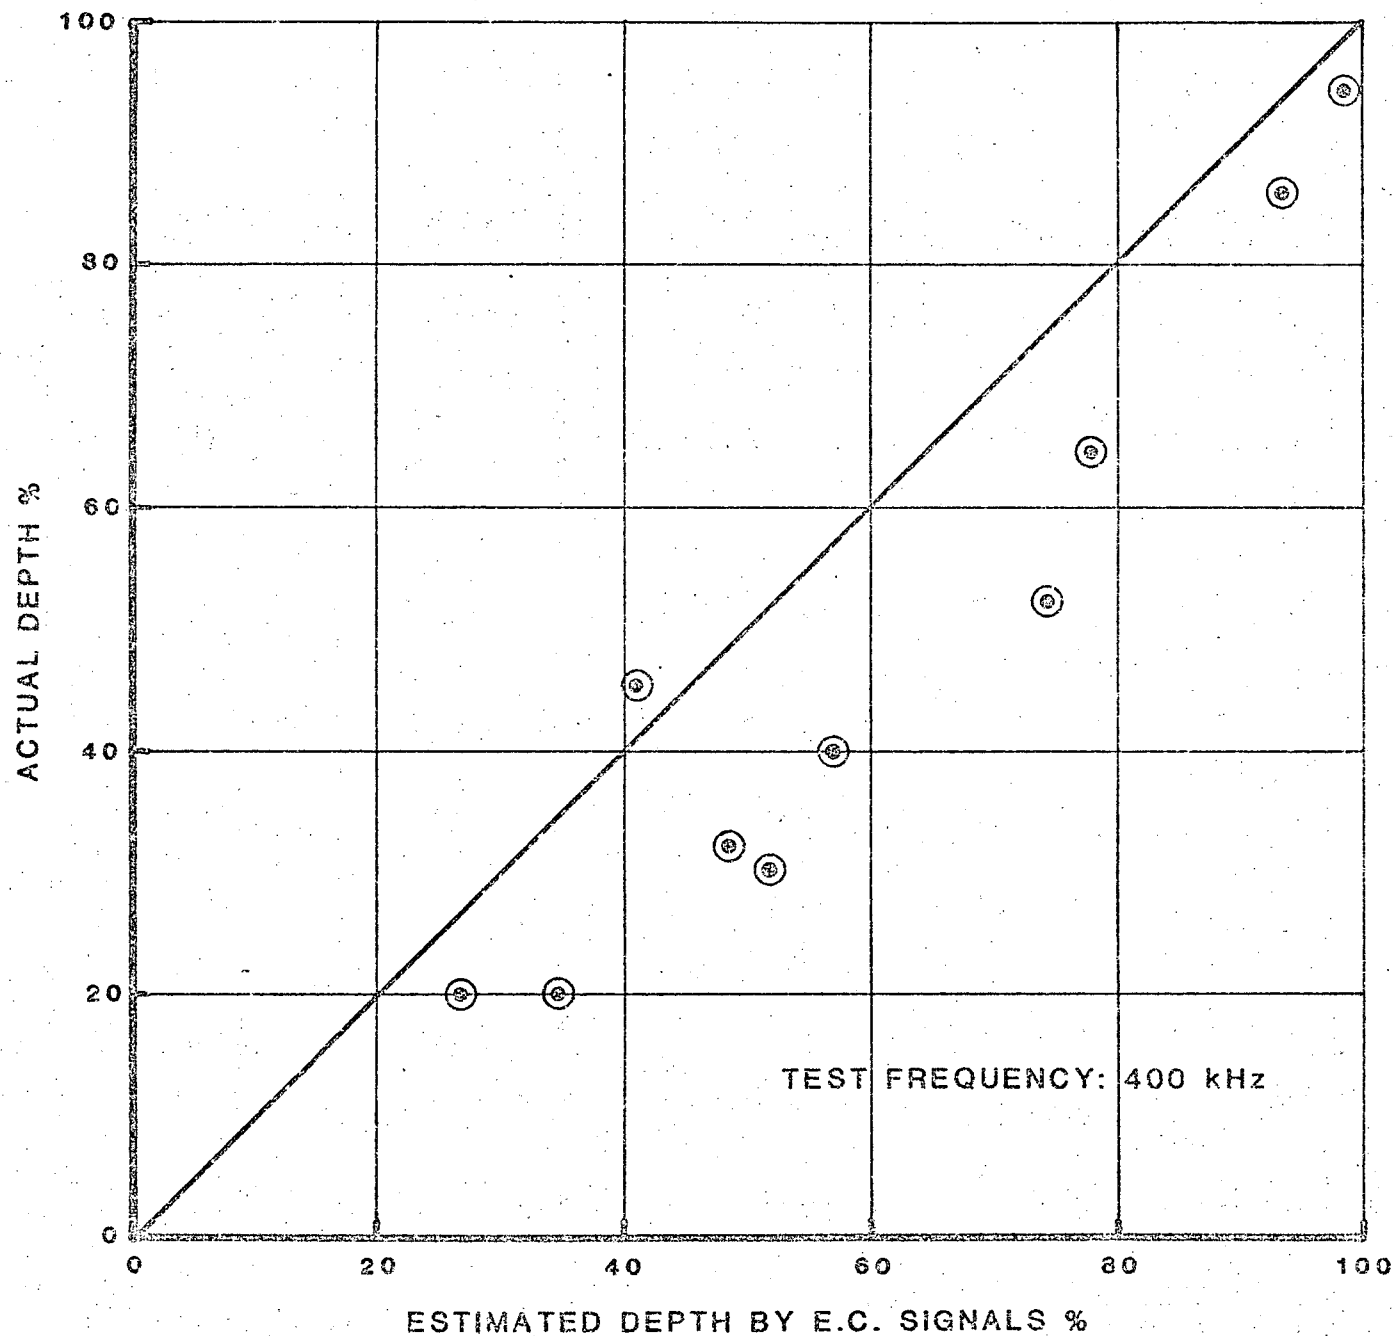
COMPARISON OF DEPTH ESTIMATES BY E.C. TECHNIQUE AND
THE ACTUAL DEPTHS OF MACHINED WASTAGE TYPE PENETRATIONS

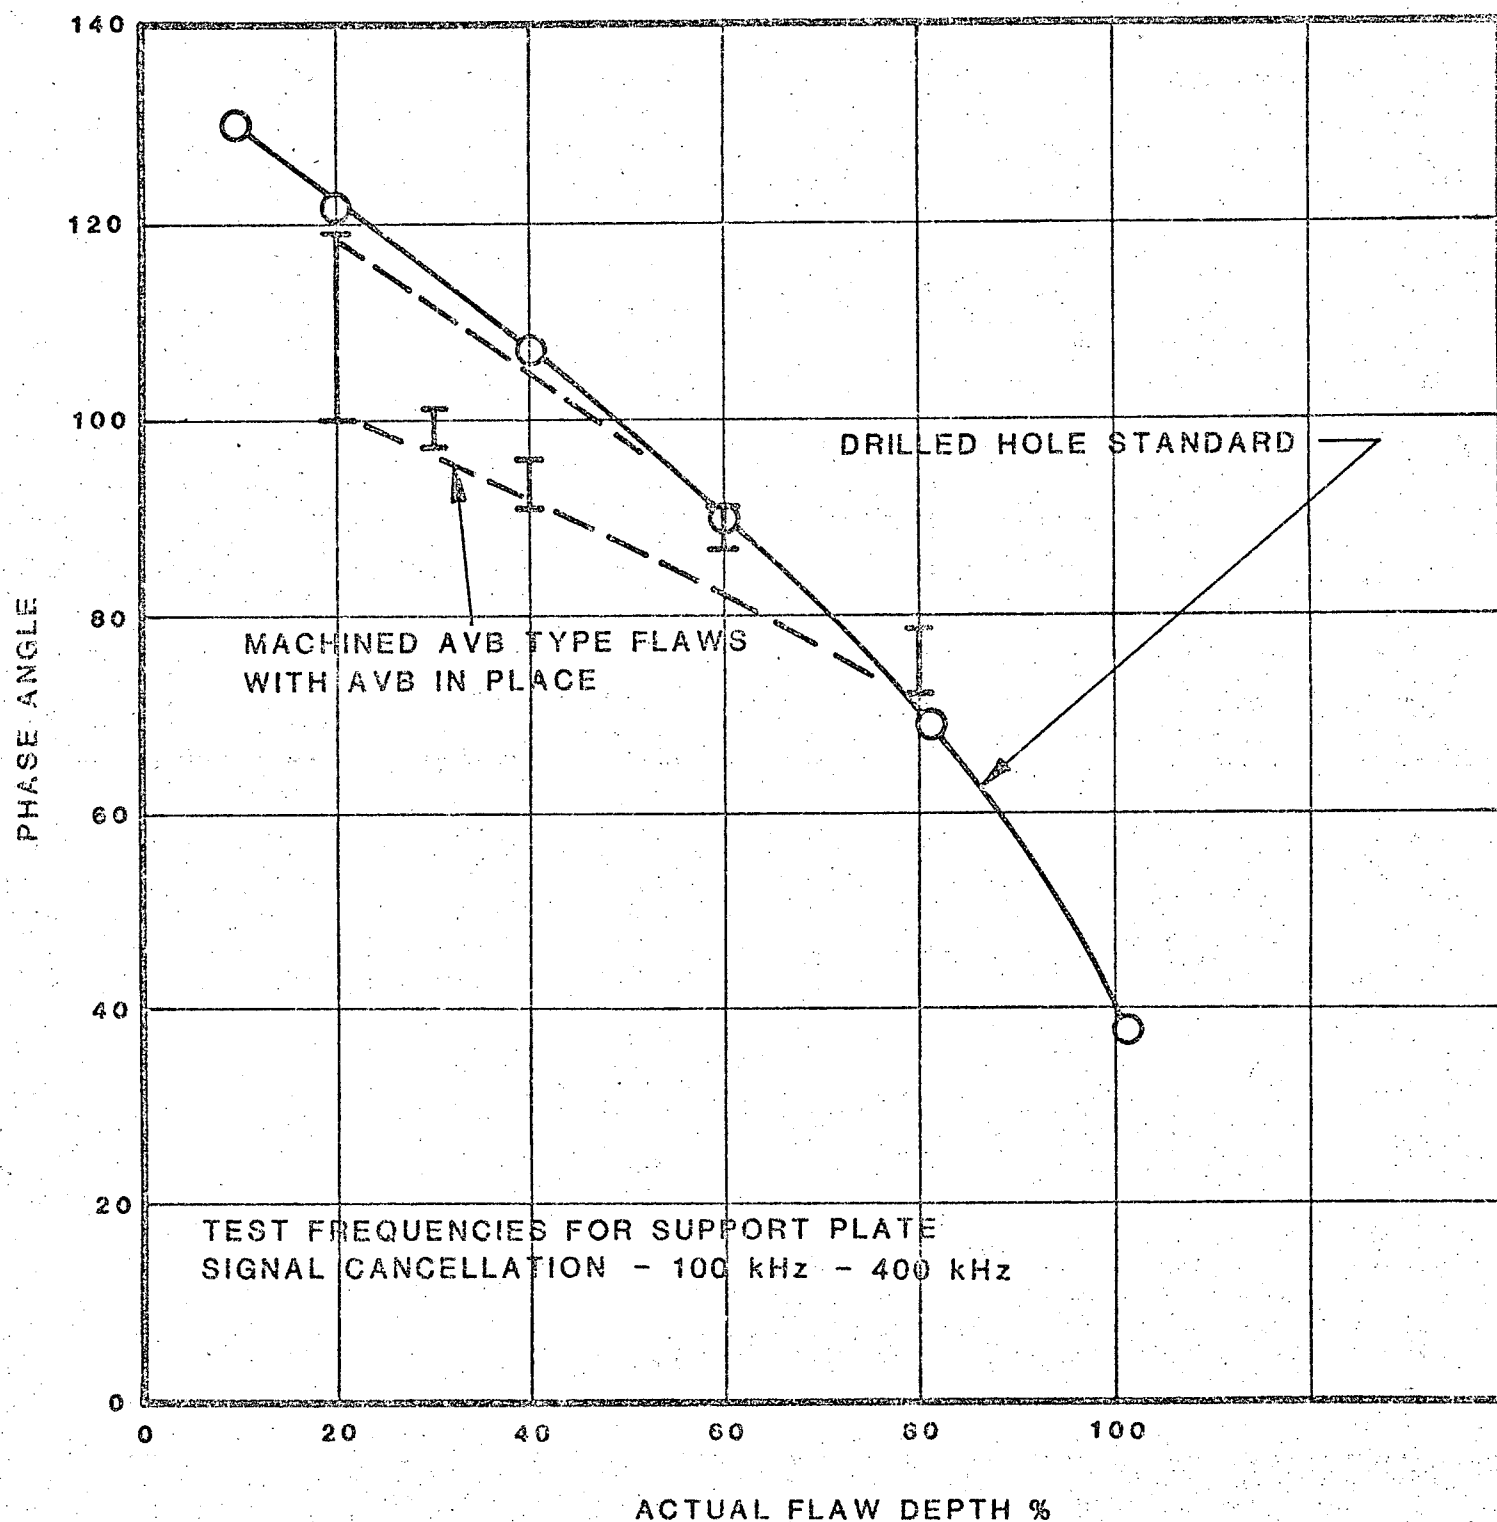
FIGURE 5

The above observations are valid for data taken at single frequency. If one uses the technique of mixing data taken at two frequencies the results are more complicated. For example, when the 400 kHz and 100 kHz data are mixed to cancel the interfering signals from support plates or Anti-Vibration Bars (AVB's) for estimating the depths of large area wear type penetrations resulting from vibrations or fretting, interpretation of the results is more complicated. Figure 5 shows laboratory data taken on wear type flaws at AVB locations. The data shows a cross-over near 60% wall penetration. The phenomenon of cross-over shown in Figure 5 is not relevant to the case where only 400 kHz data is used for depth estimation.

CALIBRATION CURVE BASED ON PHASE
ANGLES FOR THE AVB TYPE FLAWS
