H. B. ROBINSON UNIT NO. 2
ROUTINE OPERATING REPORT NO. 4
FOR PERIOD

APRIL 1, 1972 THROUGH SEPTEMBER 30, 1972

CAROLINA POWER & LIGHT COMPANY
H. B. ROBINSON STEAM ELECTRIC PLANT

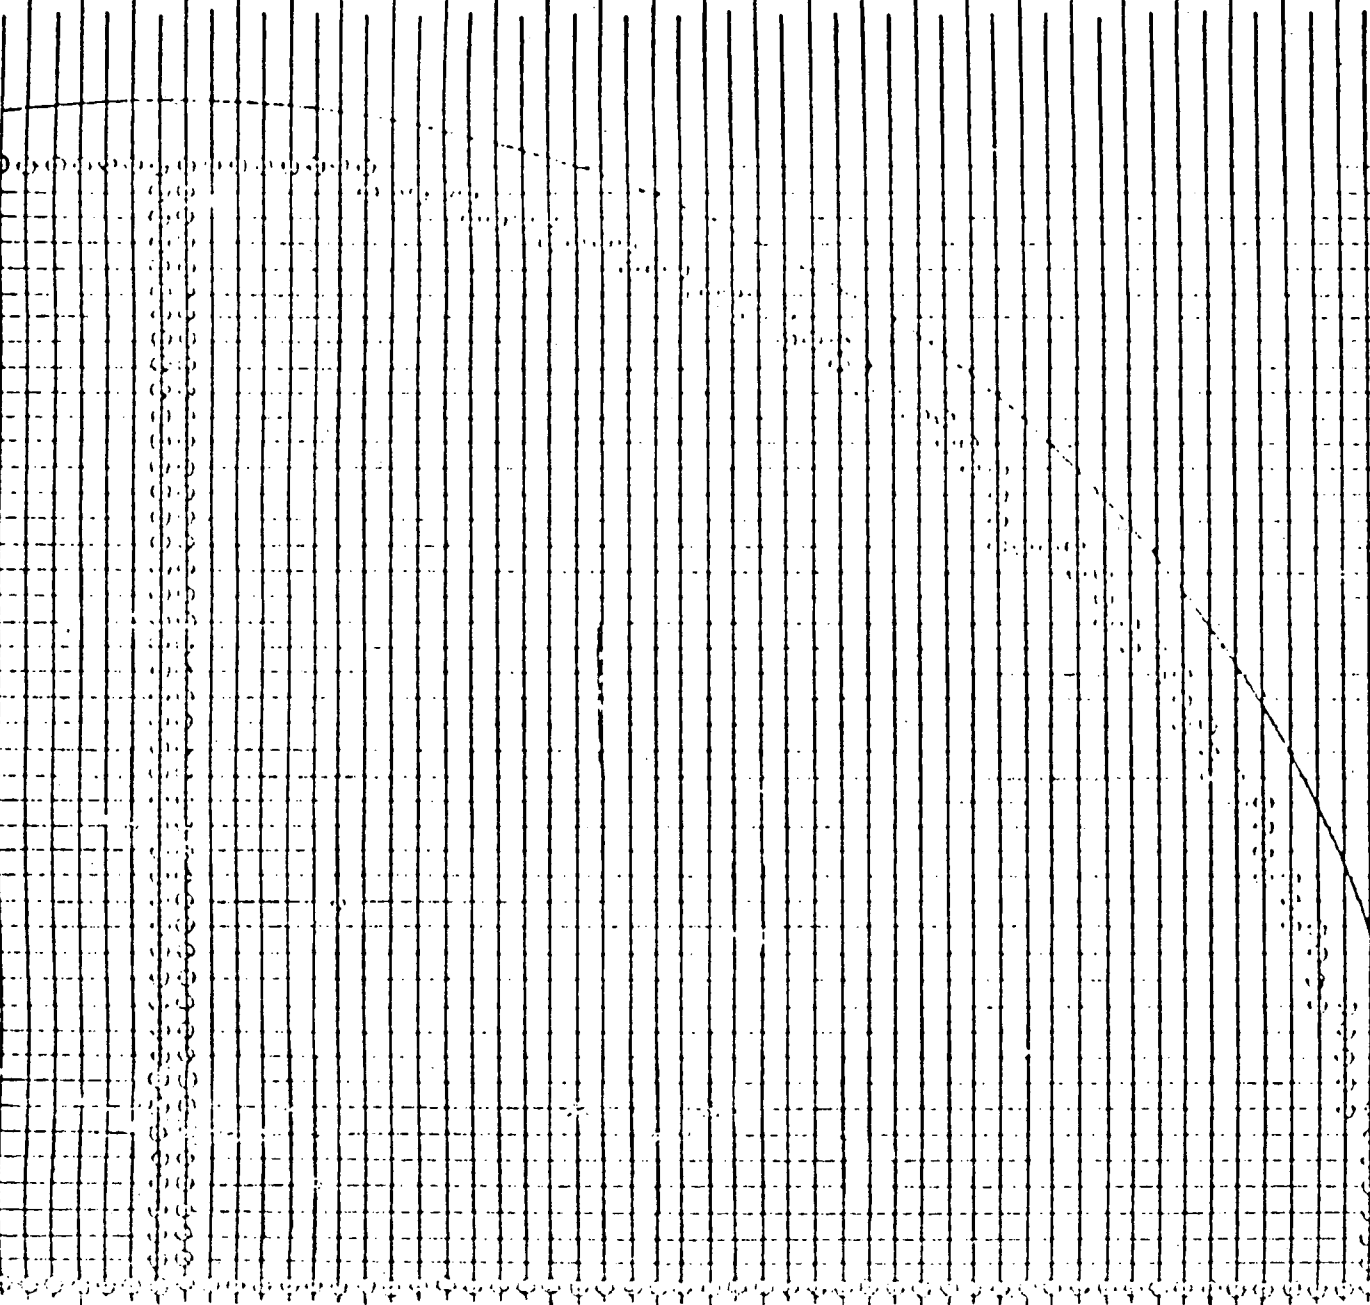
FIGURE 1

Eddy current testing of SG-"A" proceeded through May 18 and was concluded on the afternoon of May 19. Twenty-four tubes, including the leaker, out of a total of 2240 tubes inspected were found to be defective. This inspection was conducted on all tubes out to row 27. This encompassed the suspect area reported in Section I of this report and revealed that there were no defective tubes in that vicinity. For a listing and disposition of defective tubes, refer to enclosed figures 1 and 2 and table 1.

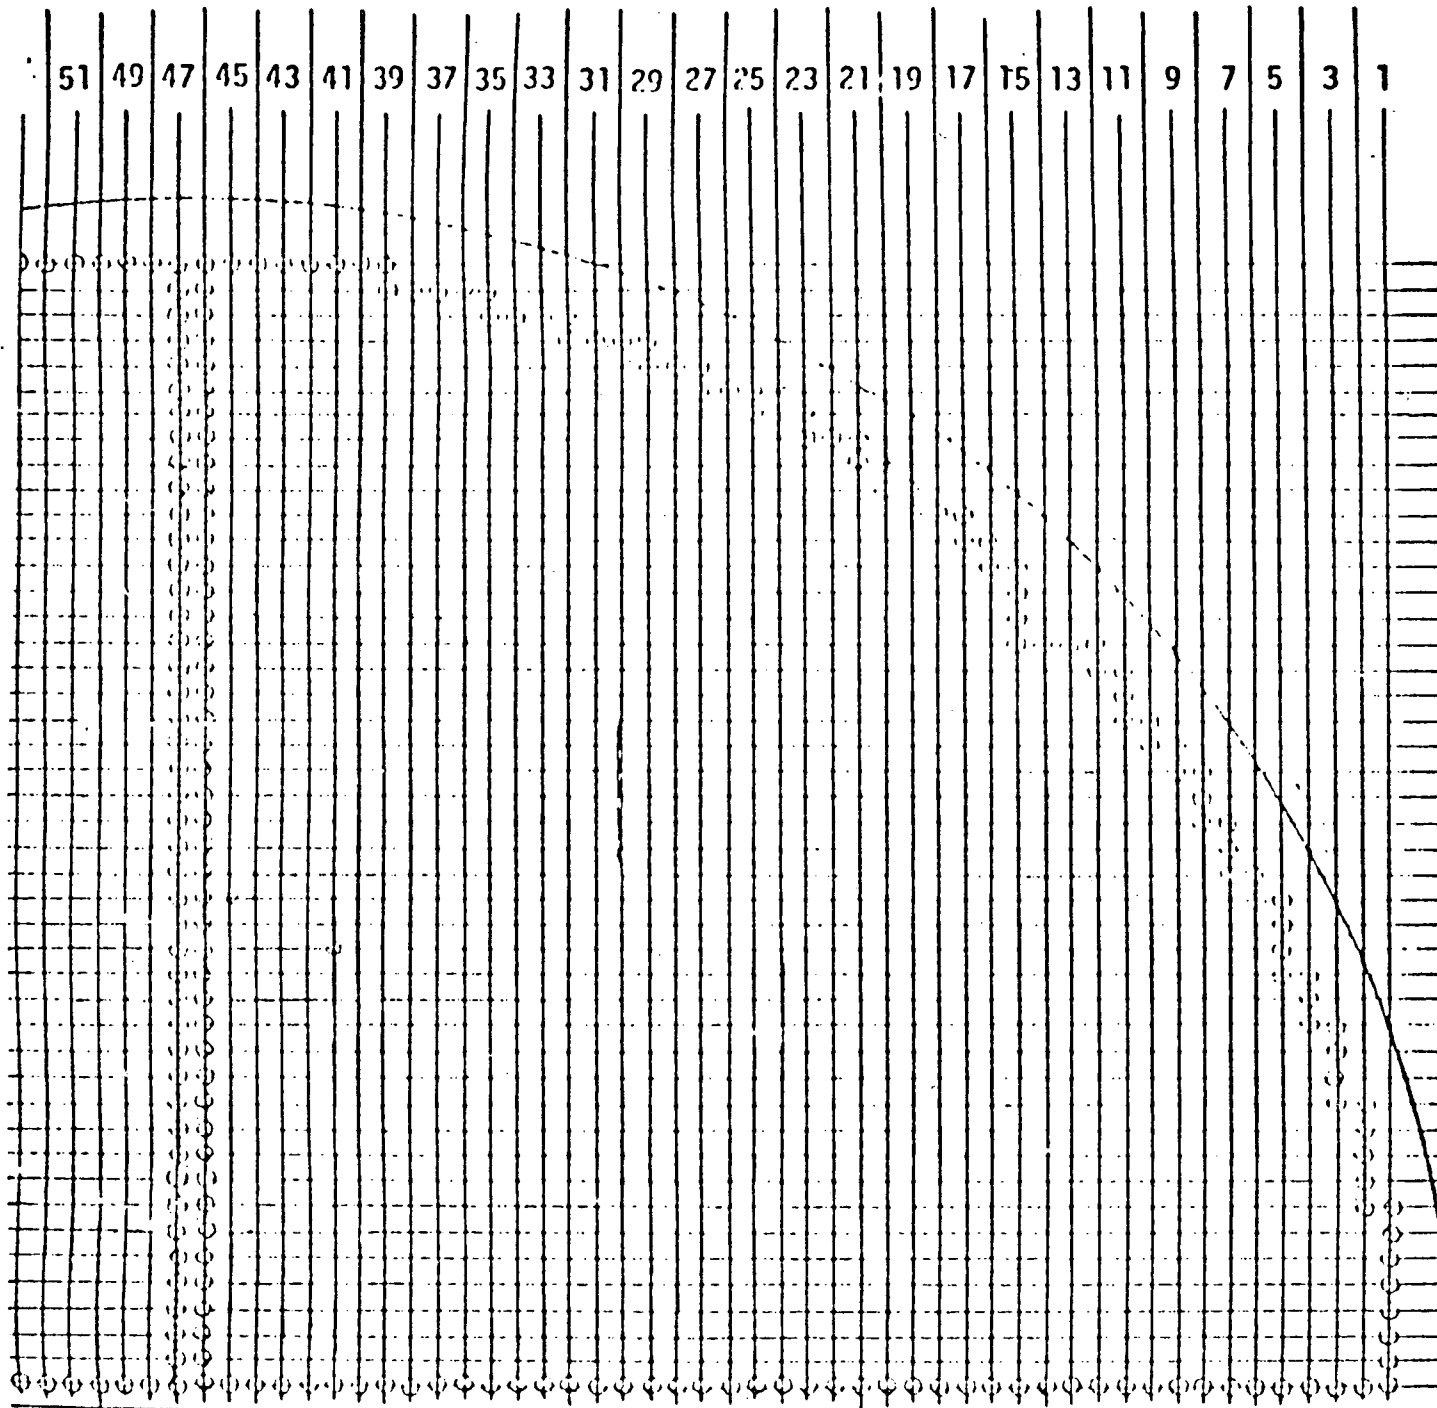
FIGURE 3.

⊙ - DEFECTIVE TUBES
LOCATED BY EDDY-
CURRENT TEST

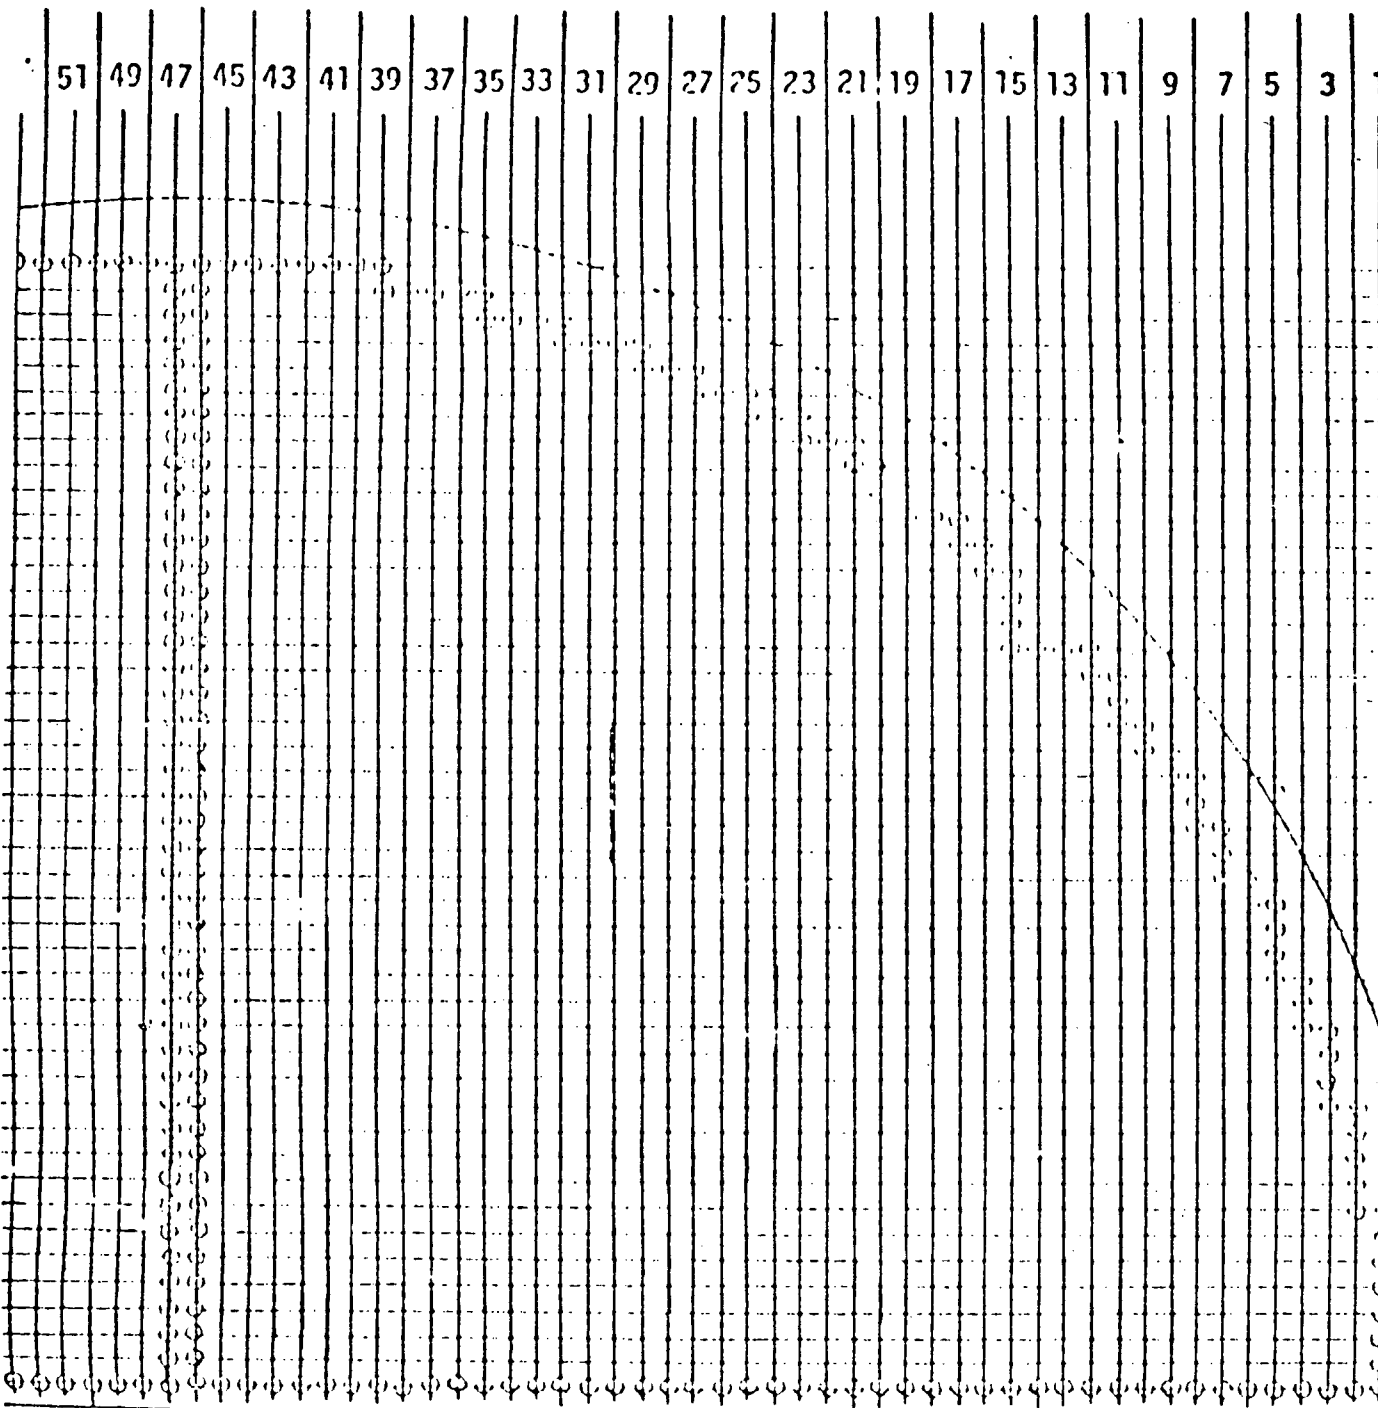
EXPLODED VIEW OF PLUGGED TUBES IN SG "C"

LEGEND:
⊙ - DEFECTIVE TUBES
LOCATED BY EDDY
CURRENT TEST

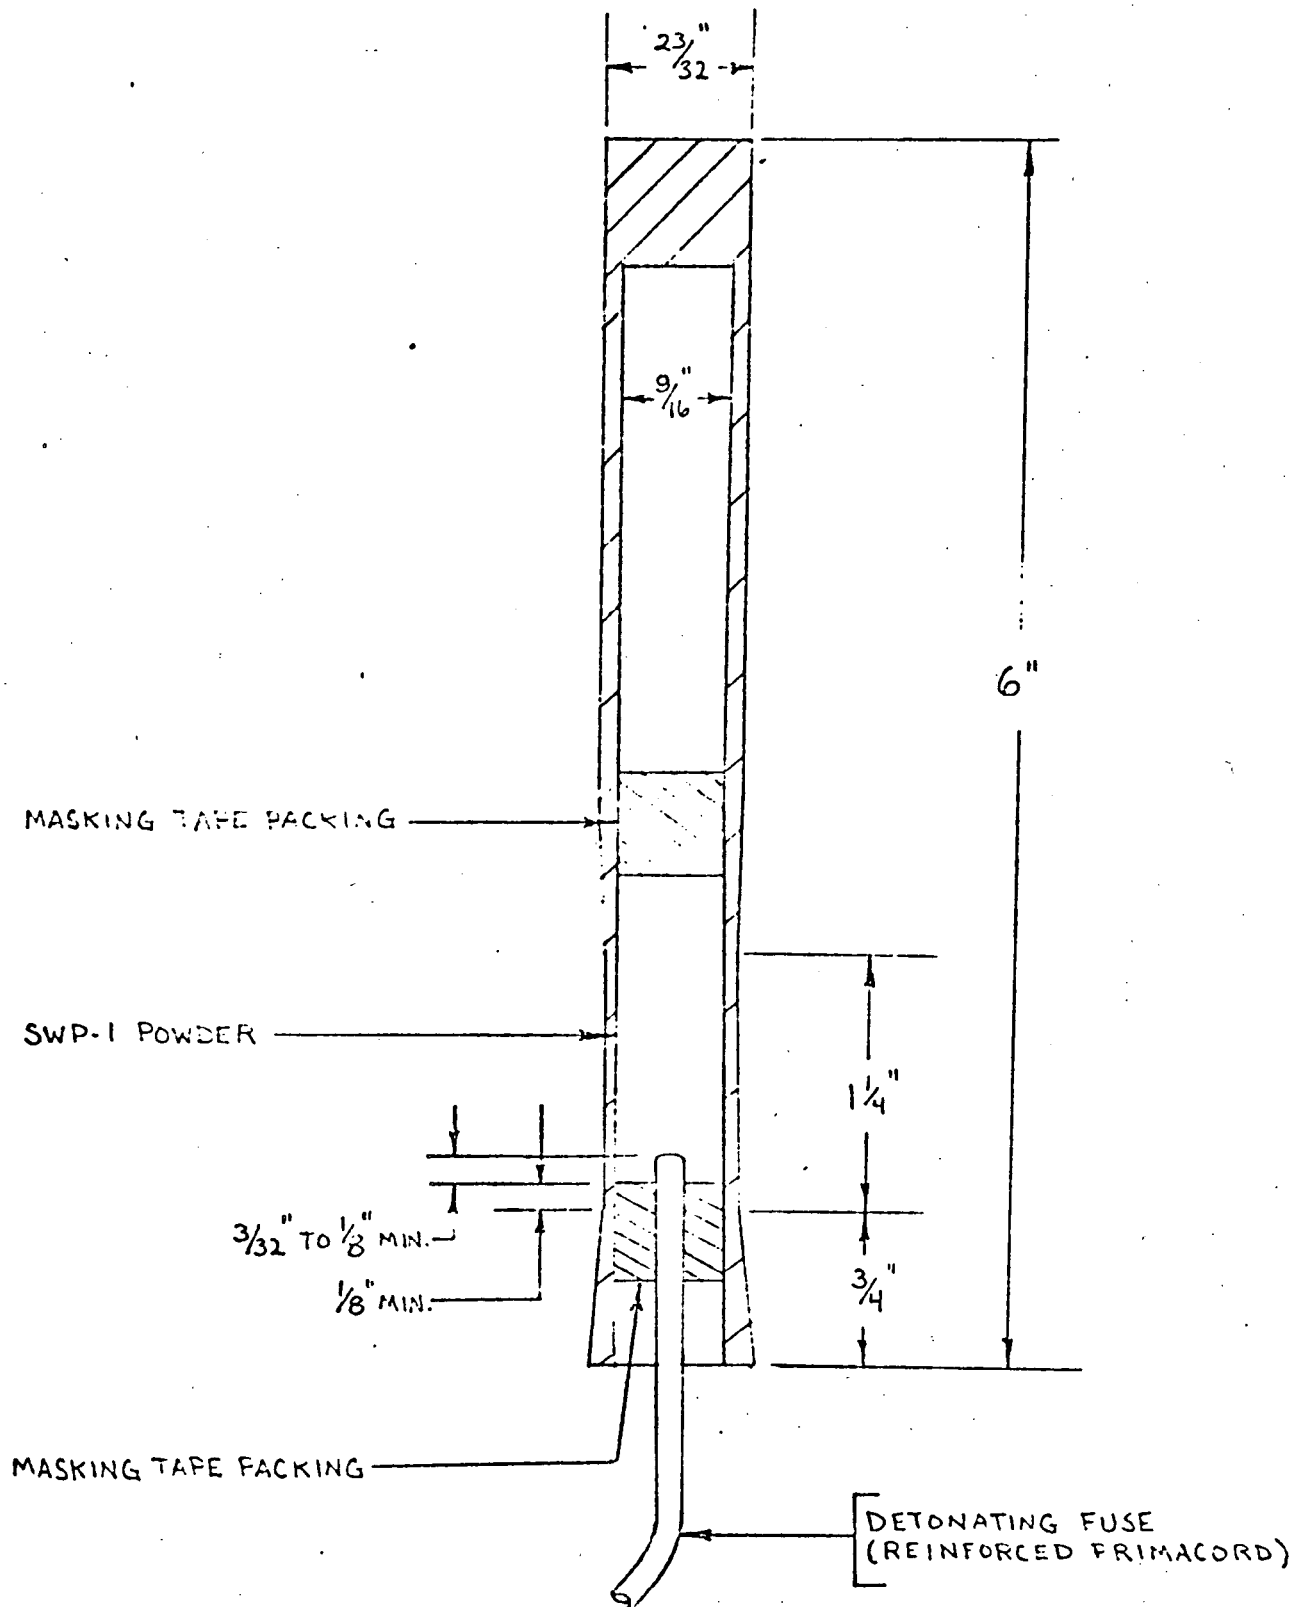
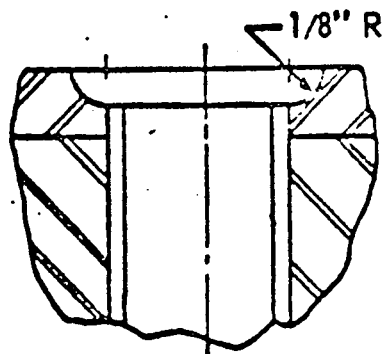
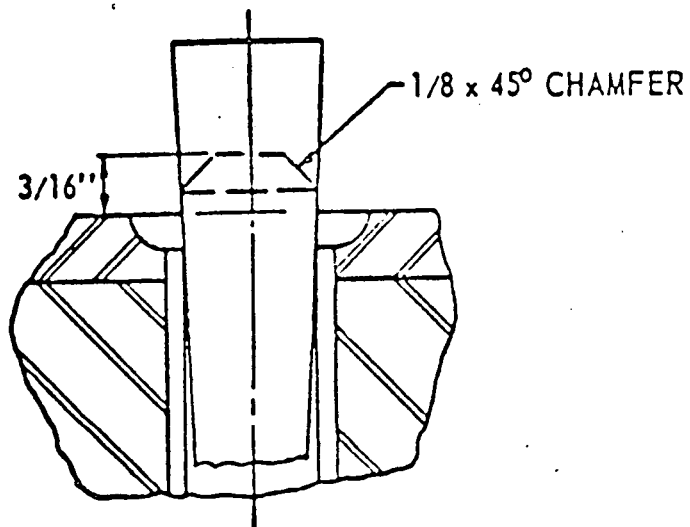
FIGURE 13

The welding to be accomplished consisted of two separate operations. One aspect of the work was fitting up of the 42 inch long plugs in the two tube stubs (Row 7, Columns 45 and 46) and propping these plugs, and seal welding the two plugs to the tube sheet and tube sheet cladding. The other was seal welding the explosive plug to the tube sheet cladding on the inlet side of Row 7, Column 44. The fit-up of the long plugs was consistent with the standard procedure used on welded type plugs. The plug was first inserted into its respective tube until handtight. A layout line was then scribed on the plug at the normal tube plate clad face. Next the plug was removed and scribed 3/16 inch above the first line. The plug was cut off at this point and end prepped to a 1/8 inch by 45° bevel. The final step prior to welding was to drive the plug into the tube until the 45° bevel was lined up with the end of the portion of the tube remaining in the tube sheet. Welding was then accomplished by depositing a minimum of two layers of weld metal around the plug and a final layer over the end of the plug. See figure 13 for a view of the plug welded end configuration.

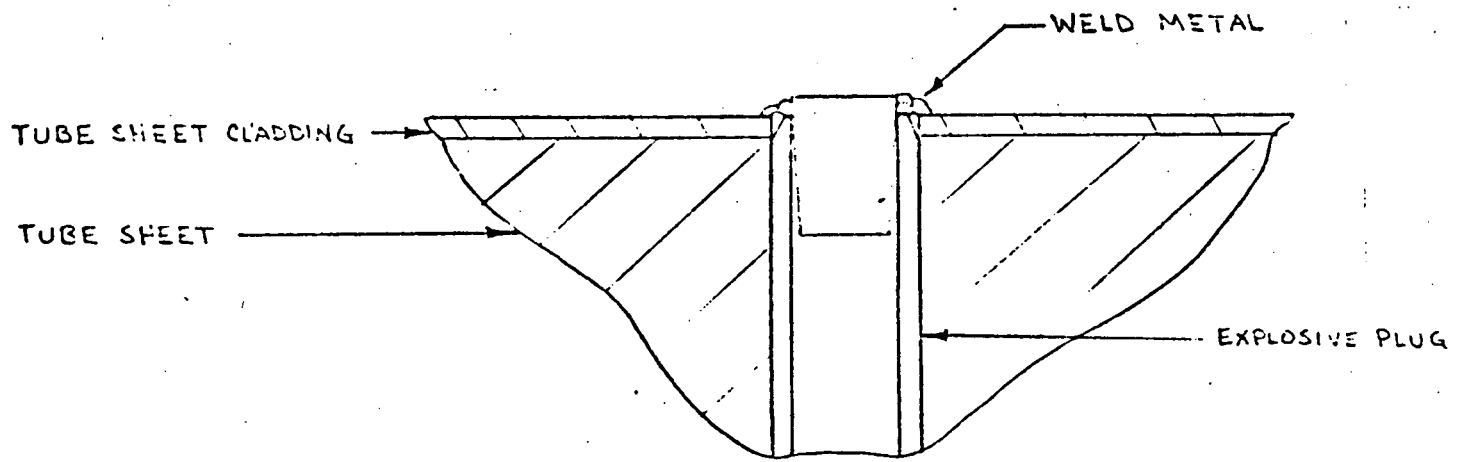
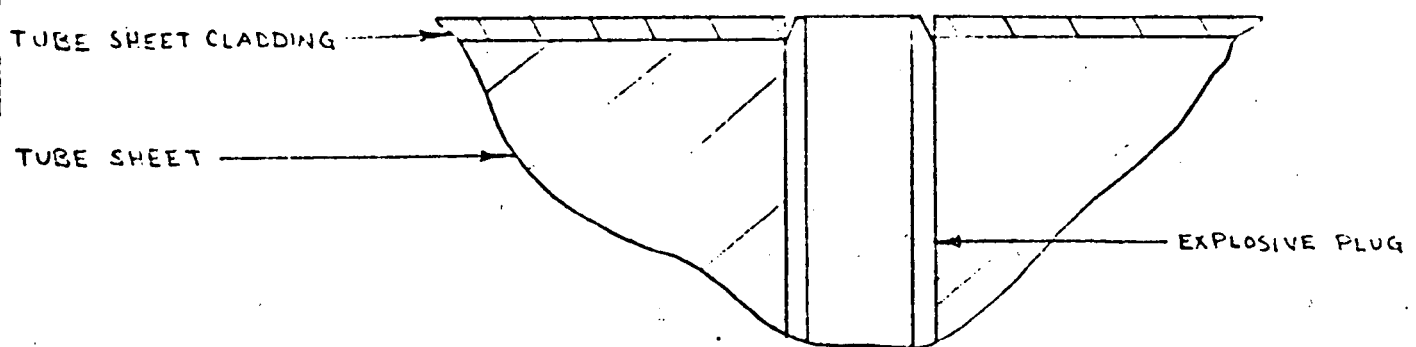
FIGURE 14

In addition to the two welded plugs, a seal weld is required between the explosive plug and the tube sheet cladding on the inlet side of Row 7, Column 44 to prevent moisture from entering between the cladding and the tube sheet. This is the location from which the section of the defect free tube was removed. The explosive plug effectively seals the tube sheet preventing leakage from the primary to the secondary side, but it does not provide a tube-sheet to tube-sheet-cladding seal. Therefore the seal weld becomes necessary. For ease of welding, a small plug is inserted into the bore of the explosive plug and welded to the explosive plug. For a typical view of this configuration, see figure 14.
