Generic Letter 95-05 Tube Intersection Burst Test, Leakage Test, and Morphology  
Conclusions  
(87 Pages Follow)

# **Interim Report: Examination of Steam Generator Tubes Removed from Beaver Valley Unit 2**

Prepared for the  
FirstEnergy Nuclear Operating Company

**SG-CCOE-14-1**  
**Revision 0**

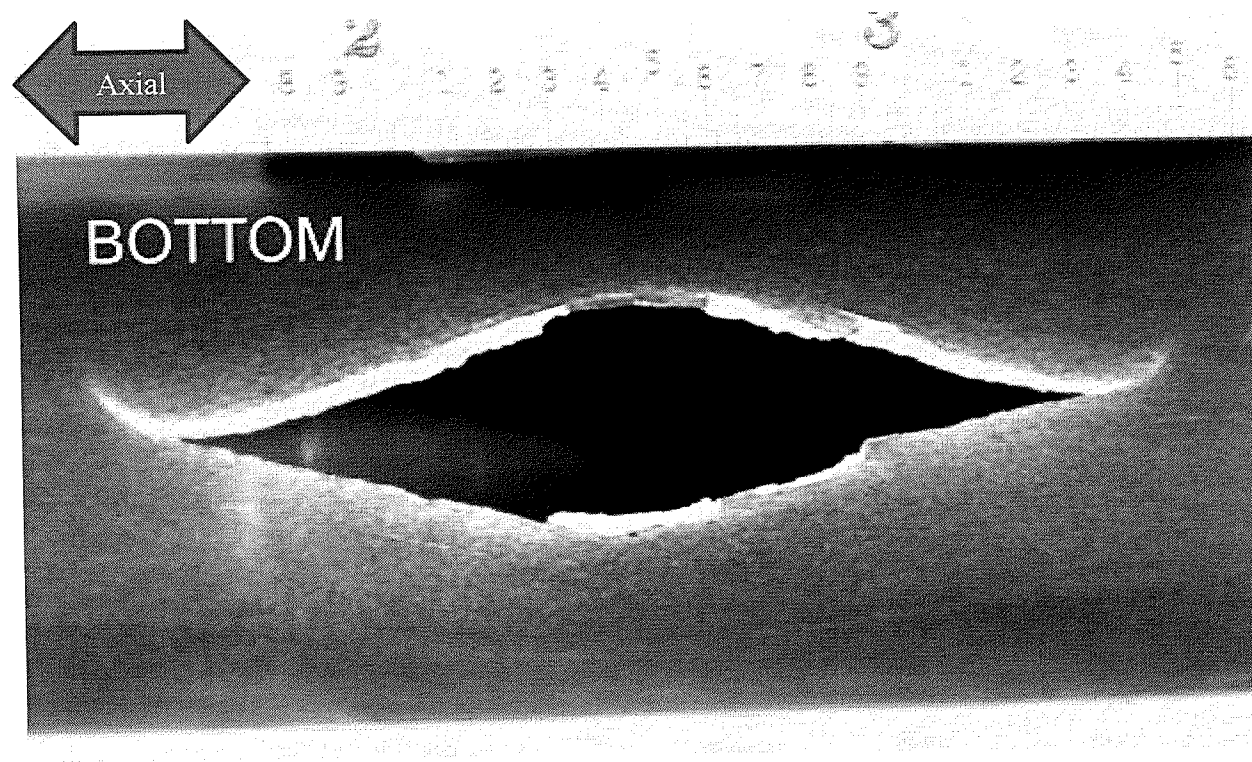
Figure 4-9: Burst Opening at R19C38-4B (Freespan)

Figure 4-8 through Figure 4-13 present photos of the burst openings. Tearing was confirmed at all burst tips, by microscope, for all six samples, thus (in accordance with Reference 8 criteria) each burst test was considered to be a valid burst test. The 02H region of R19C38 and the 04H region of R24C41 (Figure 4-8 and Figure 4-12, respectively) show secondary cracks outside of the burst opening; the freespan bursts of the other four samples showed no evidence of any cracks.

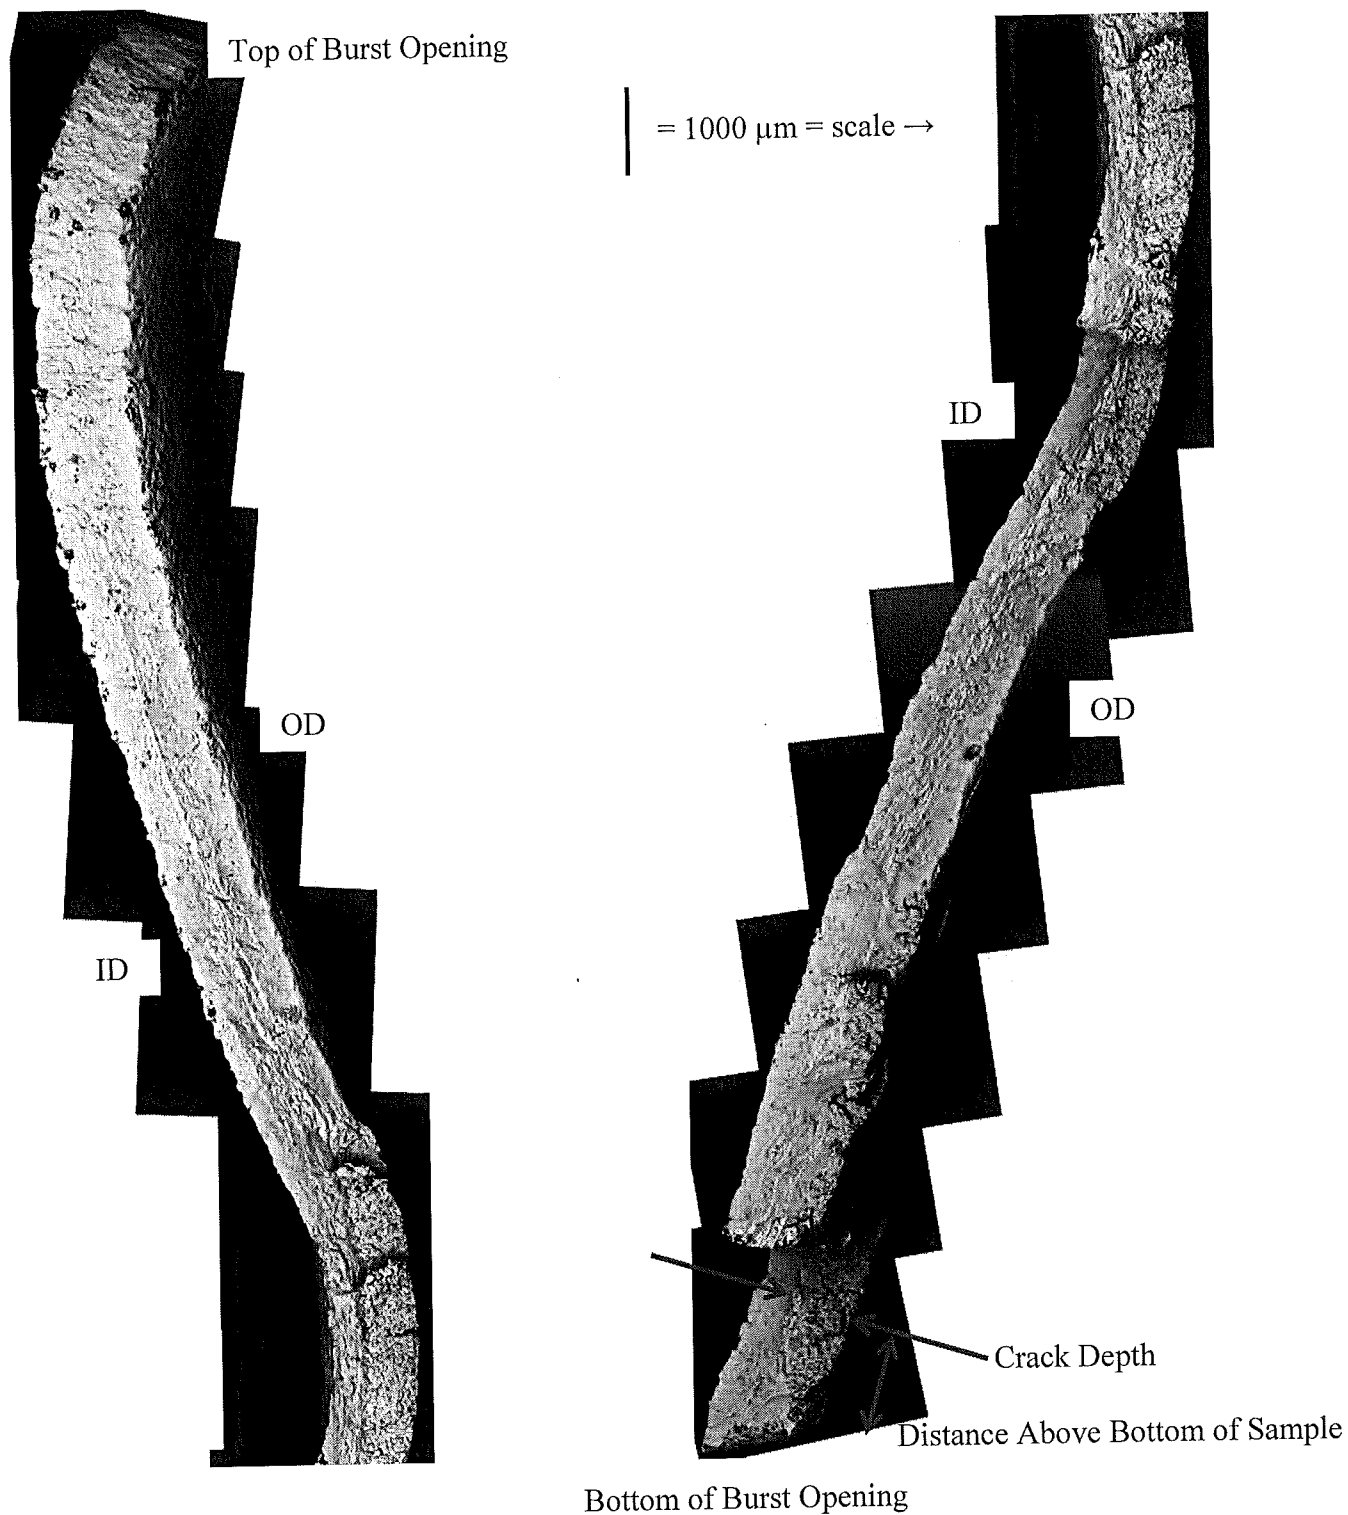
Figure 6-1: SEM Photomontage of R19C38-3B (02H) Burst Opening

The 02H TSP region of tube R19C38 burst in the TSP region. The center of the burst was skewed about 0.2 inches above the TSP centerline and the burst opening extended above and below the TSP region. The burst occurred at the 350° orientation. There were several regions of short (<0.15 inch) axial cracks around the circumference, most of which were located near the burst opening. These are shown in the Figure 4-14 diagram. Some of these short cracks can be seen near the burst opening as shown in Figure 4-8; others are shown in Figure 4-15, Figure 4-16 and Figure 4-17.

Section	Region of Burst	Crack Length (in)	Maximum Depth (%TW)
R19C38-3B	02H	0.702	49.9
R19C38-4B	Freespan	0	0
R24C41-3B	Freespan	0	0
R24C41-5B	Freespan	0	0
R24C41-6B	04H	0.270	48.6
R24C41-7B	Freespan	0	0

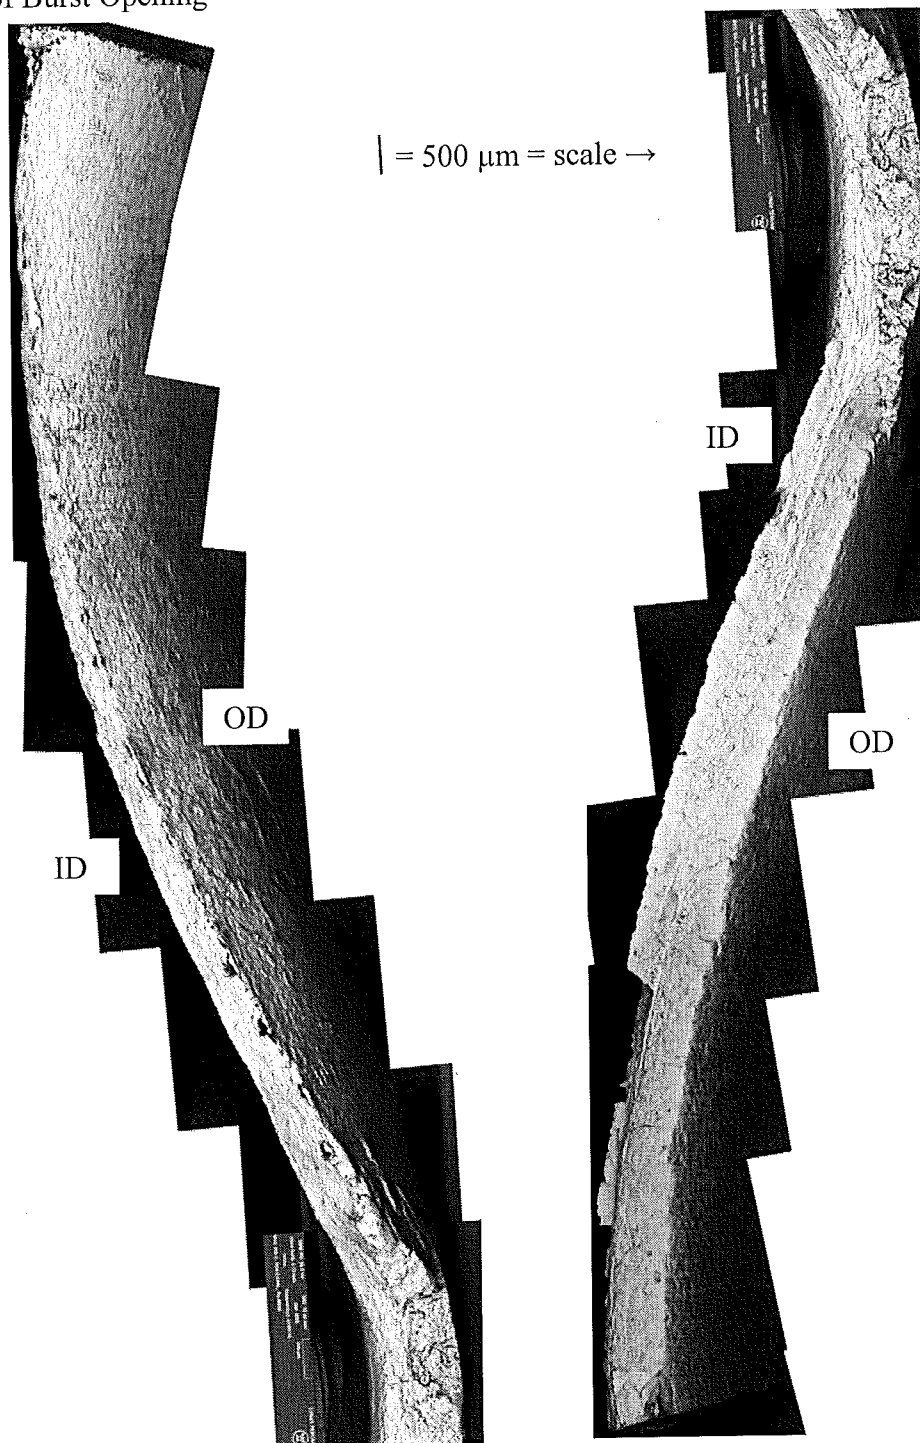
Figure 6-2: SEM Photomontage of R24C41-6B (04H) Burst Opening

The 04H TSP region of tube R24C41 burst in the TSP region. The center of the burst was aligned with the TSP centerline and the burst opening extended above and below the TSP region. The burst occurred at the 90° orientation. There were several regions of small axial cracks around the circumference, most of which were located near the centerline of the TSP region. There was another region of larger axial cracks, located between 315° and 360°, all within the center third (0.25-inch long) portion of the TSP length. These are shown in the Figure 4-23 diagram. Figure 4-24 and Figure 4-25 show the region of the larger cracks. These cracks are significantly oriented in the axial direction. Figure 4-12 shows some cracking adjacent to the burst opening; Figure 4-26 shows a closer view of these cracks.

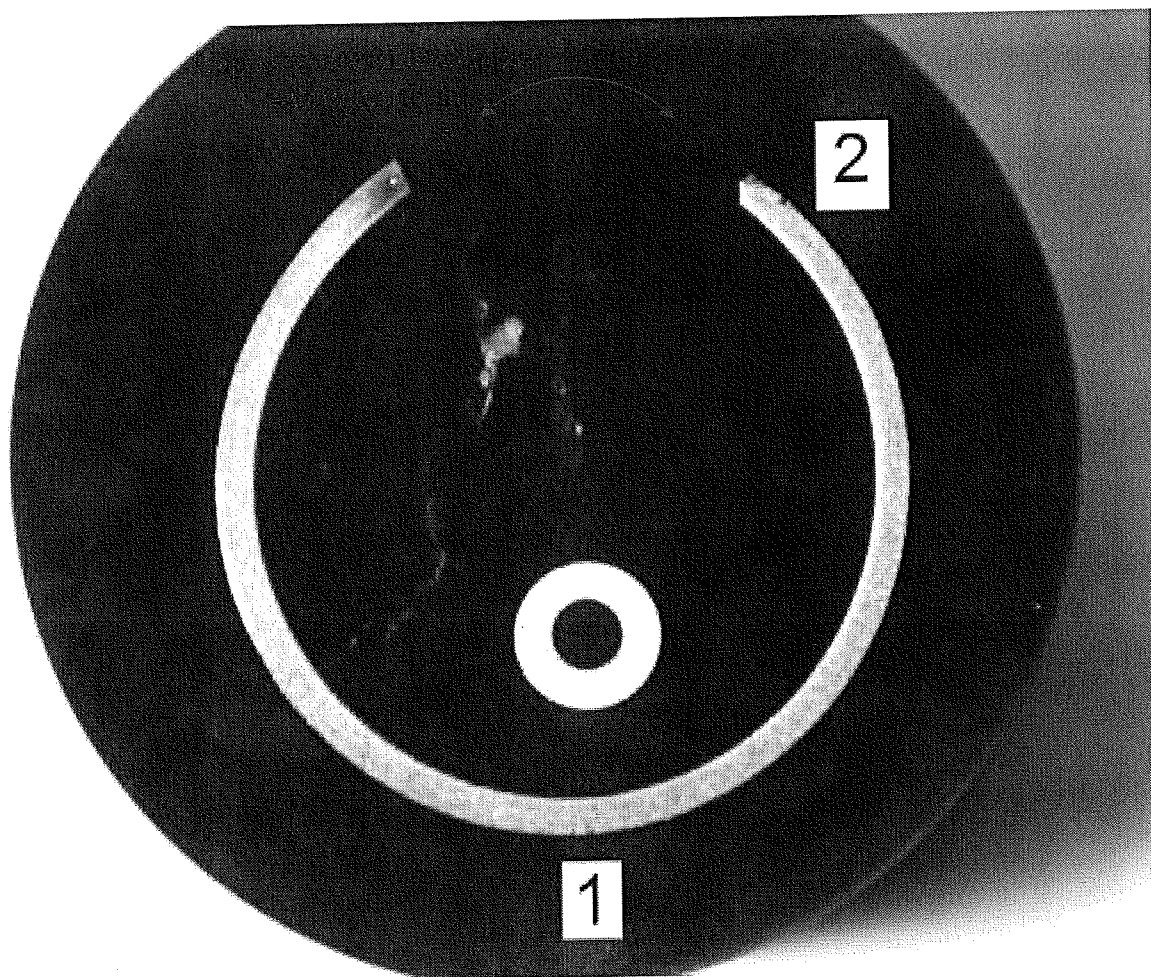
Figure 7-1: R19C38 02H - Overall View of Transverse Section

Figure 7-1 shows a view of a transverse cross-sectional sample (3B2B) taken from the 02H TSP of R19C38. The gap in the circumference is the SEM sample (refer to the Figure 5-1 sectioning diagram). The left side of the burst opening is just to the left of the '2' mark in the figure.

At this elevation of the TSP, there were only two areas, other than the burst opening, that showed any sign of corrosion; these are indicated by the number markers in Figure 7-1. The '1' marker is where the cracks at the 200° azimuthal location were identified (see Figure 4-14 and Figure 4-17). The number '2' marker is associated with the cracks near the 340° location (see Figure 4-14). Cracks near the 0° location are on the SEM sample and the cracks near the 280° location were very short and were not captured in this cross section.

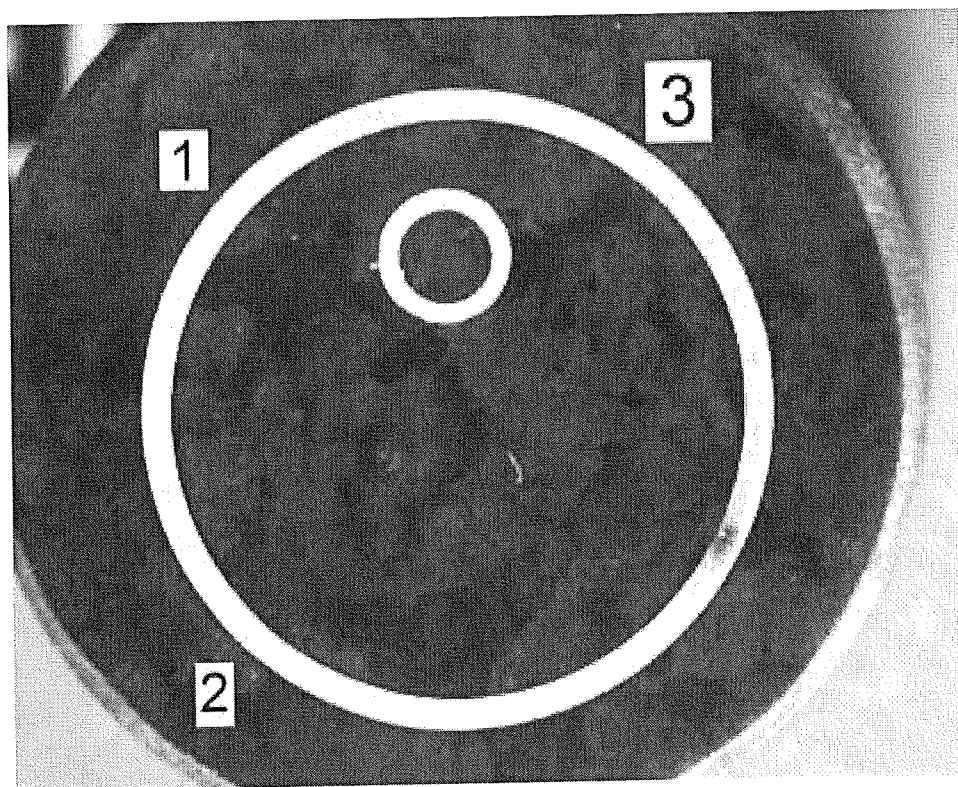
Figure 7-4: R24C41 02H - Overall View of Transverse Section

Figure 7-4 shows a view of a transverse cross-sectional sample (3B2) taken from the 02H TSP of R24C41. As the burst occurred outside of the TSP region, the entire circumference is shown. The "O" that is inside the tube corresponds with the 0° location (since the view is in the down direction, azimuthal locations proceed in the counter-clockwise direction. This elevation was chosen to show the cracks at about the 170° location and the patch of shallow corrosion on both sides of 0° (see Figure 5-3 and Figure 4-18). The '1' marker is located at about 20°, the '2' marker is at about 160° and '3' marker is located at about the 340° location.

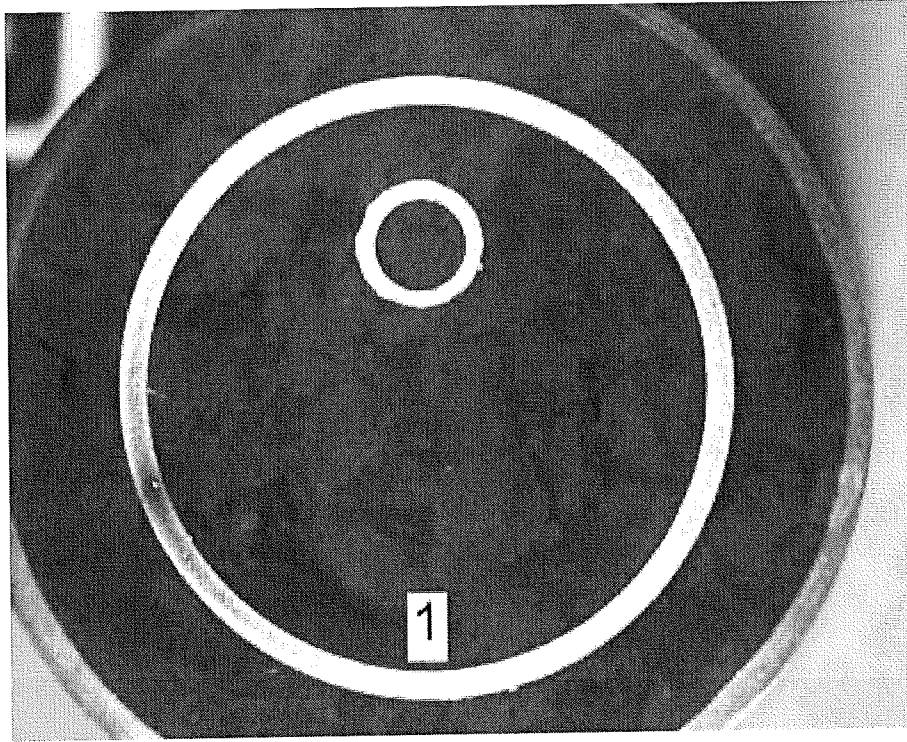
Figure 7-8: R24C41 03H - Overall View of Transverse Section

Figure 7-8 shows a view of a transverse cross-sectional sample (5B2) taken from the 03H TSP of R24C41. As the burst occurred outside of the TSP region, the entire circumference is shown. The "O" that is inside the tube corresponds with the 0° location (since the view is in the down direction, azimuthal locations proceed in the counter-clockwise direction). This elevation was chosen to show the cracks at the 180° location and the patch of shallow corrosion (see Figure 5-4 and Figure 4-20). The '1' marker is located at about 180°.

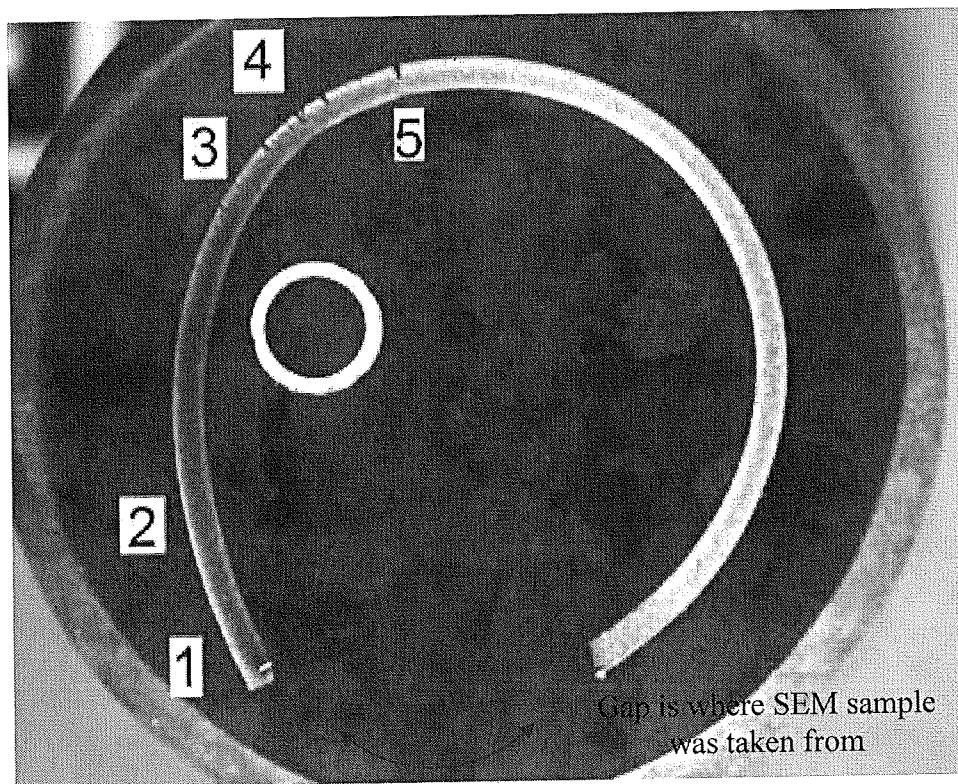
Figure 7-10: R24C41 04H - Overall View of Transverse Section

Figure 7-10 shows a view of a transverse cross-sectional sample (6B2B) taken from the 04H TSP of R24C41. The gap in the circumference is the SEM sample (refer to the Figure 5-5 sectioning diagram). The left side of the burst opening is just to the right of the '1' mark in the figure, and the "O" that is inside the tube corresponds with the 0° location (since the view is in the down direction, azimuthal locations proceed in the counter-clockwise direction).
