H. B. ROBINSON UNIT NO. 2
LICENSE DPR-23

INTEGRITY OF STEAM GENERATORS UNDER ACCIDENT CONDITIONS

DESCRIPTION OF PRESENT STATUS OF STEAM GENERATORS

H. B. ROBINSON UNIT NO. 2

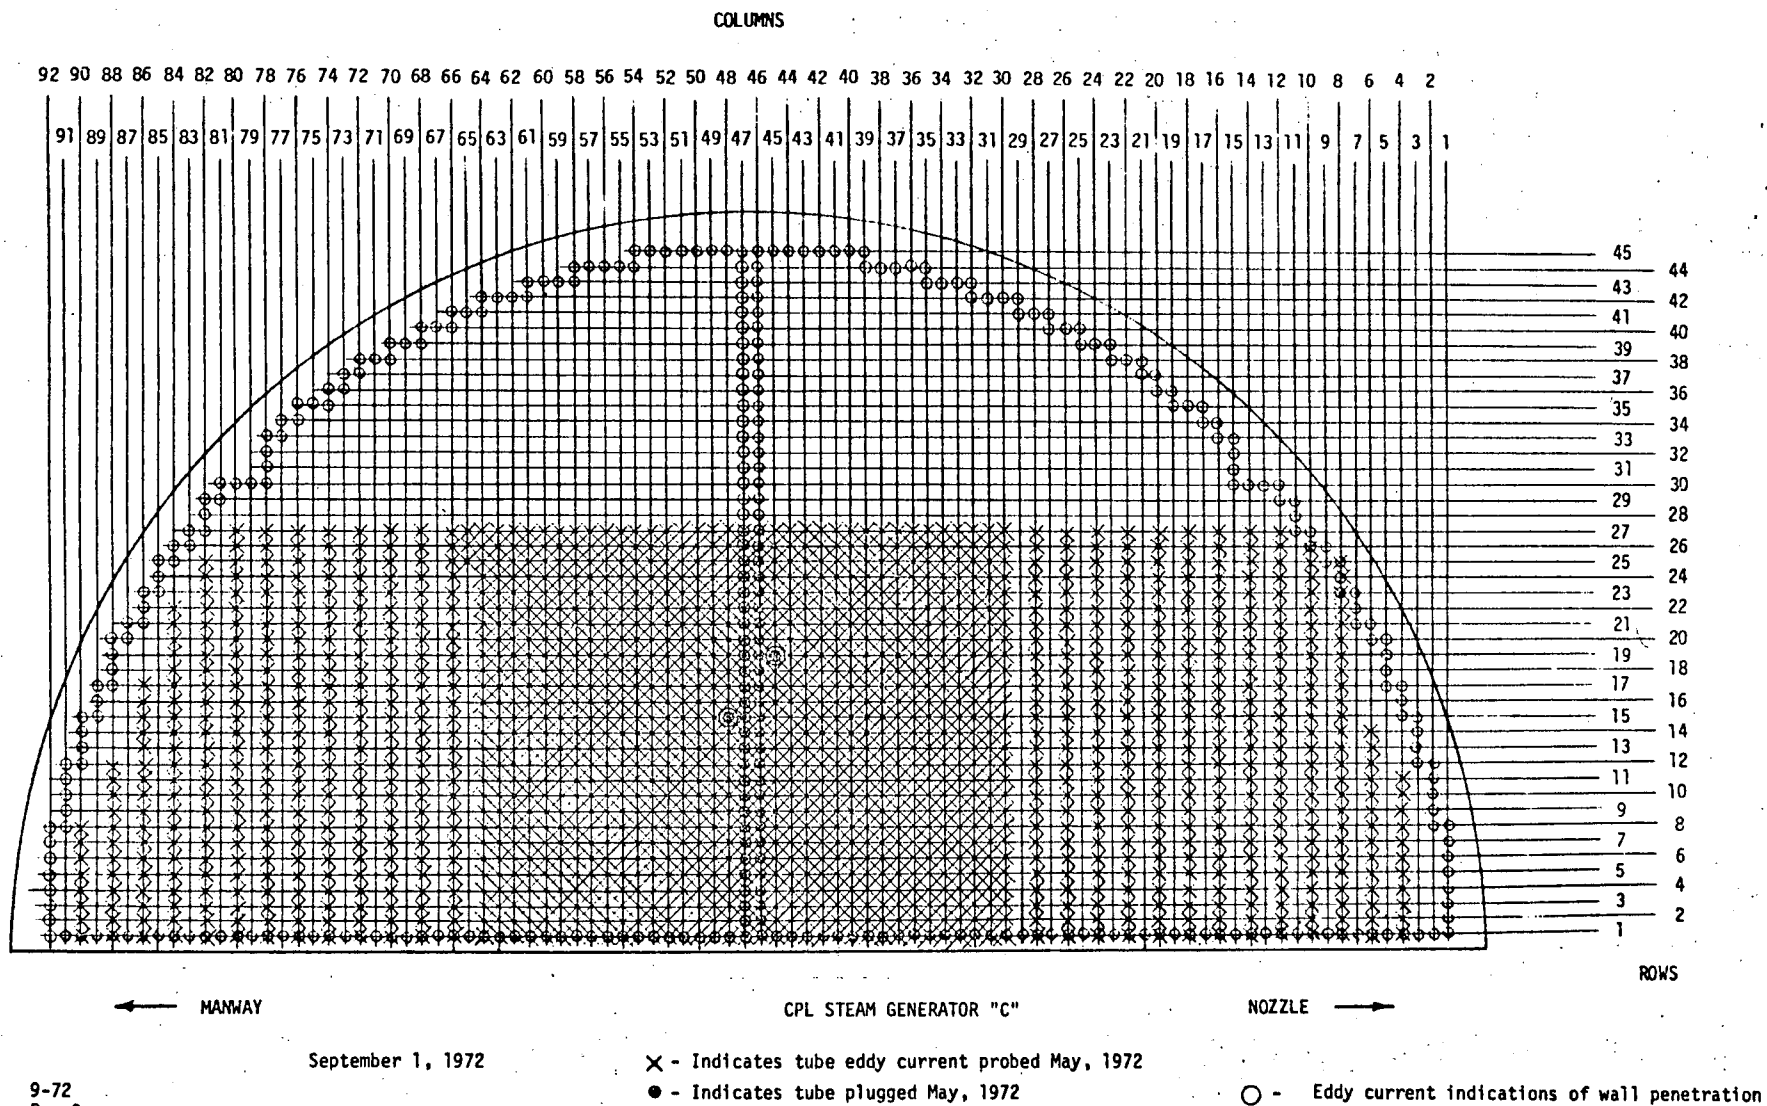
FIGURE 1

The EC test program for steam generator "A" provided for inspection of 2029 inlet side tubes up to and through the first tube support. The area of the tube sheet tested is shown graphically in Figure 1. Of the total 2029 tubes tested, 23 tubes were found to contain eddy current indications of varying degrees of outside-diameter originated wall penetration. Table 1 lists the EC indications observed during the inspection of steam generator "A".

○ - Eddy current indications of wall penetration

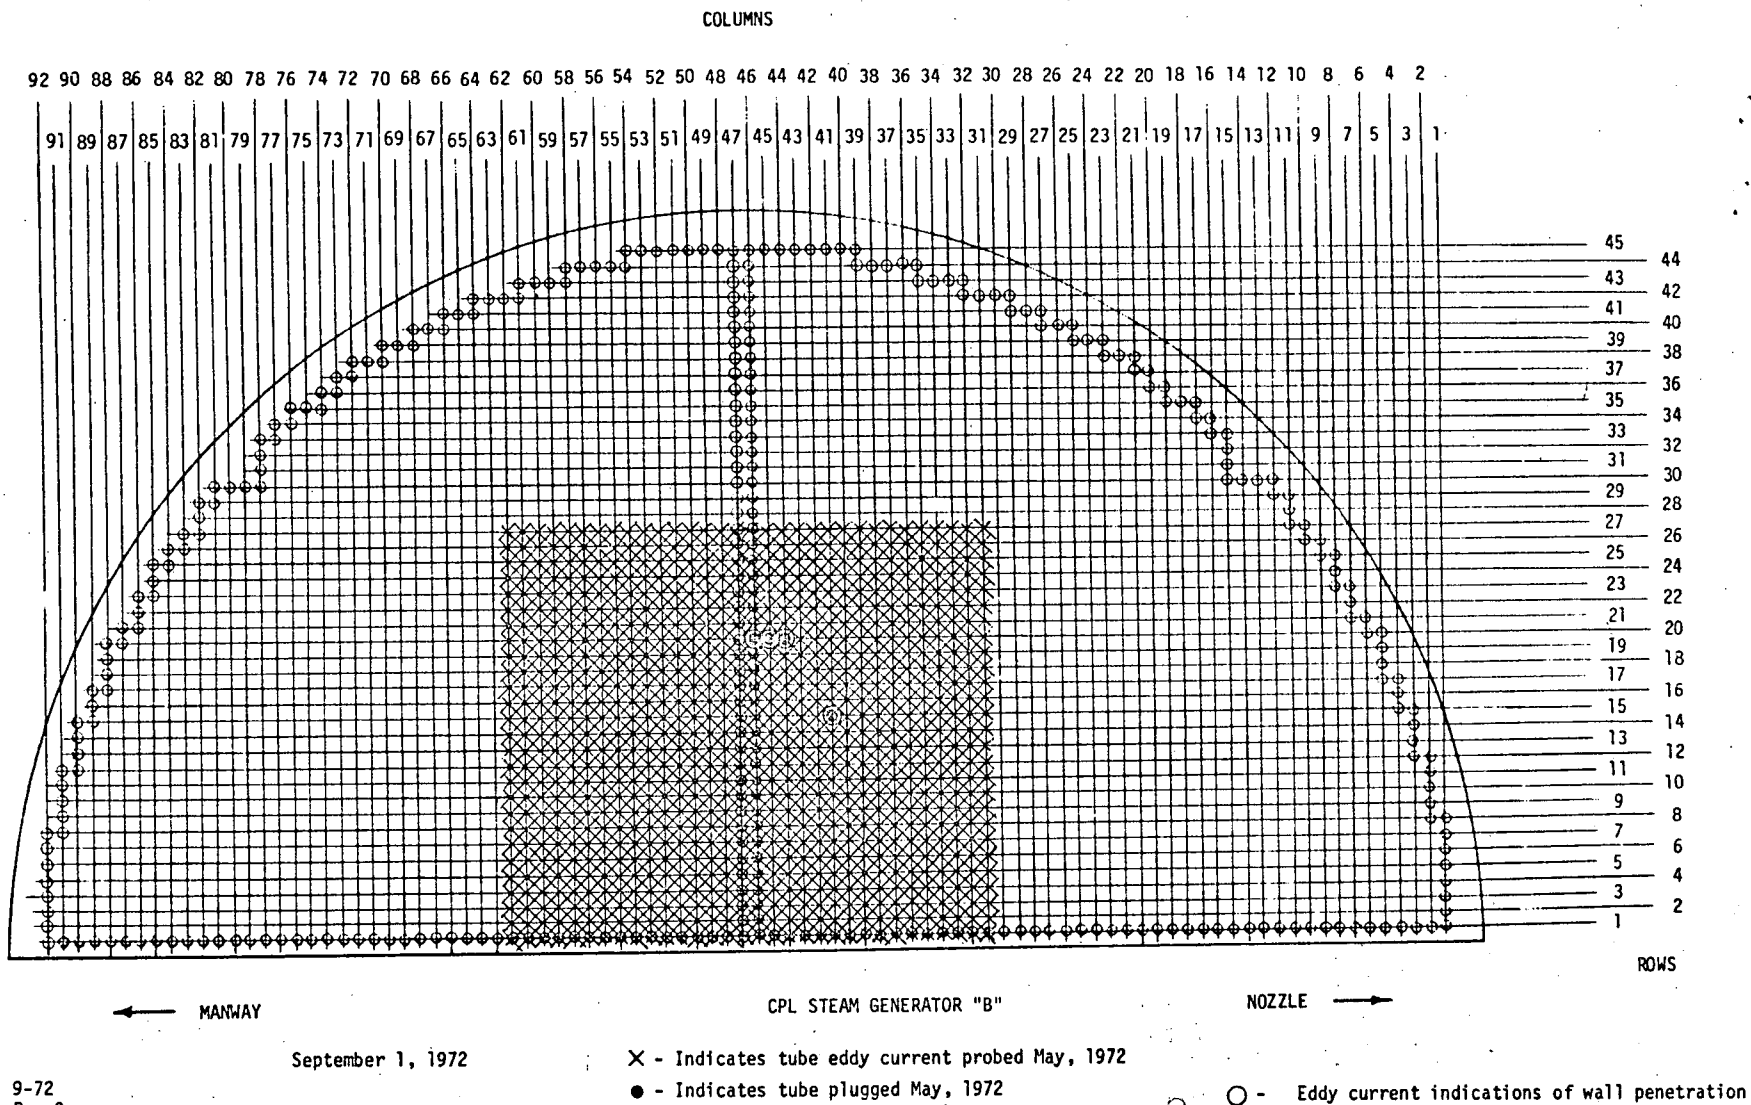
FIGURE 2

In addition to the testing of "A" generator tubes, an inspection program was carried out in the "C" and "B" units. The inspection patterns were established to give a comprehensive inspection of those areas of the generator where indications have been observed during previous inspections and also to avoid unnecessary deliberate exposure of personnel. These patterns are shown in Figures 2 and 3. A total of 1588 tubes were inspected in "C" inlet with 2 EC indications observed and 864 tubes inspected in "B" with four indications noted. These indications are tabulated in Table 1.
