Robinson File No.: 13510
Serial: RNP-RA/96-0189

H. B. ROBINSON STEAM ELECTRIC PLANT, UNIT NO. 2
DOCKET NO. 50-261/LICENSE NO. DPR-23
INFORMATION REGARDING WATER HAMMER EVENT
ON SAFETY INJECTION LINES DURING TESTING

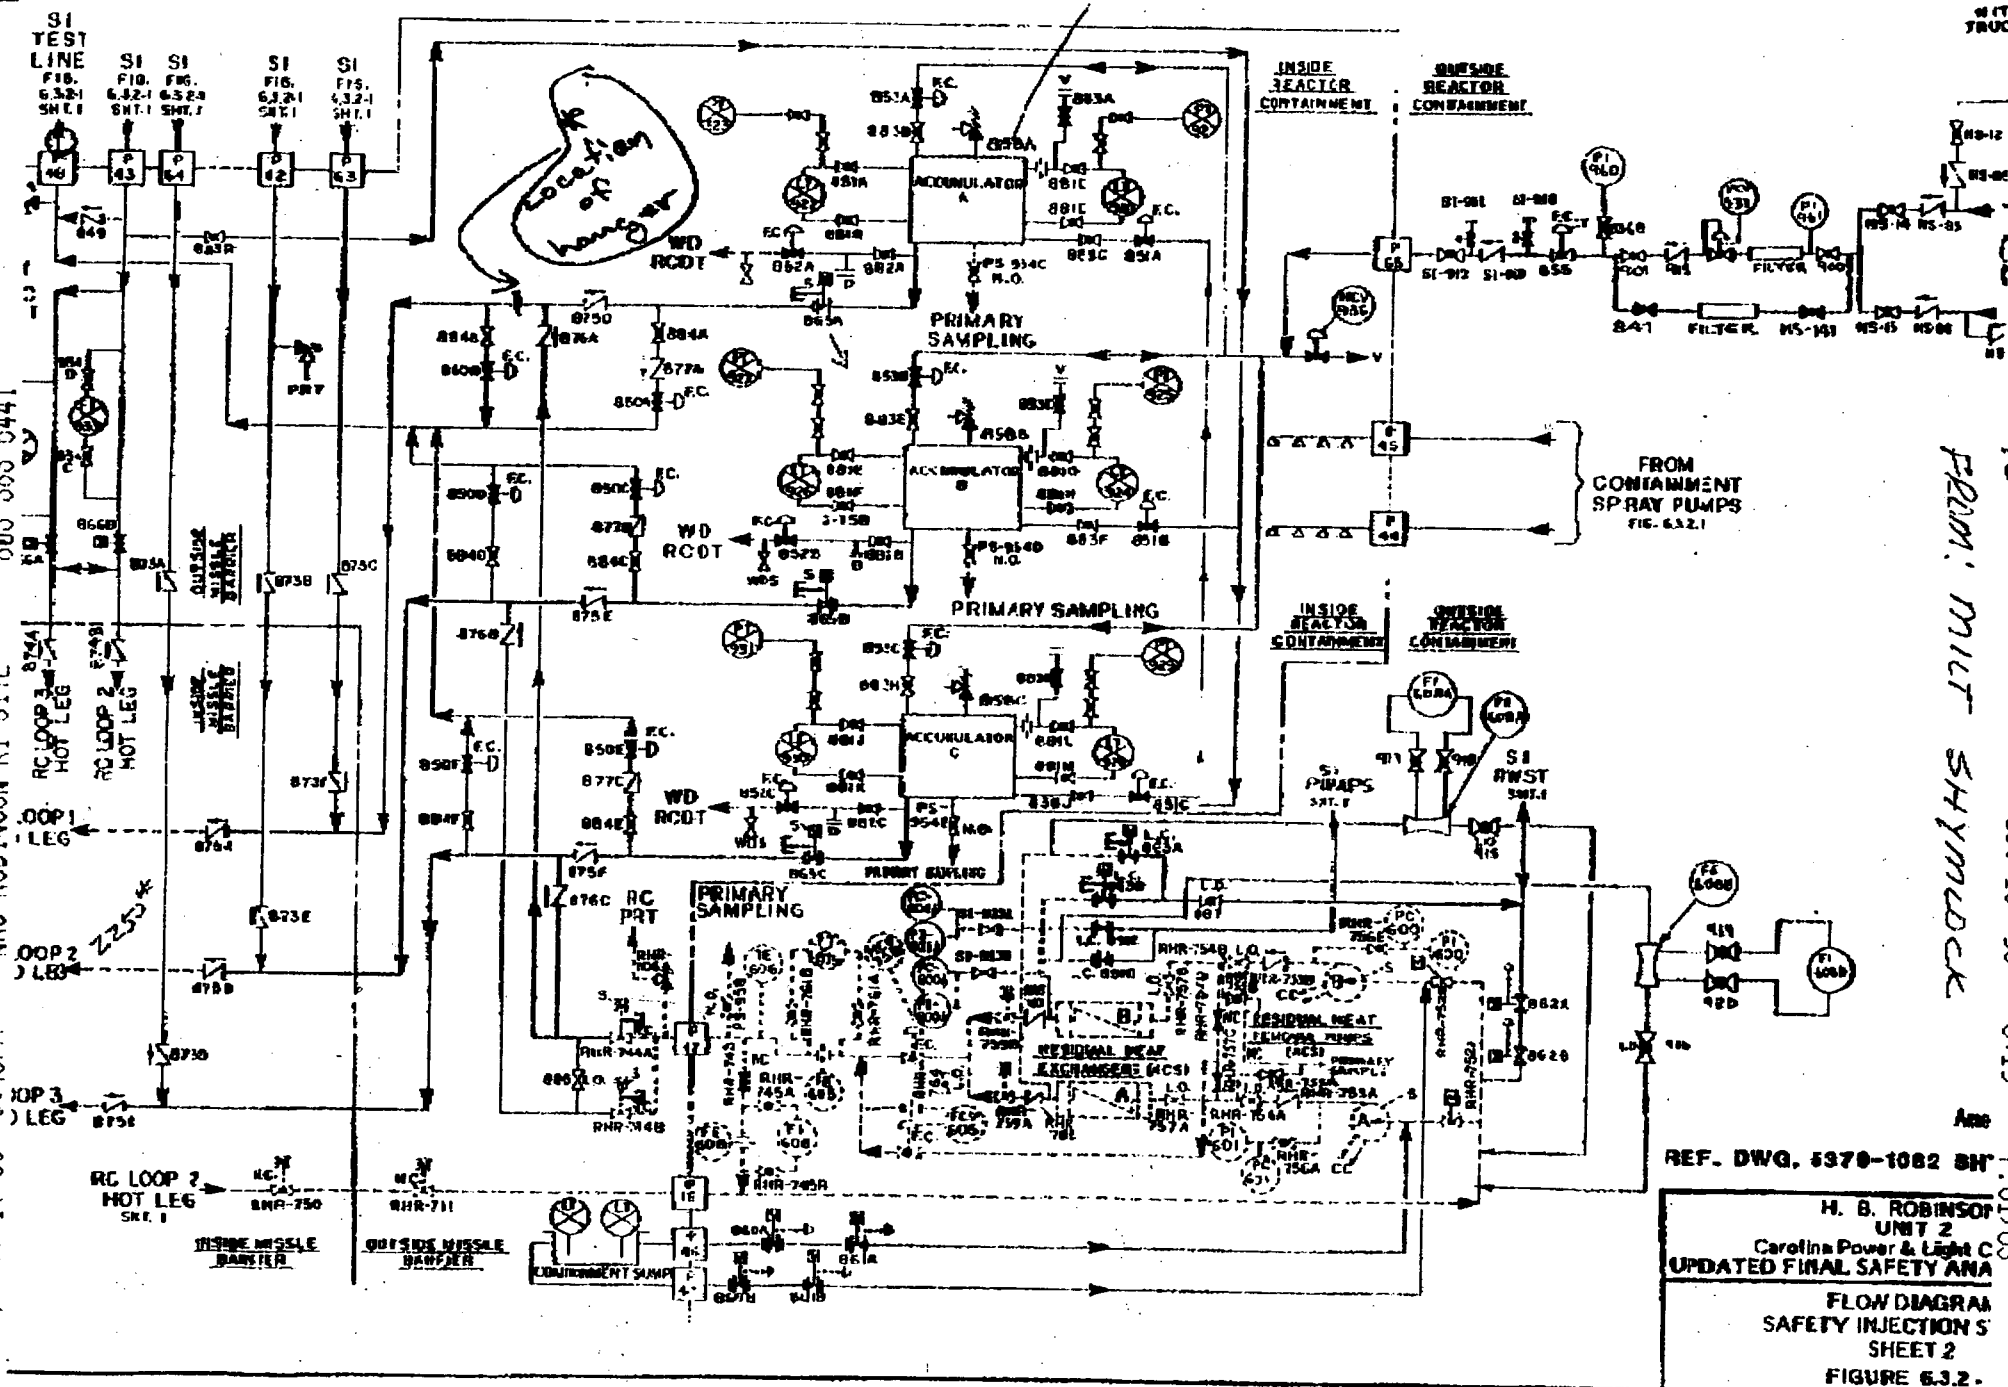
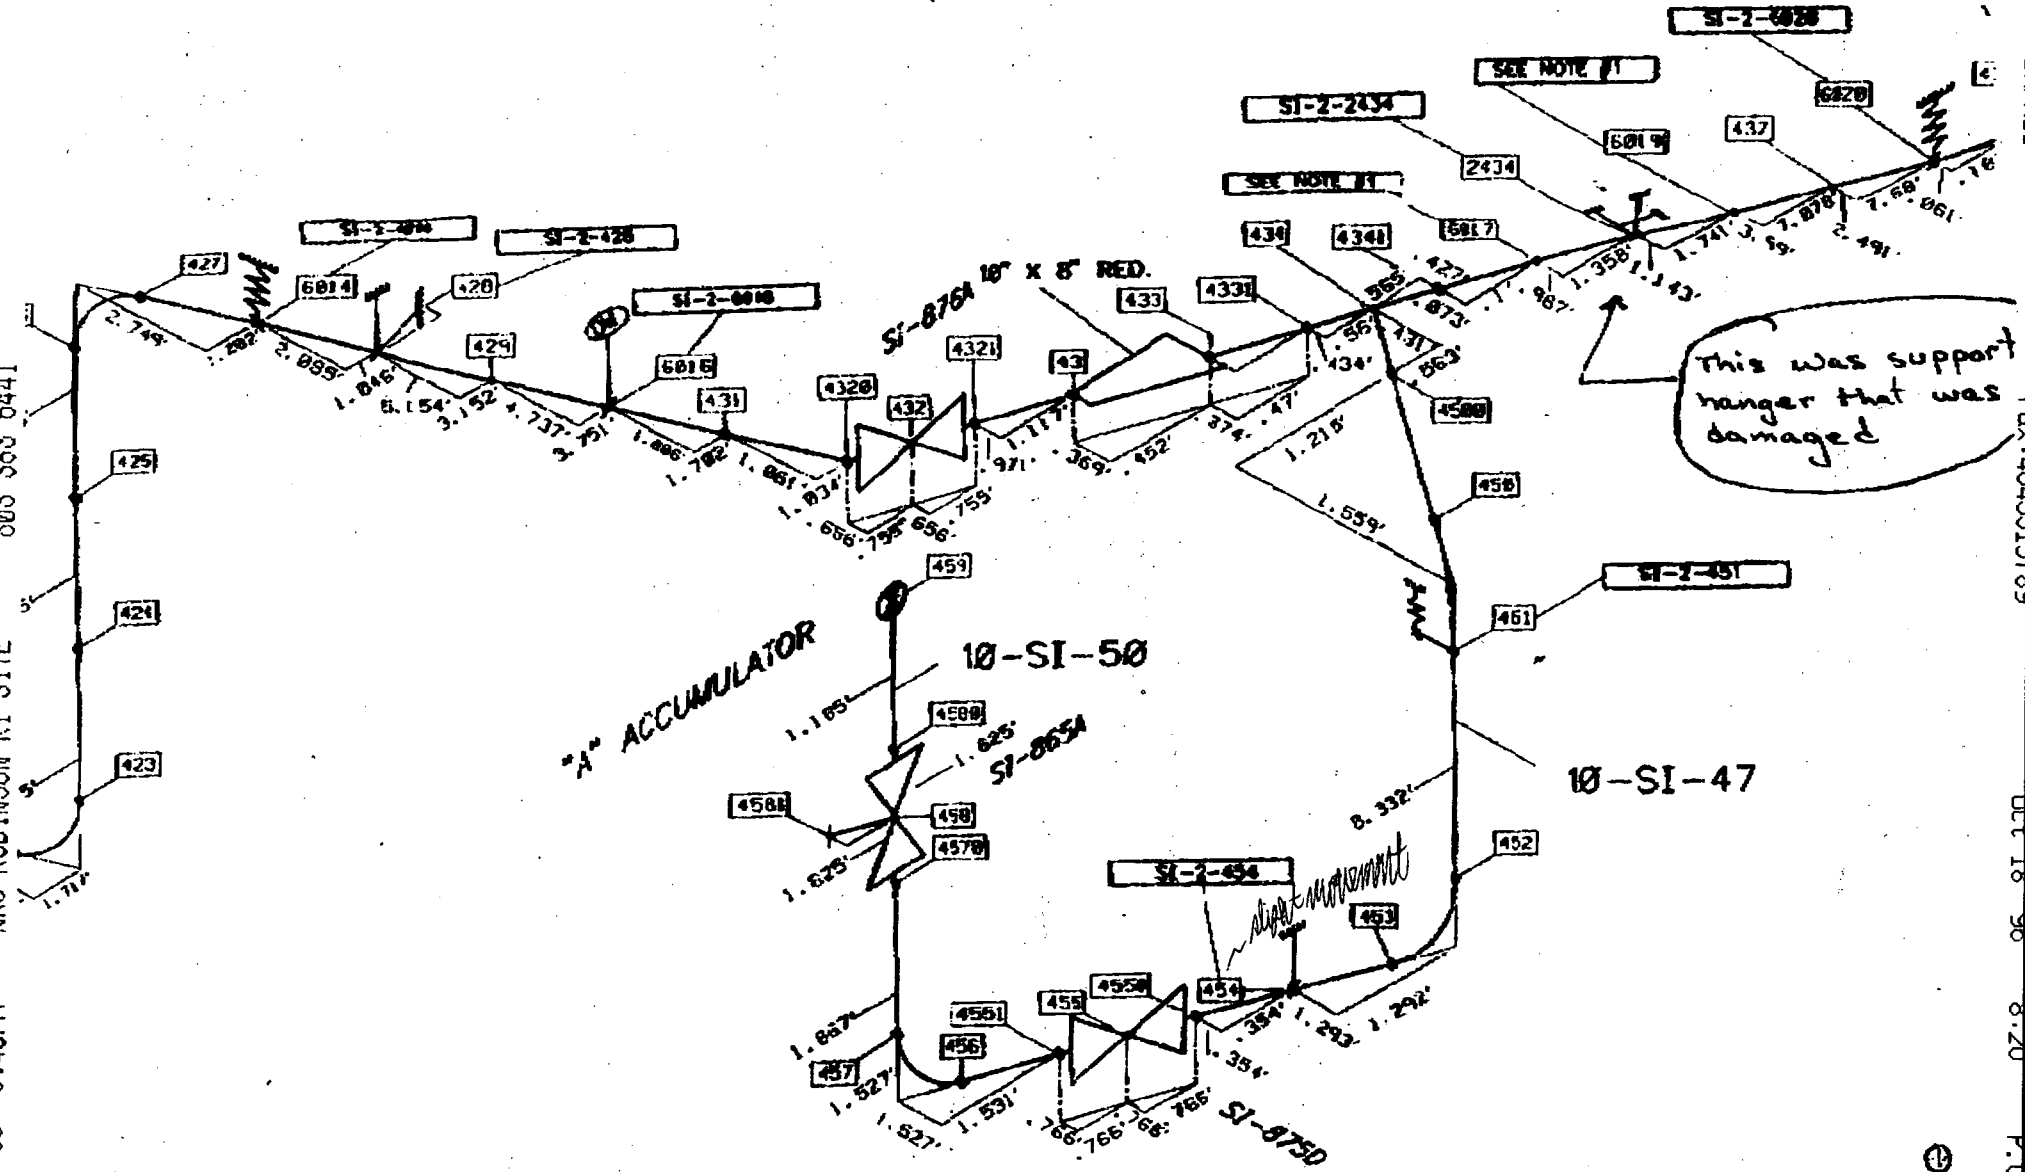
AS-CAR-
SI-2-2434
SH. 1 OF 4

The damage to seismic restraint Support SI-2-2434 consisted of a bent lug capture plate, a bent abandoned welded pipe attachment, and minor spalling of grout and concrete at the embedment plate with no undercutting of the embedment noted. Welded pipe attachments on the remaining seismic restraint supports were visually inspected and no signs of damage were found. Hot load spring settings for spring Supports SI-2-443 and SI-2-451 were observed to be well within the required range. The hot load spring setting for spring Support SI-2-6020 could not be observed due to difficult access conditions; however, the information from spring Supports SI-2-443 and SI-2-451 located upstream and downstream of spring Support SI-2-6020 indicate that spring Support SI-2-6020 is acceptable.

The damage to seismic restraint supports was evaluated in the degraded condition and was found to be acceptable when applying the short term structural integrity criteria.

The damage to the abandoned welded pipe attachment on seismic restraint Support SI-2-2434 was repaired by grinding down the broken welded pipe attachment. The bent lug capture plate on seismic restraint Support SI-2-2434 was repaired. The pipe wall and welded attachment welds were examined utilizing the dye penetrant examination method and were found to be acceptable. The seismic restraint Support SI-2-2434 was inspected visually (i.e., VT-3), and after retorquing of anchor bolts, was found to be acceptable. The bolts on seismic restraint Support SI-2-6021 were retorqued. Additionally, insulation was removed and remaining welded pipe attachments on remaining SI piping within the scope of the walkdowns were observed on October 18, 1996, and no damage was noted.
