Title: BRIEFING BY IIT ON LOSS OF IRIIDIUM-192
SOURCE AND THERAPY MISADMINISTRATION AT
INDIANA REGIONAL CANCER CENTER, INDIANA,
PA., NOVEMBER 16, 1992

Date: FEBRUARY 8, 1993

BRIEFING BY IIT ON LOSS OF IRIDIUM-192 SOURCE
AND THERAPY MISADMINISTRATION AT INDIANA
REGIONAL CANCER CENTER, INDIANA, PA.,
NOVEMBER 16, 1992

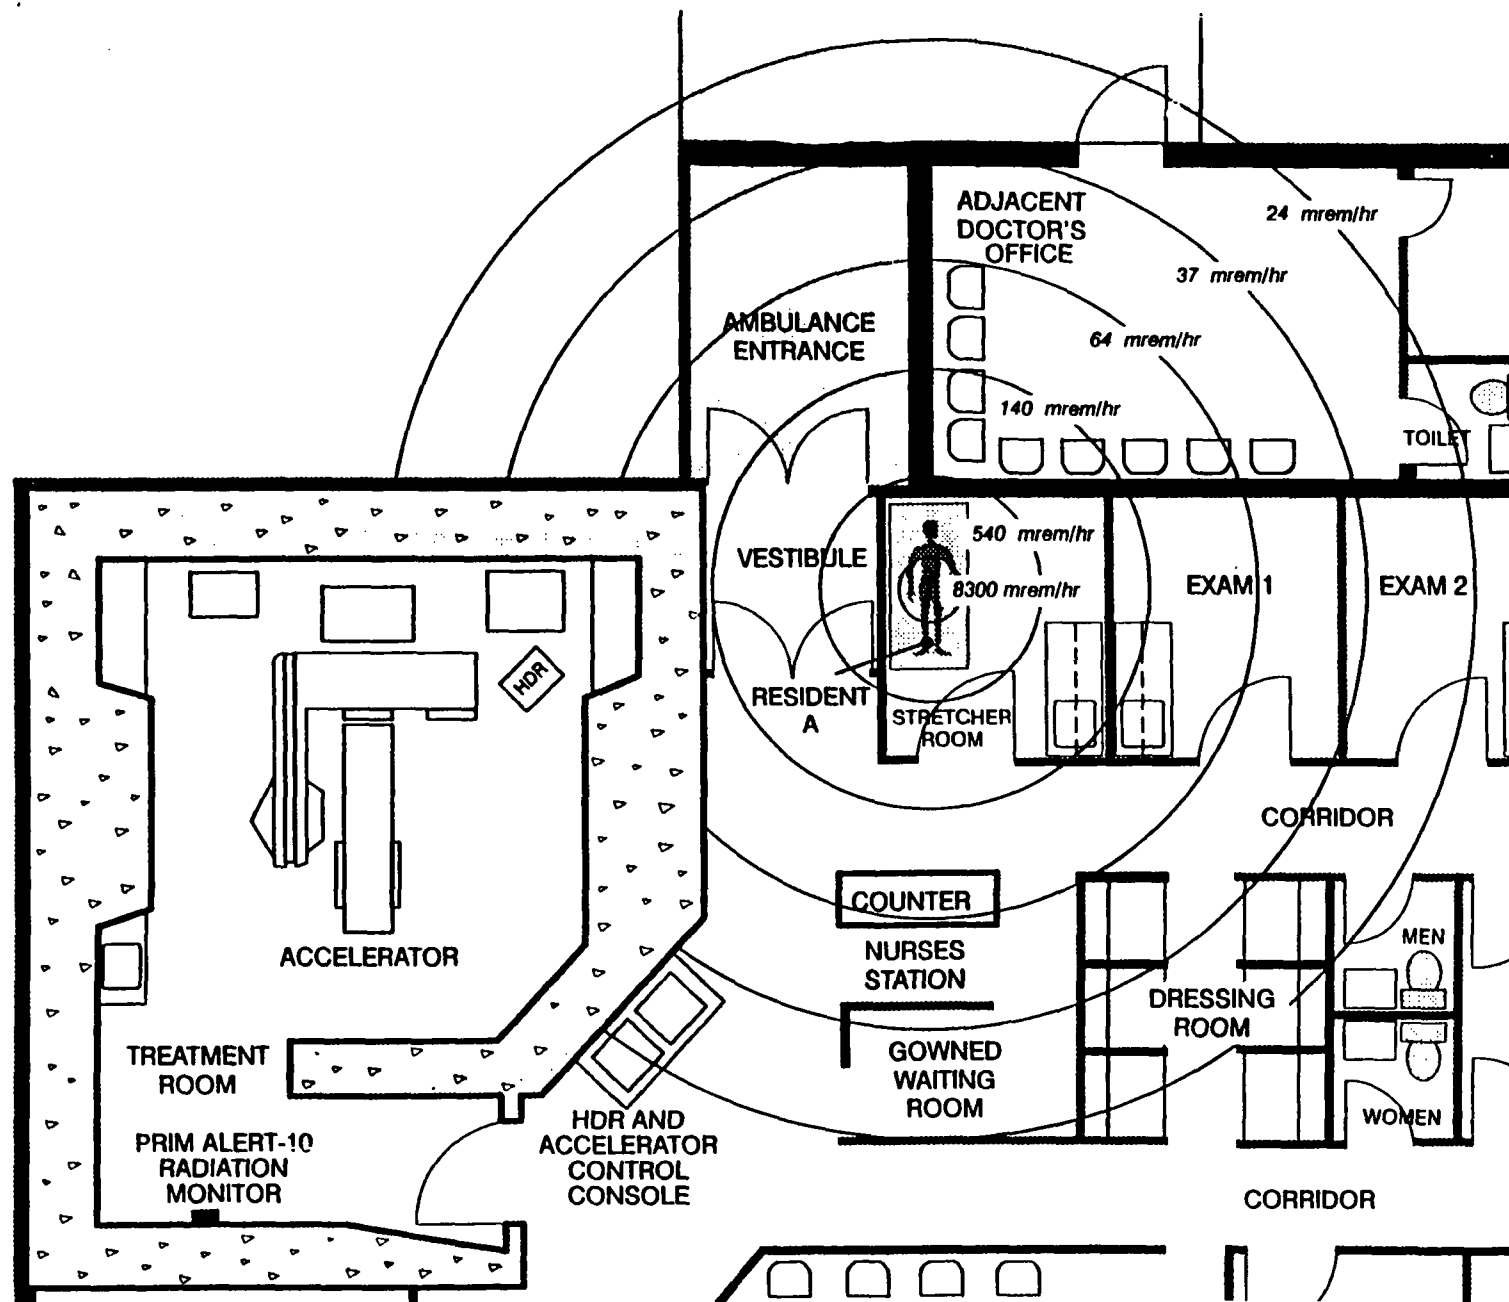
Diagram of the Indiana Regional Cancer Center Showing 2 Meter Isodose Curves from the Iridium-192 Source on November 16, 1992.

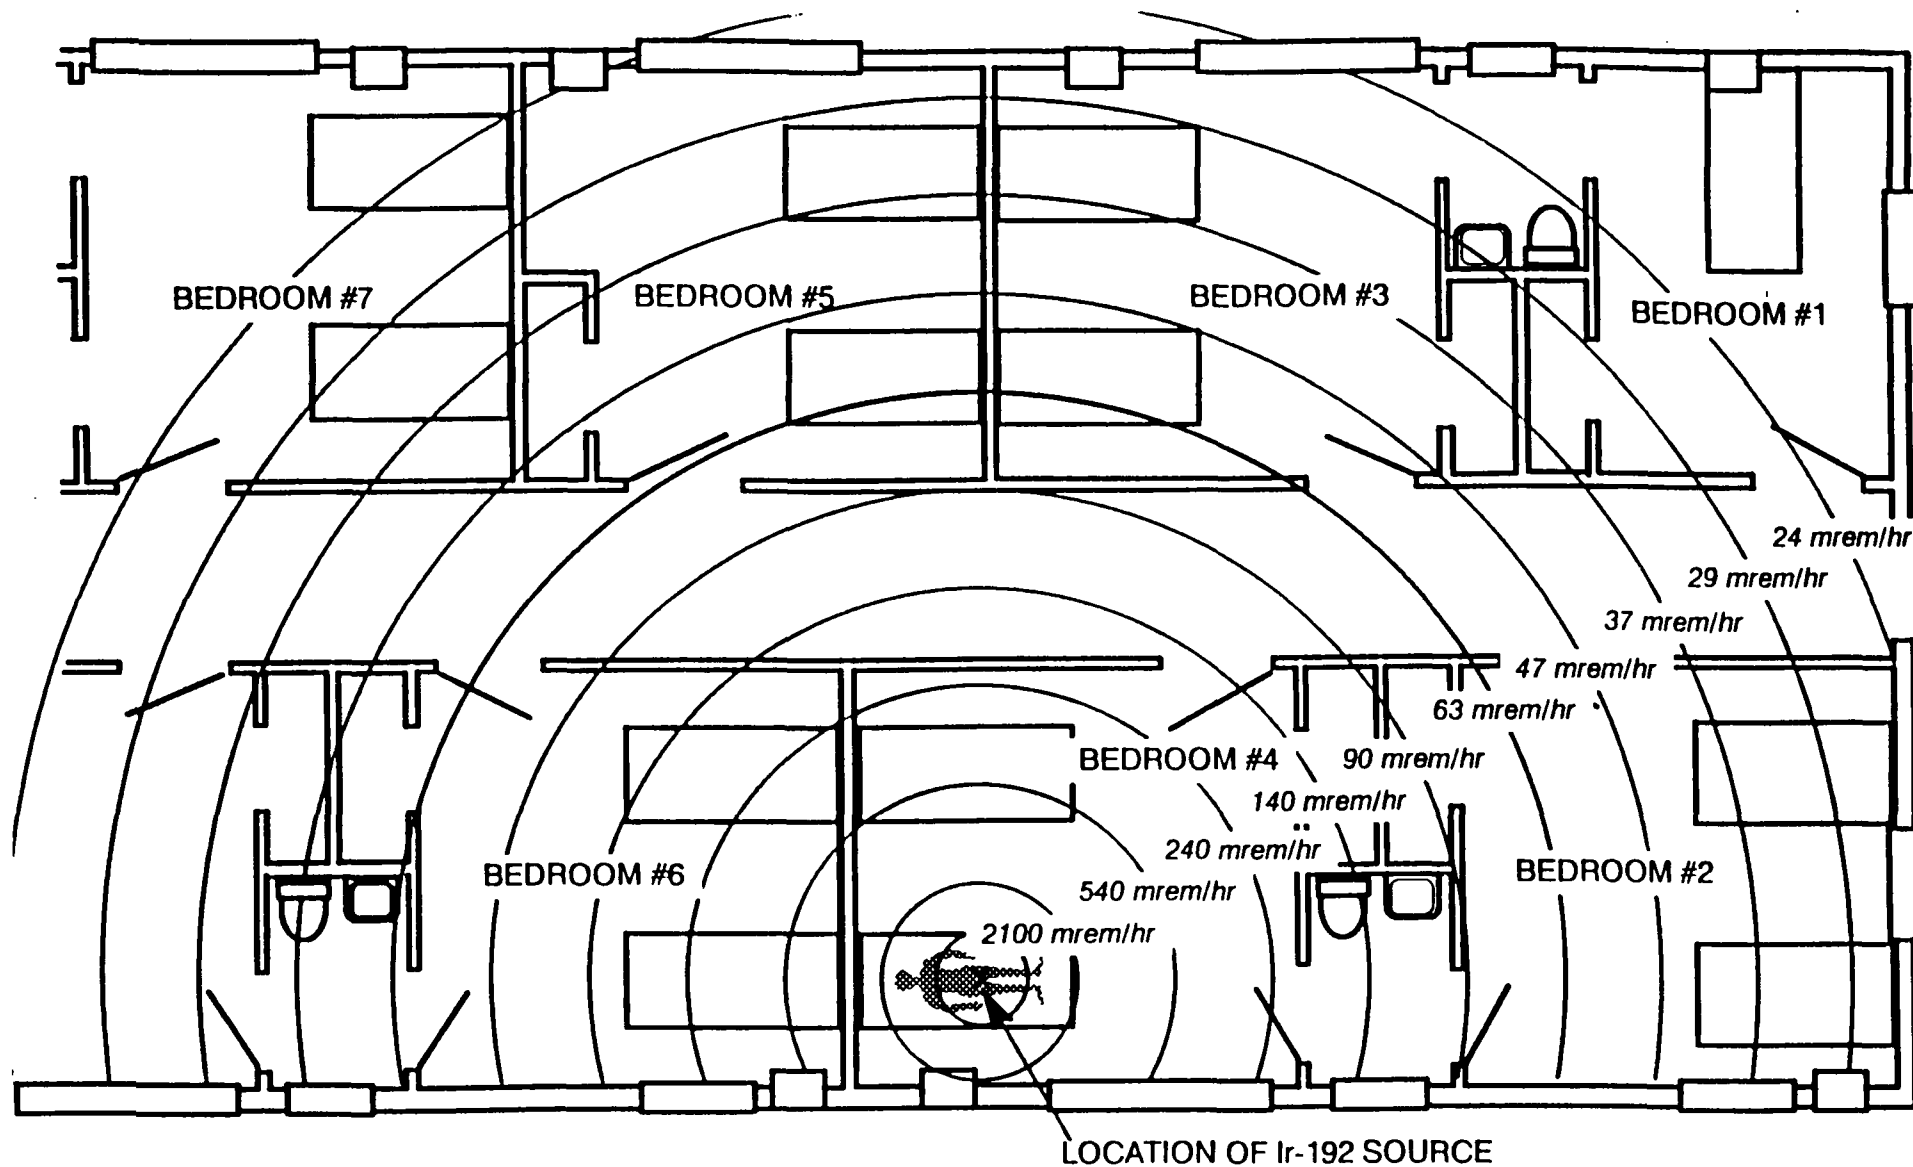
Diagram of Rooms Adjacent to Patient Room 4B Showing 1-Meter Isodose Curves from the Iridium-192 Source on November 16, 1992

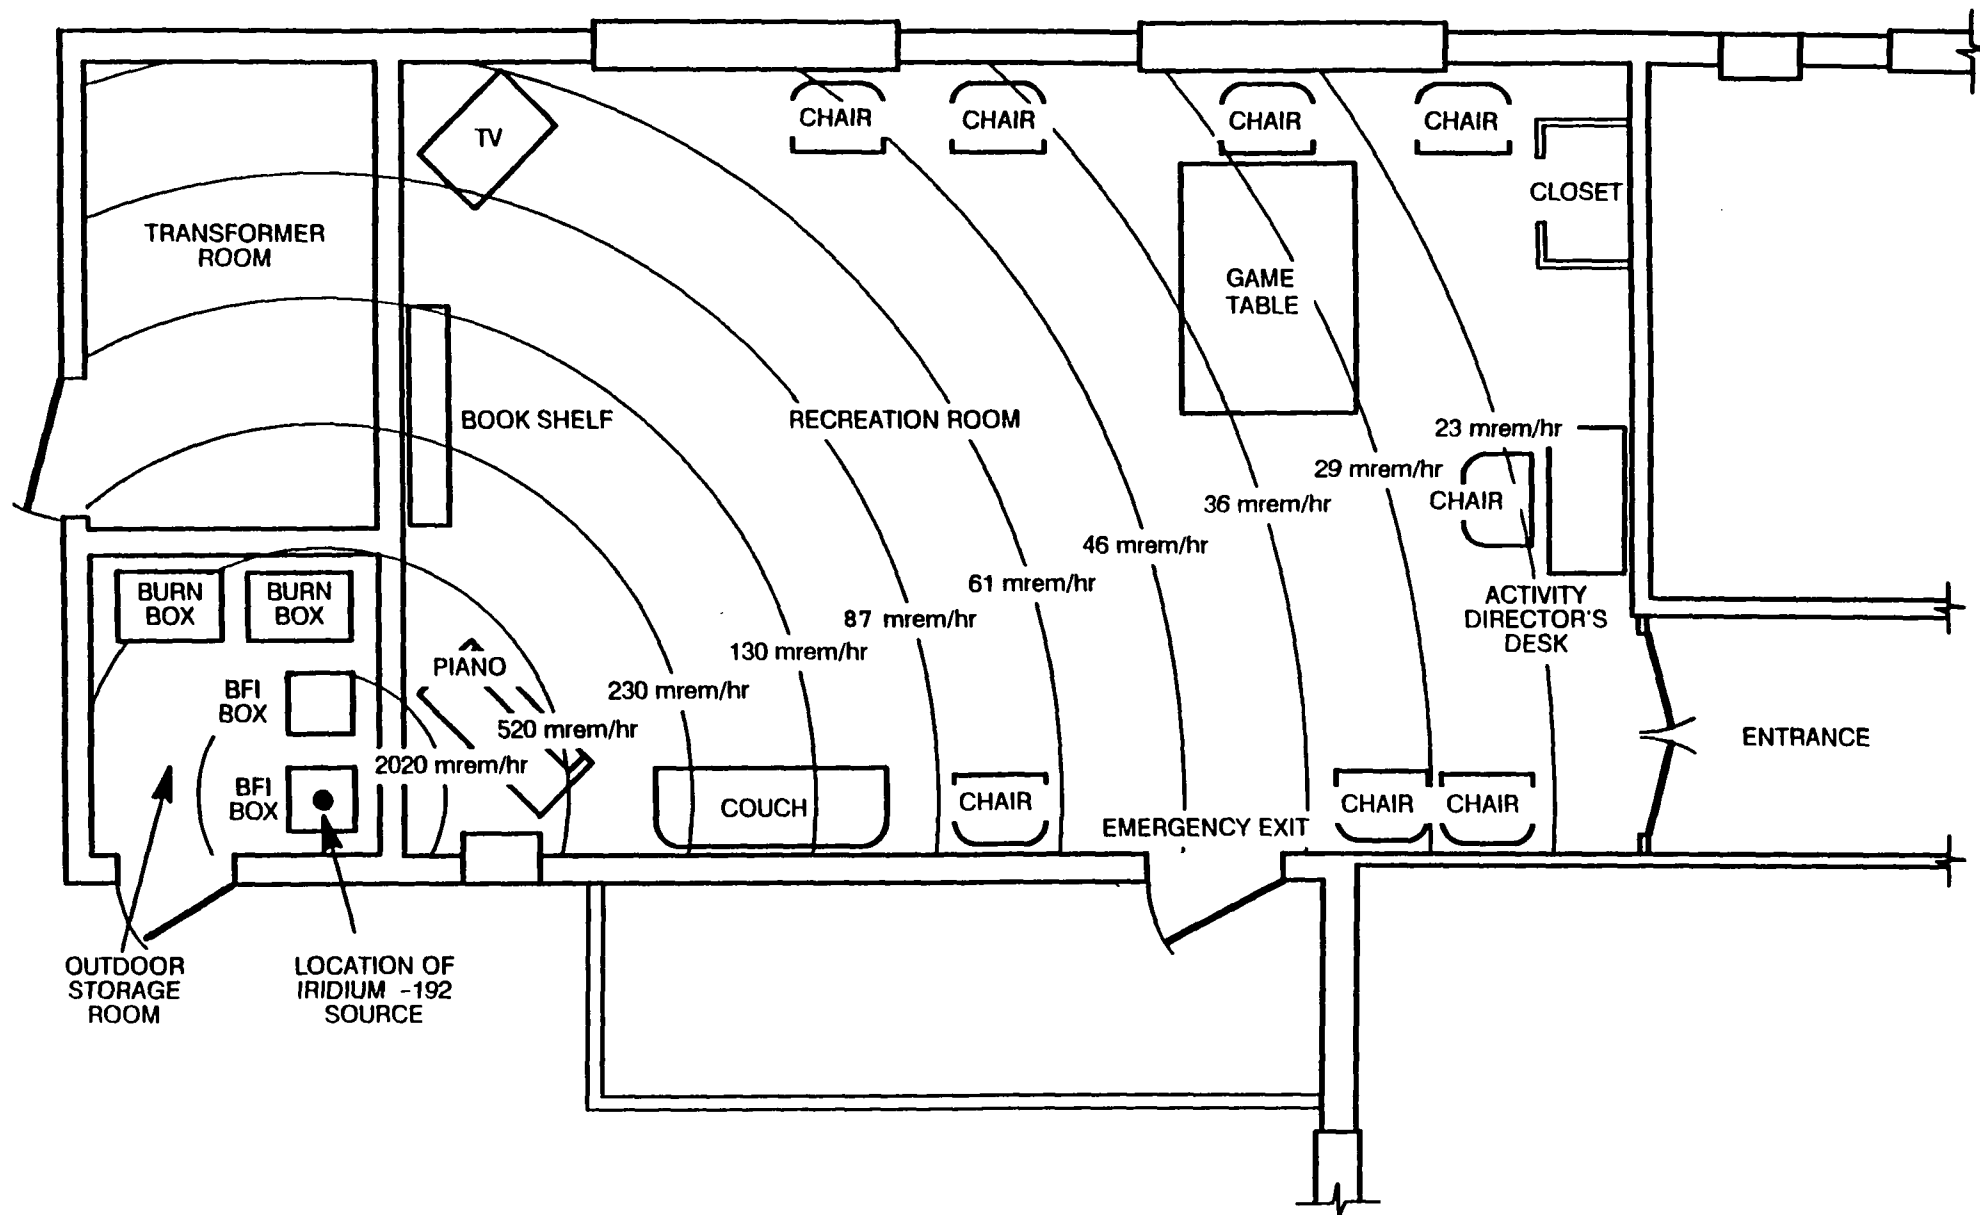
Detailed Diagram of the Scenery Hill Manor Nursing Home Recreation Room Showing 1-meter Isodose Curves from the Iridium-192 Source Located in the Outside Storage Room from November 20 to 25, 1992

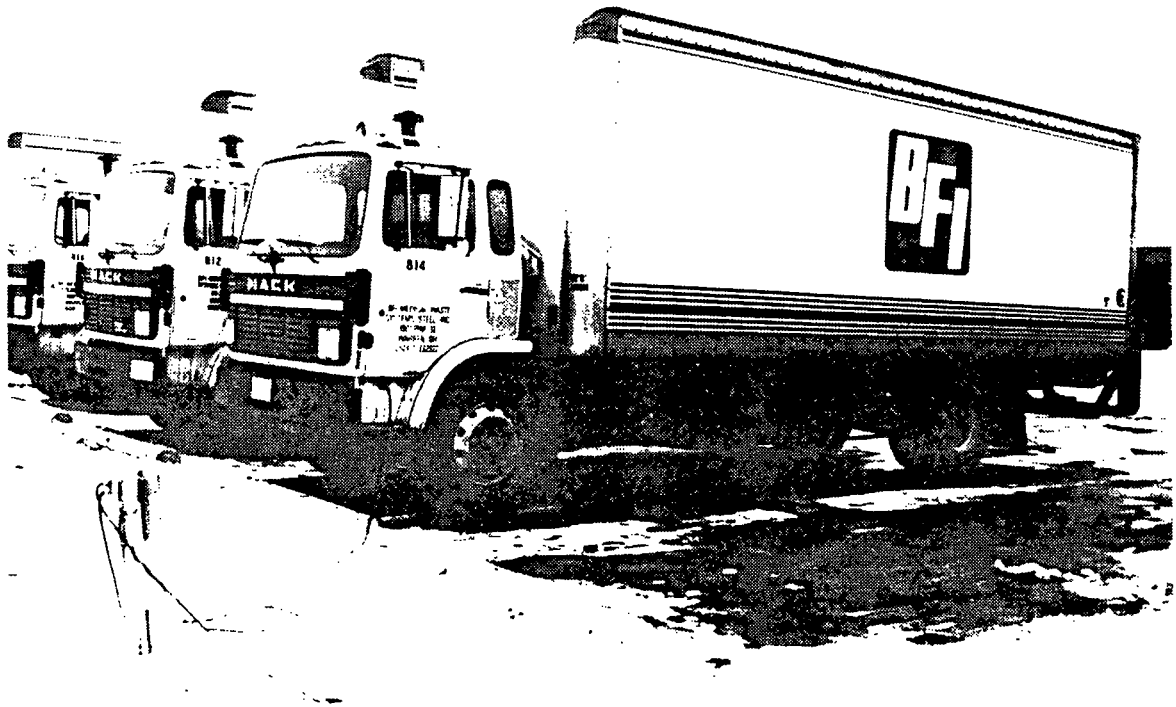
Figure 2.9 Browning - Ferris Industries Straight Truck Used to Collect Waste from Scenery Hill Manor Nursing Home

9:25 a.m. BFI Driver A arrived at his 12th stop, SHM Nursing home; picked up three boxes of red-bag waste from this facility; and placed it in a straight truck (Figure 2.9). Although BFI Driver A had a portable survey meter in the truck, he stated that he did not use it at the SHM nursing home. He continued with his regularly scheduled stops throughout the day, stopping at an additional 10 facilities before returning to BFI-Carnegie (Figure 2.10).

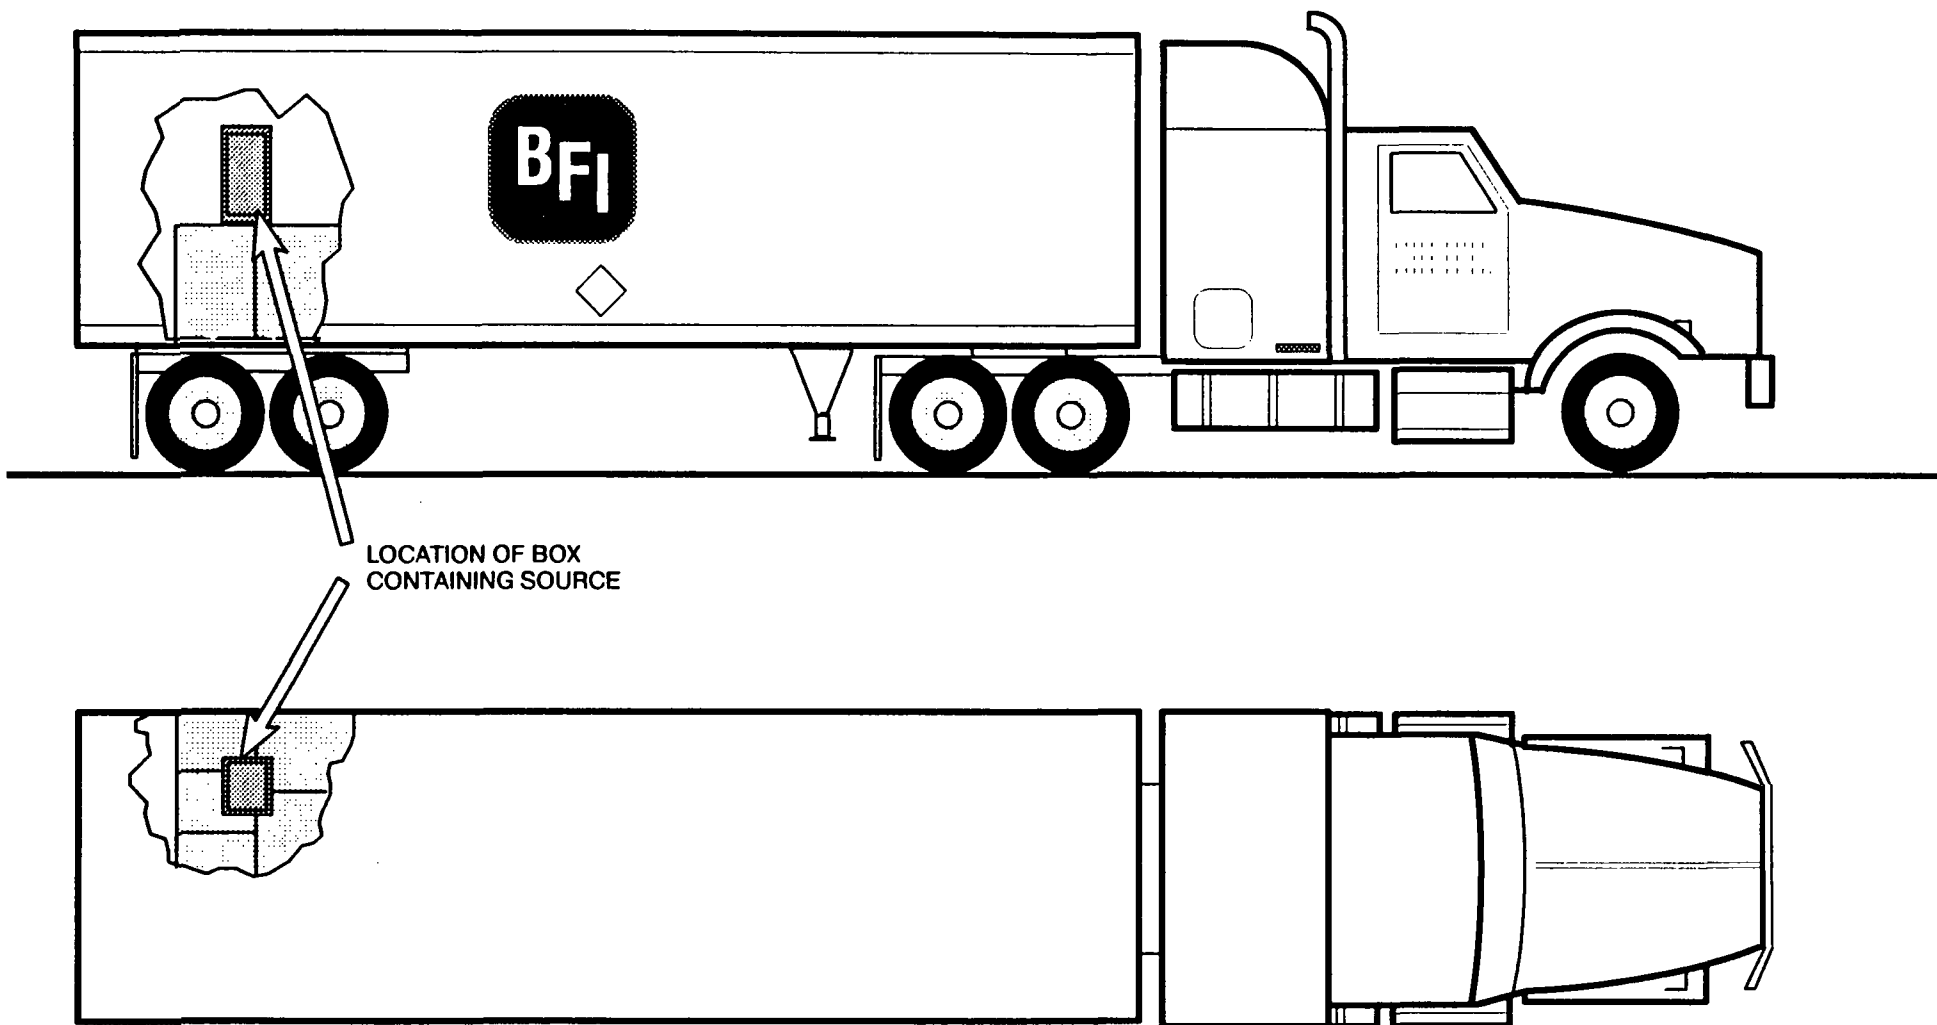
Fig. 2.11 BFI Tractor Trailer 14.63 m (48') Long Showing Location of Source Container in the Trailer.

- 2:30 p.m. BFI Driver A arrived at BFI-Carnegie.
- 3:30 p.m. BFI Driver A unloaded all the boxes by himself from the straight truck onto BFI Trailer 808, which is a 14.6-meter (48-foot) trailer and left for the day. The box containing the source was one of the last ones to be loaded. The box was positioned in the rear left-hand corner of the trailer, approximately 1.8 meters (6 feet) off the floor (Figure 2.11).

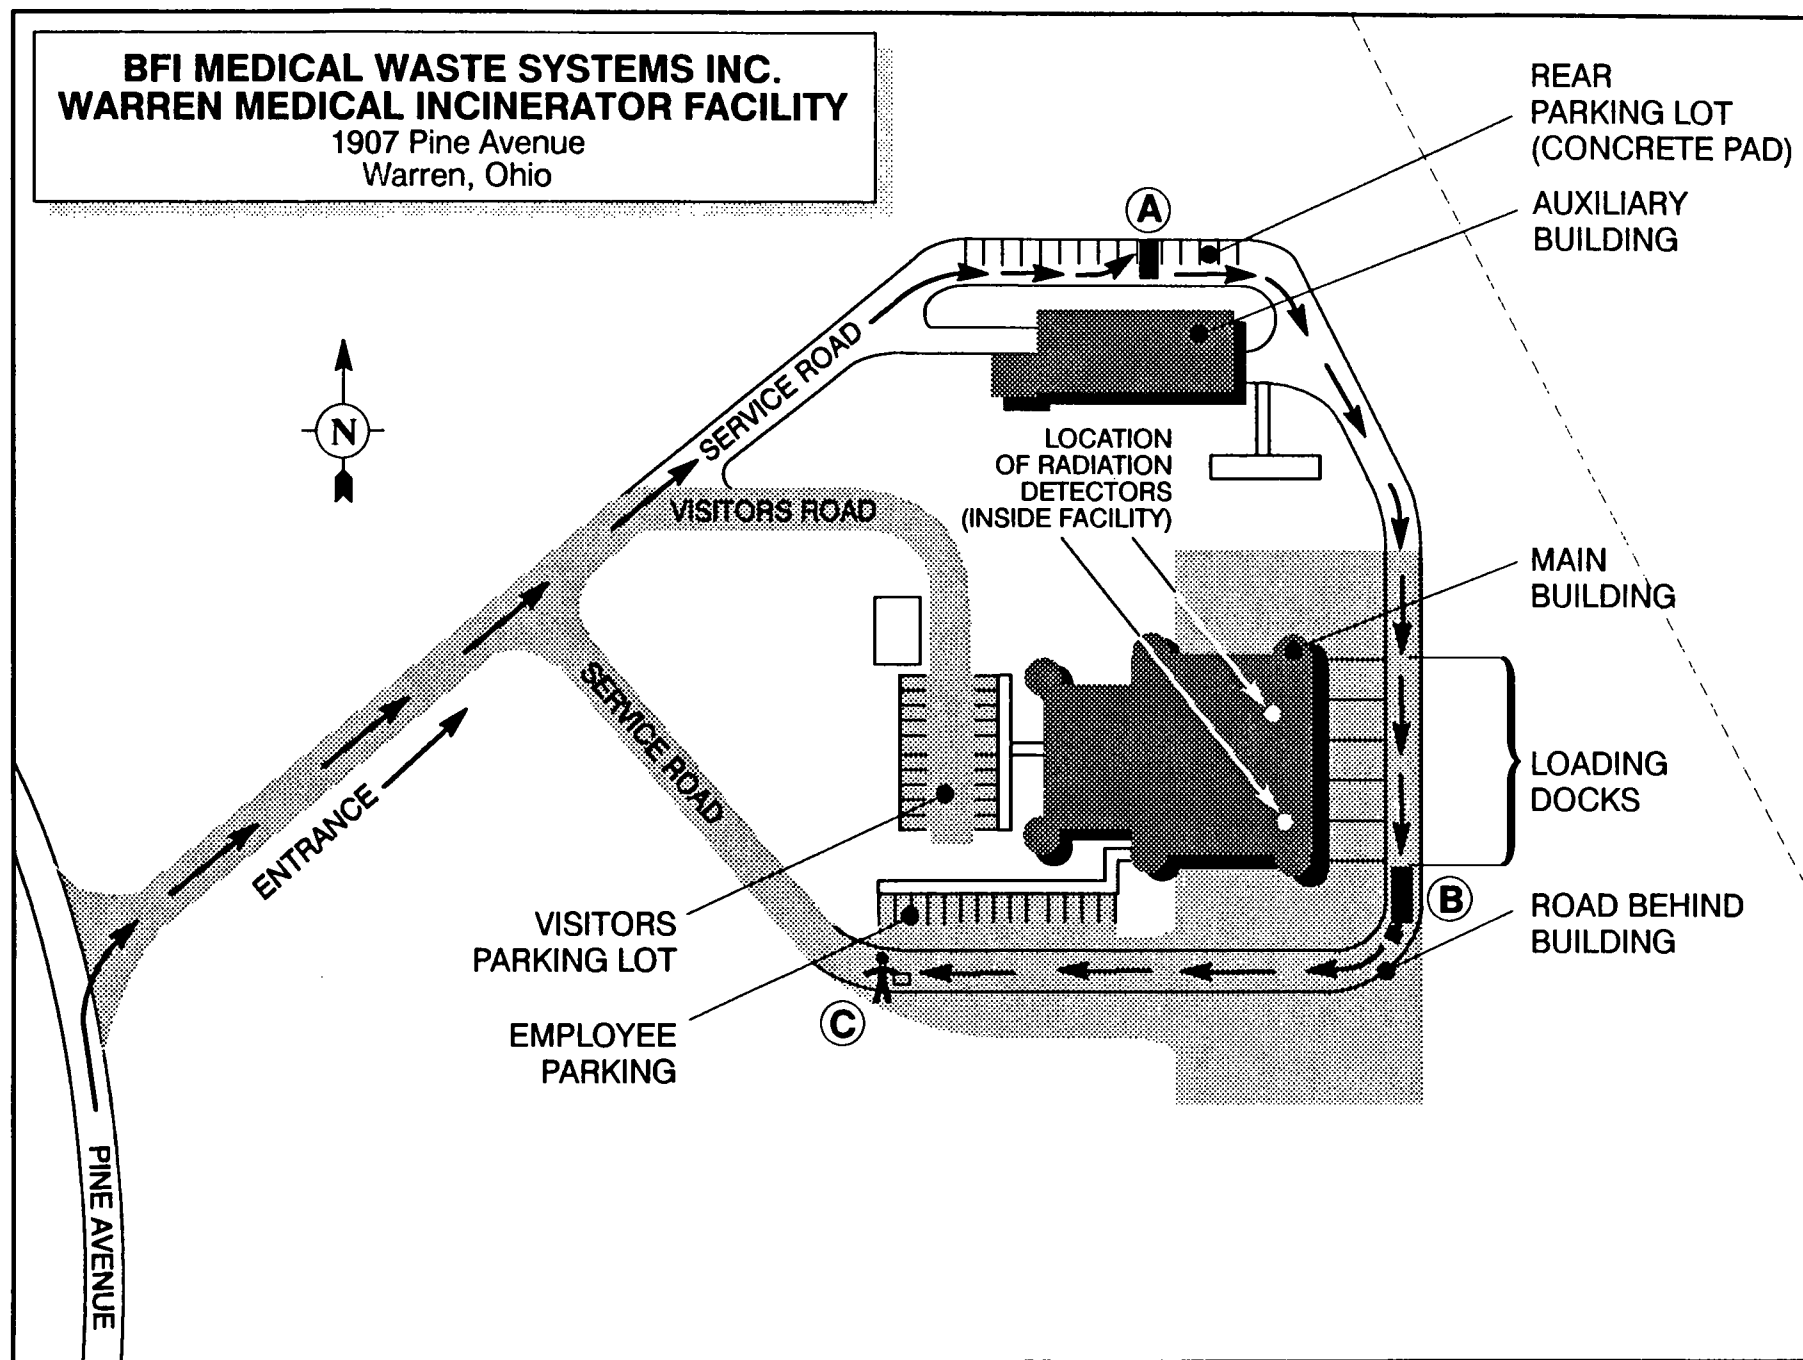
Figure 2.13 Diagram of Tractor-Trailer Route Carrying Iridium-192 Source at BFI-Warren on November 25, 1992

- 8:30 a.m. Driver B arrived at BFI-Warren, drove over to the unloading area (see Position A, Figure 2.13), disconnected Trailer 808, hooked up his cab to an empty trailer, drove to the front office, completed the paperwork for this shipment, and left BFI-Warren. Two fixed radiation monitors inside the facility alarmed, reading above their normal limits of 0.2 μSv (20 μrem) per hour. Employees working that shift began trying to locate the cause of the radiation alarms.

9:45 a.m. Because the Plant Manager and the Supervisor could not determine which trailer had the radioactive material in it, they decided to drive one trailer at a time behind the main building, (see Figure 2.13), using it as a large concrete shield, to see if any of the portable survey meters alarmed as a trailer approached Position B in Figure 2.13.

Before the tractor-trailer drove behind the main building, the Plant Manager stood at Position C in Figure 2.13 of the facility with his portable survey meter turned on. At this location, there was no indication of radioactivity. As the tractor-trailer came from behind the building, however, the portable survey meter registered its highest level.

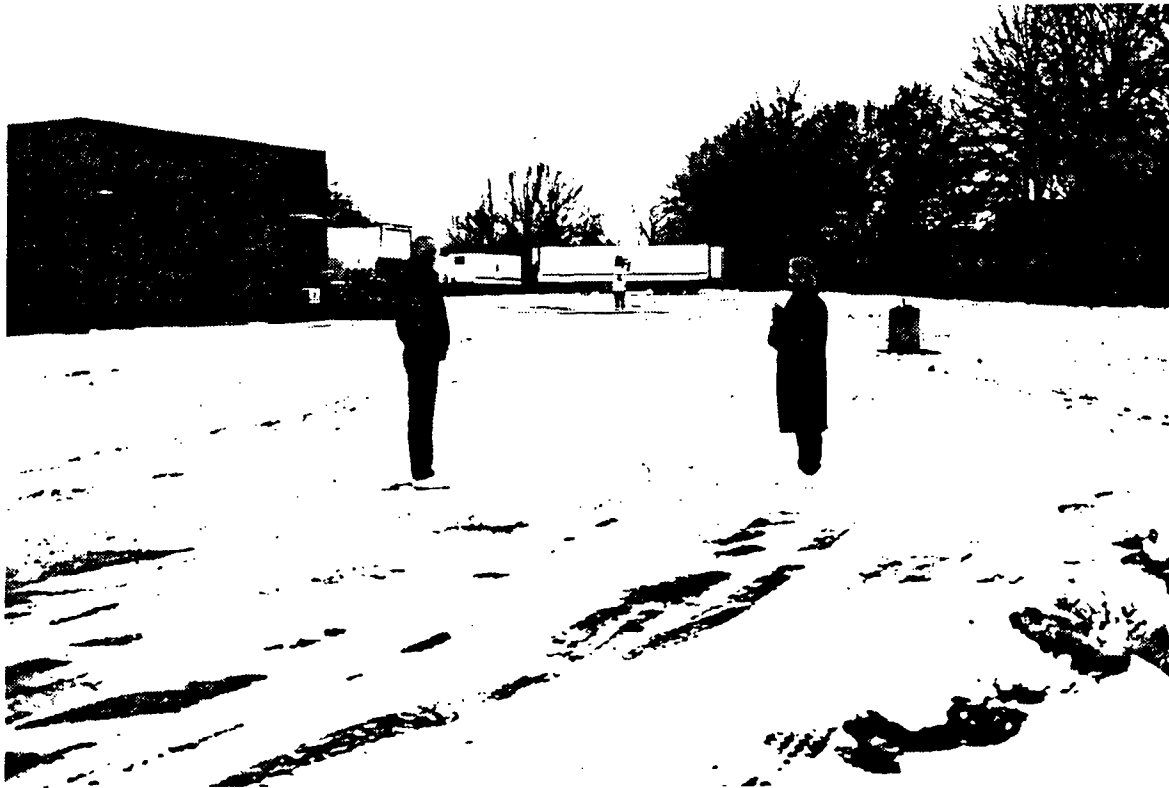
Figure 2.17 Location of Where Manager and Supervisor Detected Radiation (~ 400')
from BFI Trailer 808

After identifying the possible cause of the radiation alarms, both the Plant Manager and the Supervisor began to look for the source with their portable survey meters (Figure 2.16) outside of the parked trailers (Figure 2.17). When they came within approximately 121.9 meters (400 feet) of the trailer, both portable survey meters immediately alarmed and registered at their highest levels over 5 μSv (500 μrem) per hour.

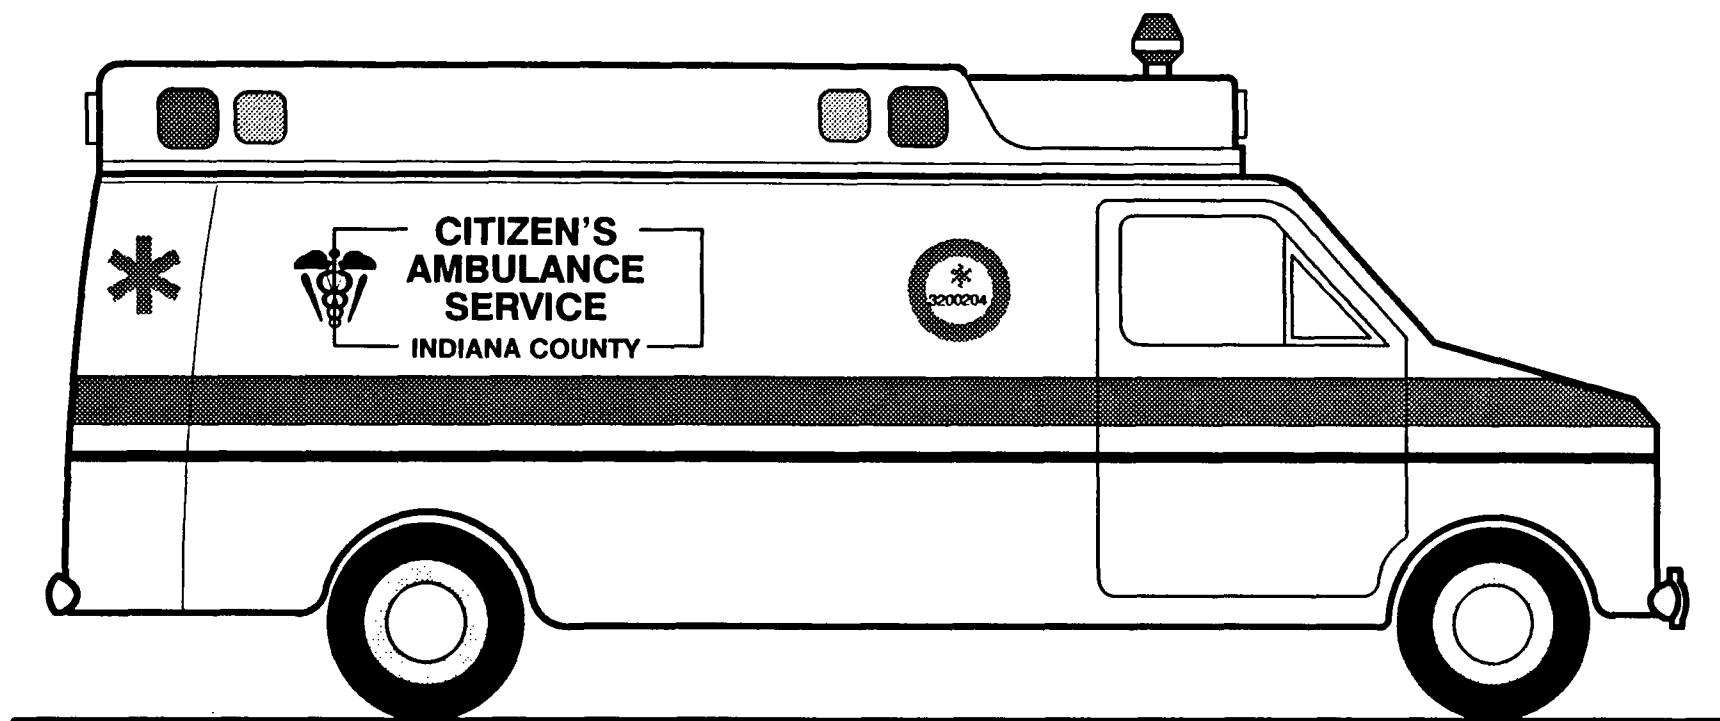
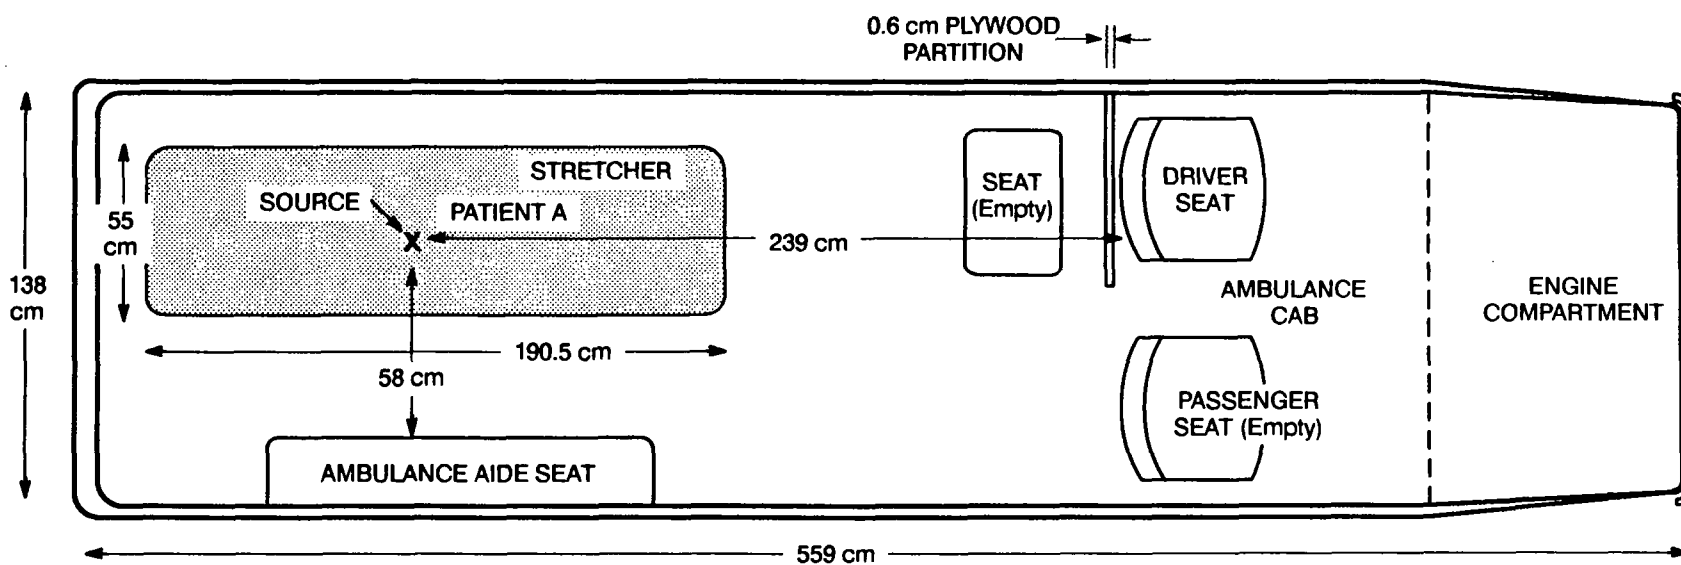
Figure 6.2 Location of Ambulance Staff and Patient A in Citizen's Ambulance

Two ambulance service employees were exposed to the iridium-192 source during transport of Patient A after Patient A received HDR treatment on November 16, 1992. The team measured probable distances that the ambulance service employees maintained from the source in Patient A and estimated the time spent at each distance based on the ambulance service's dispatch log. The team estimates that the ambulance aide received a dose in the range of 13.3 mSv (1.3 rem) to 25.7 mSv (2.6 rem), while the ambulance driver received from 4.8 mSv (0.48 rem) to 8.4 mSv (0.84 rem) (Table 6.6). The estimated dose range for the ambulance aide is higher because he spent the time in transit to SHM nursing home sitting across from Patient A approximately 58 cm (22.8 inches) away (Figure 6.2).
