Examination of Steam Generator Tubes Removed from Beaver Valley Unit 2

Prepared for the  
FirstEnergy Nuclear Operating Company

**SG-CCOE-14-4-NP**  
**Revision 1**

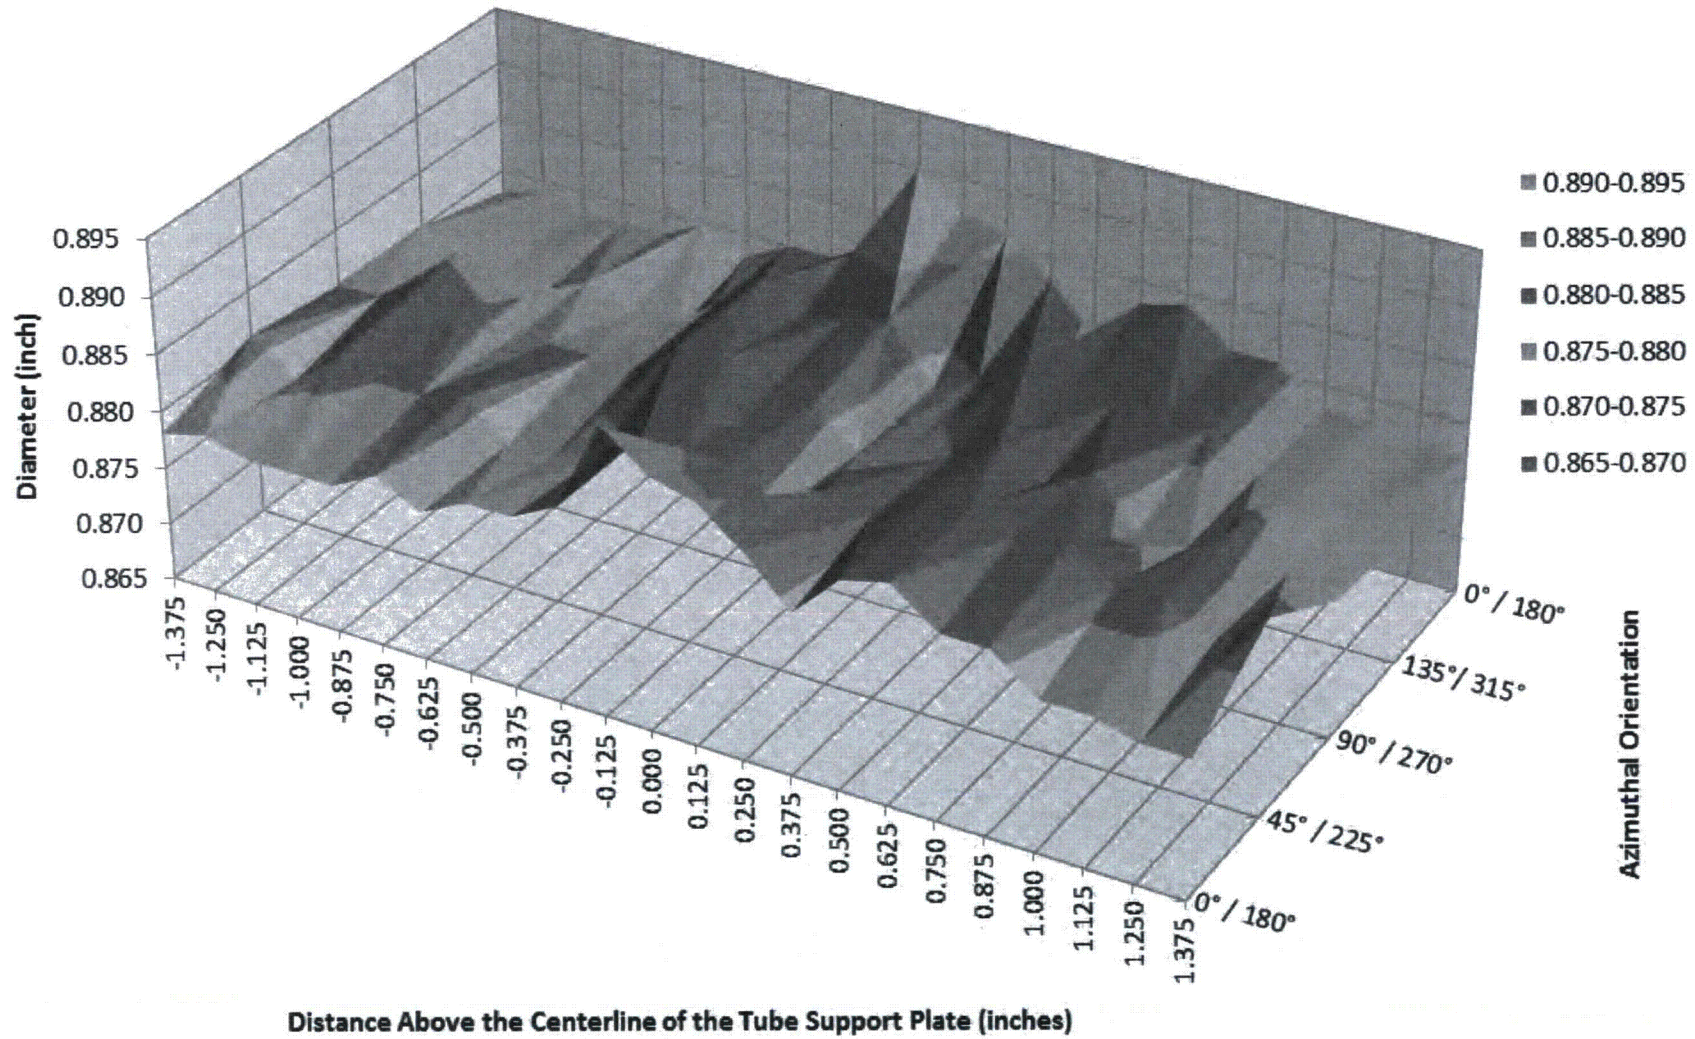
Figure 2-15: Diameter Profile of 02H TSP Region of R19C38

Figure 2-15 presents a profile of the diameter in the 02H TSP region of R19C38. The TSP region is shown as a region with elevated deposits. Denting was not evident from the diametrical measurements, but if present, may have been obscured by deposits. The deposits in the ½-inch region above the top of the TSP were, on average, about 3 mils thicker than the deposits immediately below the bottom of the TSP.

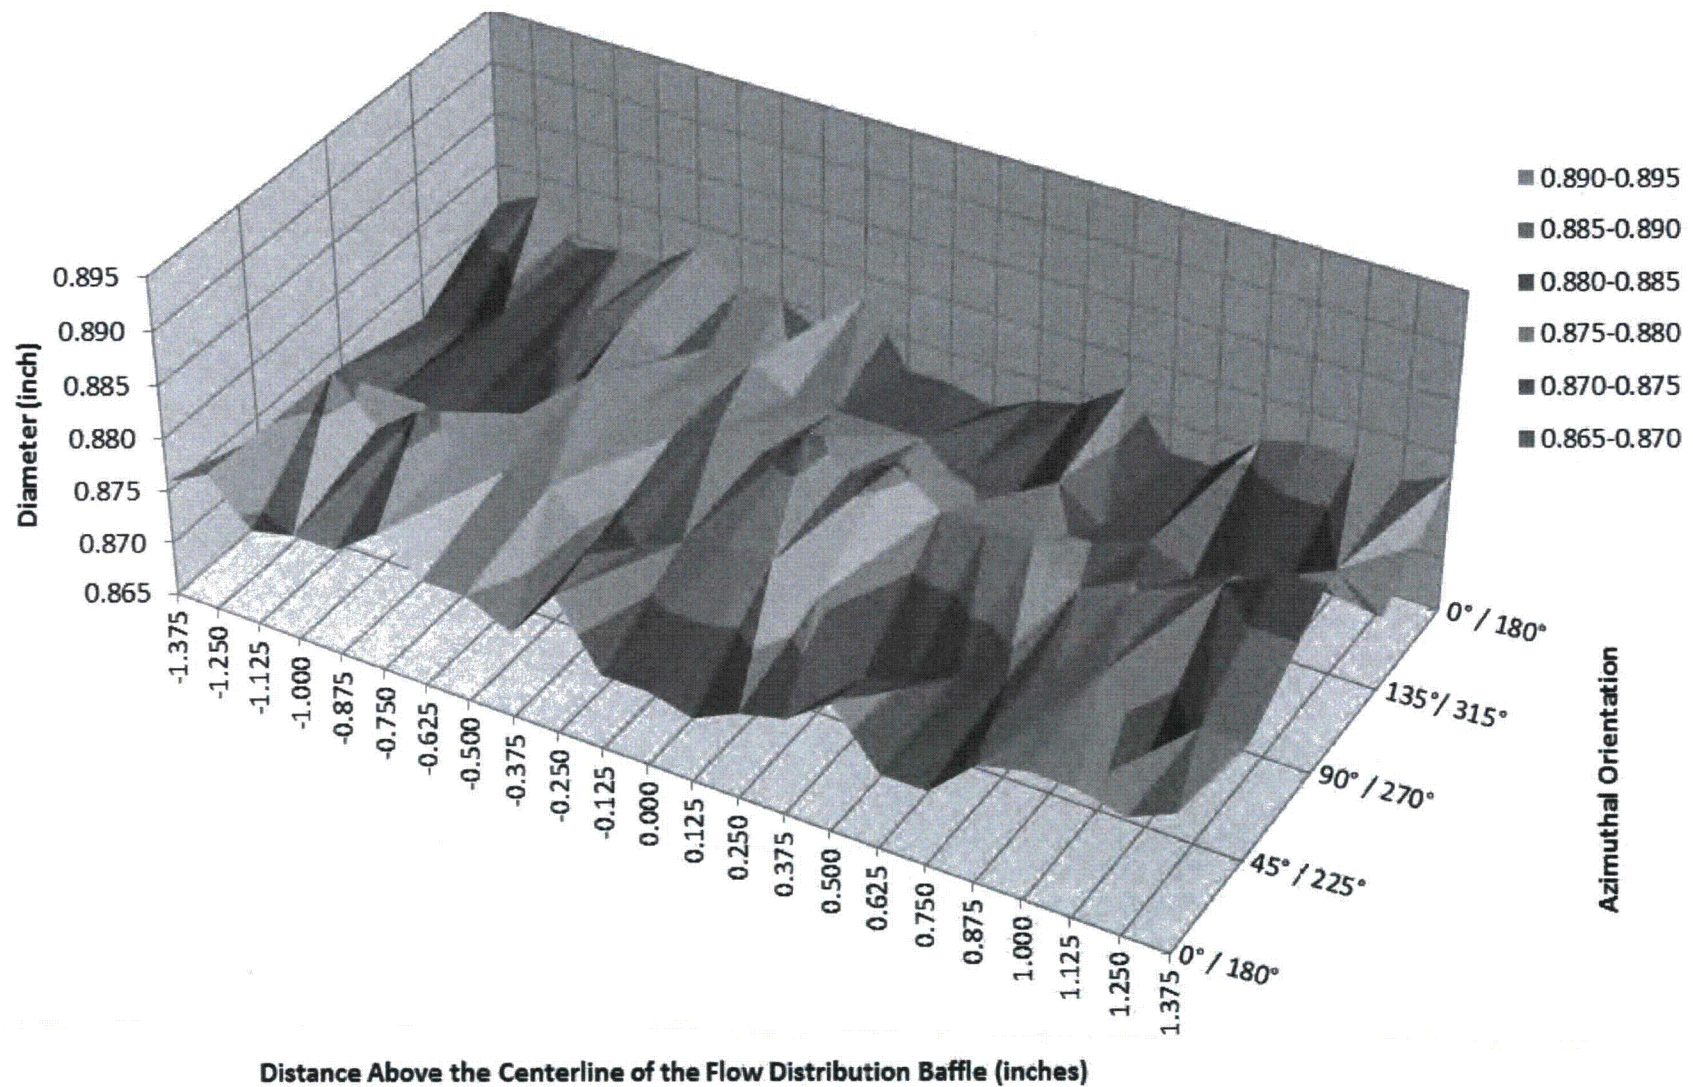
Figure 2-17: Diameter Profile of FDB Region of R24C41

Figure 2-17 presents a profile of the diameter in the FDB region of R24C41. Deposits partially interfere with the tube diameter measurements. In general, the FDB region diametrical profile is indistinguishable from the freespan tubing above and below the region.

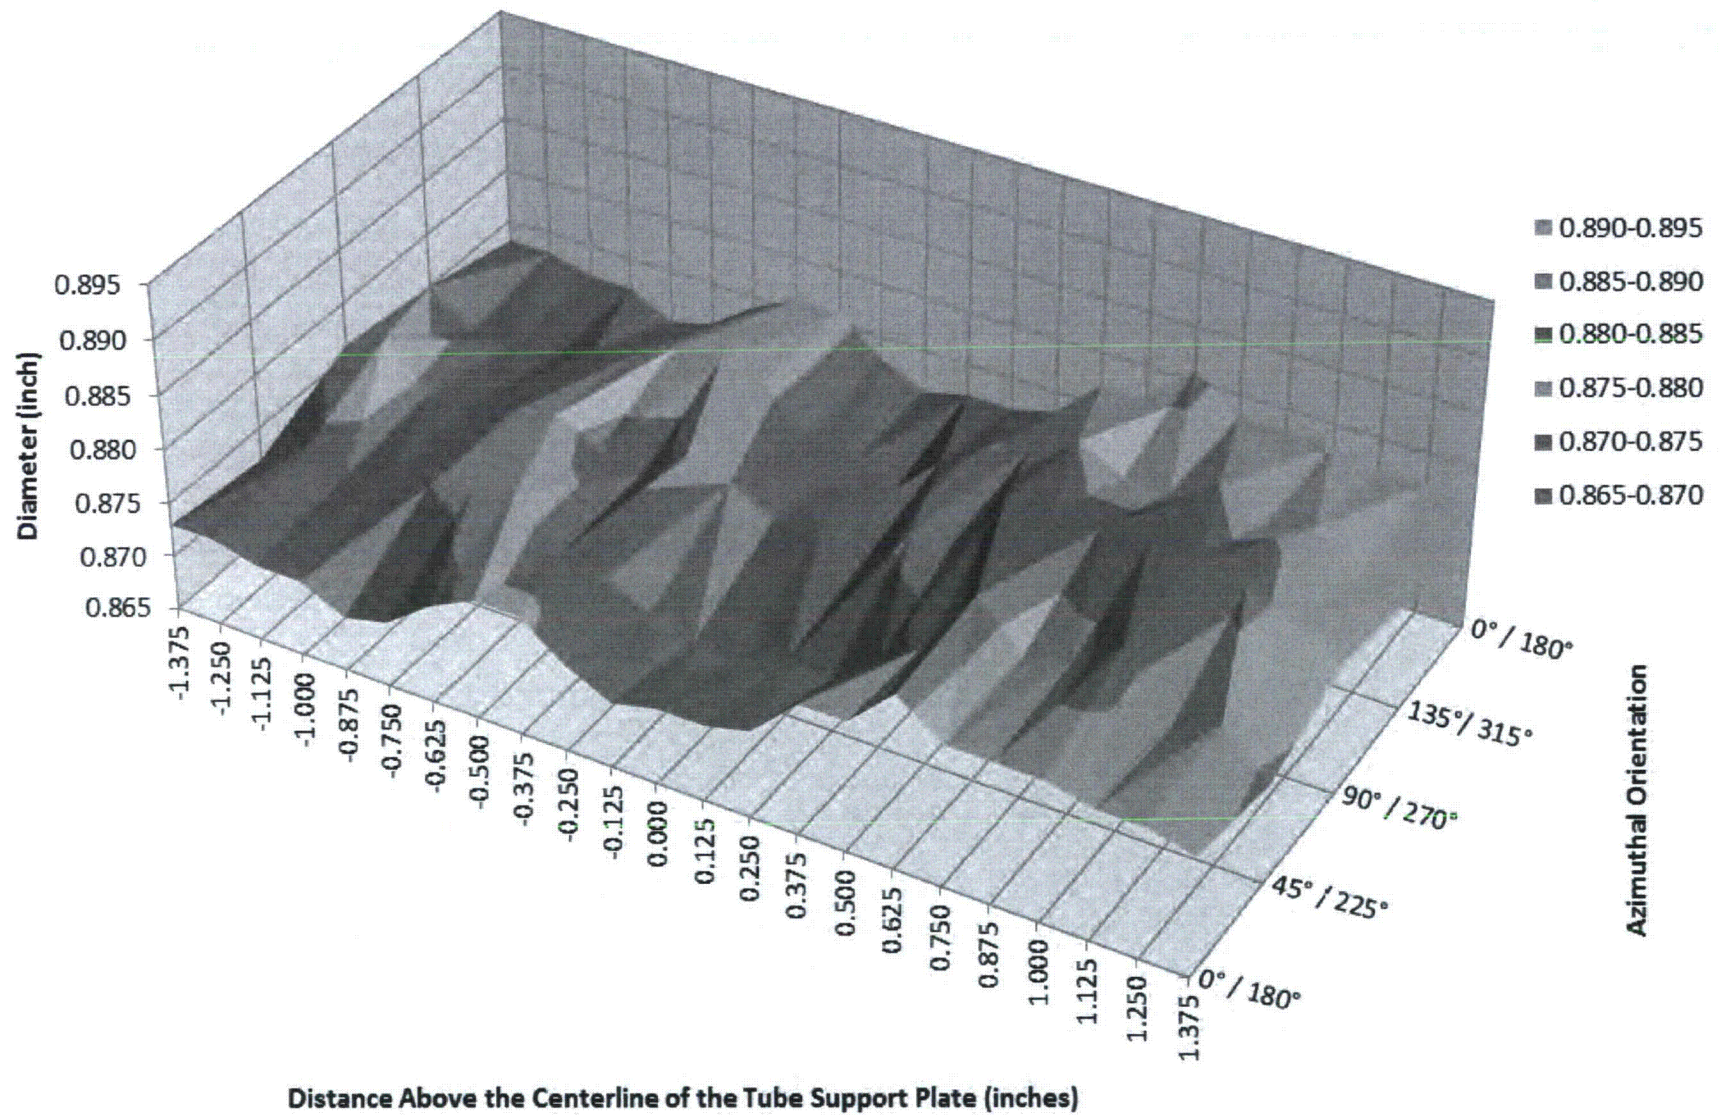
Figure 2-18: Diameter Profile of 02H TSP Region of R24C41

Figure 2-18 presents a profile of the diameter in the 02H TSP region of R24C41. As Figure 2-8 shows, there were raised deposits at the top and bottom of the TSP region, but large parts of the TSP region were free of deposits. The deposits in the ½-inch region above the top of the TSP were, on average, about 5 mils thicker than the deposits immediately below the bottom of the TSP. The diametrical measurements show a region of reduced diameter at the centerline of the TSP region at the 45°/225° orientation, although the entire centerline of the TSP had a diameter that was about 2-3 mils less than the baseline diameter (see the region above the TTS in Figure 2-16). Metallography identified three short axial cracks with a maximum depth of 14.2% throughwall at the 160° orientation and two short axial cracks with a maximum depth of 10.7% throughwall at the 340° orientation. The 160°/340° cracks are approximately orthogonal to the reduced diameter at 45°/225°. It is possible that tube diameter compression caused by corrosion products in the vicinity of the 45°/225° orientation would introduce tensile stresses to the outer surface of the tube 90° around the circumference, although there was no corresponding increase in diameter measured at the 135°/315° orientation. It is possible that the cracks identified in the 02H TSP region of R24C41 were caused by in-service denting.

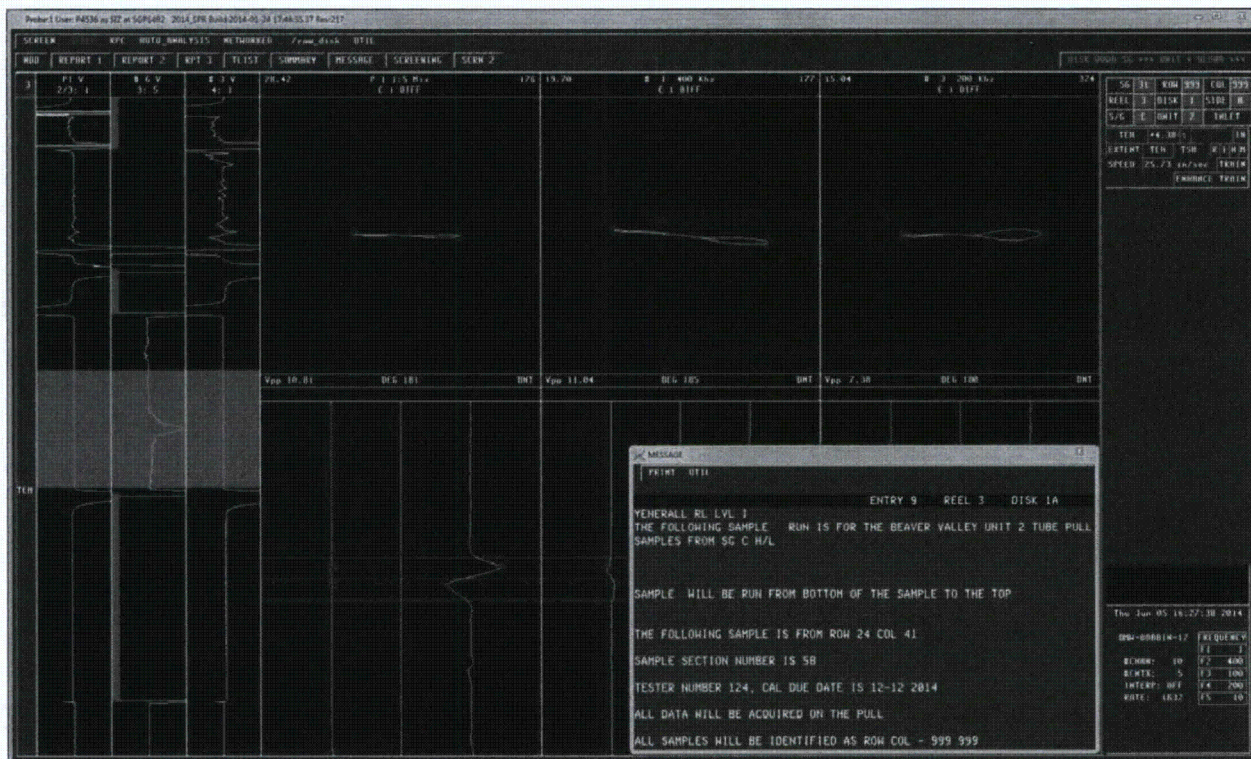
Figure 3-5: Laboratory Bobbin – R24C41-5B (03H) - DNT

(02H) has a bobbin voltage response larger than what was reported prior to pulling the tube; a factor of 3 to 4 times increase in the pre-pull bobbin voltage is not unexpected for an axial indication in a pulled tube. The three TSP locations 02H, 03H and 04H (for sections 3B, 5B and 6B, respectively) of R24C41 have a dent response at the area of interest with P1 channel voltages of 13.87, 10.81 and 10.92, respectively. No detectable degradation (NDD) can be observed at these three locations of interest due to the large over-riding dent responses. These dent-like responses are judged as being a result of the tube pull process. Section 2.3 discussed anomalies in the diameter profile for the 02H TSP of R24C41 (shown in Figure 2-18) that appeared to be denting. The two TSH locations were judged to be NDD.

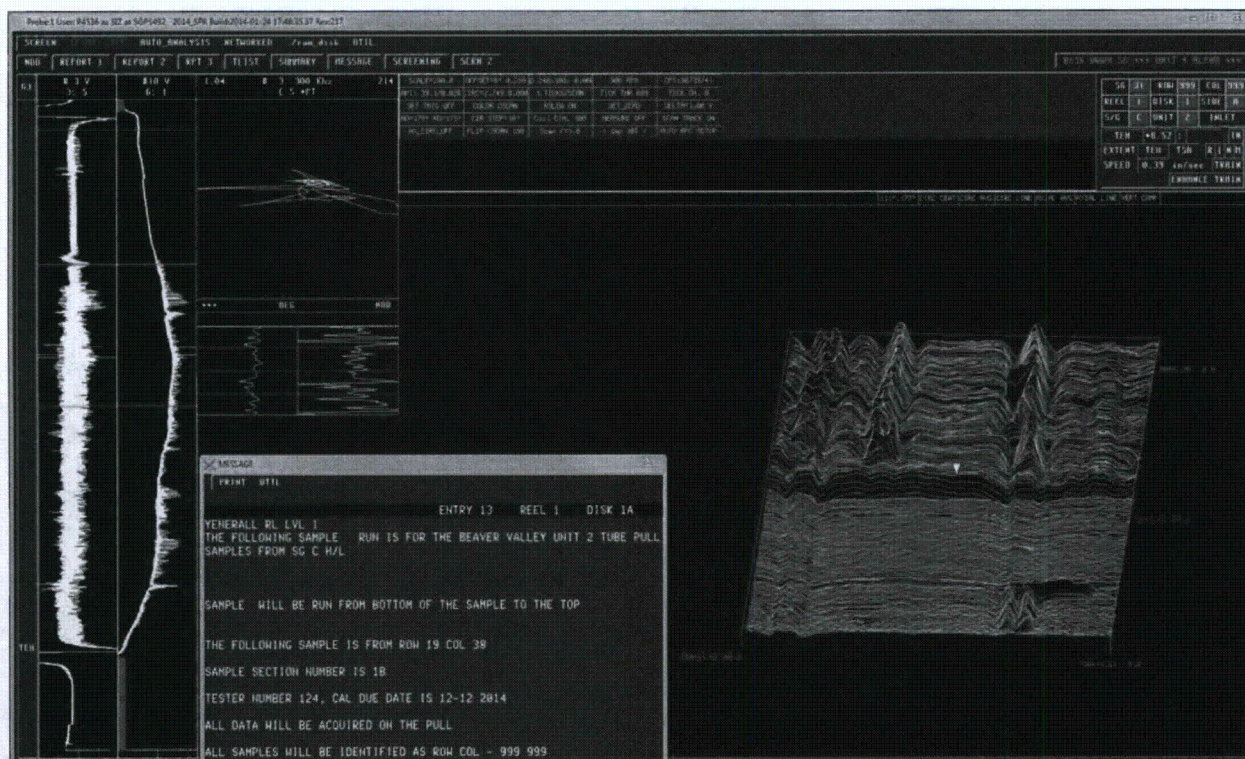
Figure 3-7: Laboratory +Point Probe – R19C38-1B TSH - NDD

Figure 3-7 and Figure 3-10 also show three long parallel axial artifacts below the top of the tubesheet. These are TIG welds used in the tube pull operation to relax the tube-tubesheet joint.

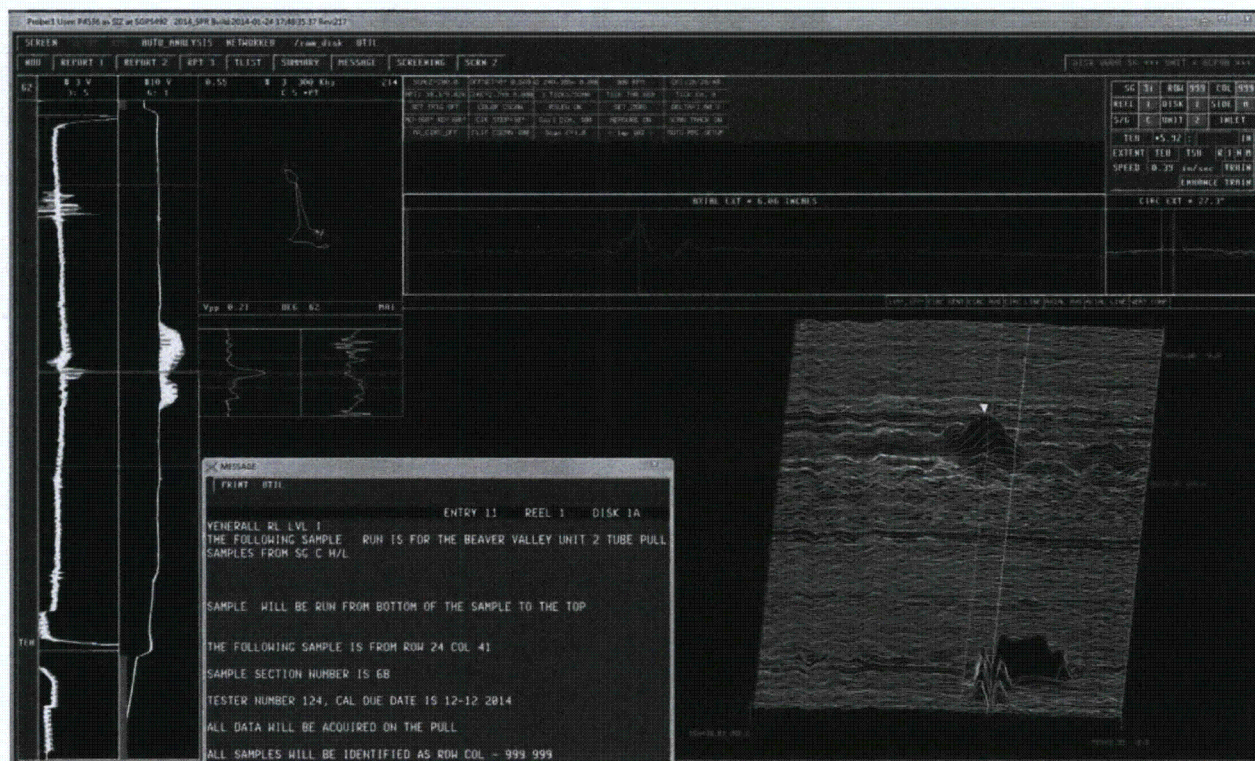
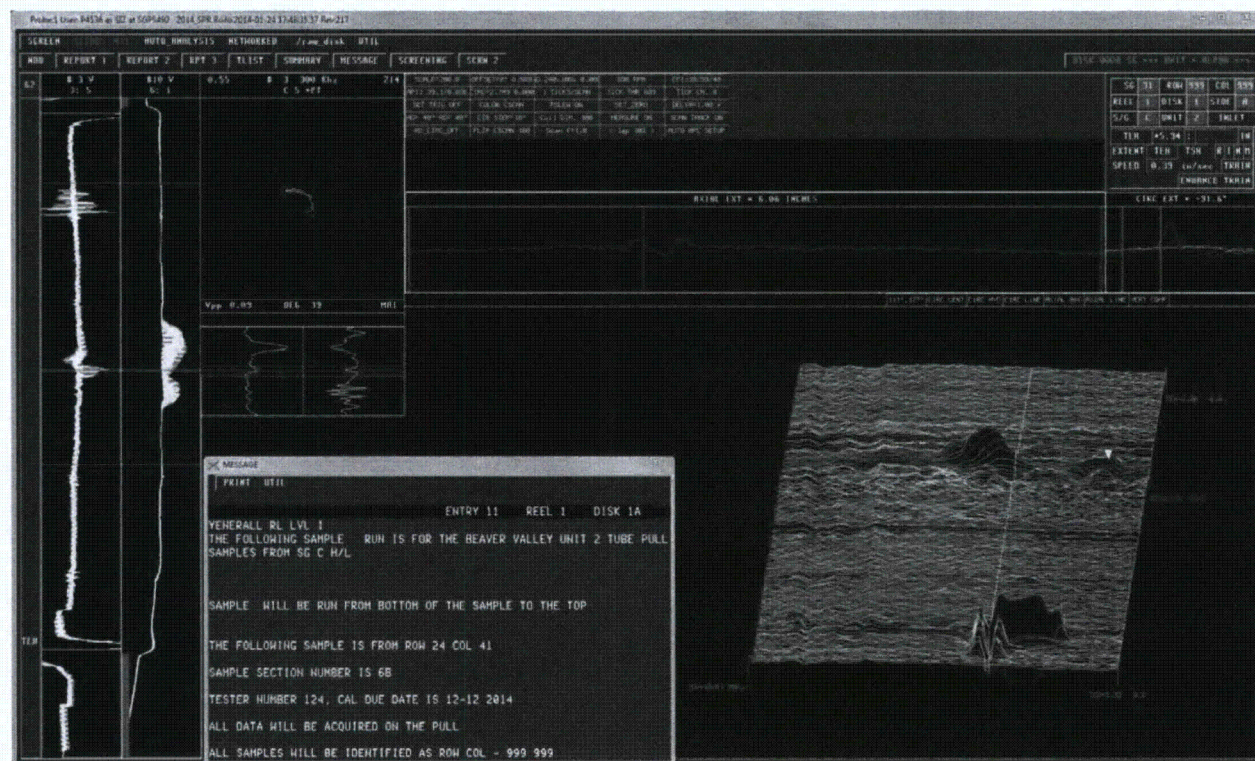
Section R19C38-3B (02H) was evaluated as having SAIs located at the top and bottom locations of the support plate. Section R24C41-6B (04H) was reported in the field ECT as having two single axial indications (SAI) in the same axial location (Table 3-2), which is actually the definition of a multiple axial indication (MAI). Each ligament of the MAI was evaluated with similar amplitudes to what was reported in the field (see Figure 3-13 and Figure 3-14). The dent-like response observed during the laboratory bobbin testing of R24C41 did not affect detectability for this +Point technique in the laboratory. The results of the remaining four sections were consistent with what was reported in the field prior to pulling the tubes (NDD).

Figure 3-13: Laboratory +Point Probe – R24C41-6B (04H) - Ligament # 1 - MAI

Figure 3-14: Laboratory +Point Probe – R24C41-6B (04H) - Ligament # 2 – MAI

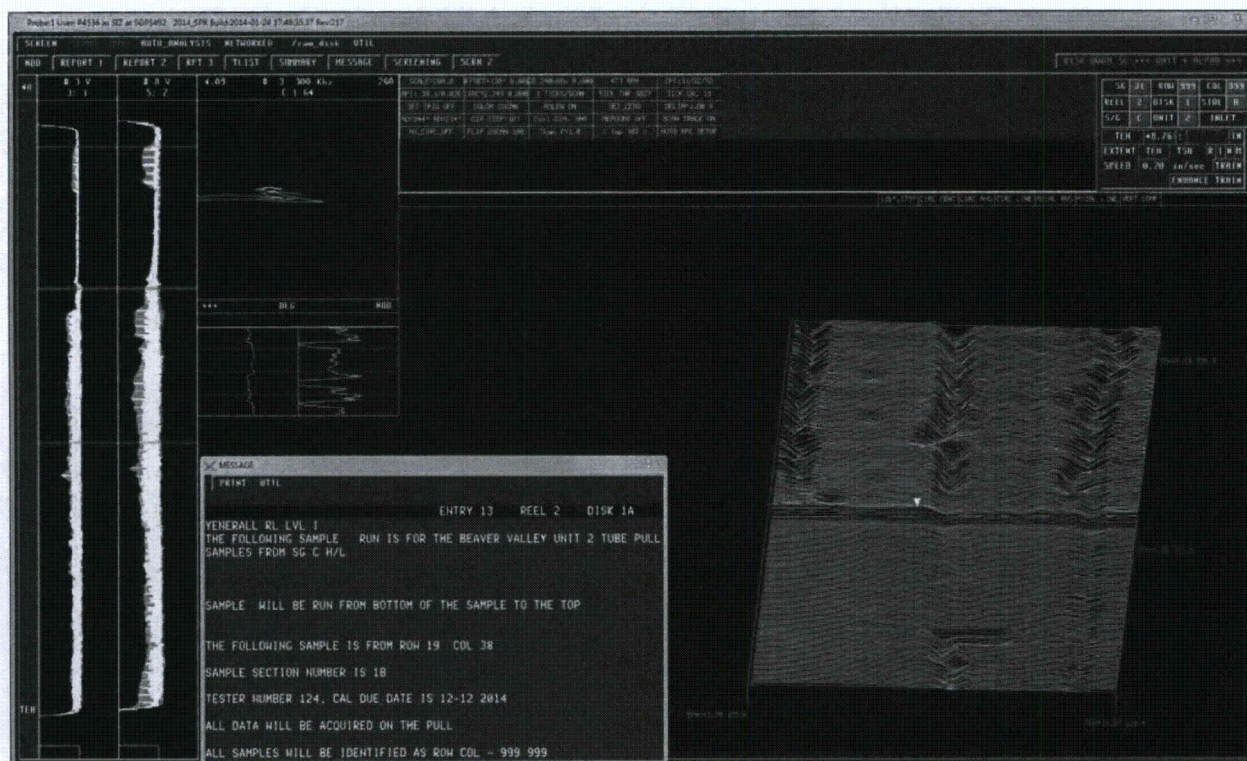
Figure 3-15: Laboratory Ghent Probe – R19C38-1B TSH – NDD

Figure 3-15 and Figure 3-18 also show three long parallel axial artifacts below the top of the tubesheet. These are TIG welds used in the tube pull operation to relax the tube-tubesheet joint.

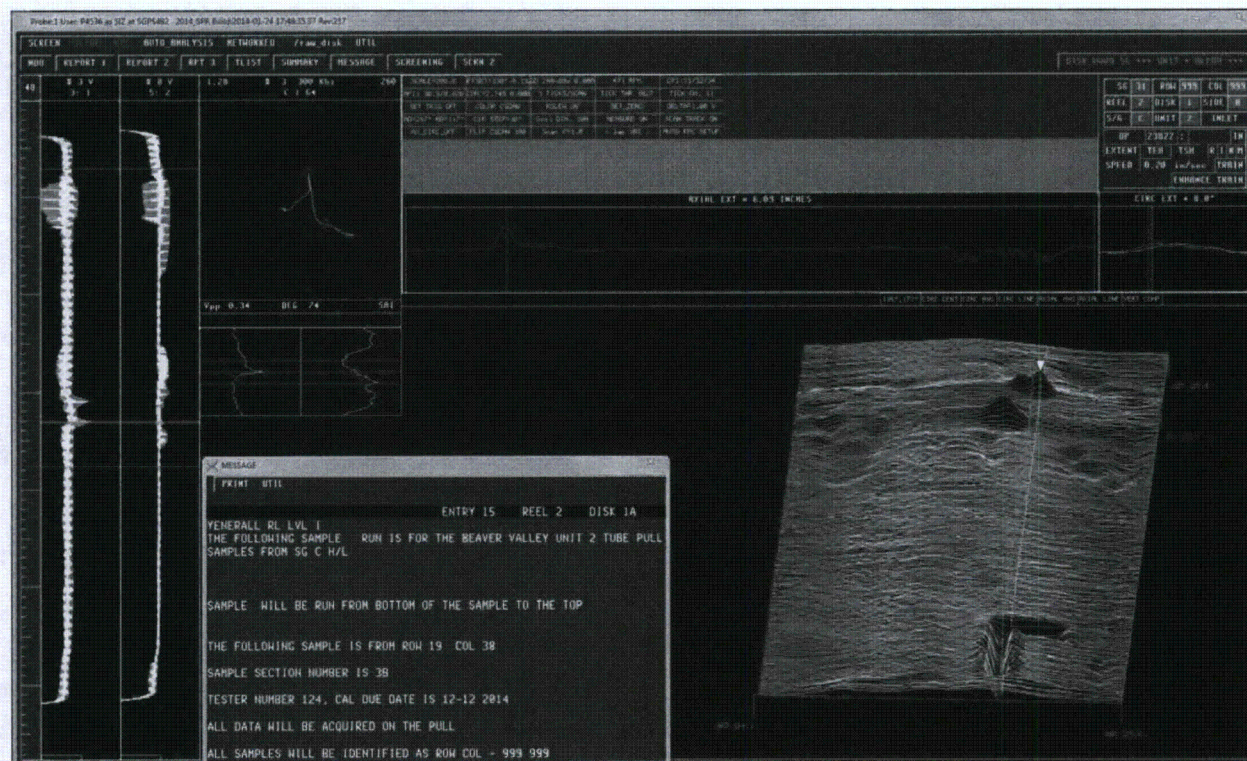
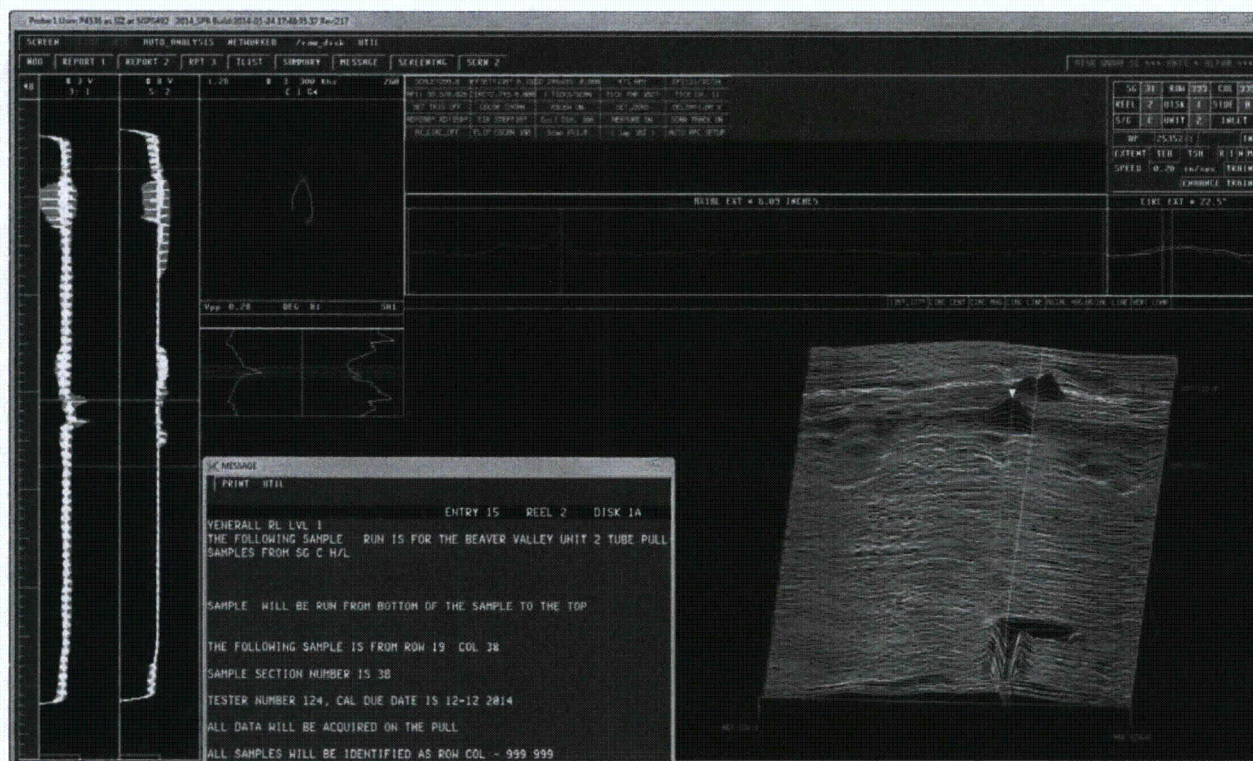
Section R19C38-3B (02H) was evaluated as having SAIs located at the top and bottom locations of the support plate. The Ghent response for section R24C41-6B (04H) revealed three ligaments for the MAI, with the additional ligament (3) being small in voltage (0.10 volts). The dent-like responses observed during the laboratory bobbin testing of R24C41 did not affect detectability for this Ghent probe technique in the laboratory. The results of the remaining four sections were consistent with what was reported in the field prior to pulling the tubes (NDD).

Figure 3-16: Laboratory Ghent Probe – R19C38-3B (02H) - Bottom – SAI

Figure 3-17: Laboratory Ghent Probe – R19C38-3B (02H) - Top – SAI

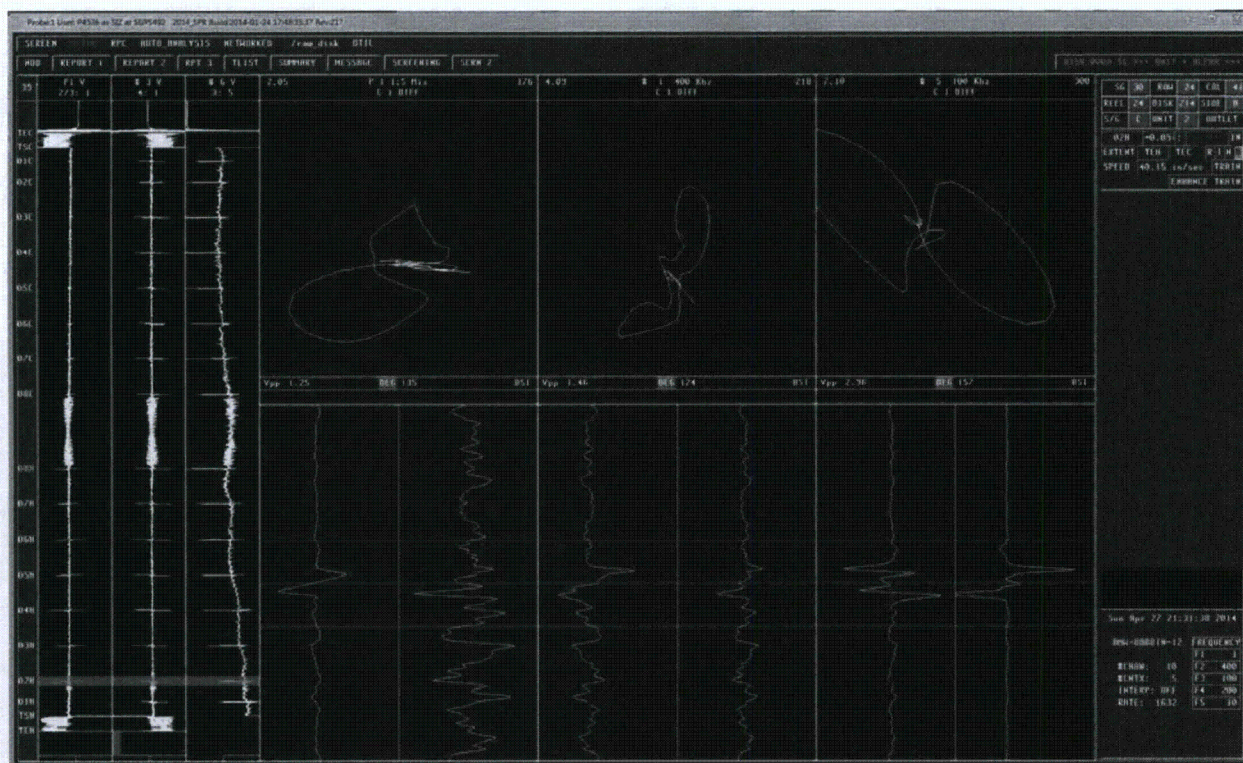
Figure 3-27: In-Generator Bobbin Probe – R24C41-3B (02H) – DSI

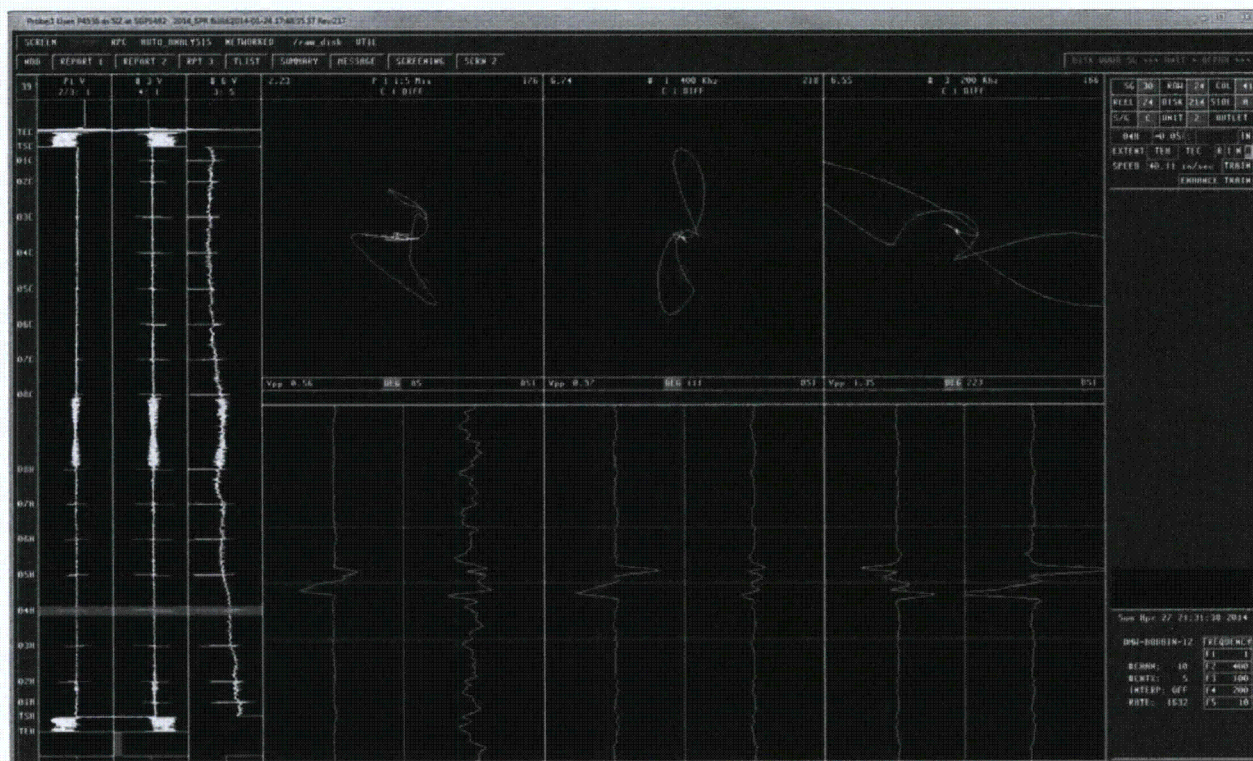
Figure 3-29: In-Generator Bobbin Probe – R24C41-6B (04H) - DSI

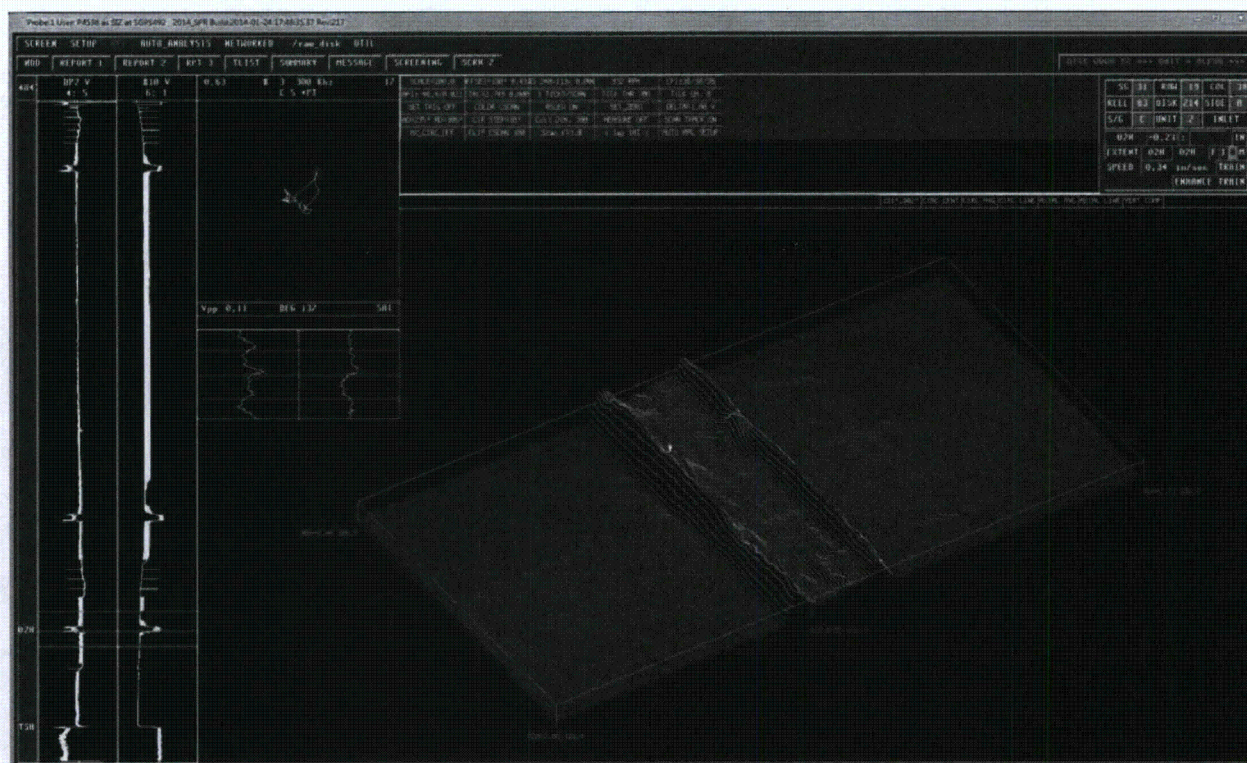
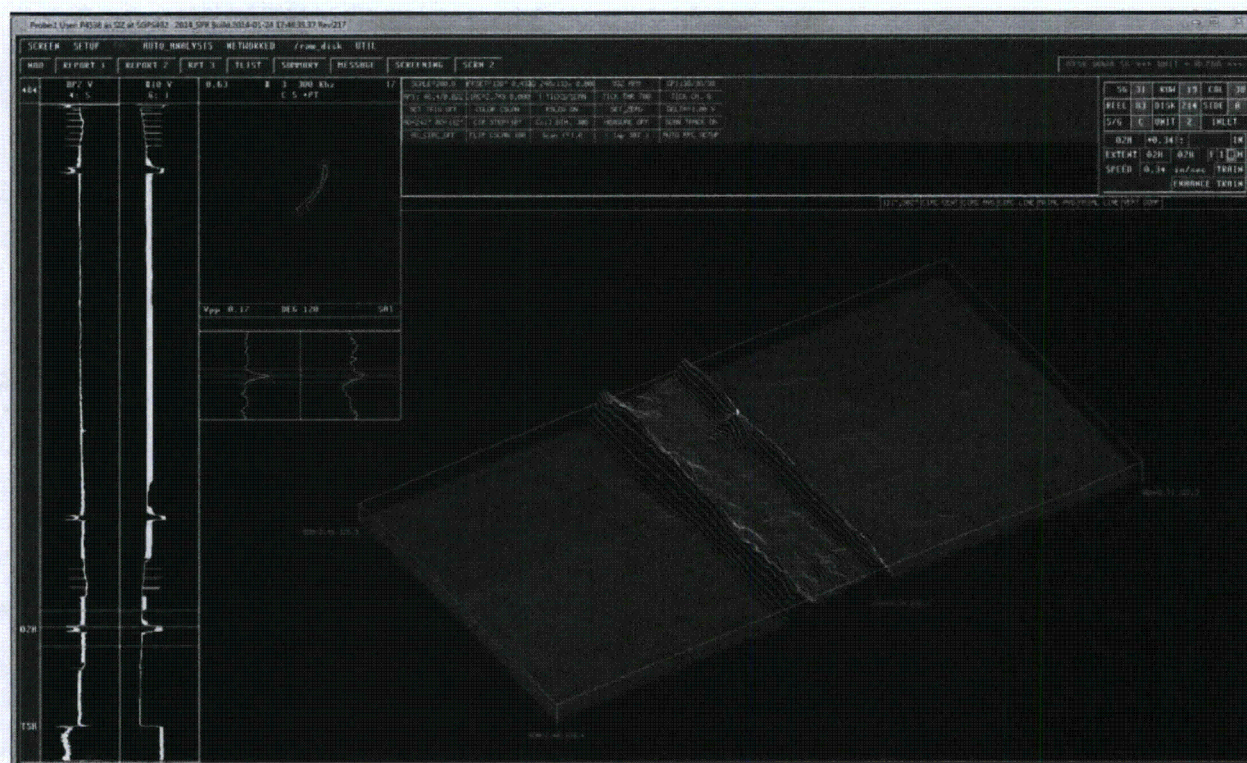
Figure 3-31: In-Generator +Point Probe – R19C38-3B (02H) – Bottom – SAI

Figure 3-32: In-Generator +Point Probe – R19C38-3B (02H) – Top – SAI

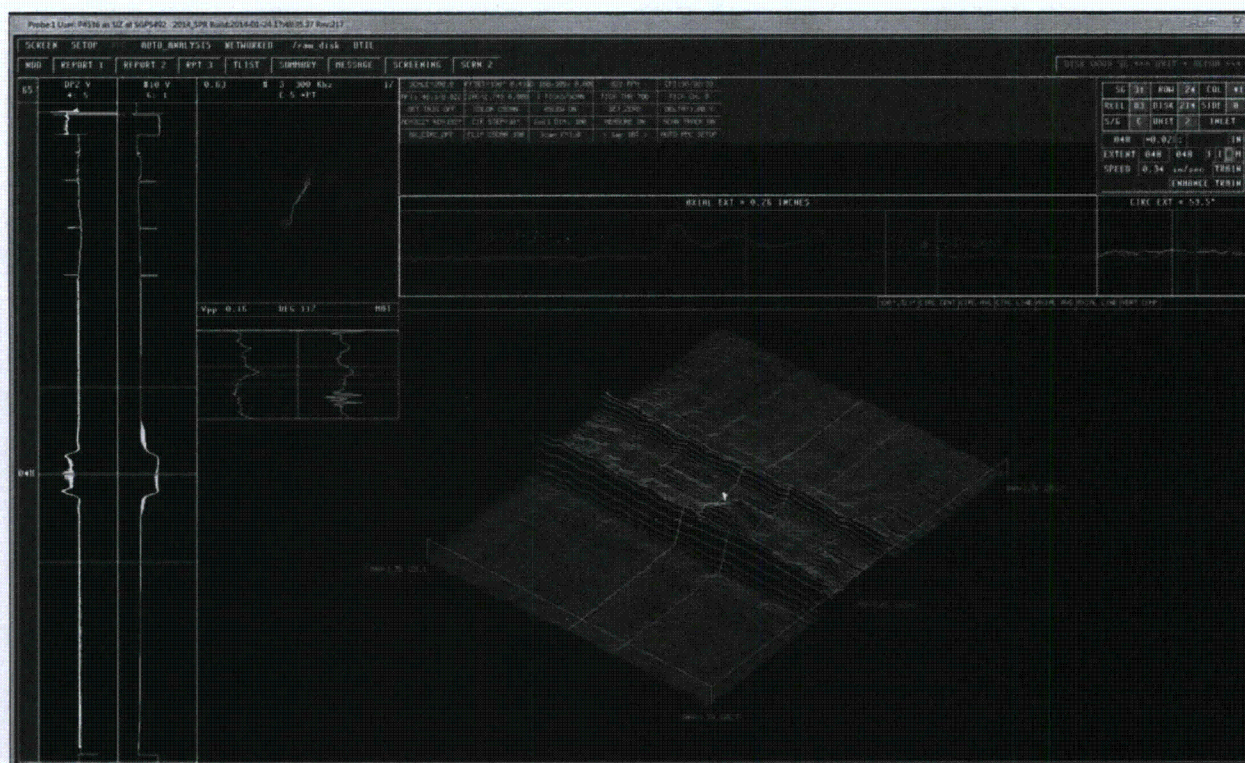
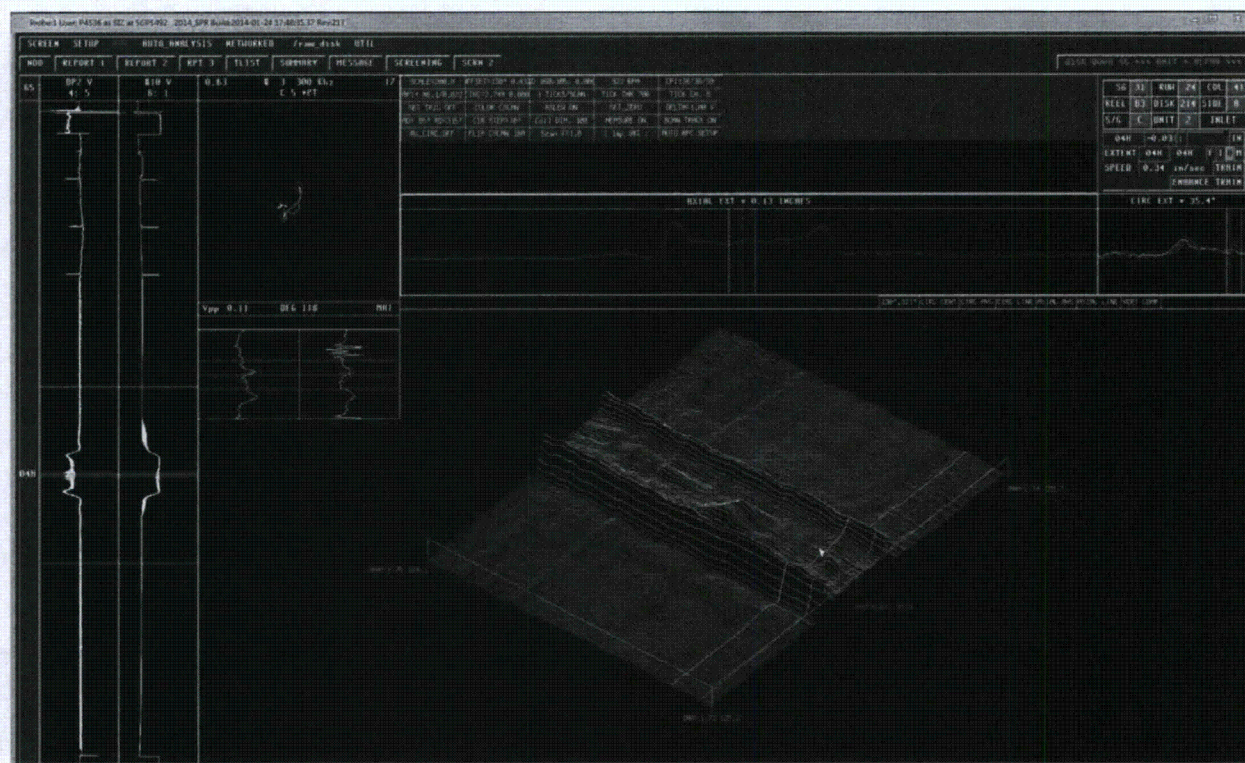
A re-evaluation of the field data collected prior to the tube pulling process was performed. Results of the re-evaluation are consistent to the results reported in the field, except with the interpretation or classification of R24C41 at 04H. The field evaluation reported two separate SAIs for this intersection with both located at the same axial location of the tube. This condition is interpreted as MAIs in the re-evaluation in the laboratory. Results of this field data review are tabulated in Table 3-2. Figure 3-24 through Figure 3-29 illustrate the re-evaluation responses for the bobbin technique and Figure 3-30 through Figure 3-36 for the +Point probe technique.

Figure 3-35: In-Generator +Point Probe – R24C41-6B (04H) – Ligament # 1 – MAI

Figure 3-36: In-Generator +Point Probe – R24C41-6B (04H) – Ligament # 2 – MAI
