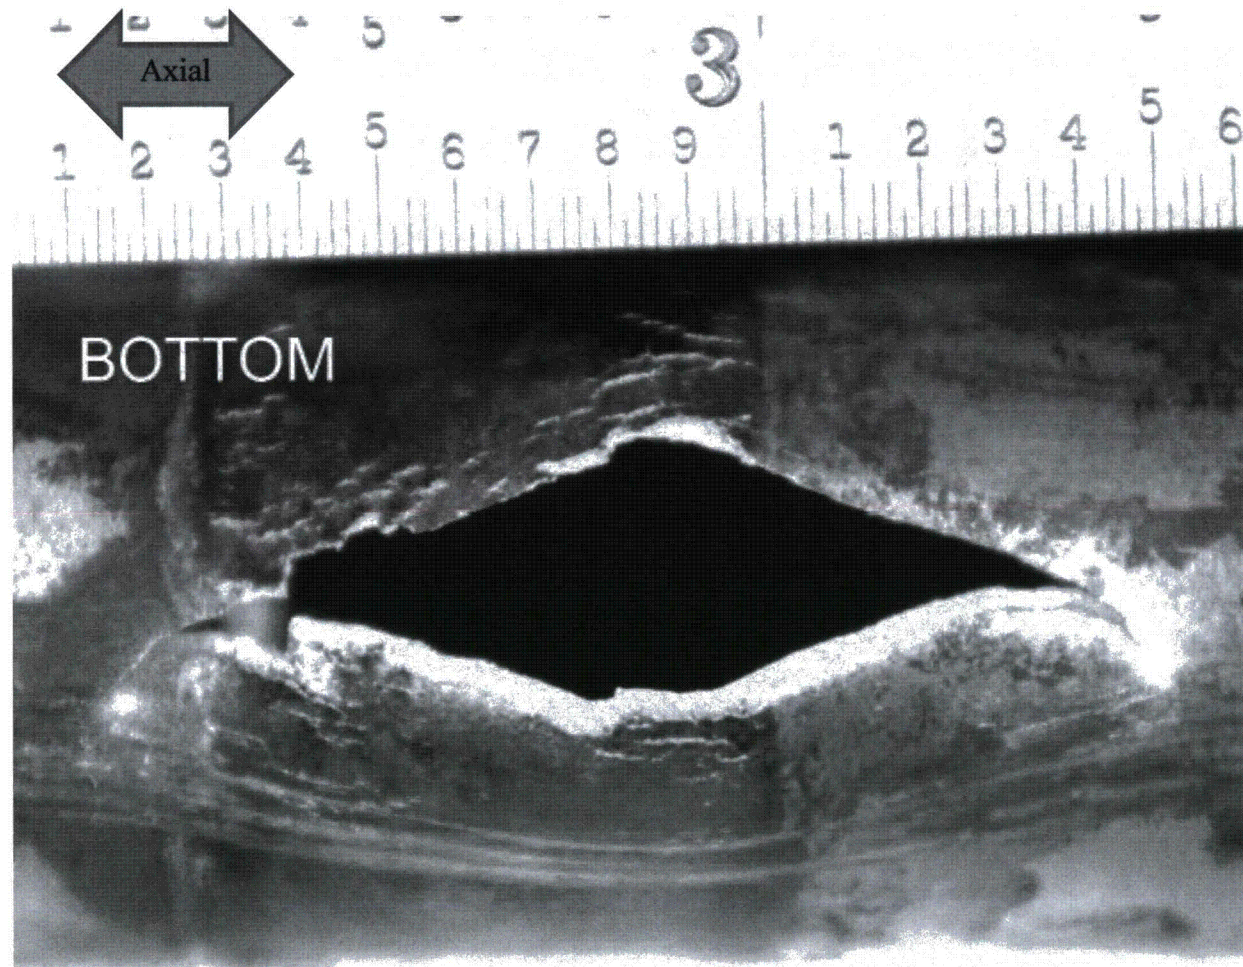
Figure 5-8: Burst Opening at R19C38-3B (02H)

Figure 5-8 through Figure 5-13 present photos of the burst openings. Tearing was confirmed at all burst tips, by microscope, for all six samples, thus (in accordance with Reference 22 criteria) each burst test was considered to be a valid burst test. The 02H region of R19C38 and the 04H region of R24C41 (Figure 5-8 and Figure 5-12, respectively) show secondary cracks outside of the burst opening; the freespan bursts of the other four samples showed no evidence of any cracks.

The 02H TSP region of tube R19C38 burst in the TSP region. The center of the burst was skewed about 0.2 inches above the TSP centerline and the burst opening extended above and below the TSP region. The burst occurred at the 350° orientation. There were several regions of short (<0.15 inch) axial cracks around the circumference, most of which were located near the burst opening. These are shown in the Figure 5-14 diagram. Some of

these short cracks can be seen near the burst opening as shown in Figure 5-8; others are shown in Figure 5-15, Figure 5-16 and Figure 5-17.

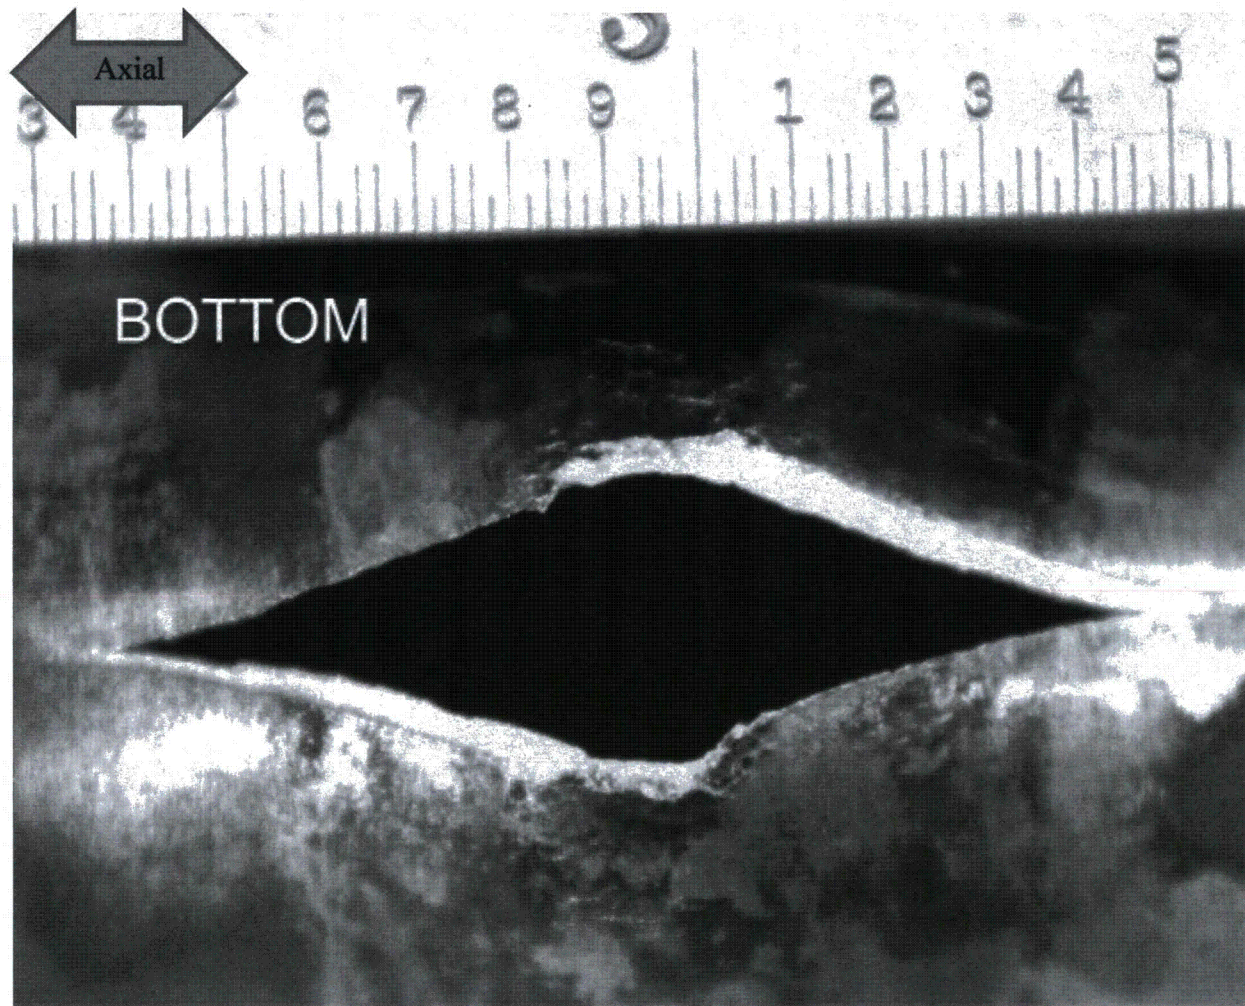
Figure 5-12: Burst Opening at R24C41-6B (04H)

The 04H TSP region of tube R24C41 burst in the TSP region. The center of the burst was aligned with the TSP centerline and the burst opening extended above and below the TSP region. The burst occurred at the 90° orientation. There were several regions of small axial cracks around the circumference, most of which were located near the centerline of the TSP region. There was another region of larger axial cracks, located between 315° and 360°, all within the center third (0.25-inch long) portion of the TSP length. These are shown in the Figure 5-23 diagram. Figure 5-24 and Figure 5-25 show the region of the larger cracks. These cracks are significantly oriented in the axial direction. Figure 5-12 shows some cracking adjacent to the burst opening; Figure 5-26 shows a closer view of these cracks.

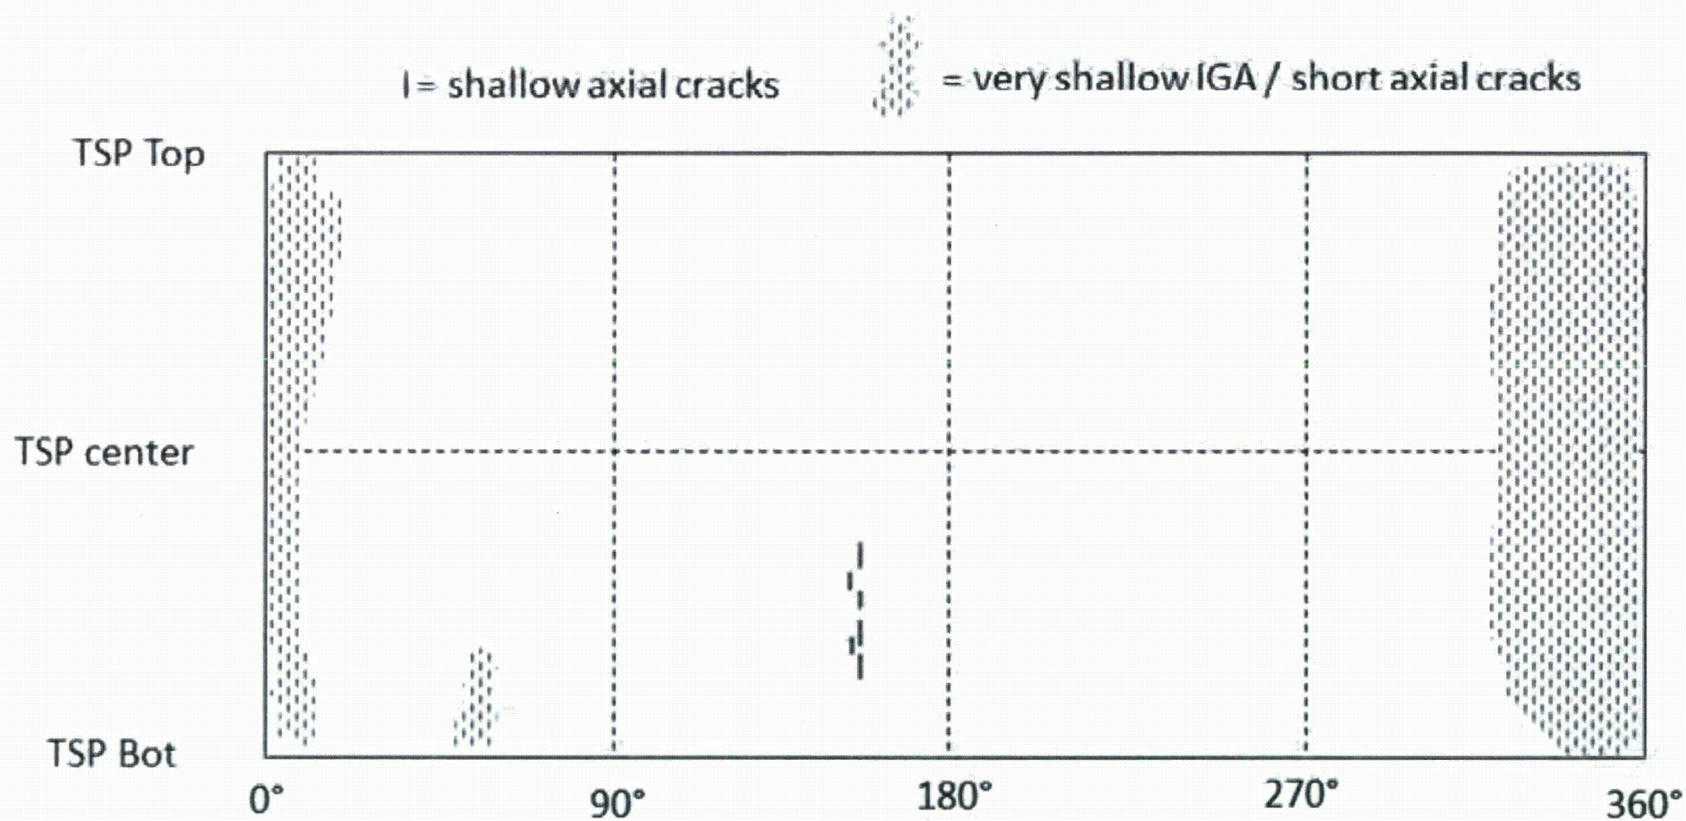
Figure 5-18: Post-Burst Observations on R24C41-3B (02H Region)

The 02H TSP region of tube R24C41 did not have a burst. There was a region of marginally-discernable (shallow) corrosion that was partially obscured by surface deposits, and was either a patch of short axial cracks or IGA. It also had another region with shallow corrosion that was discernable as axial cracks. These are shown in the Figure 5-18 diagram and in the Figure 5-19 photo.

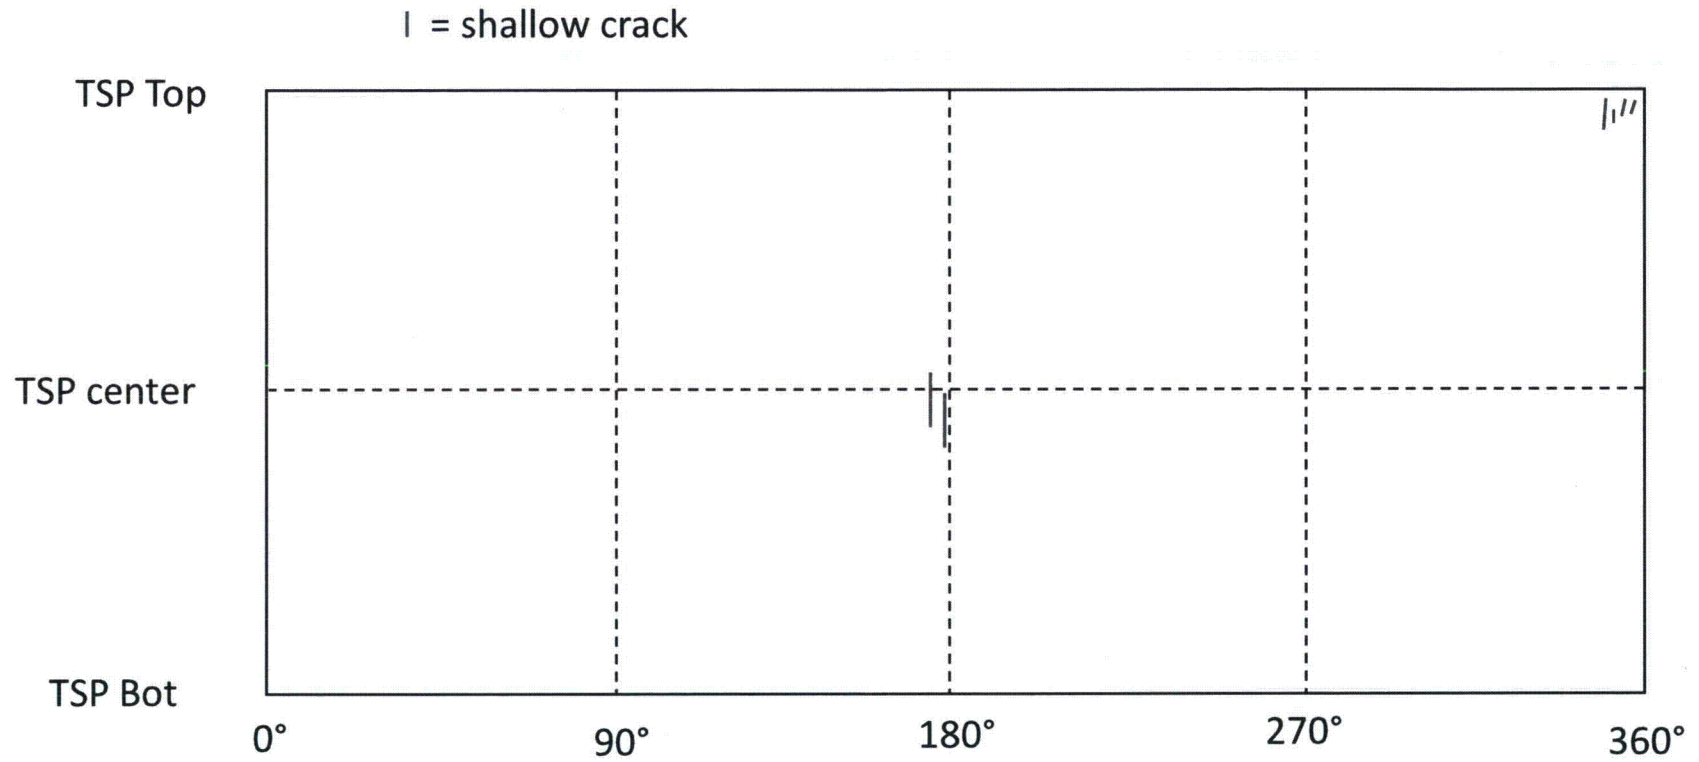
Figure 5-20: Post-Burst Observations on R24C41-5B (03H Region)

The 03H TSP region of tube R24C41 did not have a burst. There were two regions with shallow cracks. These are shown in the Figure 5-20 diagram. The photo in Figure 5-21 shows the shallow axial cracks located near the 180° orientation, as indicated by the two arrows. Figure 5-22 shows the shallow cracks at the top of the TSP region near the 0° orientation. These cracks are all less than 50 mils long and are primarily axial. The axial crack nearest the bottom of Figure 5-22 appears to have a circumferential element, but this is a shadow cast by raised surface deposits and is not a crack.

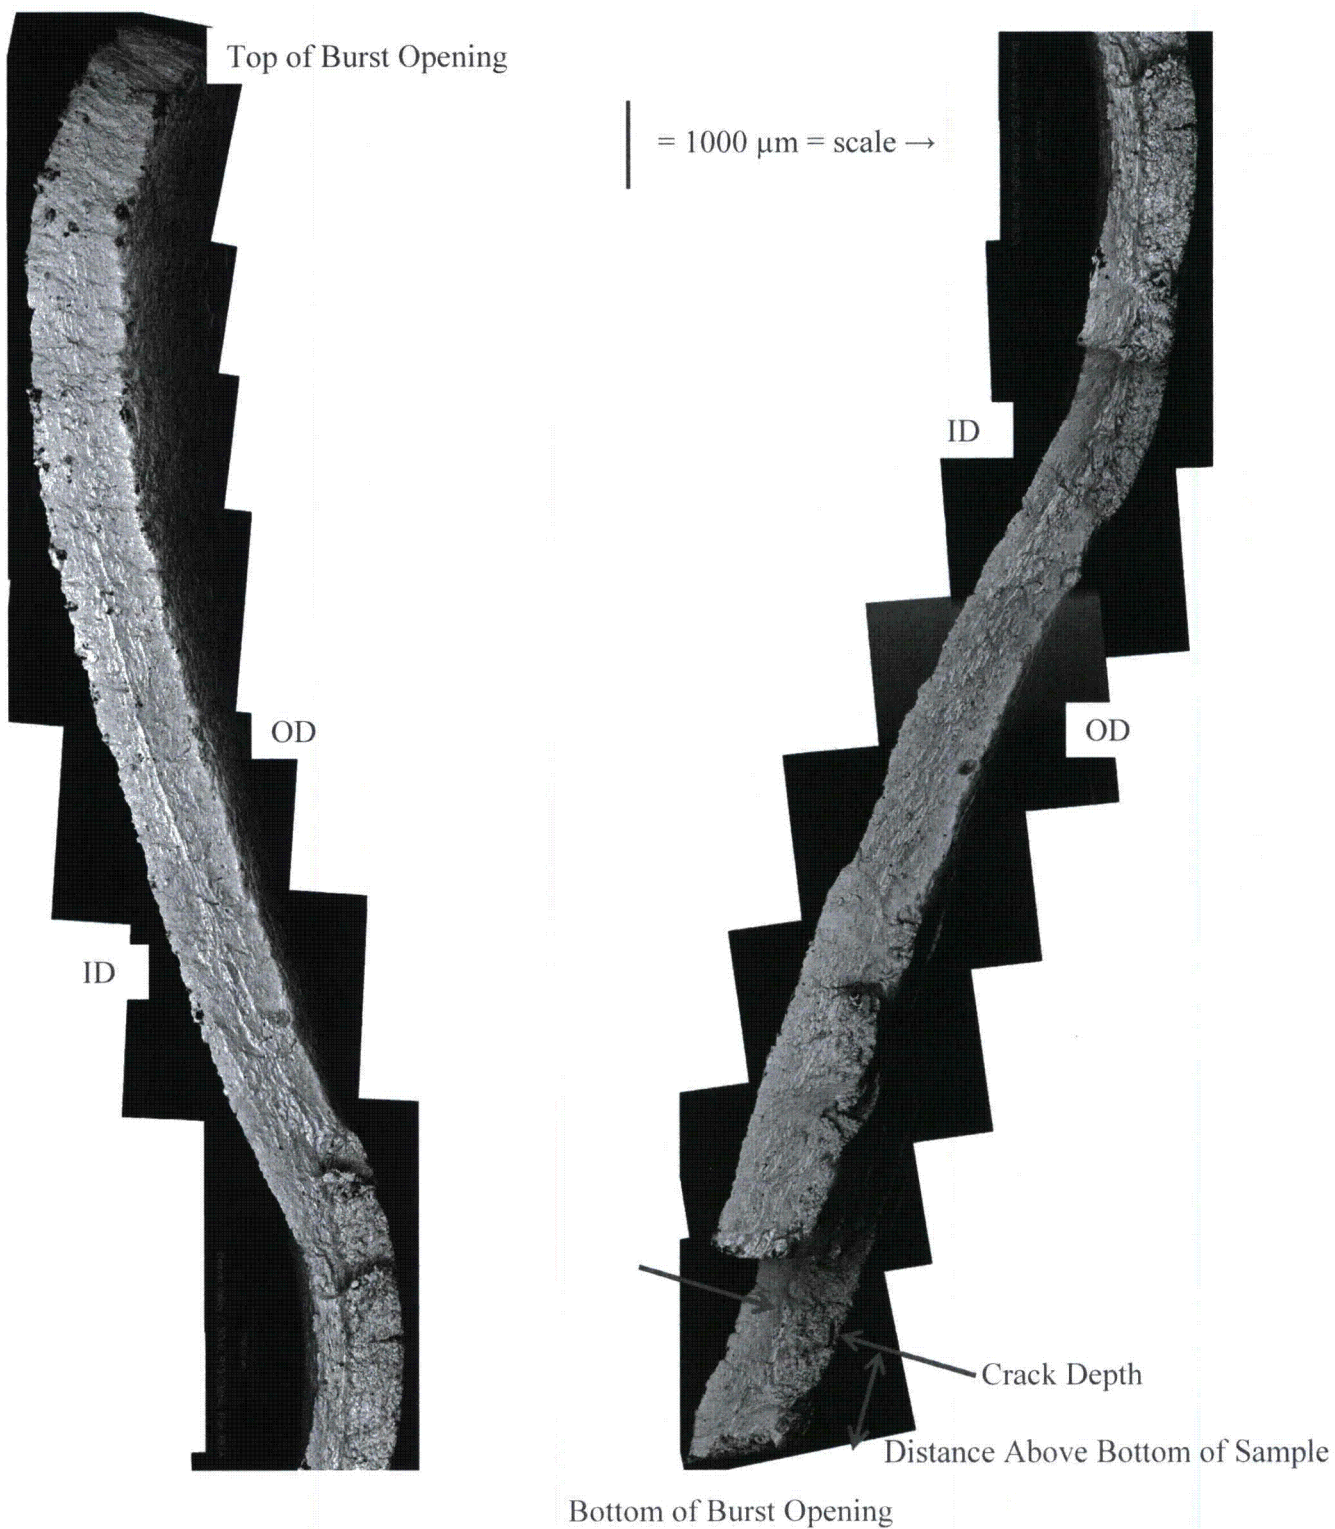
Figure 7-1: SEM Photomontage of R19C38-3B (02H) Burst Opening

Each burst opening was cut from its tube so as to include both the upper burst tip and the lower burst tip in the same sample. Figure 7-1 and Figure 7-2 show low magnification views of the burst opening fractography photomontages for R19C38-3B (02H) and R24C41-6B (04H),

Section	Region of Burst	Crack Length (in)	Maximum Depth (%TW)
R19C38-3B	02H	0.702	49.9
R19C38-4B	Freespan	0	0
R24C41-3B	Freespan	0	0
R24C41-5B	Freespan	0	0
R24C41-6B	04H	0.270	48.6
R24C41-7B	Freespan	0	0

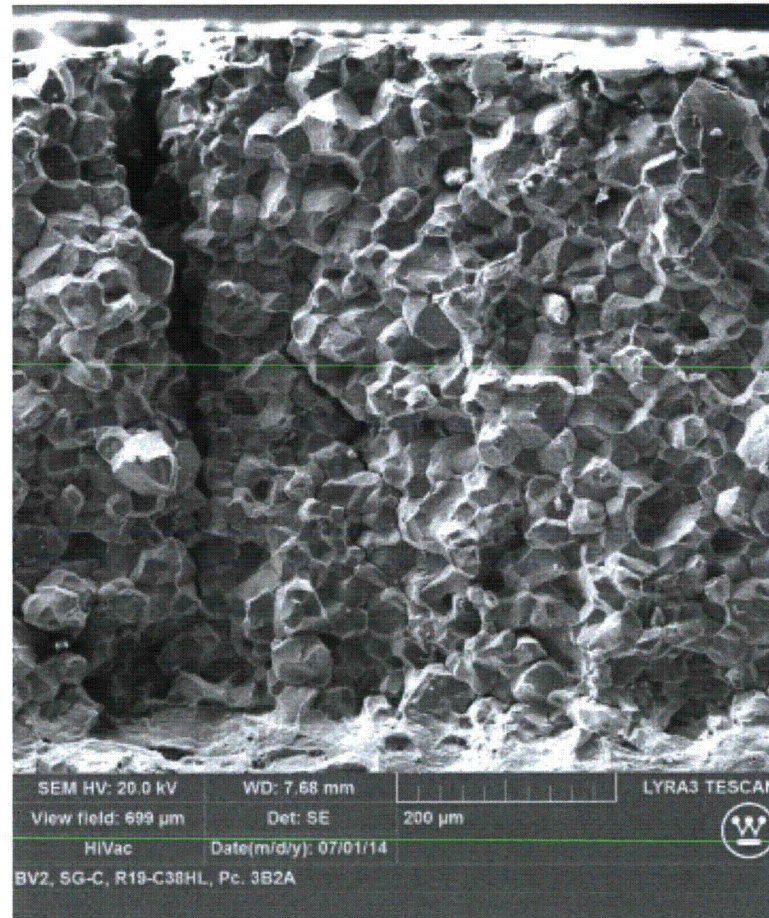
Figure 7-6: Example of R19C38-3B Burst Opening Fracture Surface (Center of Crack)

Figure 7-5 presents an example of the crack surface of the R19C38-3B burst opening. The surfaces having the rock candy appearance is intergranular cracking – this degradation of the tube wall occurred during in-service operation. The dimpled surface is ductile tearing - the part of the tube wall that mechanically failed during the burst test. Figure 7-6 presents another region of the fracture surface with intergranular cracking. The entire R19C38-3B burst opening was composed of ductile tearing and intergranular cracking of varying depth.

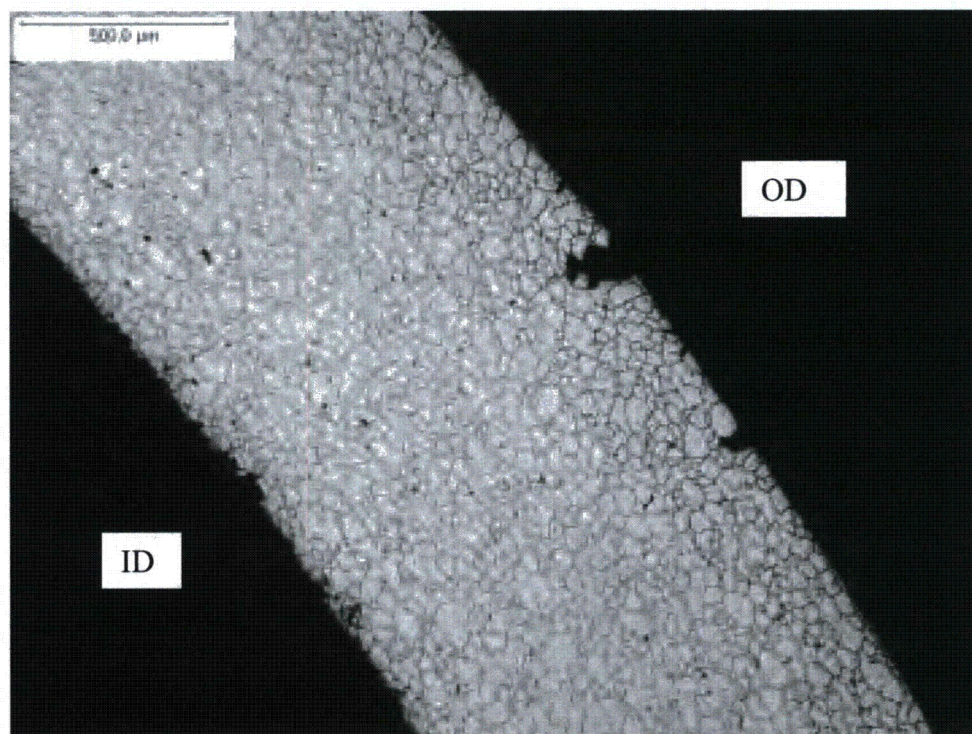
Figure 8-5: R24C41 02H, Transverse Section: Cracks at 20°

Figure 8-5 shows the 20° location of Marker ‘1’. It shows two shallow axial ODSCC, without any IGA. The maximum depth shown is 11.3%TW.

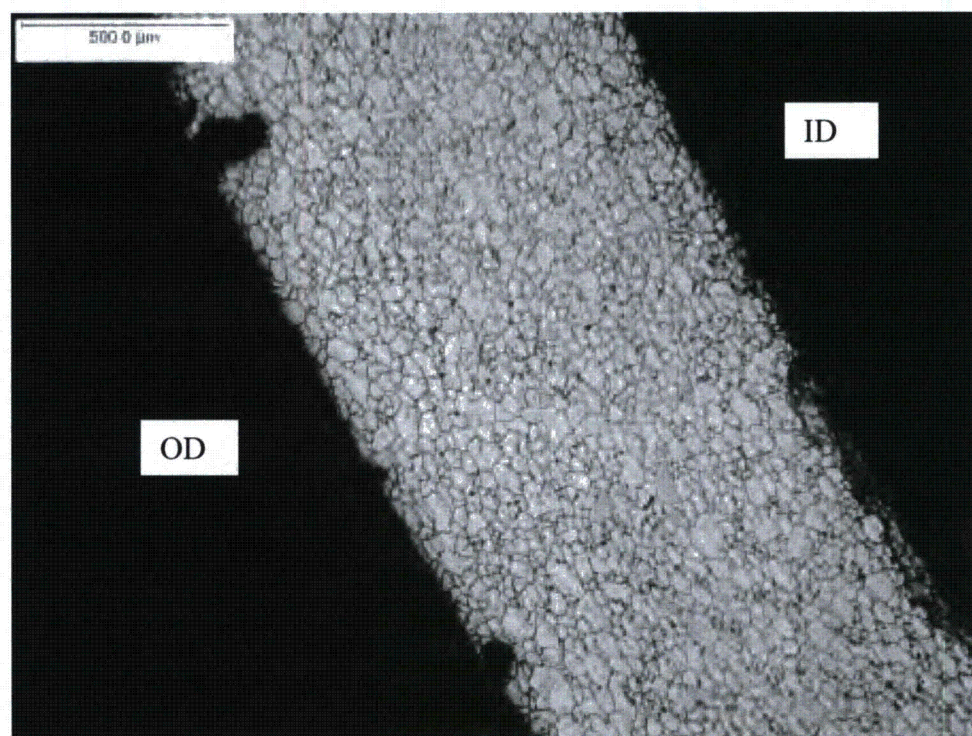
Figure 8-6: R24C41 02H, Transverse Section: Cracks at 160°

Figure 8-6 shows the 160° location of Marker ‘2’. It shows three shallow axial ODSCC, without any IGA. The maximum depth shown is 14.2%TW.

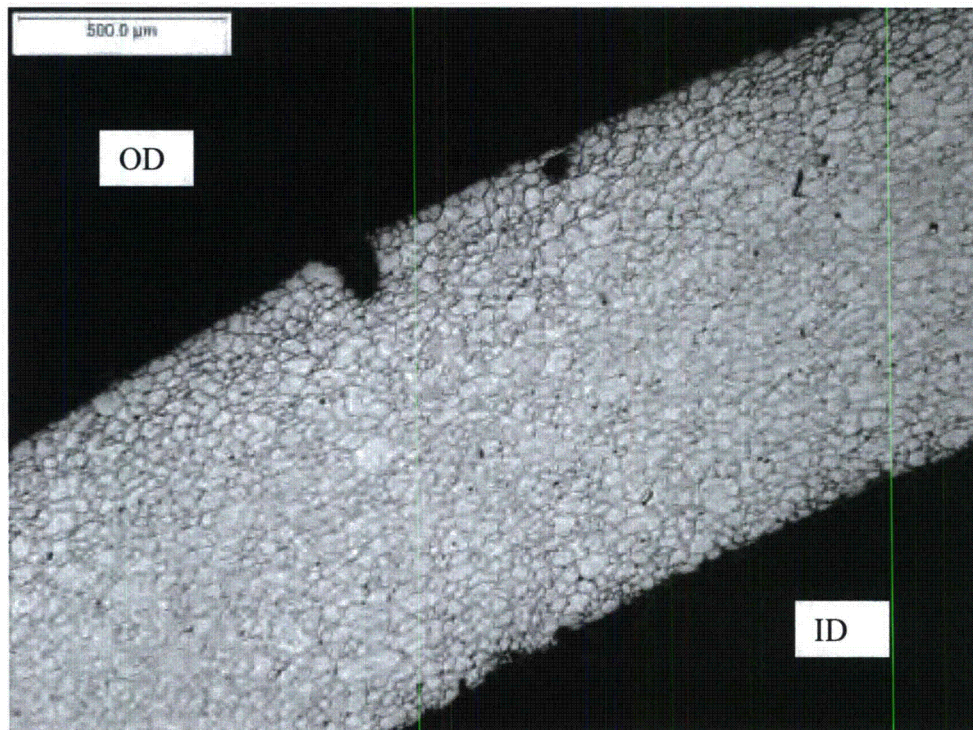
Figure 8-7: R24C41 02H, Transverse Section: Cracks at 340°

Figure 8-7 shows the 340° location of Marker ‘3’. It shows two shallow axial ODSCC, without any IGA. The maximum depth shown is 10.7%TW.

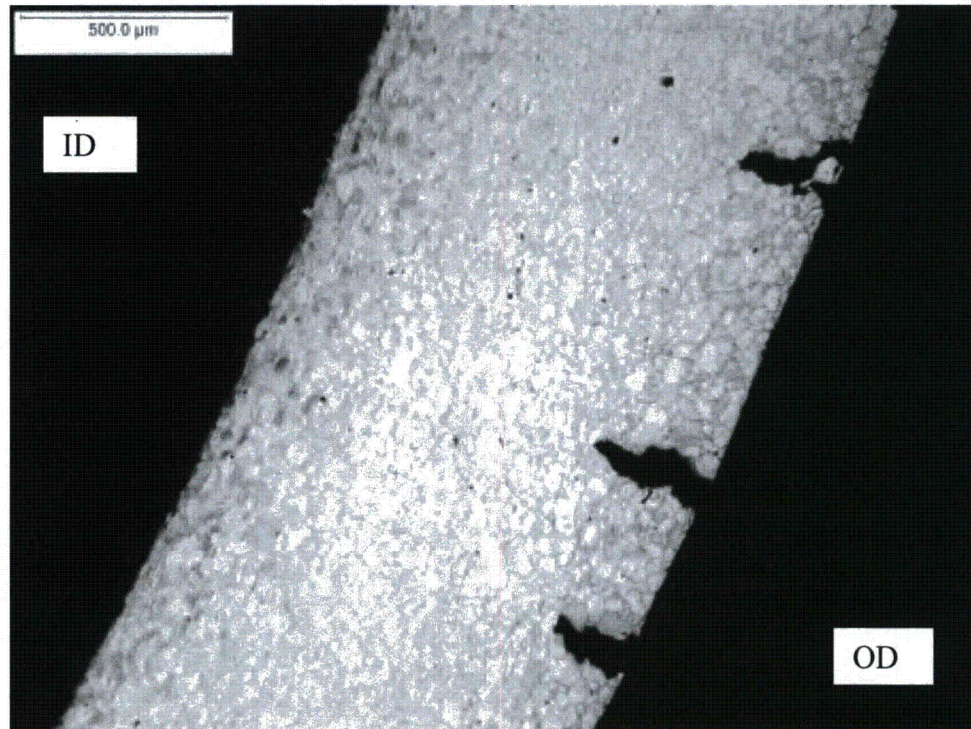
Figure 8-13: R24C41 04H, Transverse Section: Cracks at 350°

Figure 8-13 shows the 350° location of Marker '3'. It shows several axial ODSCC cracks, without any IGA. The maximum crack depth shown is 35.2%TW.

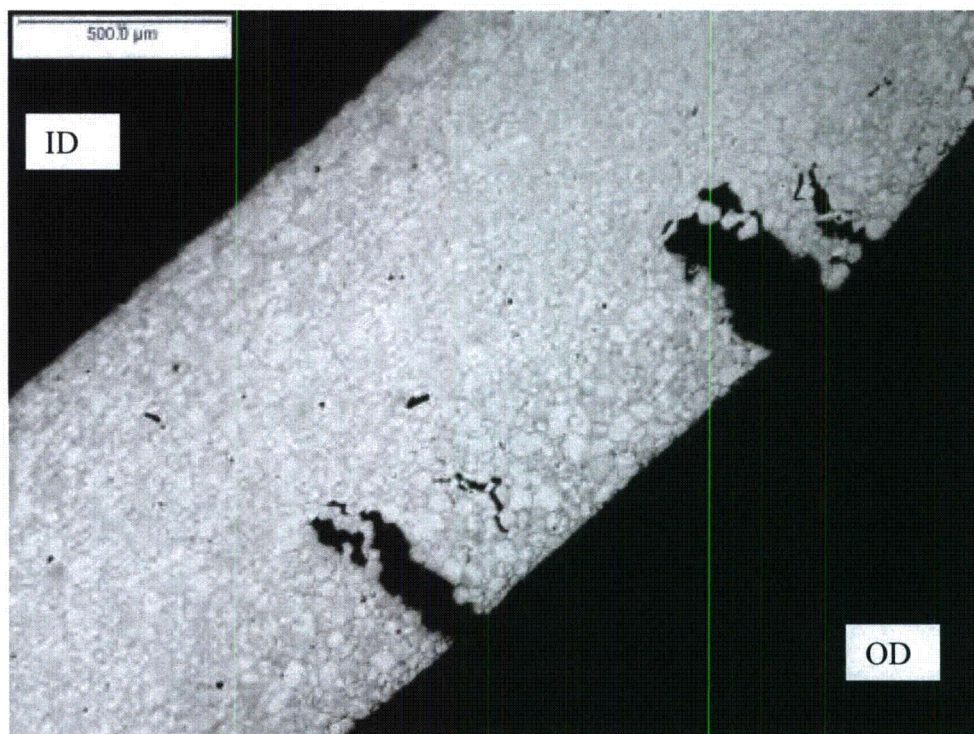
Figure 8-14: R24C41 04H, Transverse Section: Cracks at 325°

Figure 8-14 shows the 325° location of Marker '4'. It shows several axial deep ODSCC cracks, without any IGA. The maximum crack depth shown is 40.8%TW.

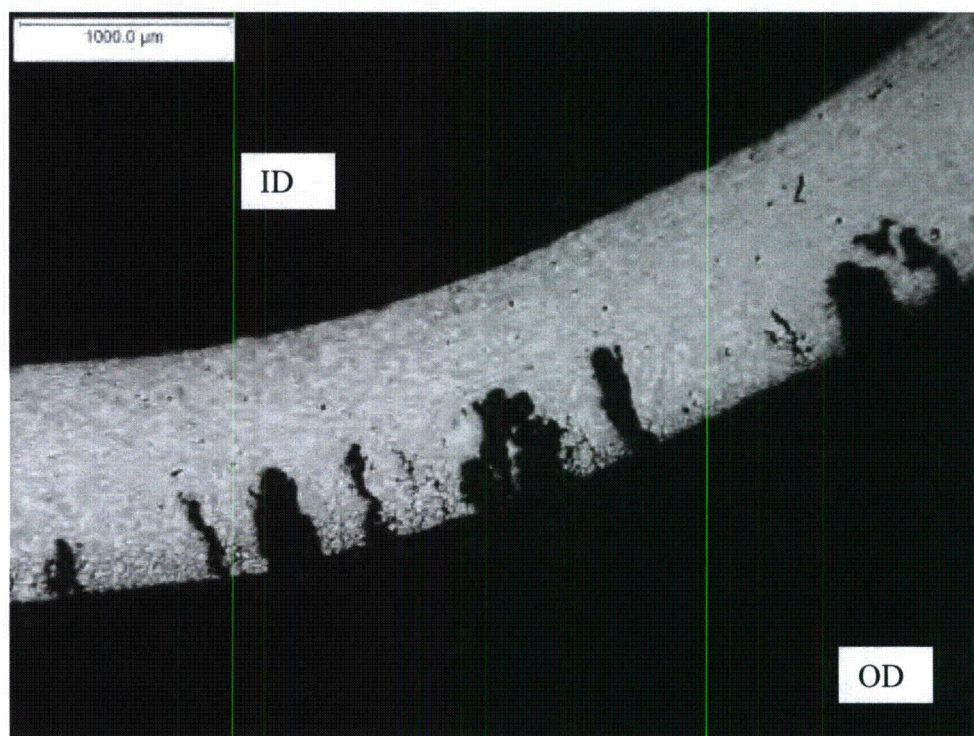
Figure 8-15: R24C41 04H, Transverse Section: Cracks at 305°

Figure 8-15 shows the 305° location of Marker '5'. It shows several axial deep ODSCC cracks, without any IGA. The maximum crack depth shown is 45.4%TW.

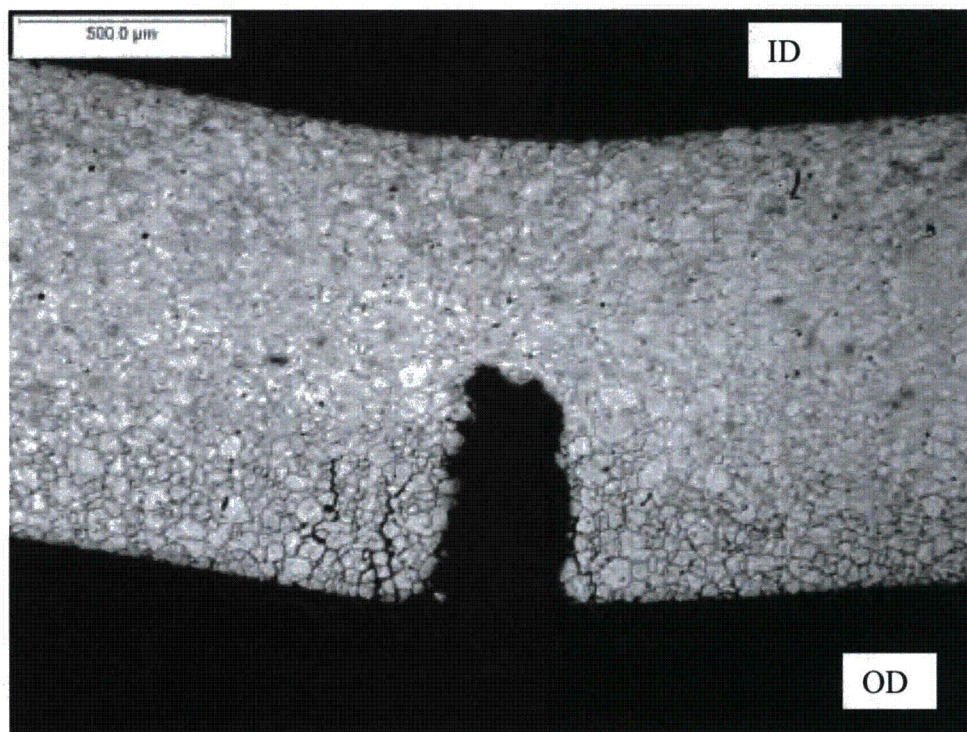
Figure 8-16: Cracks Further Characterized by Metallography (305°-350°)

Many of the cracks in the 305°-350° region approached the maximum crack depth in the burst fracture (48.6%TW). This region had a laboratory +Point/Ghent probe indication (at the 333°/336° locations, respectively) that likely corresponded with one of the field +Point indications (see Table 3-2). Consequently, another series of levels were examined to characterize the crack depths. The mounted sample was ground/polished and etched another eleven levels. The five largest cracks had depths measured along their lengths. Figure 8-16, which is a merger of Figure 5-24 and Figure 5-25, shows the cracks that were further characterized. Figure 8-17 provides a plot of the crack depths. The 350° orientation had a maximum depth of 46%TW at the 20 mil level (Figure 8-18).
