2.5 Central Processing Facility (License Renewal Environmental Assessment in Progress)

Since mining activities in the CBR current license area have been ongoing since the NRC issued the original license (ca. 1990) and are nearly complete in terms of additional wells to be drilled, the team conducted a limited site visit the morning of October 24, 2012, followed by a meeting in the project offices. The field visit focused on some archaeological sites that had been previously recorded and evaluated as potentially eligible for listing on the NRHP, particularly on the CBR protective management practices for such sites during operations.

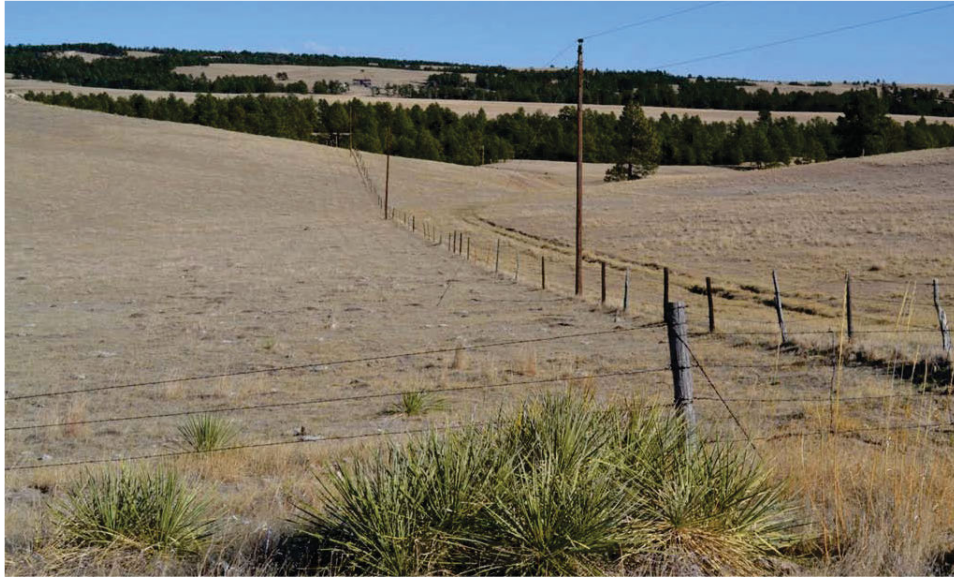
Figure 11. MEA. Top: View from county road along the western section line of Section 13, NE 1/4, T. 29 N, R. 51 W, looking northeast. The proposed satellite facility building will be located in the upper center of the image. Bottom: View to the east, taken about 1.5 miles north of the top photograph. (Photos: PRN, October 23, 2012)

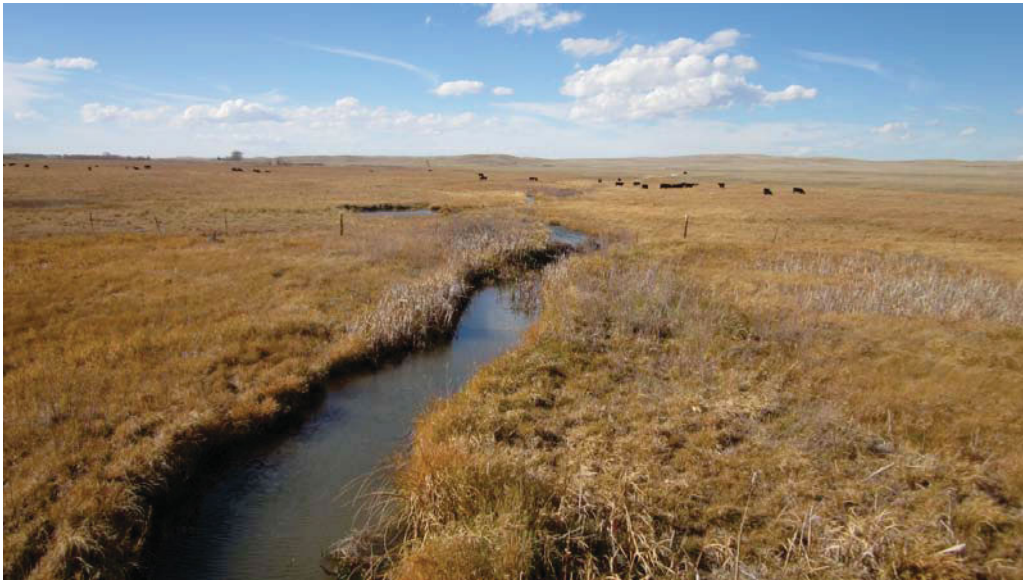
The Niobrara River is located about a mile to the southwest of MEA (**Figure 12**).

Figure 12. The Niobrara River; photograph taken approximately 1 mile to the southwest of the MEA. (Photo: DB, October 23, 2012)

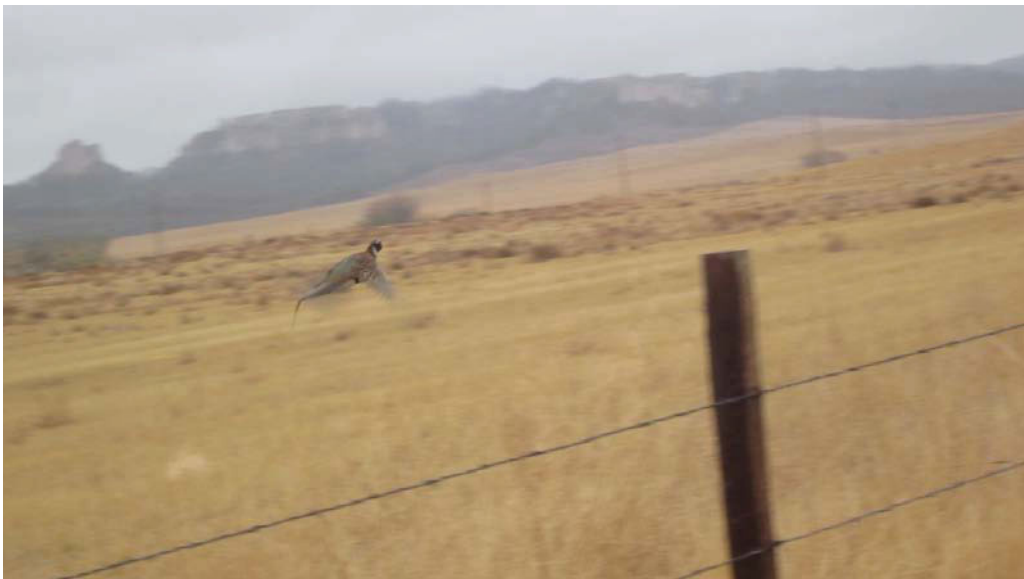
Figure 21. Pheasant flying at the CPF. (Photo: DB, October 24, 2012)

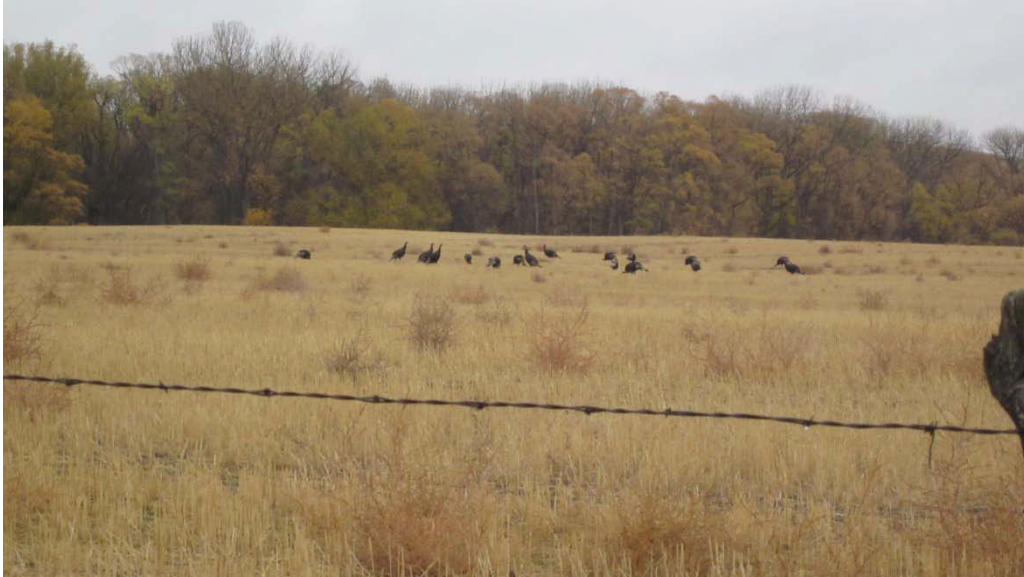
Figure 22. Turkeys grazing on the CPF. (Photo: DB, October 24, 2012)
