Fort Calhoun Station, Unit No. 1
Renewed Facility Operating License No. DPR-40
NRC Docket No. 50-285

Subject: Omaha Public Power District (OPPD) Response to NRC Request for
Additional Information Regarding Relief Request RR-14

REQUEST FOR ADDITIONAL INFORMATION
RELIEF REQUEST NUMBER RR-14
ALTERNATIVE INSPECTION OF REACTOR VESSEL
CLOSURE HEAD WITH RESPECT TO ASME
CODE CASE N-729-1 AS CONDITIONED BY 10CFR50.55A
OMAHA PUBLIC POWER DISTRICT
DOCKET NUMBER 50-285

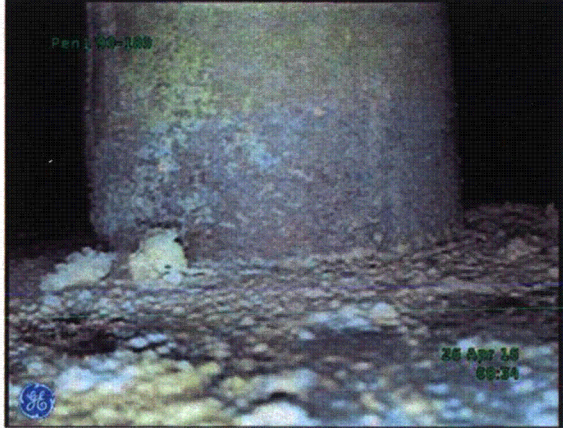
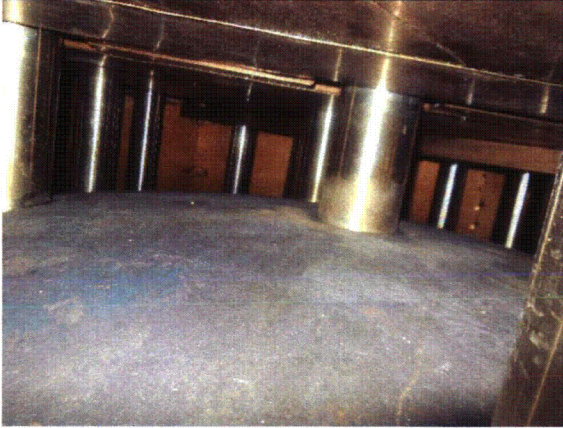
CEDM Nozzle 1	As-Found	As-Left
<p>Question 1 (a) Buildup of discolored deposits around and on nozzle (b) Relevant</p> <p>Question 2 (b) Deposits show flow conditions from above with visible leakage indications from insulation. Deposits have yellowish tint to them. Known CCW leak from flex hose near CEDM 3 and 8 in upper seal housing flowing down CEDM 3 and 8 and pooling on insulation and further leakage on reactor vessel head near surrounding penetrations. See plan view of page one of Attachment 2. Post vacuuming VE showed no sign of degradation/nozzle leakage. (c) Sample not performed.</p> <p>Question 3 N/A - Relevant</p> <p>Question 4 N/A – Relevant with an evaluation per - 3142.1(b)(1) of CC N-729-1 *Leak Source determined CCW Flex Hose leak near CEDM 3/8 (WR #224908)*</p>

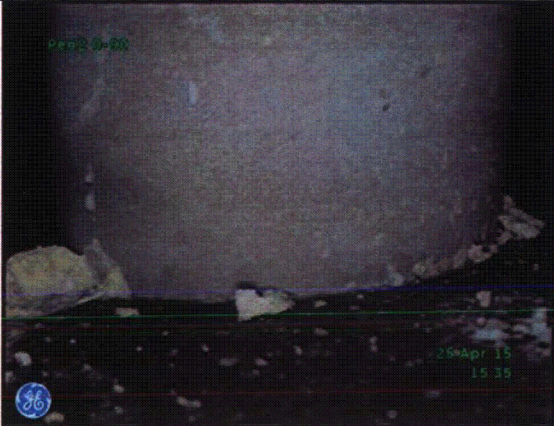
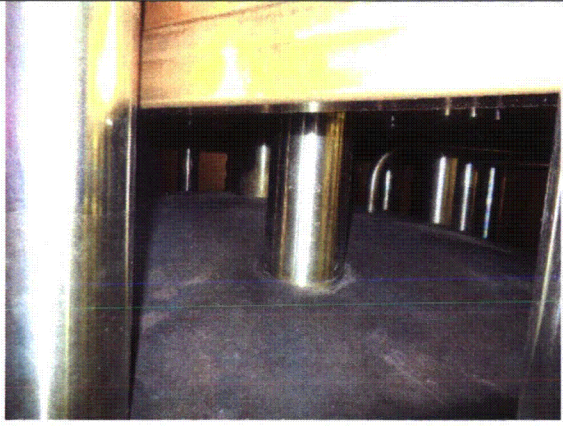
CEDM Nozzle 2	As-Found	As-Left
<p>Question 1 (a) Buildup of discolored deposits around and on nozzle (b) Relevant</p> <p>Question 2 (b) Deposits show flow conditions from above with visible leakage indications from insulation. Deposits have yellowish tint to them. Known CCW leak from flex hose near CEDM 3 and 8 in upper seal housing flowing down CEDM 3 and 8 and pooling on insulation and further leakage on reactor vessel head near surrounding penetrations. See plan view of page one of Attachment 2. Post vacuuming VE showed no sign of degradation/nozzle leakage. (c) Sample not performed.</p> <p>Question 3 N/A - Relevant</p> <p>Question 4 N/A – Relevant with an evaluation per - 3142.1(b)(1) of CC N-729-1 *Leak Source determined CCW Flex Hose leak near CEDM 3/8 (WR #224908)*</p>

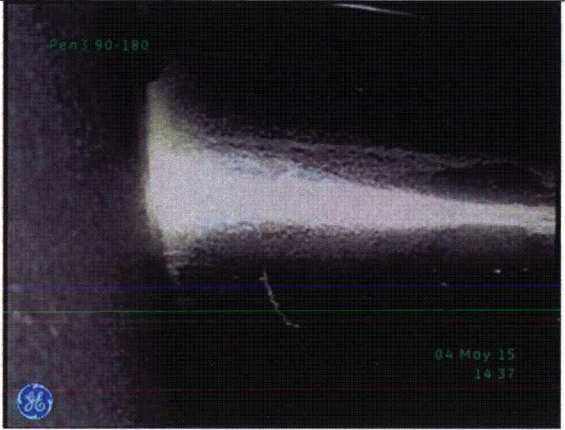
CEDM Nozzle 3	As-Found	As-Left
<p>Question 1 (a) Buildup of discolored deposits around and on nozzle (b) Relevant</p> <p>Question 2 (b) Deposits show flow conditions from above with visible leakage indications from insulation. Deposits have yellowish tint to them. Known CCW leak from flex hose near CEDM 3 and 8 in upper seal housing flowing down CEDM 3 and 8 and pooling on insulation and further leakage on reactor vessel head near surrounding penetrations. See plan view of page one of Attachment 2. Post vacuuming VE showed no sign of degradation/nozzle leakage. (c) Sample not performed.</p> <p>Question 3 N/A - Relevant</p> <p>Question 4 N/A – Relevant with an evaluation per - 3142.1(b)(1) of CC N-729-1 *Leak Source determined CCW Flex Hose leak near CEDM 3/8 (WR #224908)*</p>

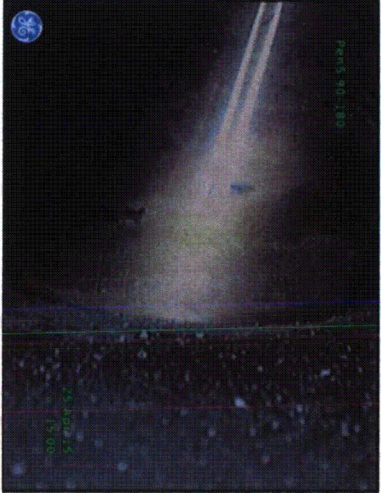
CEDM Nozzle 5	As-Found	As-Left
<p>Question 1 (a) Light Boric Acid dust accumulation around annulus (b) Initial Evaluation as Not Relevant later re-evaluated as Relevant</p> <p>Question 2 (b) See Answer 3 (c) Sample not performed.</p> <p>Question 3 The photos from the initial bare metal inspection on all four sides show a small amount of light dust residue collected around the penetration annulus, more concentrated in the downslope side in the protective leeward side of the penetration nozzle. There is light discoloration of the nozzle itself on the 90-180 view. The granule paths in the dust show that drifting has occurred downslope on the RVH, as one would expect from blown dust on a sloped surface.</p> <p>Question 4 See Answer 3 for basis of not evaluating per -3142.1(b)(1) of CC N-729-1 *Leak Source determined RC-100 packing leak (WO #551054)*</p>

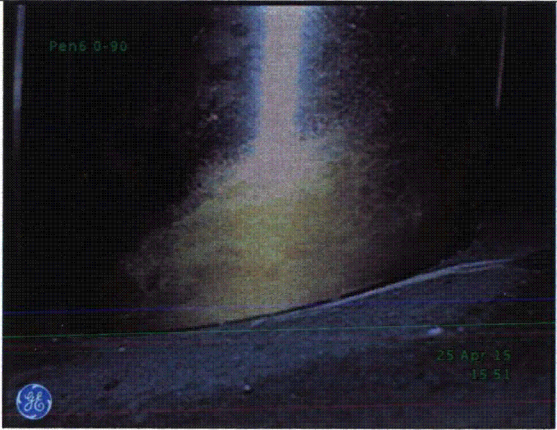
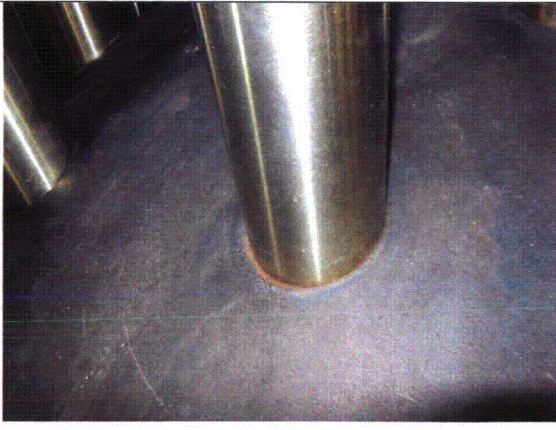
CEDM Nozzle 6	As-Found	As-Left
<p>Question 1 (a) Little to no residue accumulation. Slight discoloration around nozzle. (b) Initial Evaluation as Not Relevant later re-evaluated as Relevant</p> <p>Question 2 (b) See Answer 3 (c) Sample not performed.</p> <p>Question 3 Photos from the 0-90 and 90-180 views of the initial bare metal inspection show little-to-no residue or dust collected around the penetration annulus. The nozzle itself is clean, albeit lightly discolored on the bottom and with a large glare from the camera flash. The annulus itself appears slightly lighter than surrounding bare metal, but no accumulation or BA crystals are present.</p> <p>Question 4 See Answer 3 for basis of not evaluating per -3142.1(b)(1) of CC N-729-1 *Leak Source determined RC-100 packing leak (WO #551054)* *Post Cleaning VE determined acceptable*</p>

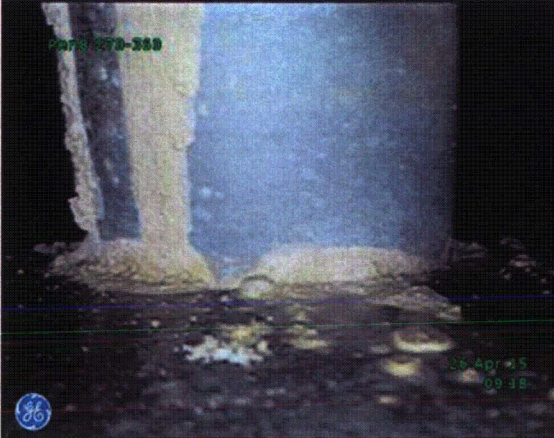
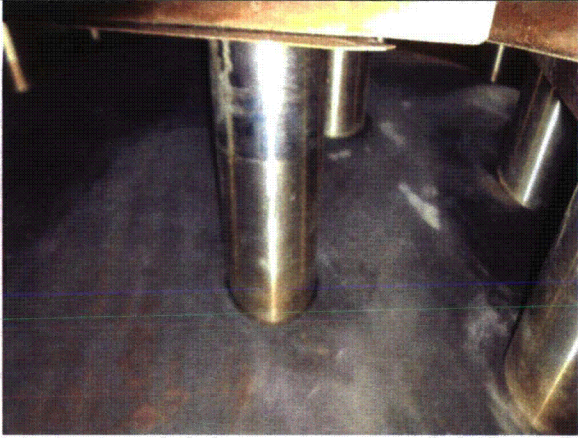
CEDM Nozzle 8	As-Found	As-Left
<p>Question 1 (a) Buildup of discolored deposits around and on nozzle (b) Relevant</p> <p>Question 2 (b) Deposits show flow conditions from above with visible leakage indications from insulation. Deposits have yellowish tint to them. Known CCW leak from flex hose near CEDM 3 and 8 in upper seal housing flowing down CEDM 3 and 8 and pooling on insulation and further leakage on reactor vessel head near surrounding penetrations. See plan view of page one of Attachment 2. (c) See chemistry description at end of report.</p> <p>Question 3 N/A - Relevant</p> <p>Question 4 N/A – Relevant with an evaluation per - 3142.1(b)(1) of CC N-729-1 *Leak Source determined CCW Flex Hose leak near CEDM 3/8 (WR #224908)*</p>

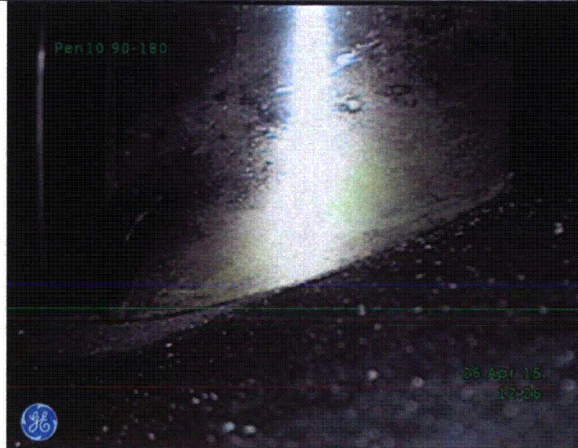
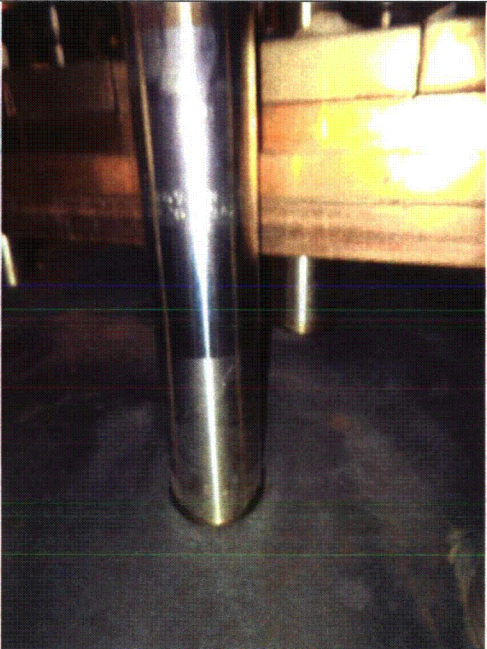
CEDM Nozzle 10	As-Found	As-Left
<p>Question 1 (a) Small amount of dust accumulation (b) Initial Evaluation as Not Relevant later re-evaluated as Relevant</p> <p>Question 2 (b) See Answer 3 (c) Sample not performed.</p> <p>Question 3 The initial bare metal inspection photos document no large accumulations or deposits of residue. The 0-90 and 90-180 views show no accumulation of any residue on the upslope portion and sides of the penetration; the darker bare metal of the RVH is clearly apparent. A small amount of dust residue is shown accumulated in the downslope side penetration. What may be a light discoloration of the very bottom of the penetration nozzle can be seen in the photos.</p> <p>Question 4 See Answer 3 for basis of not evaluating per -3142.1(b)(1) of CC N-729-1 *Leak Source determined RC-100 packing leak (WO #551054)* *Post Cleaning VE determined acceptable*</p>

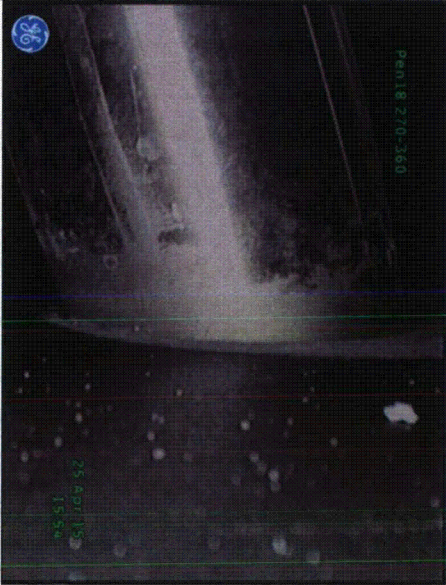
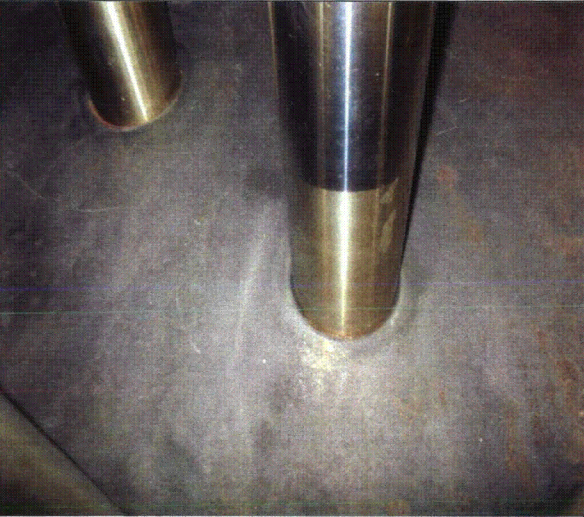
CEDM Nozzle 18	As-Found	As-Left
<p>Question 1 (a) Indication of small amounts of dust deposits on side and base of penetration. No corrosion. Yellow film on housing is from CCW. (b) Initial Evaluation as Not Relevant later re-evaluated as Relevant</p> <p>Question 2 (b) See Answer 3 (c) Sample not performed.</p> <p>Question 3 The initial bare metal inspection photos document no large accumulations or deposits of residue. The yellow stain on the CEDM housing is indicative of CCW. A light dust residue and loose particles is shown to have settled in the annulus region on the upslope side of the penetration where it is relatively protected from air currents and cannot drift down slope in any vibration-induced drift. This residue extends downslope along the penetration sides where it has been able to drift down. Again, from this view there are no large deposits or any large stains. There is slight discoloration of the bottom of the nozzle and a very small accumulation of heavier residue in the down slope of the penetration, but neither is indicative of a BA leak source from the penetration.</p> <p>Question 4 See Answer 3 for basis of not evaluating per -3142.1(b)(1) of CC N-729-1 *Leak Source determined CCW Flex Hose leak near CEDM 3/8 (WR #224908)* *Post Cleaning VE determined acceptable*</p>

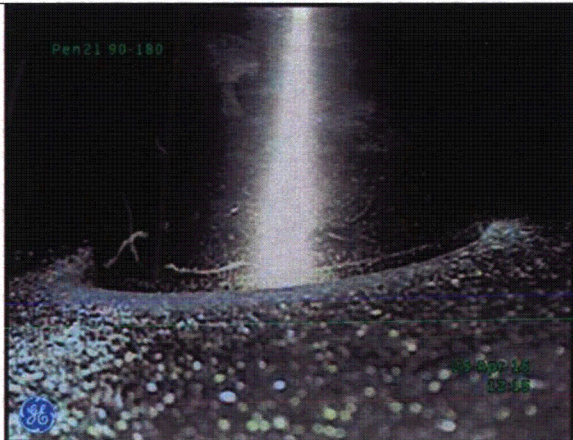
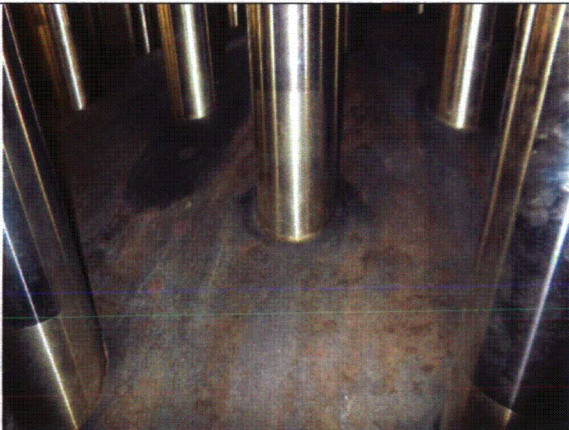
CEDM Nozzle 21	As-Found	As-Left
<p>Question 1 (a) Indication of possible Boric Acid deposits on base of penetration (b) Relevant</p> <p>Question 2 (b) Deposits indicate light dusting in a blowing fashion in the direction of 90-180 degree. Known RCS leak from RC-100 packing near CEDM #21 in the 270-360 degree direction. Dusting due to blown leakage from RC-100. (c) Sample not performed.</p> <p>Question 3 N/A - Relevant</p> <p>Question 4 N/A – Relevant with an evaluation per - 3142.1(b)(1) of CC N-729-1 *Leak Source determined RC-100 packing leak (WO #551054)*</p>

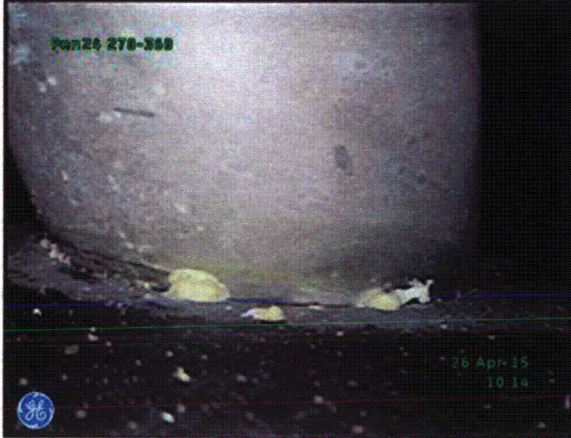
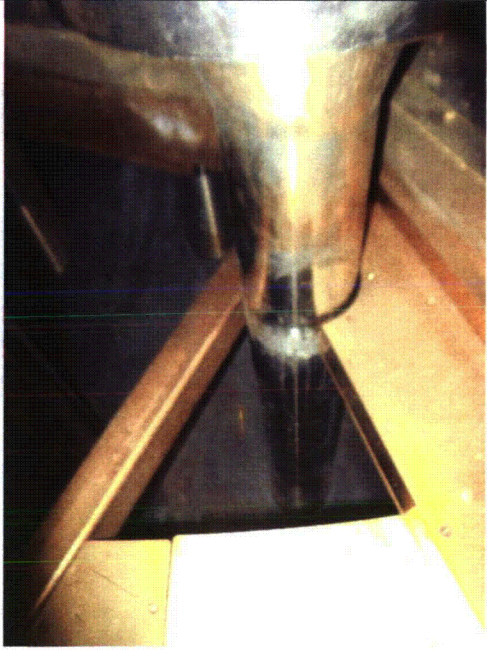
CEDM Nozzle 24	As-Found	As-Left
<p>Question 1 (a) Indication of possible Boric Acid deposits on base of penetration (b) Relevant Question 2 (b) Deposits indicate leakage flow down the head past the penetration. The leak path appears to be up the curvature of the head from the penetration. The leak source appears to be the known CCW leak from the flex hose near CEDM 3 and 8 in upper seal housing. This appears to be flowing down CEDM 3 and 8, which is pooling on insulation. (c) Sample not performed. Question 3 N/A - Relevant Question 4 N/A – Relevant with an evaluation per - 3142.1(b)(1) of CC N-729-1 *Leak Source determined CCW Flex Hose leak near CEDM 3/8 (WR #224908)*</p>

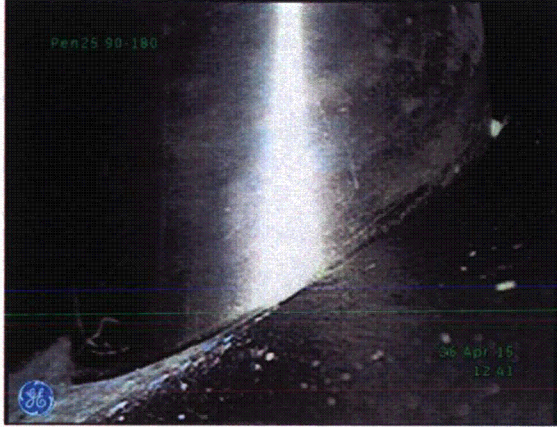
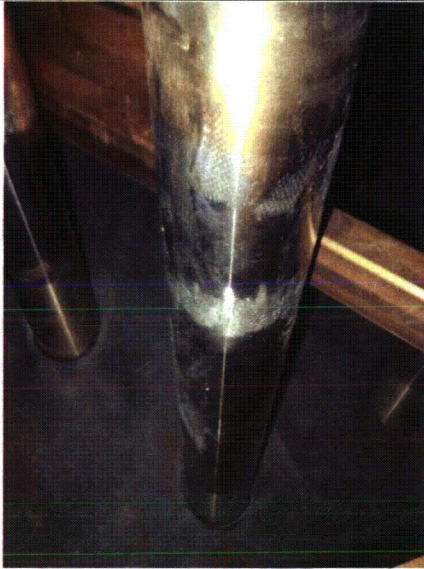
CEDM Nozzle 25	As-Found	As-Left
<p>Question 1 (a). Indication of possible Boric Acid deposits on base of penetration. (b). Relevant</p> <p>Question 2 (b). Deposits are of light dusting showing indication of being blown around penetration and collecting on one side. (c) See chemistry description at end of report.</p> <p>Question 3 N/A - Relevant</p> <p>Question 4 N/A – Relevant with an evaluation per - 3142.1(b)(1) of CC N-729-1 *Leak Source determined RC-100 packing leak (WO #551054)*</p>

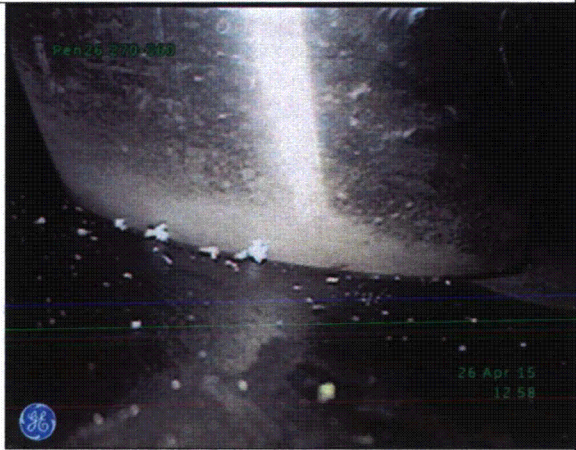
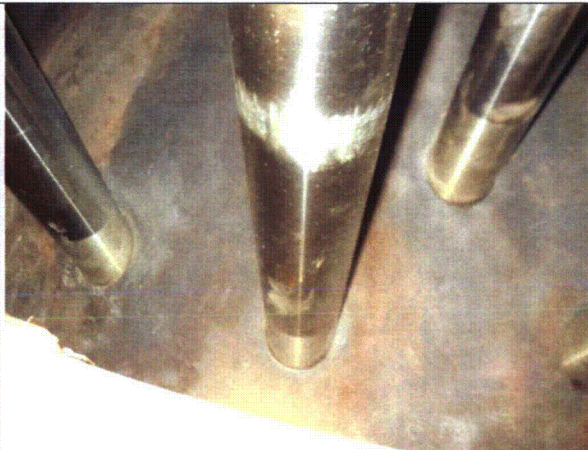
CEDM Nozzle 26	As-Found	As-Left
<p>Question 1 (a). Indication of small amounts of dust deposits on side and base of penetration. No corrosion. Yellow film is indicative of CCW. (b). Initial Evaluation as Not Relevant later re-evaluated as Relevant</p> <p>Question 2 (b). See Answer 3 (c) Sample not performed.</p> <p>Question 3 The initial bare metal inspection photos document no large accumulations or deposits of residue. There is no residue shown on the sides or upslope portion of the penetration nozzle, although residue dust has collected down slope in the protective leeward side of the penetration and there are a few small granules pictured in the 270-360 view. There are no leaks from above; the granules appear to have settled after drifting downslope on the RVH. A series of white marks are visible in the 180-270 view that appear to be small scrapes with white BA dust residue caught in them. The penetration is very close to the edge of the RVH and ICI penetration 45. The scratch marks appear to have no depth and there is no leakage or staining originating from them or present in their vicinity. Neither these scrapes nor the dust accumulated could be masking any leak or deficiency.</p> <p>Question 4 See Answer 3 for basis of not evaluating per -3142.1(b)(1) of CC N-729-1 *Leak Source determined CCW Flex Hose leak near CEDM 3/8 (WR #224908)* *Post Cleaning VE determined acceptable*</p>

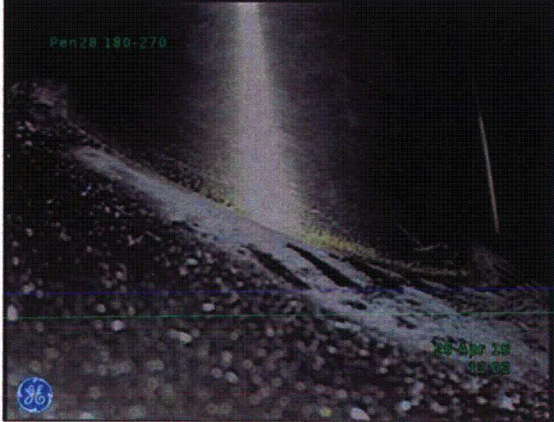
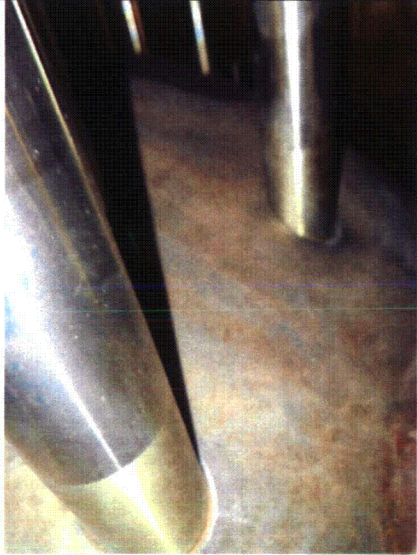
CEDM Nozzle 28	As-Found	As-Left
<p>Question 1 (a). Indication of possible Boric Acid deposits on base of penetration (b). Relevant</p> <p>Question 2 (b). Deposits are of light dusting showing indication of being blown around penetration and collecting around the penetration. Known RCS leak from RC-100 packing near 270-360 degree direction. Dusting due to blown leakage from RC-100. (c) Sample not performed.</p> <p>Question 3 N/A - Relevant</p> <p>Question 4 N/A – Relevant with an evaluation per - 3142.1(b)(1) of CC N-729-1 *Leak Source determined RC-100 packing leak (WO #551054)*</p>

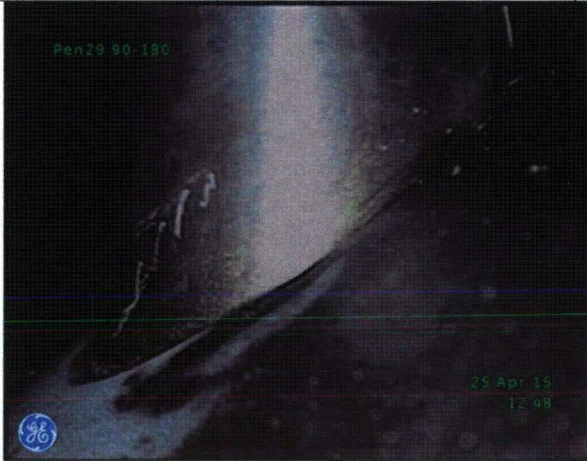
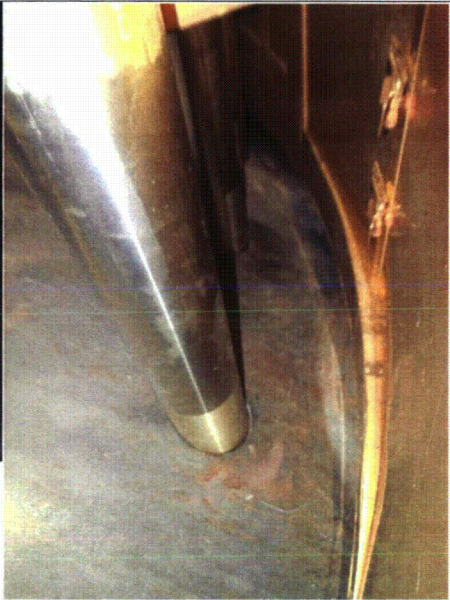
CEDM Nozzle 29	As-Found	As-Left
<p>Question 1 (a). Indication of small amounts of dust deposits on side and base of penetration (b). Initial Evaluation as Not Relevant later re-evaluated as Relevant</p> <p>Question 2 (b). See Answer 3 (c) Sample not performed.</p> <p>Question 3 The initial bare metal inspection photos document no large accumulations or deposits of residue. There is no residue shown on the sides or upslope portion of the penetration nozzle, although residue dust has collected down slope in the leeward side of the penetration. The residue has not settled directly in the annulus region. A white mark is visible in the 90-180 view that appears to be a small scrape with white BA dust residue caught in it. As the penetration is very close to the edge of the RVH and ICI penetration 47, the scratch was likely made by a foot or tool from personnel performing maintenance or installing insulation. The scratch mark appears to have no depth. There is light discoloration near the bottom of the nozzle, but neither this nor the dust accumulated could be masking any leak or deficiency.</p> <p>Question 4 See Answer 3 for basis of not evaluating per -3142.1(b)(1) of CC N-729-1 *Leak Source determined CCW Flex Hose leak near CEDM 3/8 (WR #224908)* *Post Cleaning VE determined acceptable*</p>

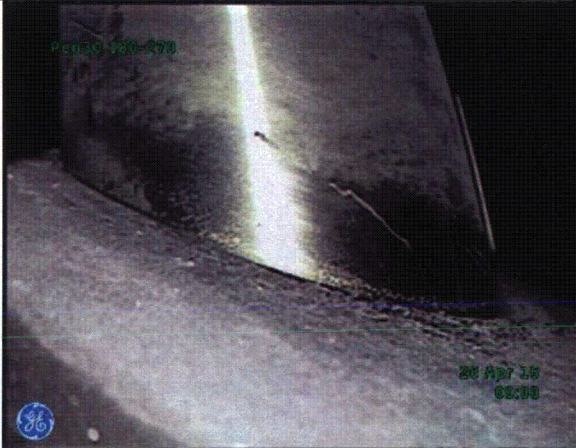
CEDM Nozzle 30	As-Found	As-Left
<p>Question 1 (a). Indication of possible Boric Acid deposits on base of penetration (b). Relevant</p> <p>Question 2 (b). Deposits are of light dusting showing indication of being blown around the penetration and collecting around the penetration. Known RCS leak from RC-100 peaking near 270-360 degree direction. Dusting due to blown leakage from RC-100. (c) Sample not performed.</p> <p>Question 3 N/A - Relevant</p> <p>Question 4 N/A – Relevant with an evaluation per - 3142.1(b)(1) of CC N-729-1 *Leak Source determined RC-100 packing leak (WO #551054)*</p>

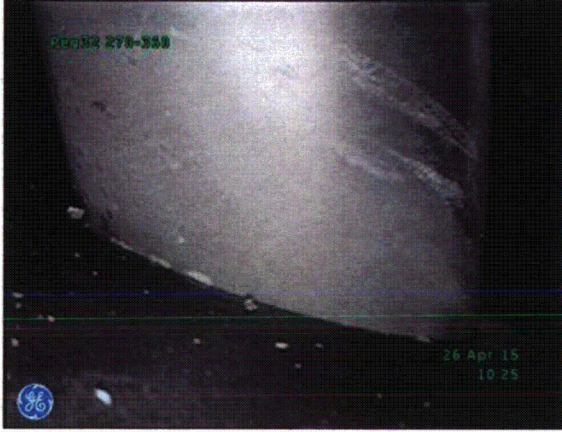
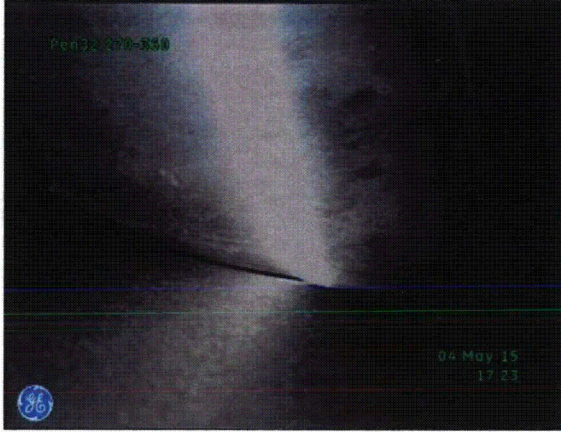
CEDM Nozzle 32	As-Found	As-Left
<p>Question 1 (a). Indication of possible Boric Acid deposits on base of penetration (b). Relevant</p> <p>Question 2 (b). Deposits indicate leakage flow down the head past penetration. The leak path is up the curvature of the head from the penetration. The leak source appears to be the known CCW leak from the flex hose near CEDM 3 and 8 in upper seal housing which is then flowing down the curvature of the head to Nozzle 32. See plan view for location (c) See chemistry report at end of report</p> <p>Question 3 N/A - Relevant</p> <p>Question 4 N/A – Relevant with an evaluation per - 3142.1(b)(1) of CC N-729-1 *Leak Source determined CCW Flex Hose leak near CEDM 3/8 (WR #224908)*</p>

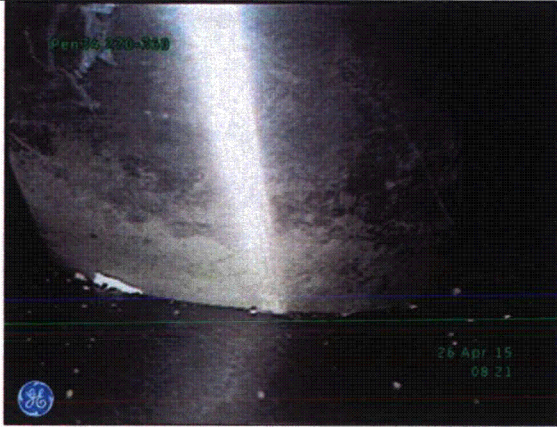
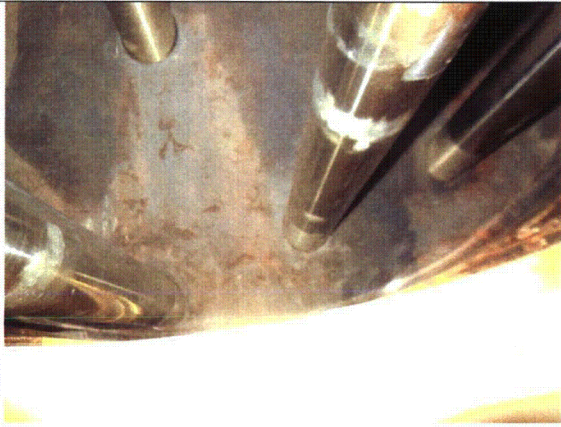
<p>Penetration 34-313</p> <p>26 Apr 15 08 23</p> <p>GE</p>

CEDM Nozzle 34	As-Found	As-Left
<p>Question 1 (a). Indication of possible Boric Acid deposits on base of penetration (b). Relevant</p> <p>Question 2 (b). Deposits indicate leakage flow down the head past penetration. Known CCW leak from flex hose near CEDM 3 and 8 in upper seal housing flowing down CEDM 3 and 8 and pooling on insulation and further leakage on reactor vessel head near surrounding penetrations. Flow from CCW flex hose leakage through penetrations above penetration #34 as source (c) Sample not performed.</p> <p>Question 3 N/A - Relevant</p> <p>Question 4 N/A – Relevant with an evaluation per - 3142.1(b)(1) of CC N-729-1 *Leak Source determined CCW Flex Hose leak near CEDM 3/8 (WR #224908)*</p>

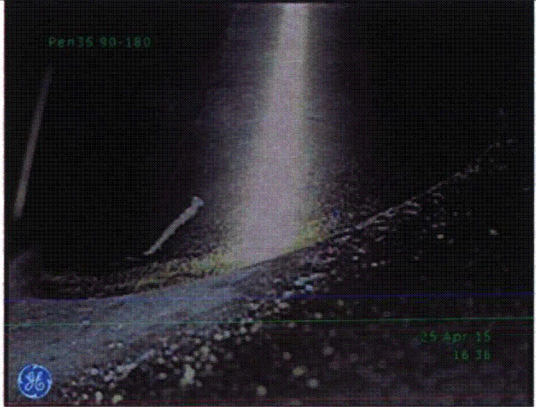
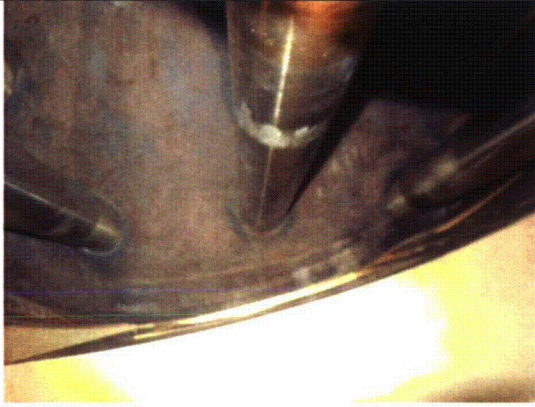
CEDM Nozzle 35	As-Found	As-Left
<p>Question 1 (a). Indication of possible Boric Acid deposits on base of penetration (b). Relevant</p> <p>Question 2 (b). Deposits indicate leakage flow down the head past penetration. Leak path up the curvature of the head from the penetration. Known CCW leak from flex hose near CEDM 3 and 8 in upper seal housing flowing down CEDM 3 and 8 and pooling on insulation and further leakage on reactor vessel head near surrounding penetrations. Flow from CCW flex hose leakage through penetrations above penetration #35 as source. (c) Sample not performed.</p> <p>Question 3 N/A - Relevant</p> <p>Question 4 N/A – Relevant with an evaluation per - 3142.1(b)(1) of CC N-729-1 *Leak Source determined CCW Flex Hose leak near CEDM 3/8 (WR #224908)*</p>

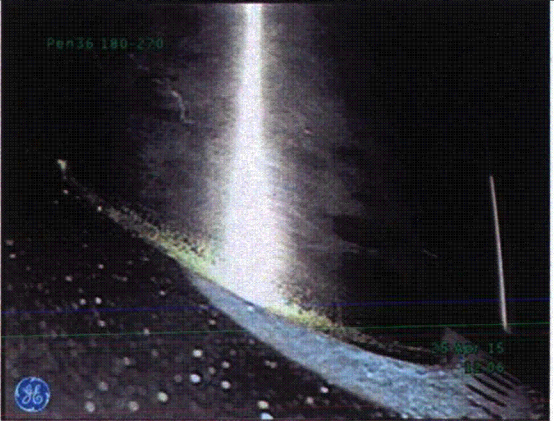
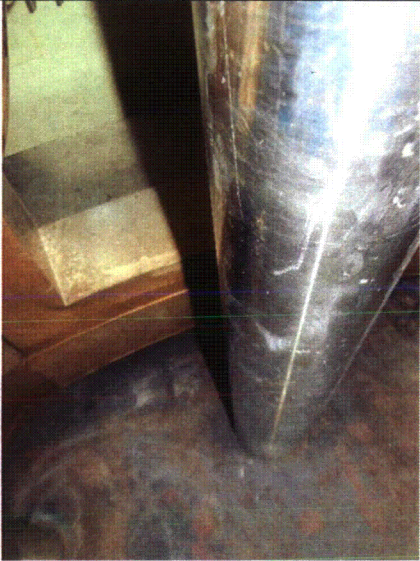
CEDM Nozzle 36	As-Found	As-Left
<p>Question 1 (a). Indication of possible Boric Acid deposits on base of penetration (b). Relevant</p> <p>Question 2 (b). Deposits indicate light dusting in a blowing fashion in the direction of 090-180 degree. Known RCS leak from RC-100 packing near CEDM #36 in the 270-360 degree direction. Dusting due to blown leakage from RC-100. (c) See chemistry report at end of report</p> <p>Question 3 N/A - Relevant</p> <p>Question 4 N/A – Relevant with an evaluation per - 3142.1(b)(1) of CC N-729-1 *Leak Source determined RC-100 packing leak (WO #551054)*</p>

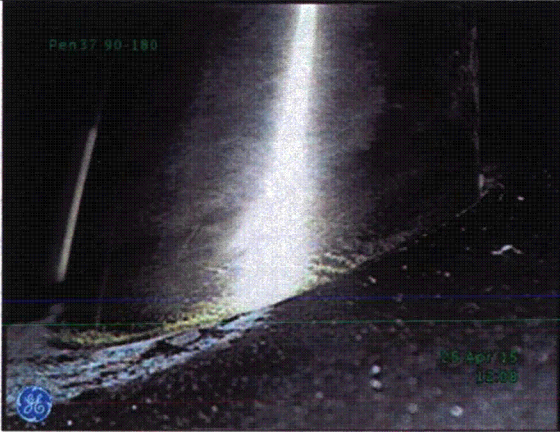
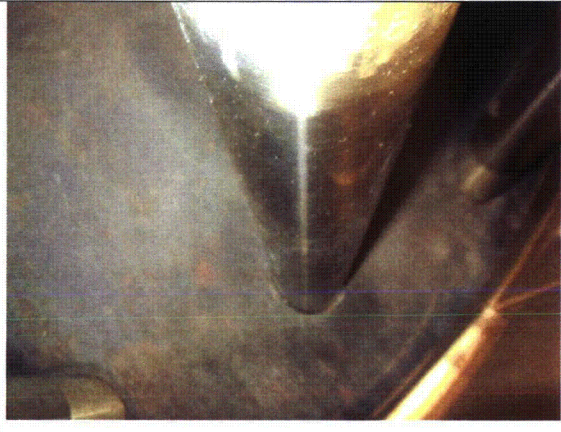
CEDM Nozzle 37	As-Found	As-Left
<p>Question 1 (a). Indication of possible Boric Acid deposits on base of penetration. (b). Relevant</p> <p>Question 2 (b) Deposits indicate light dusting in a blowing fashion in the direction of 090-180 degree. Known RCS leak from RC-100 packing near CEDM #37 in the 270-360 degree direction. Dusting due to blown leakage from RC-100. (c) Sample not performed.</p> <p>Question 3 N/A - Relevant</p> <p>Question 4 N/A – Relevant with an evaluation per - 3142.1(b)(1) of CC N-729-1 *Leak Source determined RC-100 packing leak (WO #551054)*</p>

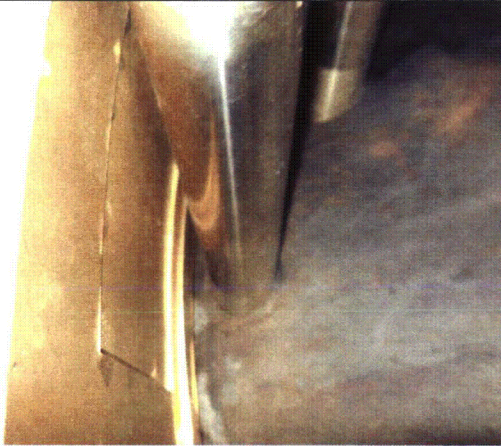
CEDM Nozzle 38	As-Found	As-Left
<p>Question 1 (a). Indication of possible Boric Acid deposits on base of penetration (b). Relevant</p> <p>Question 2 (b). Deposits indicate leakage flow down the head past penetration. Leak path from up the curvature of the head from the penetration. Known CCW leak from flex hose near CEDM 3 and 8 in upper seal housing flowing down CEDM 3 and 8 and pooling on insulation and further leakage on reactor vessel head near surrounding penetrations. Flow from CCW flex hose leakage through penetrations above penetration #38 as source (c) See Chemistry report at end of report</p> <p>Question 3 N/A - Relevant</p> <p>Question 4 N/A – Relevant with an evaluation per - 3142.1(b)(1) of CC N-729-1 *Leak Source determined CCW Flex Hose leak near CEDM 3/8 (WR #224908)*</p>

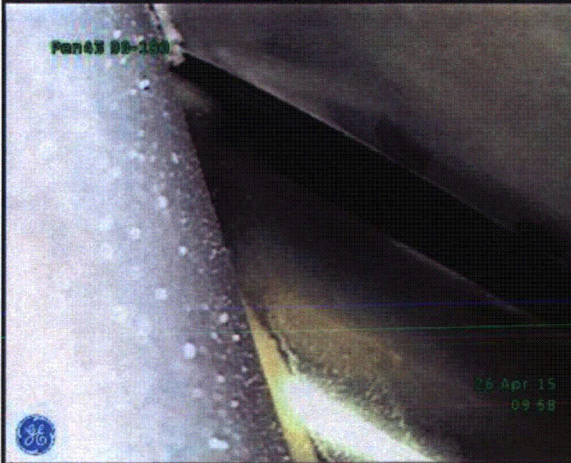
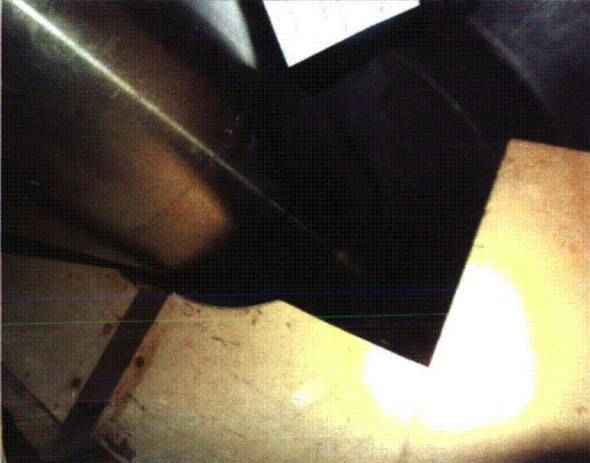
ICI Nozzle 43	As-Found	As-Left
<p>Question 1 (a). Indication of possible medium amount of Boric Acid deposits on base of penetration (b). Initial Evaluation as Not Relevant later re-evaluated as Relevant</p> <p>Question 2 (b). See Answer 3 (c). Sample not performed.</p> <p>Question 3 The angle of the slope around penetration 43 is quite steep which would allow deposits from above to easily collect around it. The deposits found were medium amount and the deposits near the annulus were from the high point of the RVCH sloop around nozzle 43. This would be expected for the amount of deposits above penetration around Nozzle 3 and 8.</p> <p>Question 4 See Answer 3 for basis of not evaluating per -3142.1(b)(1) of CC N-729-1 *Leak Source determined CCW Flex Hose leak near CEDM 3/8 (WR #224908)* *Post Cleaning VE determined acceptable*</p>

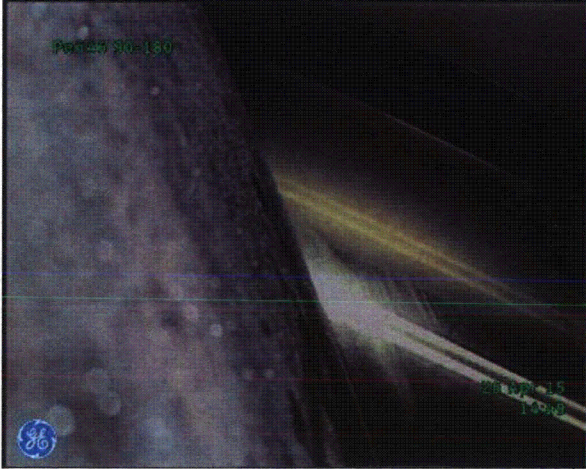
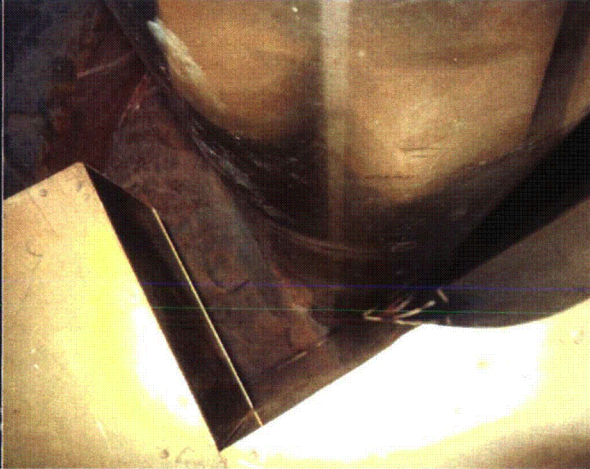
ICI Nozzle 46	As-Found	As-Left
<p>Question 1 (a). Indication of possible light Boric Acid deposits on base of penetration (b). Initial Evaluation as Not Relevant later re-evaluated as Relevant</p> <p>Question 2 (b). See Answer 3 (c). Sample not performed.</p> <p>Question 3 The angle of the slope around penetration 46 is quite steep which would allow deposits from above to easily collect around it. The deposits found were of light amount and the deposits near the annulus were from the high point of the RVCH sloop around nozzle 46. This would be expected for the accumulation of loose deposits above nozzle at Nozzle 21</p> <p>Question 4 See Answer 3 for basis of not evaluating per -3142.1(b)(1) of CC N-729-1 *Leak Source determined RC-100 packing leak (WO #551054)* *Post Cleaning VE determined acceptable*</p>

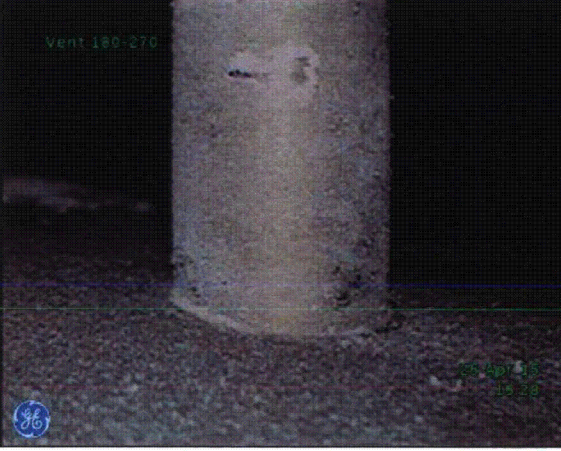
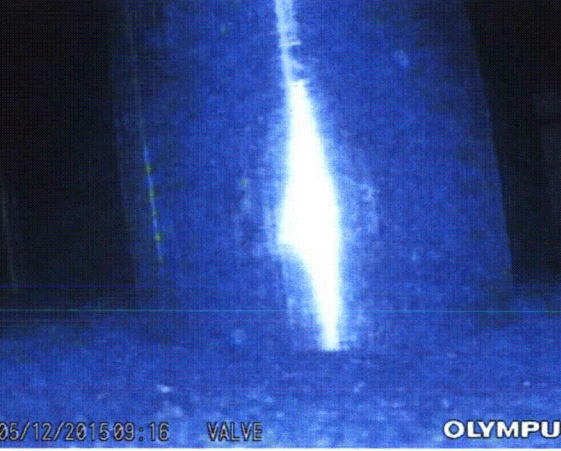
Vent Penetration	As-Found	As-Left
<p>Question 1 (a). Indication of possible heavy Boric Acid deposits on base of penetration (b). Initial Evaluation as Not Relevant later re-evaluated as Relevant</p> <p>Question 2 (b). See Answer 3 (c) Sample not performed.</p> <p>Question 3 Deposits on the side and base of RC-100 penetration. Visual leak path could be traced to above annulus towards the insulation where CCW was pooled from flex hose leak around CEDM 3 and 8.</p> <p>Question 4 See Answer 3 for basis of not evaluating per -3142.1(b)(1) of CC N-729-1 *Leak Source determined CCW Flex Hose leak near CEDM 3/8 (WR #224908)* *Post Cleaning VE determined acceptable*</p>
