# Alloy 152-LAS Dilution Zone PWSCC Testing

***Mychailo Toloczko, Matt Olszta,  
Nicole Overman, and Steve Bruemmer***

*Pacific Northwest National Laboratory*

*ICG-EAC 2015*

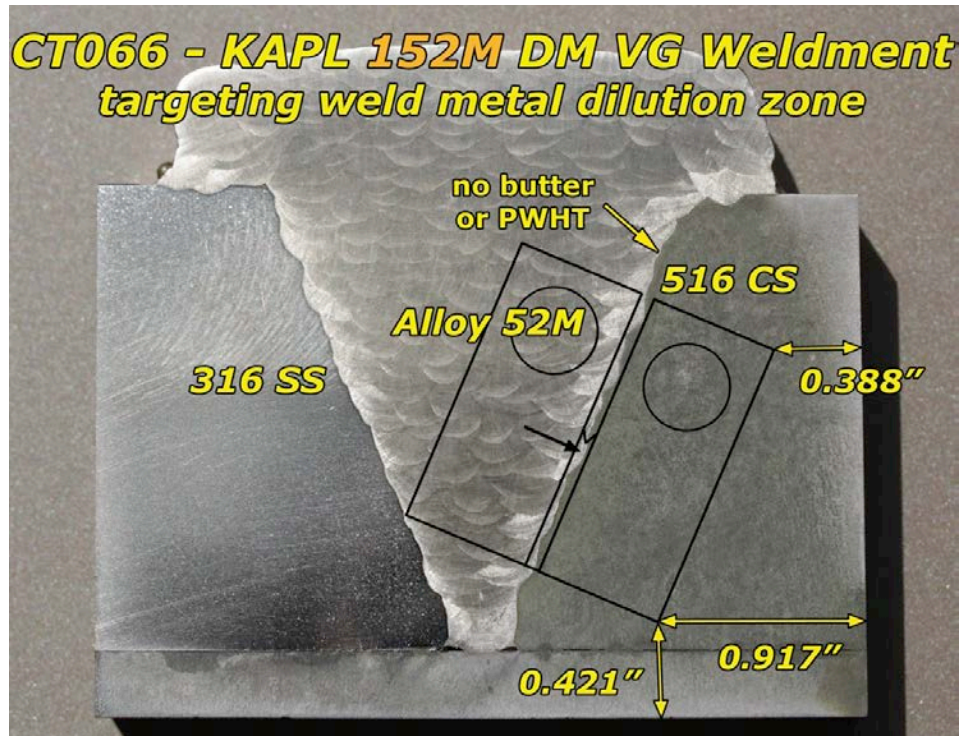
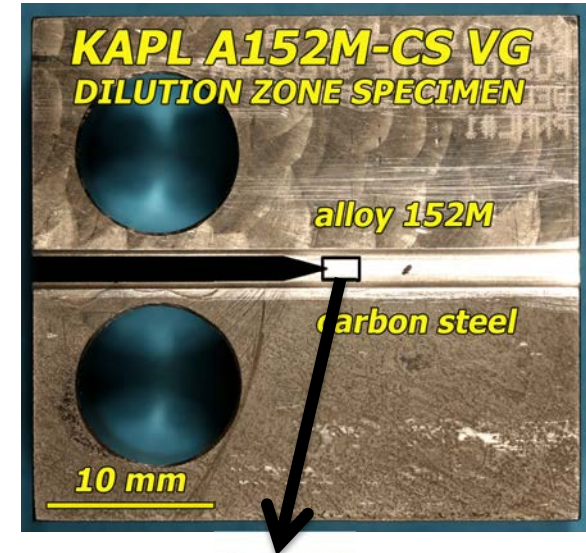
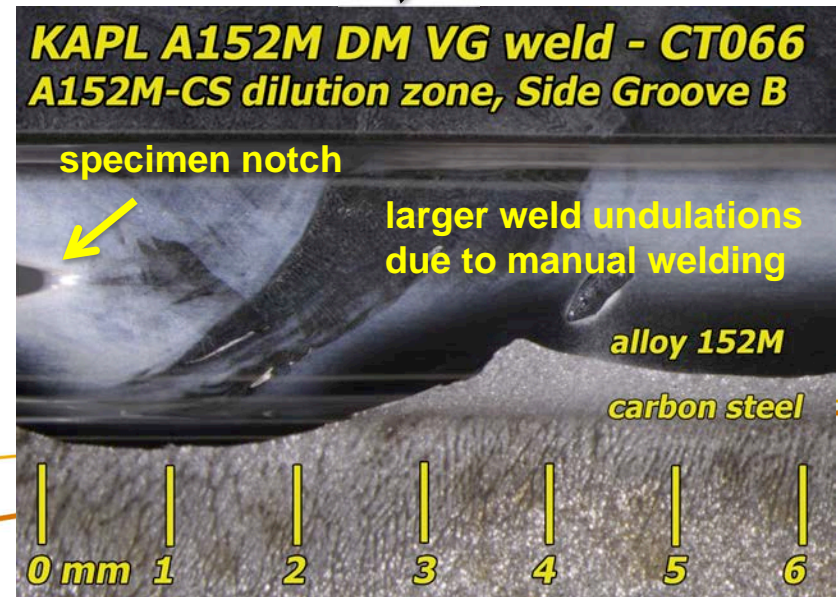
## KAPL Alloy 152M weldment

*Goal was to measure weld dilution zone response ~0.5-1 mm from fusion line.*

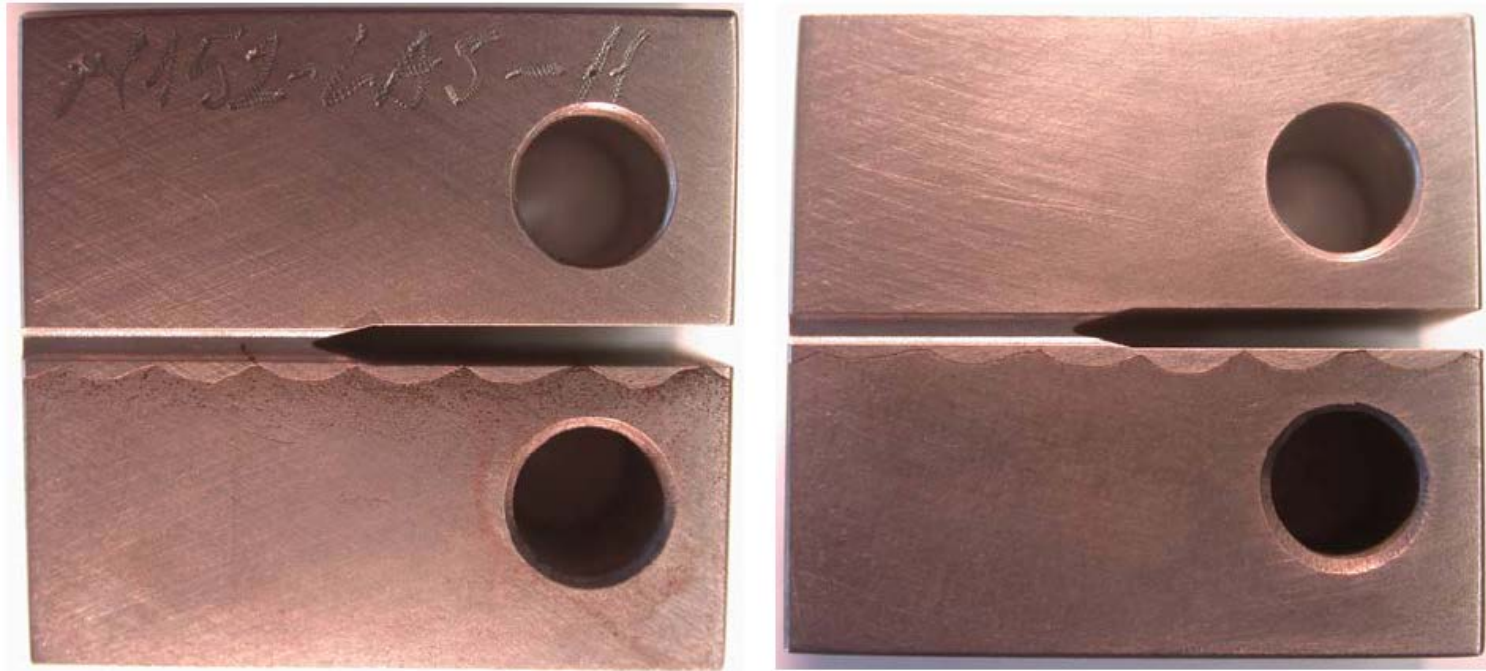
Both sides of the specimen

- ▶ *N152-LAS-11 specimen has roughly similar alignment relative to the fusion line as the KAPL alloy 152M-CS dilution zone specimen tested at PNNL.*

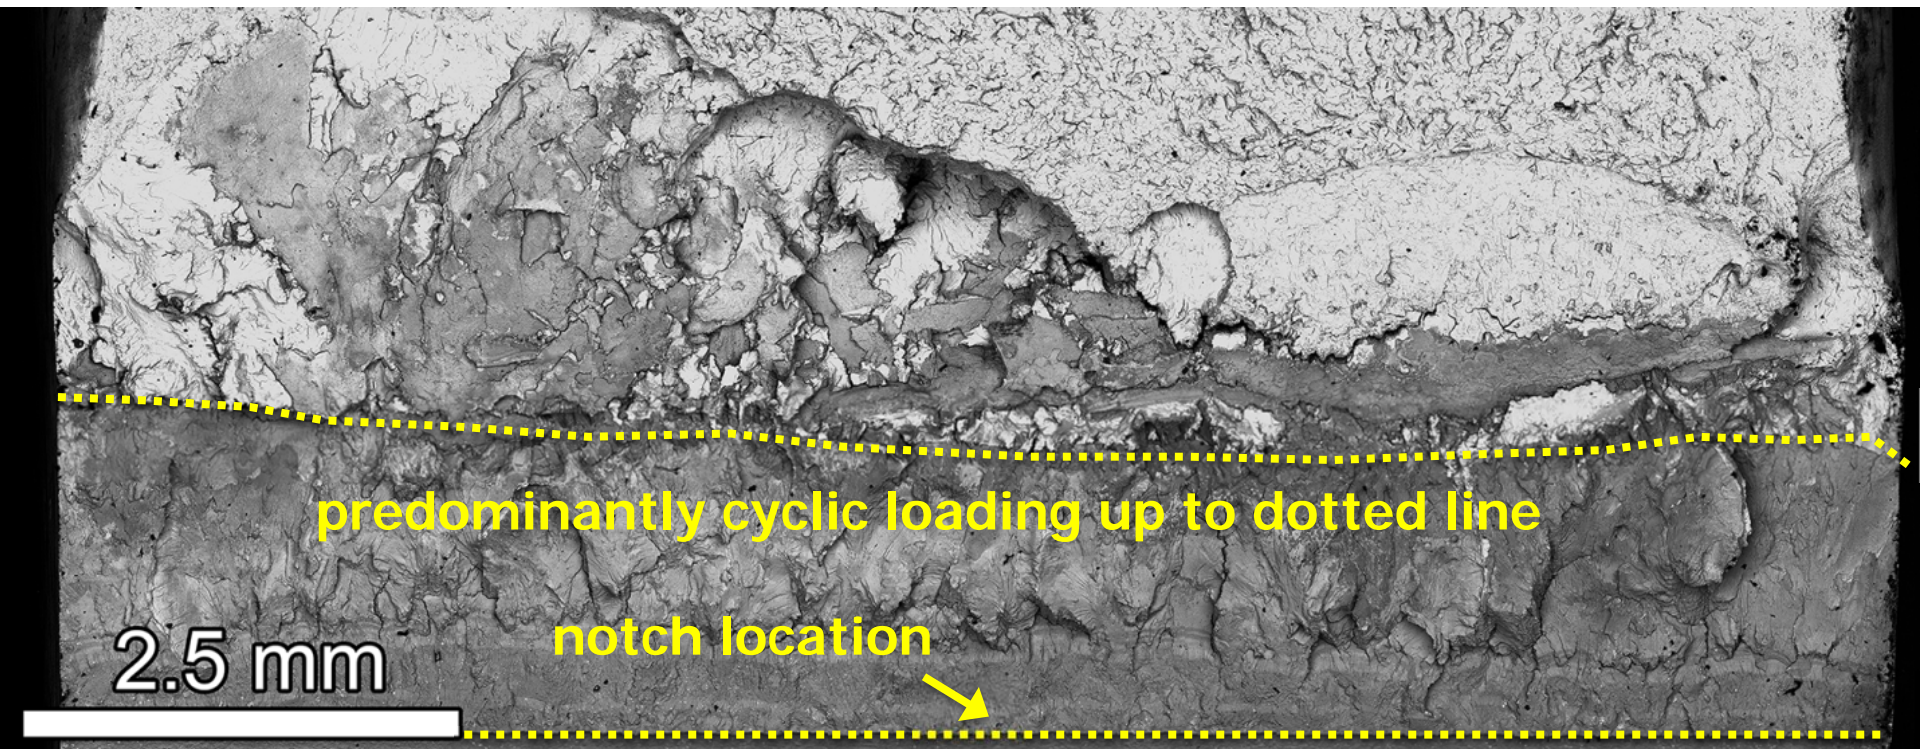
# ANL N152-LAS-11 Specimen Crack Surface Observations

- *Predominantly cyclic loading prior to constant load SCC response that was shown in the previous slide.*

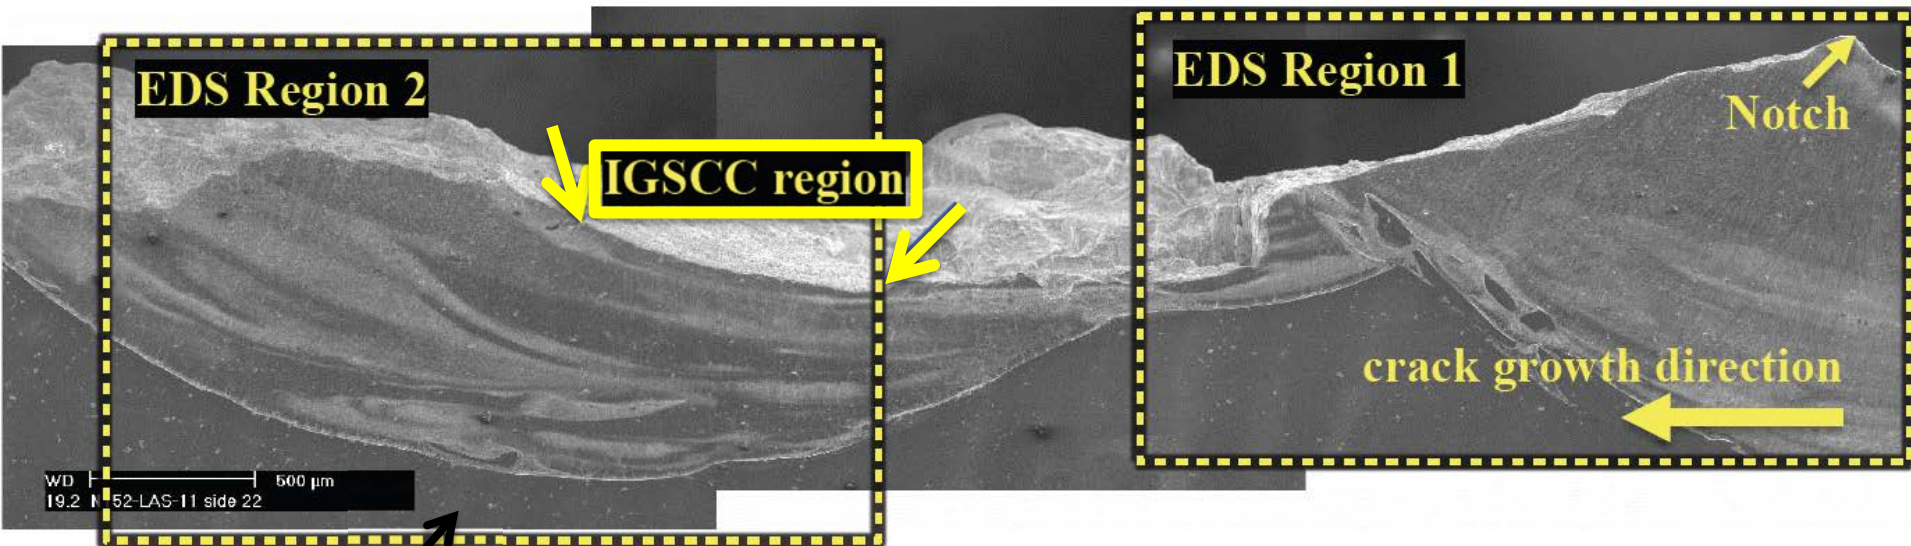
# ANL N152-LAS-11 Specimen Cross-Section Observations

- Specimen was fractured - one side of the specimen was cross-sectioned after fracture.

Region of interest near that contains constant load crack extension

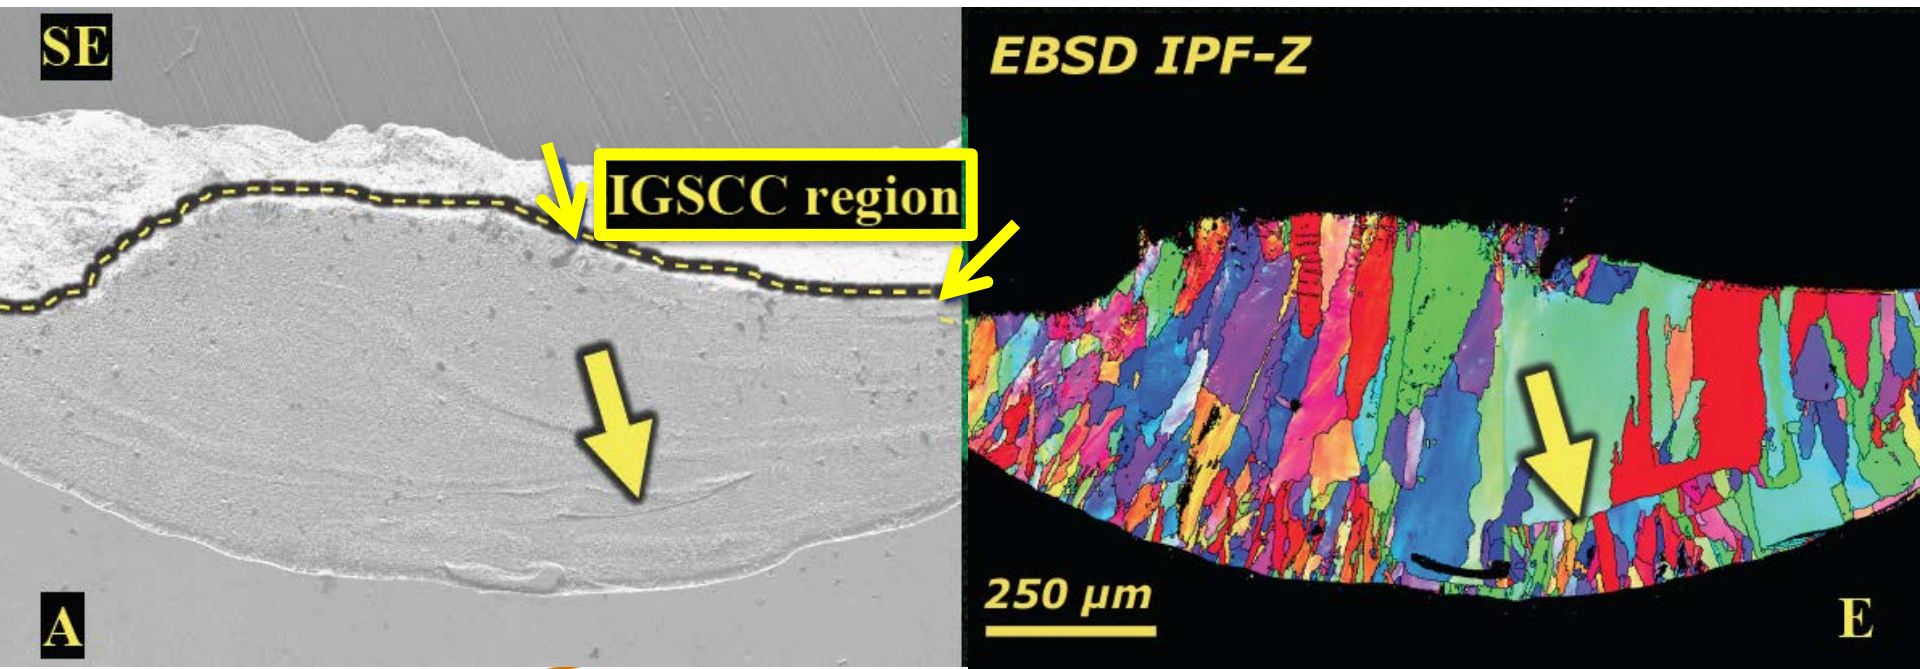
# ANL N152-LAS-11 Specimen Summary

- ▶ SCC tested at ANL. Additional exams performed at PNNL.
- ▶ High constant load crack growth rates were observed.
- ▶ 23-26Cr near SCC region in cross-section.
- ▶ Not well aligned to grain boundaries, but IG appearance.
- ▶ Origin of crack path possibly an interpass boundary or this "unexpected" boundary.
- ▶ Additional exams needed to better understand this.

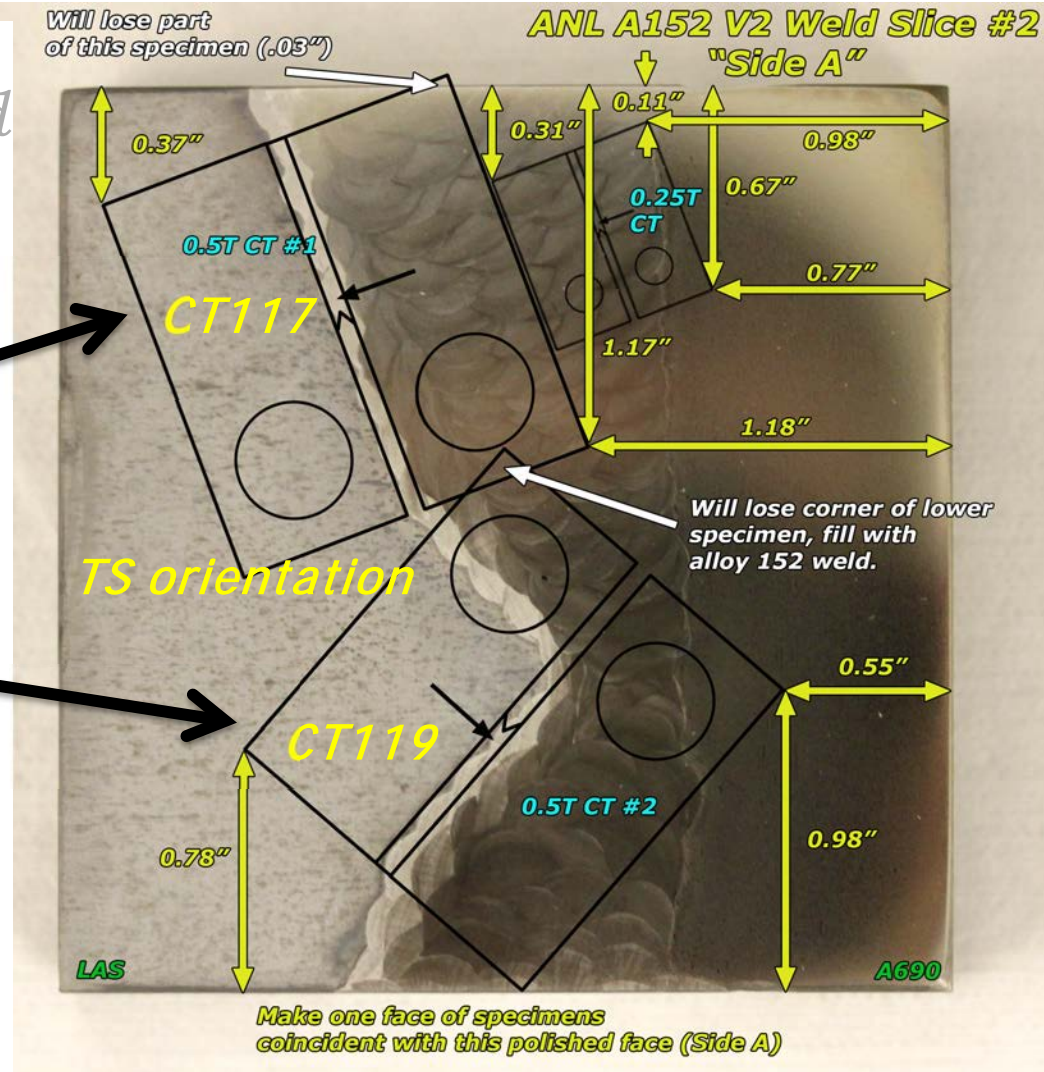
# A152v2-LAS PNNL #1 (CT117) and #2 (CT119)

- ▶ Cut from same weldment as ANL N152-LAS-11 and N152-LAS-1 specimens.
- ▶ **CT117** aligned to same region of weld as ANL N152-LAS-11 specimen tested at ANL.
- ▶ CT119 does not correspond to any ANL tests.
- ▶ CT117 and CT119 tested separately.
- ▶ Tested in 360° C PWR primary water with 25 cc/kg dissolve H<sub>2</sub>.

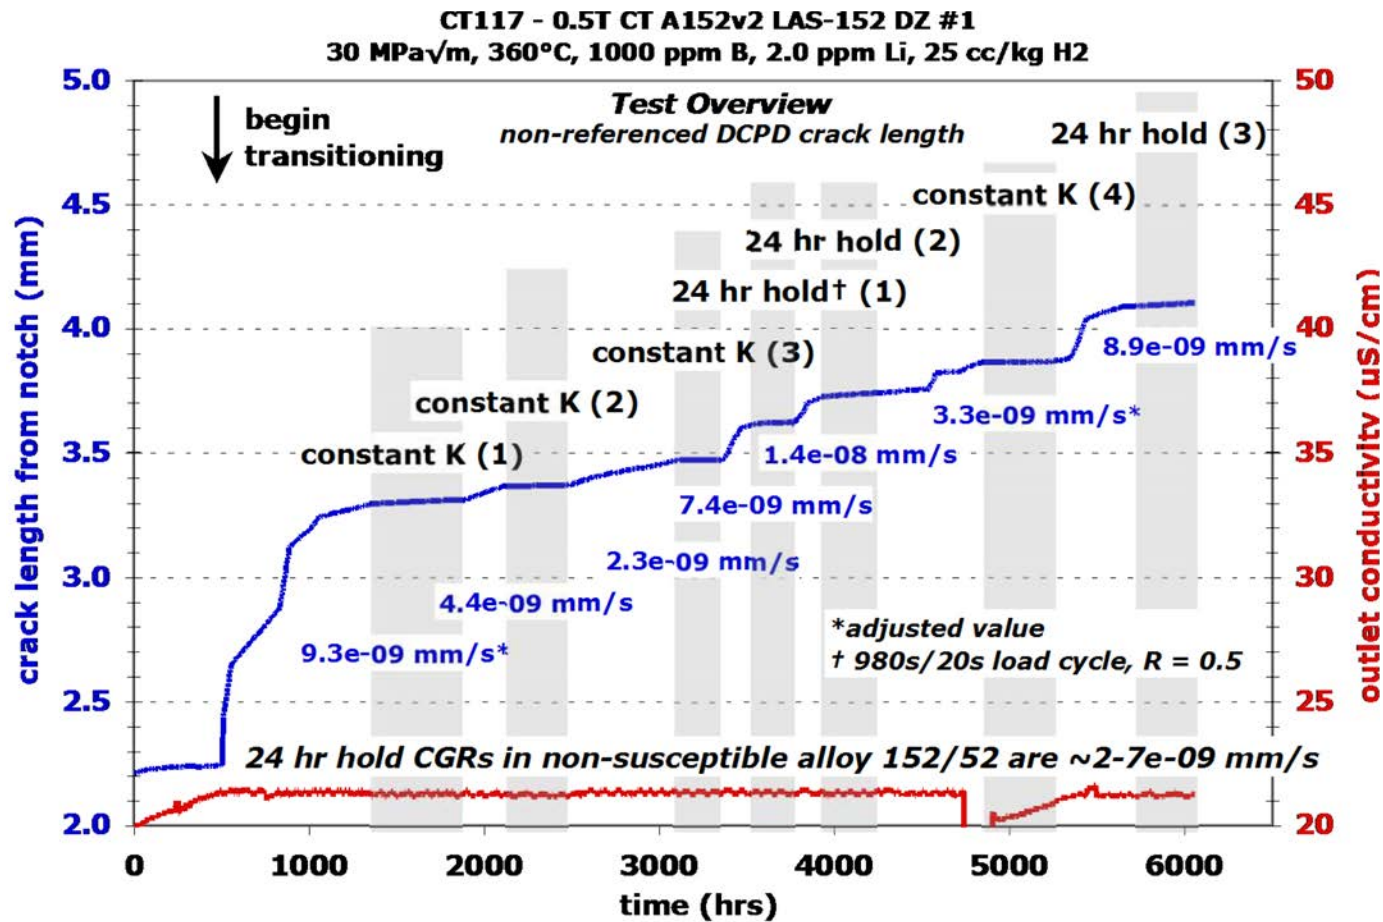
- ▶ Sidegrooves indicate possible dilutions over the range of 3.25 mm to 4.5 mm from the crack notch.
  - Have been assessing carefully starting at 3.3 mm.
- ▶ Using constant  $K$  and 24 hr hold loading.

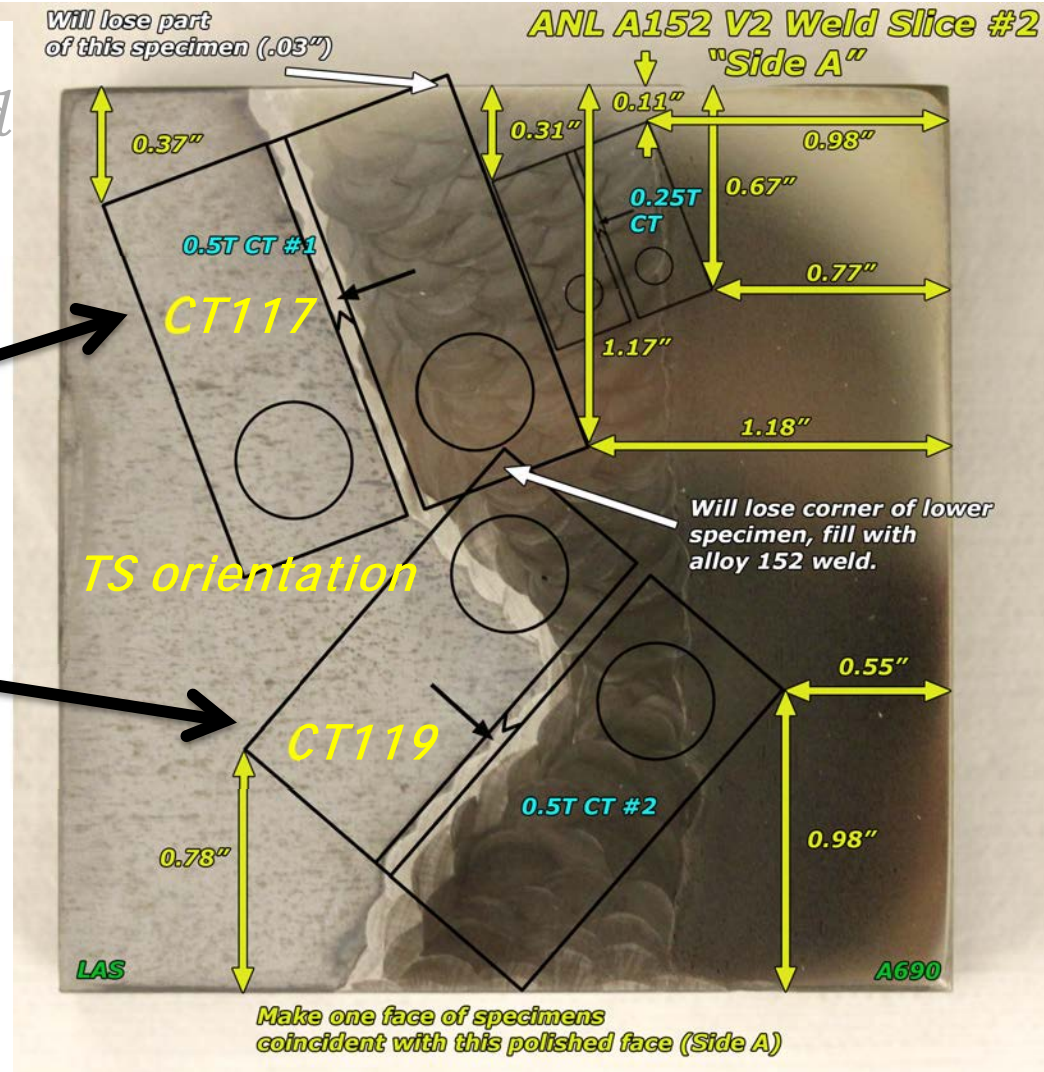
# A152v2-LAS PNNL #1 (CT117) and #2 (CT119)

- ▶ Cut from same weldment as ANL N152-LAS-11 and N152-LAS-1 specimens.
- ▶ CT117 aligned to same region of weld as ANL N152-LAS-11 specimen tested at ANL.
- ▶ **CT119** does not correspond to any ANL test specimens.
- ▶ CT117 and CT119 tested separately.
- ▶ Tested in 360° C PWR primary water with 25 cc/kg dissolve H<sub>2</sub>.

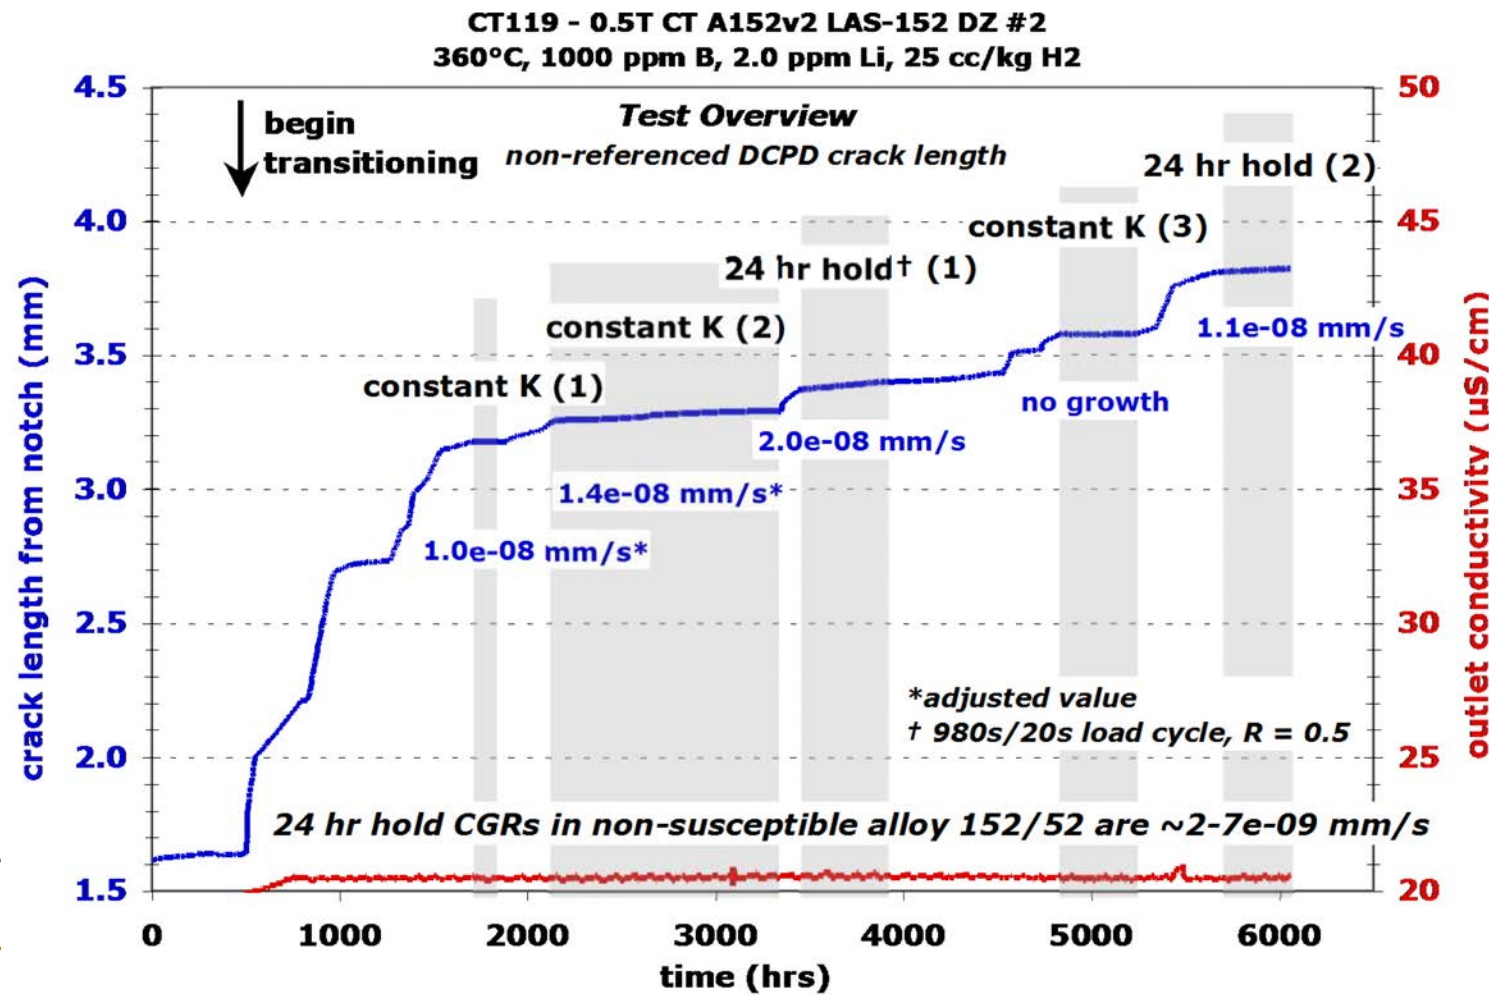
- ▶ Fewer indications of dilutions in the sidegrooves but have been assessing carefully starting at 3.2 mm.
- ▶ Using constant  $K$  and 24 hr hold loading.

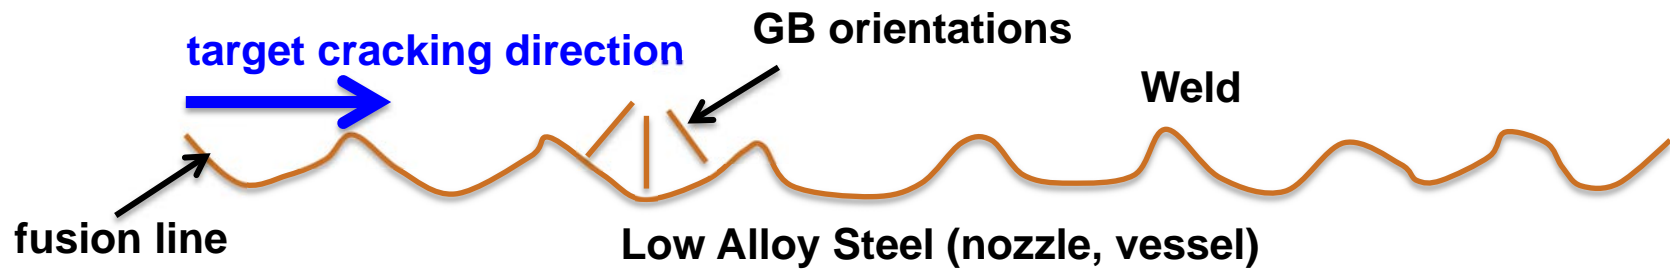
# Additional Comments on Weld-LAS Dilution Zone Susceptibility

- ▶ *Leak path is parallel to the fusion line.*
- ▶ *Dilution zones within the weld may be a challenging crack path.*
  - *Grain boundaries typically misaligned to target crack path.*
  - *Dilution regions appear to be discontinuous.*
  - *Strong dilutions appear to be more common in manual welds.*
- ▶ *Is the fusion line between the weld and LAS a likely path?*
  - *Curved path of fusion line is not ideal but...*
  - *Must be dilution in close vicinity of the fusion line.*
  - *Needs to be a continuous dilution from wetted surface to exterior.*

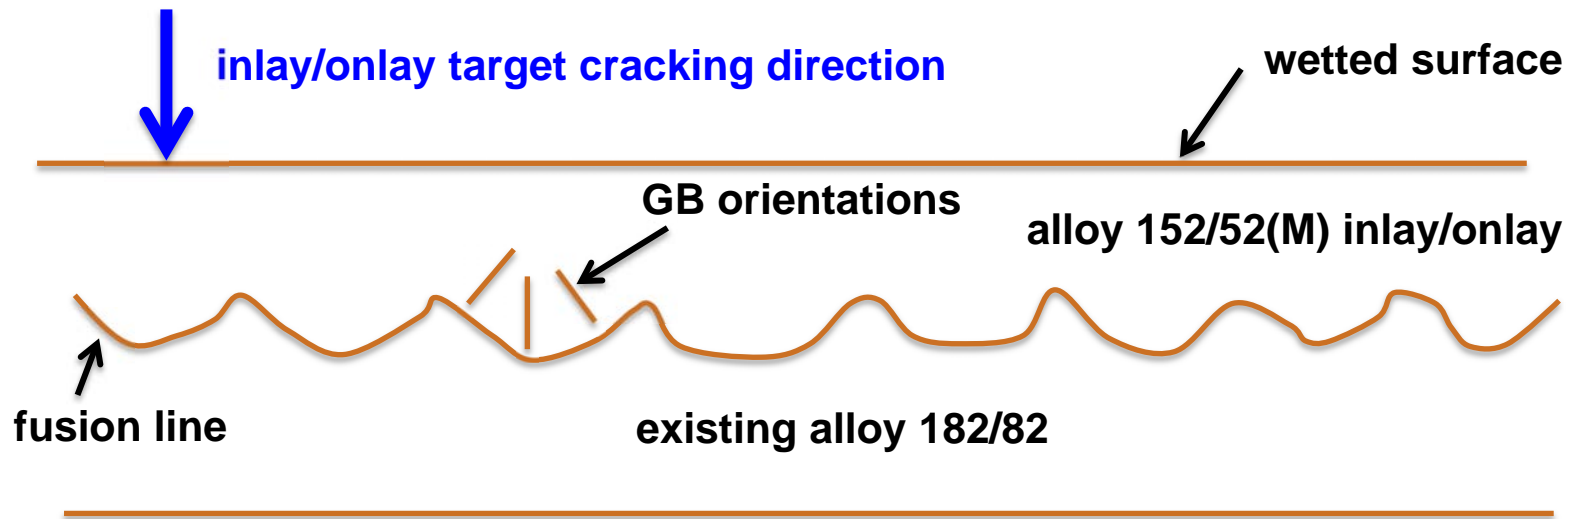
# Cracking Through Inlay/Onlay Dilutions

- ▶ *Target crack path can be aligned to weld grain boundaries.*
- ▶ *Concern for SCC susceptibility if dilutions can exist in thin inlay/onlay welds.*
