Subject: Potential 10CFR Part 21 Notification on Struthers Dunn Relays

Investigation for Potential Part 21 for Struthers Dunn Relays

To: **Bryan Ohmert, (856) 339-2949, PSEG-Nuclear**
From: **Lance Walls, 610-380-2309 lance.walls@exelonpowerlabs.com**
Project: **PSE-72352**
Subject: **Failure Analysis of a Relay**
Manufacturer: Struthers Dunn
Stock Code/Cat ID: X400405
Quantity Received: 1
Model: 219BBX200
Purchase Order No.: 4500850488-0
Qualtech Tag#: CJ358602-05
Date: **19 March 2015**

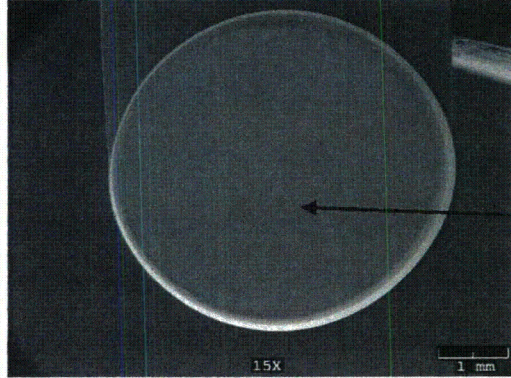
Photograph 10: Contact 8 Surface – Center Area

Photograph 10 exhibits the striation patterns that were present on the contact 8 surface. Again, these patterns are not a typical wear pattern observed relay contact make/break or wipe operations. Gold was primary elemental constituent in both snapshots, with similar concentrations of Nickel and Copper in both.
