**SUBJECT: DAVIS-BESSE NUCLEAR POWER STATION - INSPECTION OF APPARENT  
CAUSE EVALUATION EFFORTS FOR PROPAGATION OF LAMINAR CRACKING  
IN REINFORCED CONCRETE SHIELD BUILDING AND CLOSURE OF  
UNRESOLVED ITEM INVOLVING SHIELD BUILDING LAMINAR CRACKING  
LICENSING BASIS - INSPECTION REPORT 05000346/2014008**

Inspection Report 05000346/2014008; 11/03/2014 – 04/15/2015, Davis-Besse Nuclear Power Station; Inspection of Apparent Cause Evaluation Efforts for Propagation of Laminar Cracking in Reinforced Concrete Shield Building; Closure of Unresolved Item Regarding Whether the Licensee's Acceptance of Laminar Cracking in the Shield Building Required NRC Review and Approval.

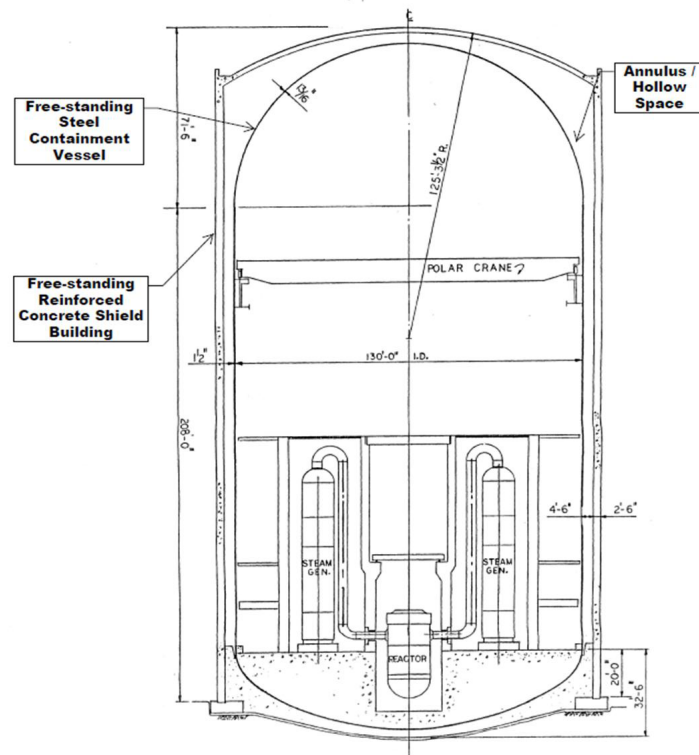
**Figure 1: Simplified Davis-Besse Shield Building and Steel Containment Vessel**

The containment system consists of three basic structures: a steel containment vessel (CV), a reinforced concrete shield building (SB), and the internal structures (Figure 1). The CV is a cylindrical steel pressure vessel which houses components and systems, including the reactor vessel and reactor coolant piping. The SB is a reinforced concrete structure that surrounds the CV, and has a cylindrical wall nominally 30 inches thick with vertical and horizontal reinforcement on both the inside and outside faces, and a shallow dome roof. An annular space is provided between the wall of the CV and the SB, and clearance is also provided between the CV and the dome of the SB. With the exception of the concrete under the CV, there are no structural ties between the CV and the SB above the foundation slab.

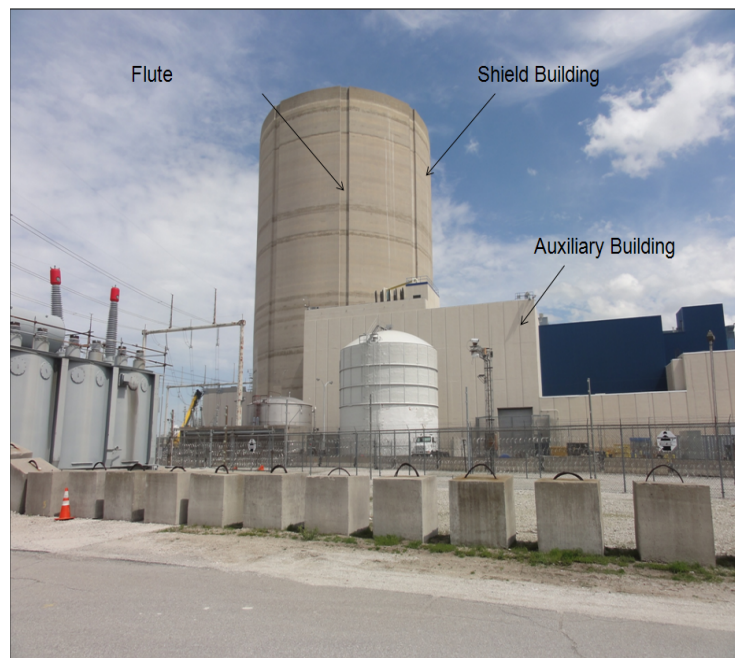
**Figure 2: Davis-Besse Shield Building**

The cylindrical SB wall contains an inner and an outer rebar mat, each located approximately 3 inches into the concrete from their respective inner and outer wall surfaces. A rebar mat is a grid of reinforcing steel bars that adds strength to the concrete. In addition, the structure includes additional concrete elements (called shoulders) that extend out from the 2.5 foot thick wall to provide the appearance of eight evenly spaced, vertical cutouts (called flutes) in the outer wall surface (Figure 2). These shoulders (16 in toto) are a maximum thickness on each side of the flute (approximately 18 inches thick), and gradually blend into the 2.5 foot thick wall away from the flute. These shoulders are reinforced by additional rebar located below their concrete surfaces (Figure 3).
