## Tube support plate clogging up of French PWR steam generators

*Herve BODINEAU & Thierry SOLIER*

IRSN - Reactor Safety Division

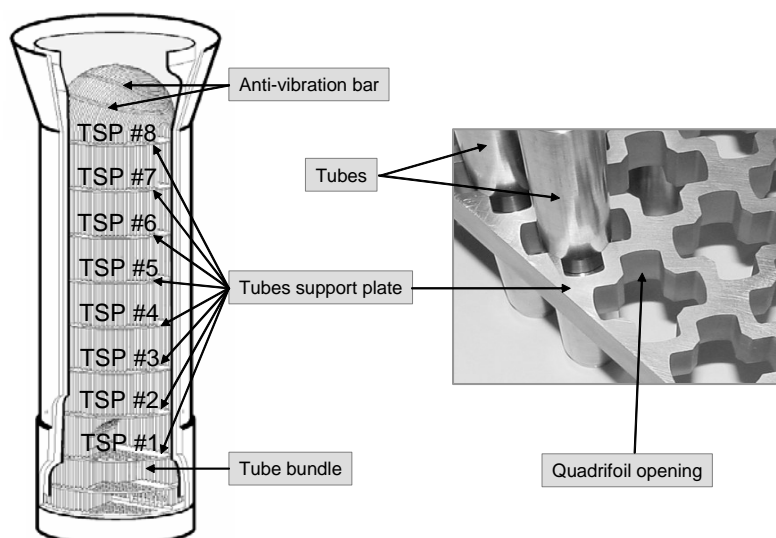
The results of in situ examination initiated by the Cruas NPP operator showed that the flow holes of the uppermost Tube Support Plates (TSPs) were partially or completely blocked by corrosion products. This phenomenon is referred to in this paper as TSP “clogging-up” and it was considered potentially generic for EDF NPP fleet. For the Cruas leakages, it was established that the association of TSP clogging-up and the specificity of the Cruas steam generator (central area in the tube bundle where no tubes are installed) were responsible for a significant increase in the velocity of the secondary fluid in the tube bundle central area. The high velocity of the fluid in this region increases the risk of fluidelastic instability for the tubes. Based on this preliminary analysis, EDF has implemented preventive measures (stabilizing and plugging of tubes in the central area of the tube bundle deemed sensitive to high cycle fatigue risk).

Pic. # 1: Location of the TSP and presentation of quadrifoil openings

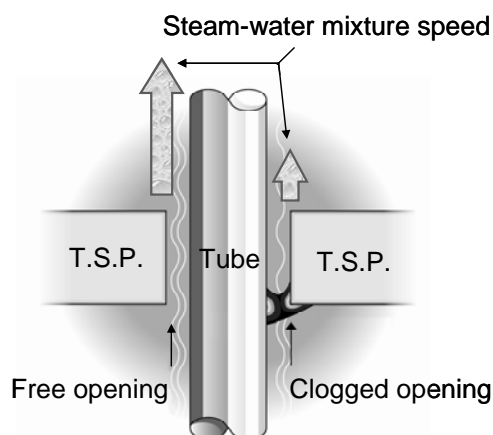
The phenomenon of cracking due to high cycle fatigue of U-bend tubes not supported by an Anti-Vibration Bar (AVB) was highlighted as early as 1987 (tube rupture in the NORTH ANNA 1 plant) and 1991 (MIHAMA). The tubes which leaked at Cruas were all located in raw 8 and were not supported by AVB by design. They were not considered sensitive to high cycle fatigue. A new fact caused the leakages observed on the Cruas units: the heavy build-up of deposits on the secondary side of the steam generator which changed the flow conditions in the center of the tube bundle. The deposits reduced or blocked water/steam flow through the quadrifoil-shaped holes in TSPs, forcing more water and steam into the center of the tube bundle, which caused the excessive vibration of the tubes near the center of the tube bundle. This excessive vibration due to fluid-elastic instability resulted in fatigue cracking of the tube.

Pic. # 3: Representation of the water-steam flow through the quadrifoil holes

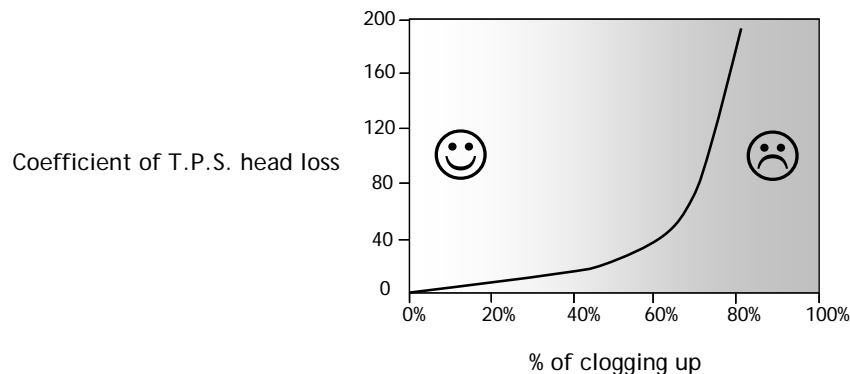
The clogging-up of TSPs results in greater resistance to water flows than considered at the design stage. Therefore TSPs and tie-rods could be subjected to heavier loads than considered at the design phase for transients.

Pic. # 8: Correlation between clogging up % and TSP head losses

The proper behaviour of these components in a clogged configuration should therefore be checked both during normal reactor operations and for incident and accident conditions. The situation where there is the highest stress (i.e. the flow rate crossing the plates is at the maximum) is that of a large steam line break (very low probability event) resulting in complete draining of the steam generator in a very brief lapse of time. Studies have been conducted by EDF on this subject.

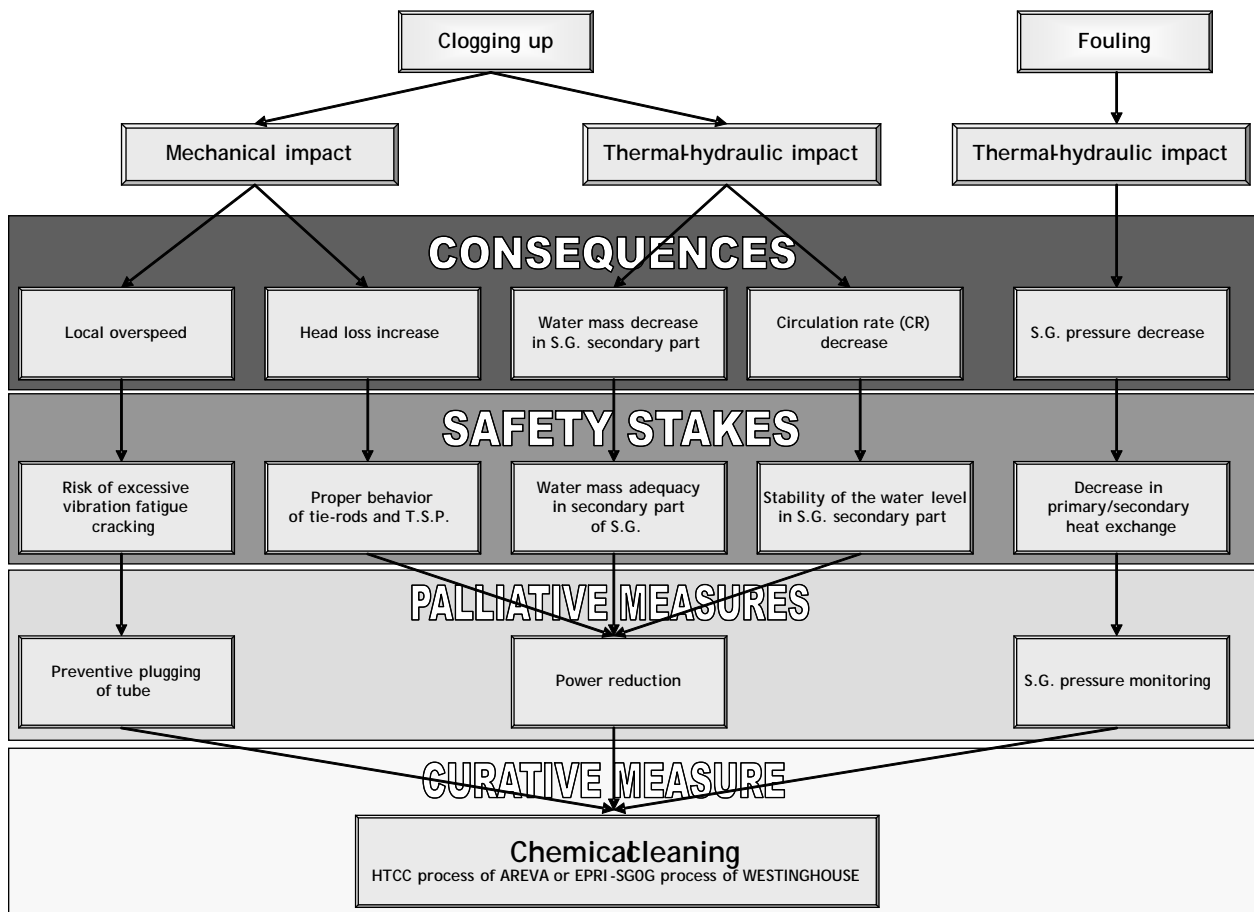
In brief, according to the nature of the anomaly (fouling or clogging up), the consequences on the plant safety are the following:

Pic. # 10: Effects on plant safety with respect to tube fouling and clogging up

On the basis of its safety analysis of the TSP clogging-up, at the end of 2006, IRSN recommended that the ASN (French Nuclear Safety Authority) should ask EDF to clean the tube support plates in the steam generators in Cruas unit 4 within three months.
