Edwin I. Hatch Nuclear Plant – Unit 2
Inservice Inspection Program
Owner's Activity Report for Outage 2R23

SNC and SI Evaluation Core Shroud Axially Oriented Flaw

BWRVIP EVALUATION

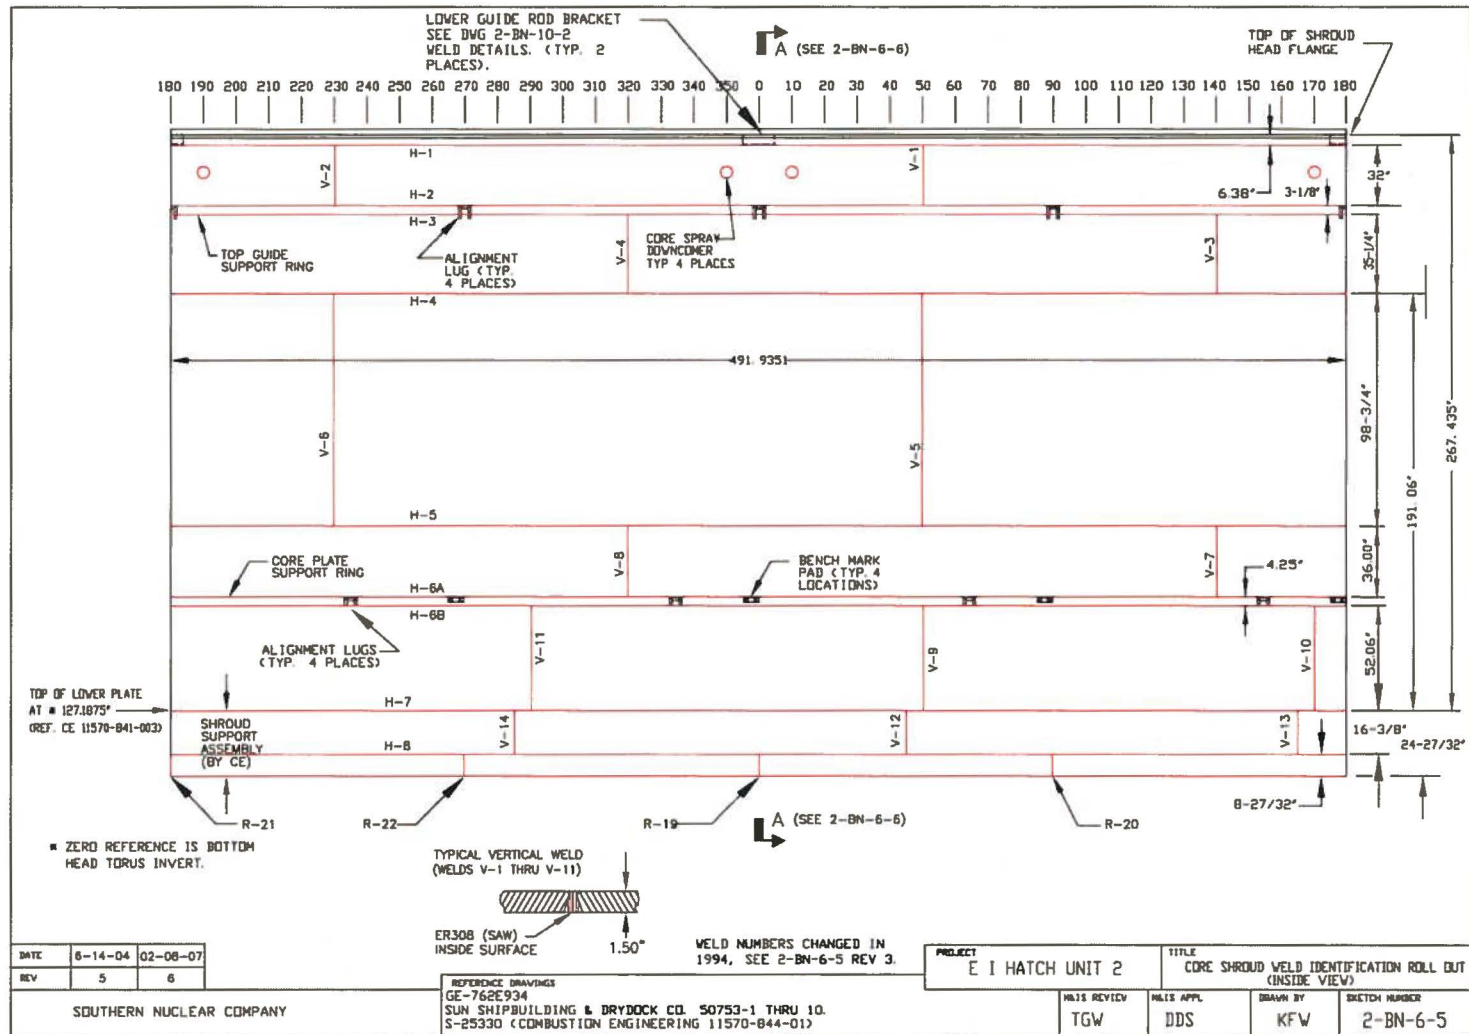
Figure 1. HNP2 Core Shroud Configuration [11]

Figure 1 illustrates the HNP2 core shroud configuration and weld locations, while Figure 2 illustrates the locations and sizes of reported indications, based on 2R23 inspection results [1].

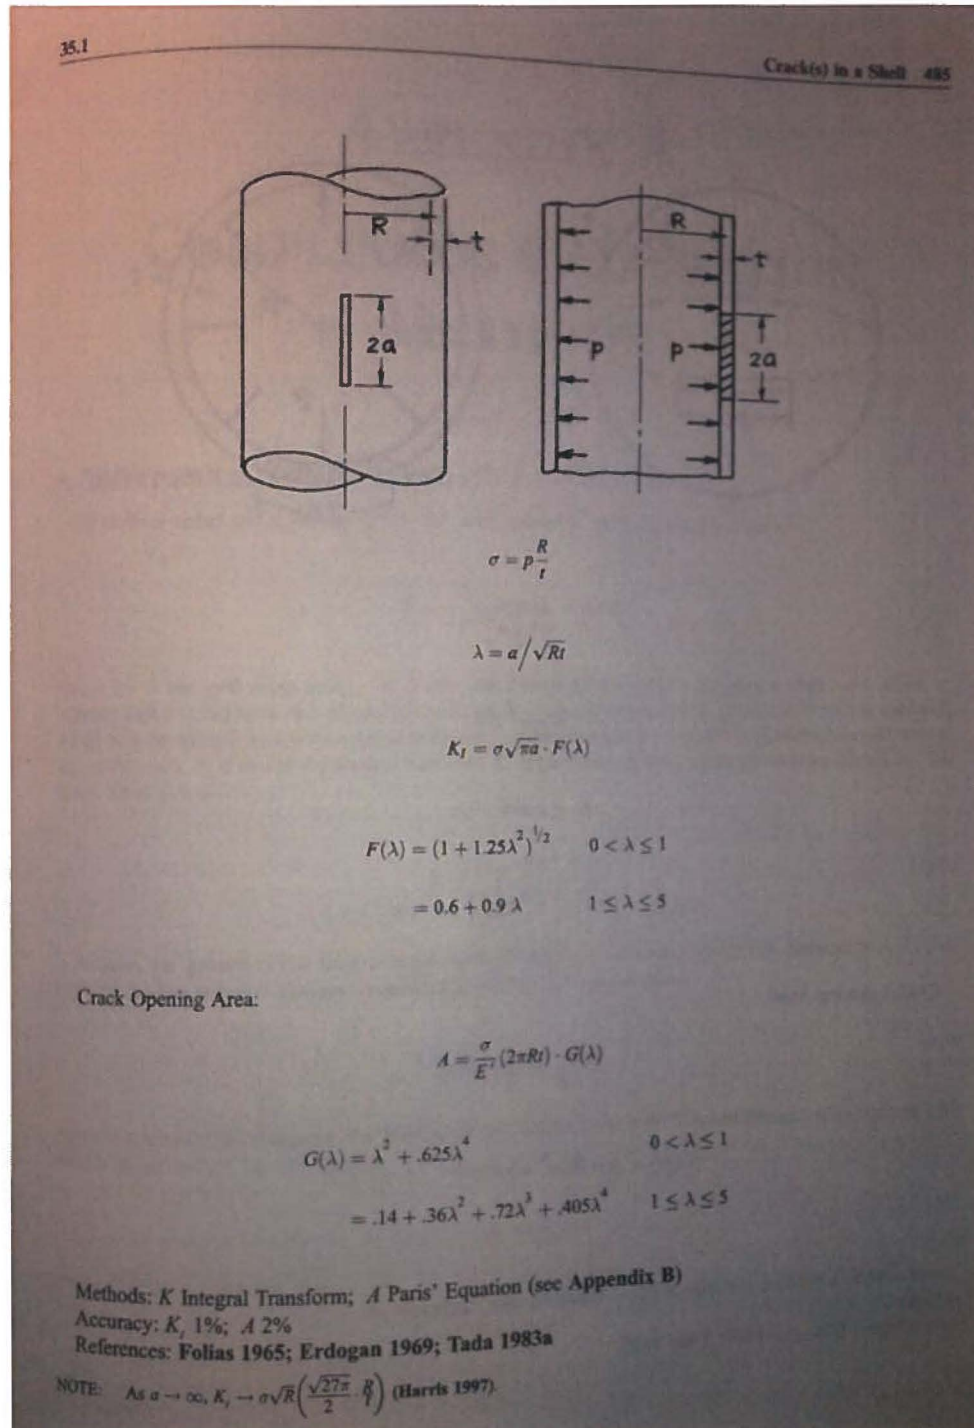
Figure 3. LEFM Solution for a Single Through-wall Axial Crack in an Internally Pressurized Cylinder [10]

- Single through-wall axial flaw in an internally pressurized cylinder (See Figure 3) [10, pg. 485],
- Infinite array of parallel through-wall flaws in a plate subjected to a membrane load (See Figure 4) [10, pg. 256],
- Plastic zone size correction [10, pg. 16].

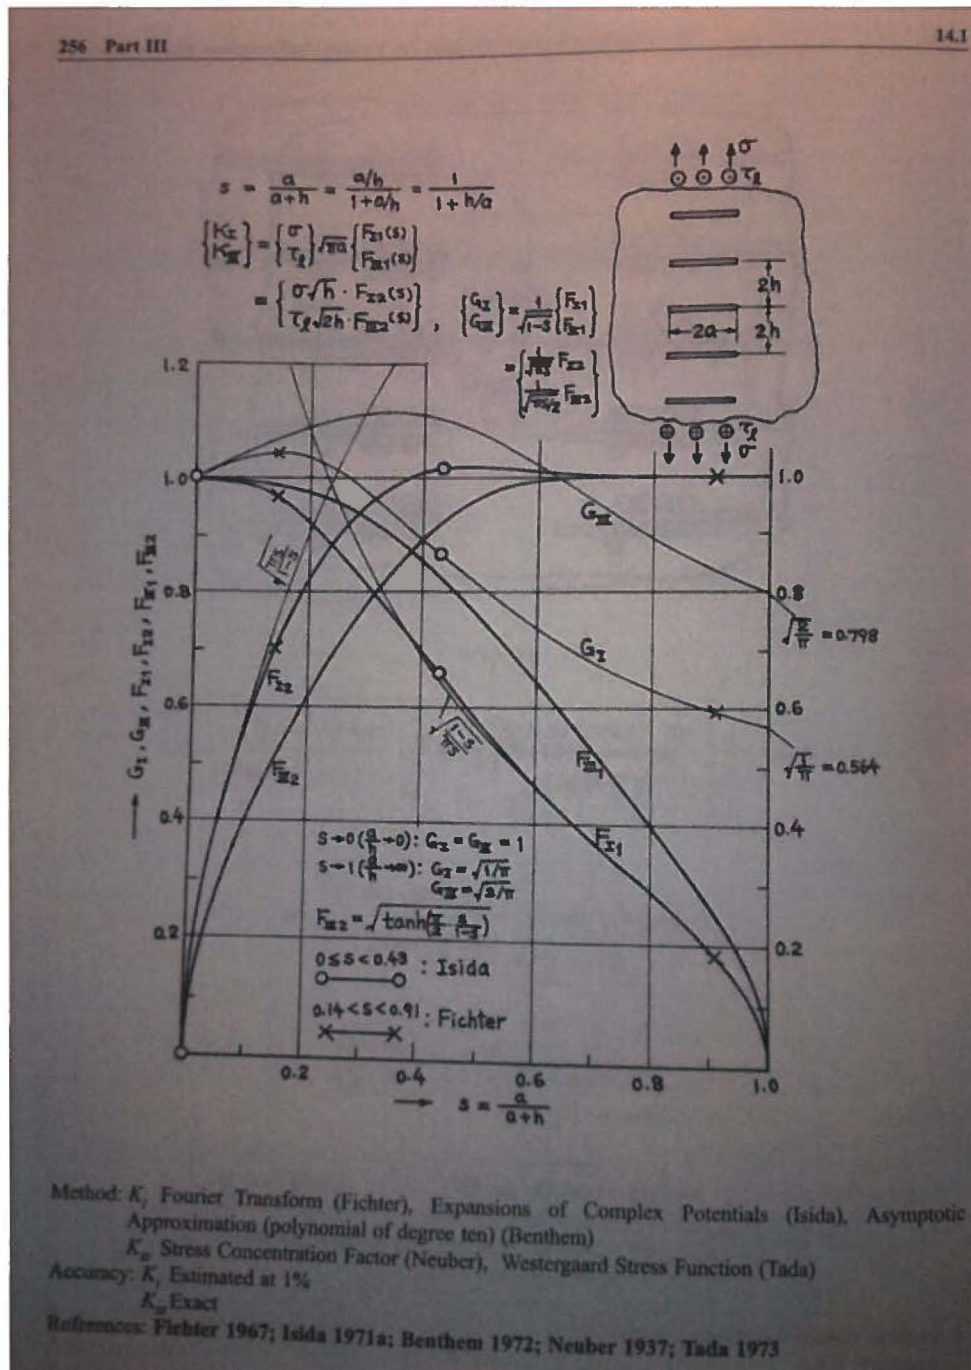
Figure 4. LEFM Solution for an Infinite Array of Through-wall Cracks in a Plate with a Membrane Load [10]

2. Review of the LEFM solution shown in Figure 4 illustrates that the crack driving force for parallel flaws in a plate is reduced compared to the case of a single flaw in a plate, as shown by observation of the F_{II} curve for $s \rightarrow 0$ which corresponds to a single flaw. Consequently, multiple aligned flaws can be bounded by treating each as a separate flaw.
3. The longest flaw reported near the H4/V3 intersection is selected for evaluation and clearly bounds all flaw lengths reported. This flaw is assumed to be a single continuous flaw passing through the H4 weld. The initial flaw size considered, before addition of uncertainty and crack growth, is 6.3 inches [1c].
