Clinton Power Station
8401 Power Road
Clinton, IL 61727

Clinton Power Station, Unit 1
Facility Operating License No. NPF-62
NRC Docket No. 50-461

Subject: Clinton Power Station Regulatory Conference Supplemental Information

Regulatory Conference Clinton Power Station Division 3 SX Pump

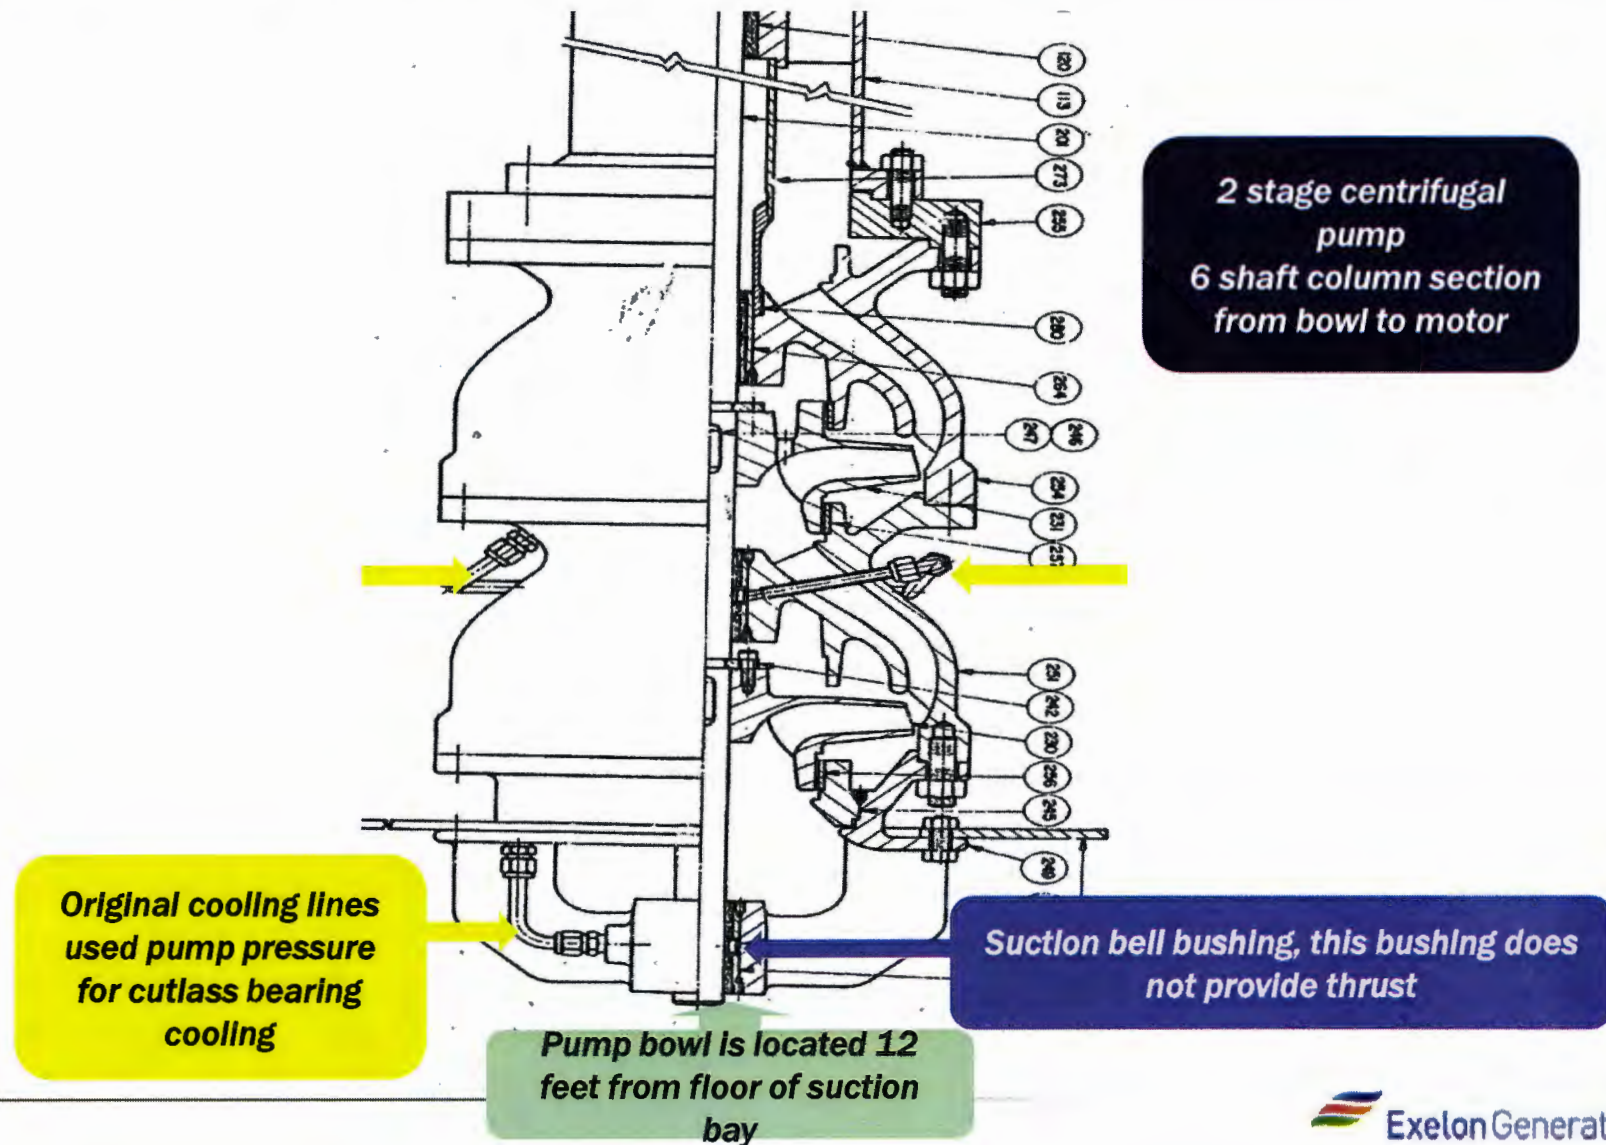
Original Pump Construction

- Original pump design had nine rubber cutlass bushings with cooling water for the upper bushings being supplied from the pump discharge and the lower bushings supplied from the pump casing.
- August 1990 – incurred failure of this pump to start, found excessive amounts of silt in the bushings, inner tube and cooling flush lines. The silt was determined to be from the external cooling water supply depositing inside the enclosure tube and between bushing clearances. Pump was cleaned and restored with additional testing to monitor for degradation.
- 1991 – the station developed seven options to address the pump failure mechanism with input from various pump experts including Sulzer-Bingham, Byron Jackson and American Pump Co.

- May 1991 – Following rigorous research, the reasonable decision was made to replace pump with a modified design that removed the inner tube, removed the external supply of water and replaced the bushings with bronze bushings that were cooled with internal fluids. This course of action addressed the identified failure mechanisms. Other options were dismissed based on introduction of new failure modes. Resolution selected was common to input from the pump experts.
