Clinton Power Station
8401 Power Road
Clinton, IL 61727

Subject: Clinton Power Station Regulatory Conference Supplemental Information

Regulatory Conference Clinton Power Station Division 3 SX Pump

Summary of Preliminary White Finding (Inspection Report 05000461/2015001)

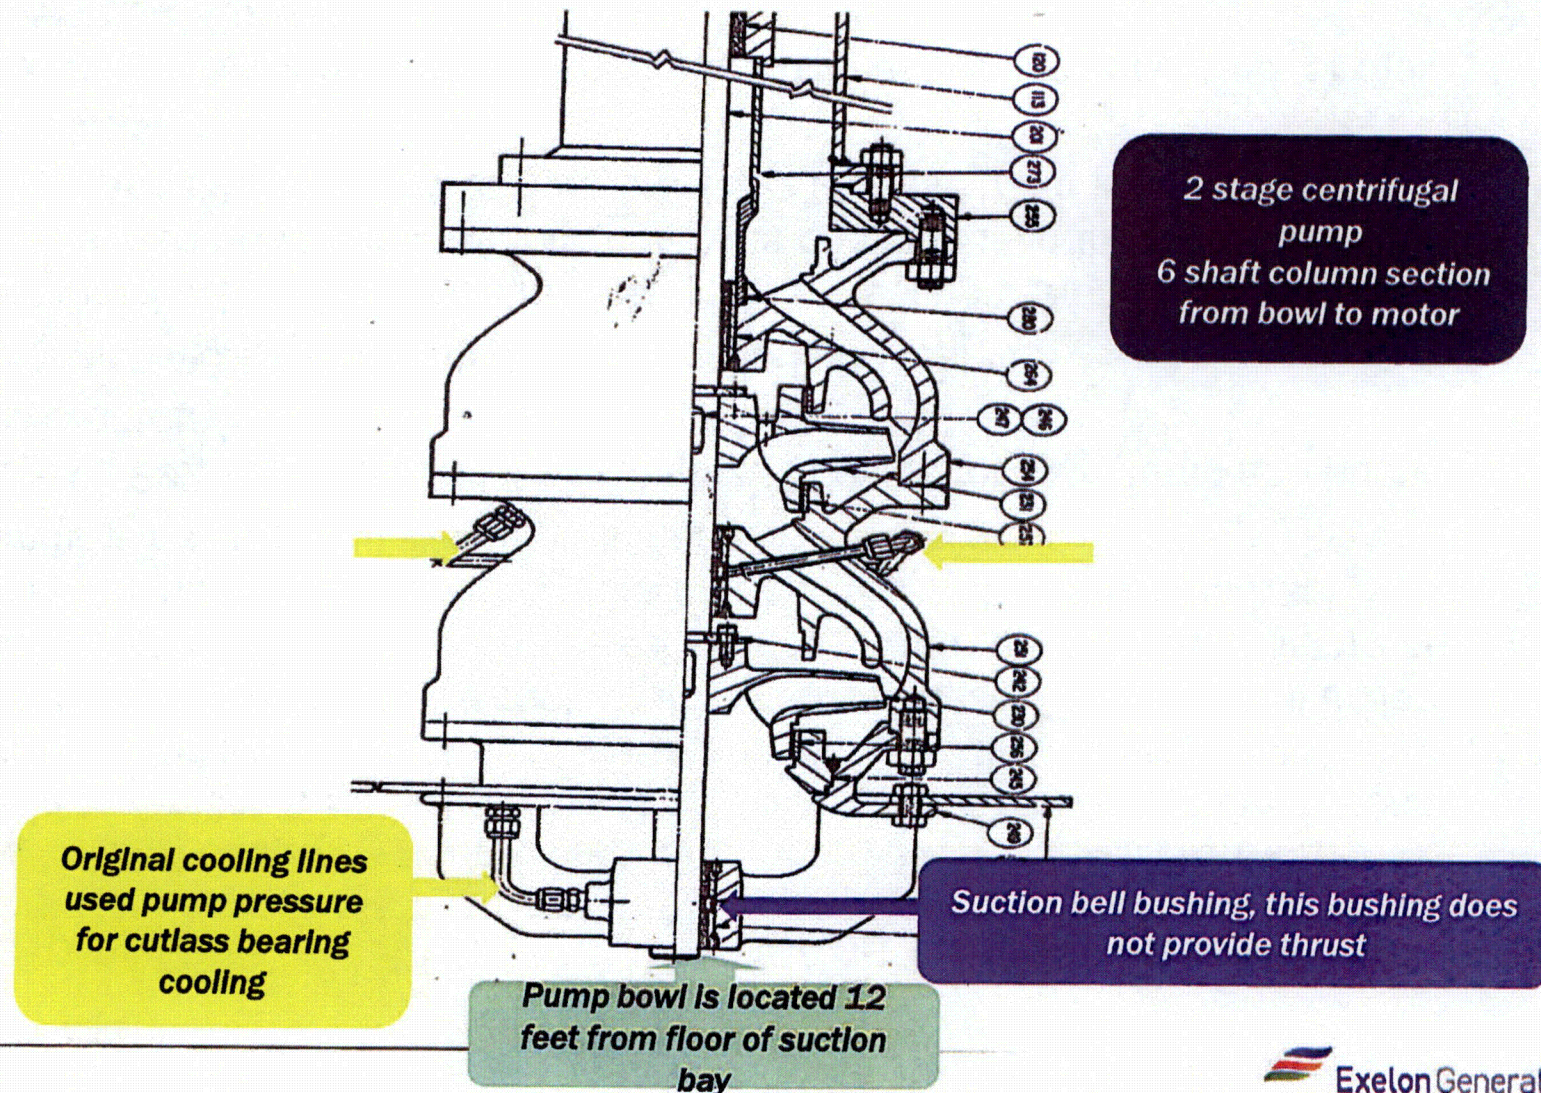
Original Pump Construction

- Original pump design had nine rubber cutlass bushings with cooling water for the upper bushings being supplied from the pump discharge and the lower bushings supplied from the pump casing.
- August 1990 – incurred failure of this pump to start, found excessive amounts of silt in the bushings, inner tube and cooling flush lines. The silt was determined to be from the external cooling water supply depositing inside the enclosure tube and between bushing clearances. Pump was cleaned and restored with additional testing to monitor for degradation.
- 1991 – the station developed seven options to address the pump failure mechanism with input from various pump experts including Sulzer-Bingham, Byron Jackson and American Pump Co.

- May 1991 – Following rigorous research, the reasonable decision was made to replace pump with a modified design that removed the inner tube, removed the external supply of water and replaced the bushings with bronze bushings that were cooled with internal fluids. This course of action addressed the identified failure mechanisms. Other options were dismissed based on introduction of new failure modes. Resolution selected was common to input from the pump experts.
