Part 21 (PAR)

## PART 21 - ACTUATOR SHAFT DID NOT MEET DIMENSIONAL REQUIREMENTS

**ENGINEERING EVALUATION**  
**10CFR21 File No. 89**

**SUBJECT:** Actuator Shaft supplied for 6-900 Exercisable Swing Check Valve, Drawing No. 3489-3 manufactured by Anchor/Darling Valve Co. and installed at Energy Northwest (ENW) - Columbia Station.

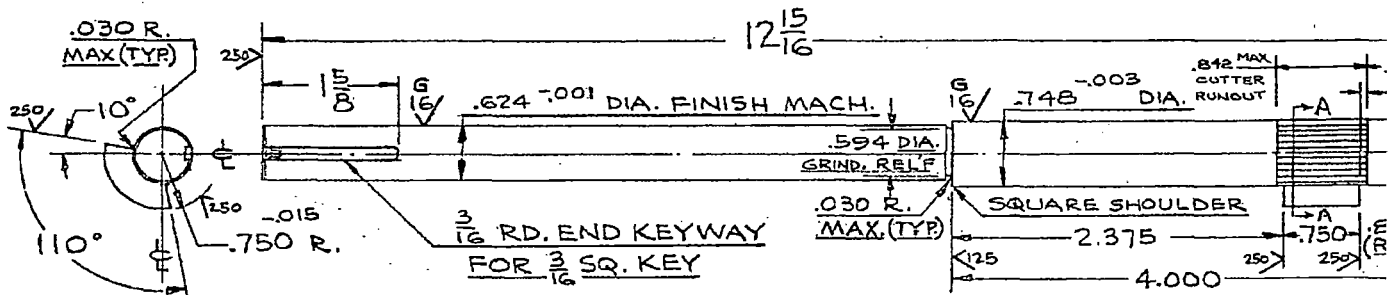
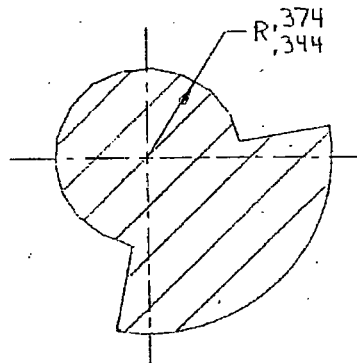
SECTION A-A

**PROBLEM:** ENW - Columbia reported the replacement actuator shaft was different than the one removed and could not be installed. After consultation with Flowserve it was determined the actuator shaft did not meet the dimensional requirements of the manufacturing drawing. The shaft includes an off-set lug that engages the hinge and allows testing or exercising the valve disc. The shaft diameter opposite the lug must be equal to or less than the basic diameter adjacent to the lug in order to allow free disc swing. See figures 1 photos and 2 drawing.

**ROOT CAUSE:** The actuator shaft was machined by a Flowserve subvendor which incorrectly interpreted the machining drawing and produced the shaft with a large, out of tolerance radius around the lug. The drawing was not clear to the subvendor. Flowserve inspection did not discover the discrepancy during subsequent dimensional inspection.

An excessively large diameter at the lug will not allow installation of a replacement actuator shaft. A shaft with a diameter opposite the lug that is greater than design but still small enough to allow installation could retard or prevent free disc swing and adversely affect check valve function.

**PROPOSED ACTION:** Flowserve will revise actuator shaft drawing to clearly define the radius/diameter at the lug. Flowserve will notify the customers in table 1 of the attached evaluation of the defect and will request that the actuator shafts be returned to Flowserve for evaluation and/or replacement at no charge.
