FRAMATOME  
TECHNOLOGIES

## ENGINEERING INFORMATION RECORD

Document Identifier 51 - 5000239 - 00Title INTERIM BWOOG REPORT ON HPI/MU NOZZLE CRACKING

The purpose of this interim report is to collect information relative to the cracking found in the high pressure injection/makeup nozzle at Oconee Unit 2 in April, 1997. This report represents the first phase of a program to determine the root cause behind the cracking. This interim report does not attempt to determine the root cause behind the cracking. This report provides partial response to the Request for Information transmitted by the NRC on 5/27/97 (Attachment 1).

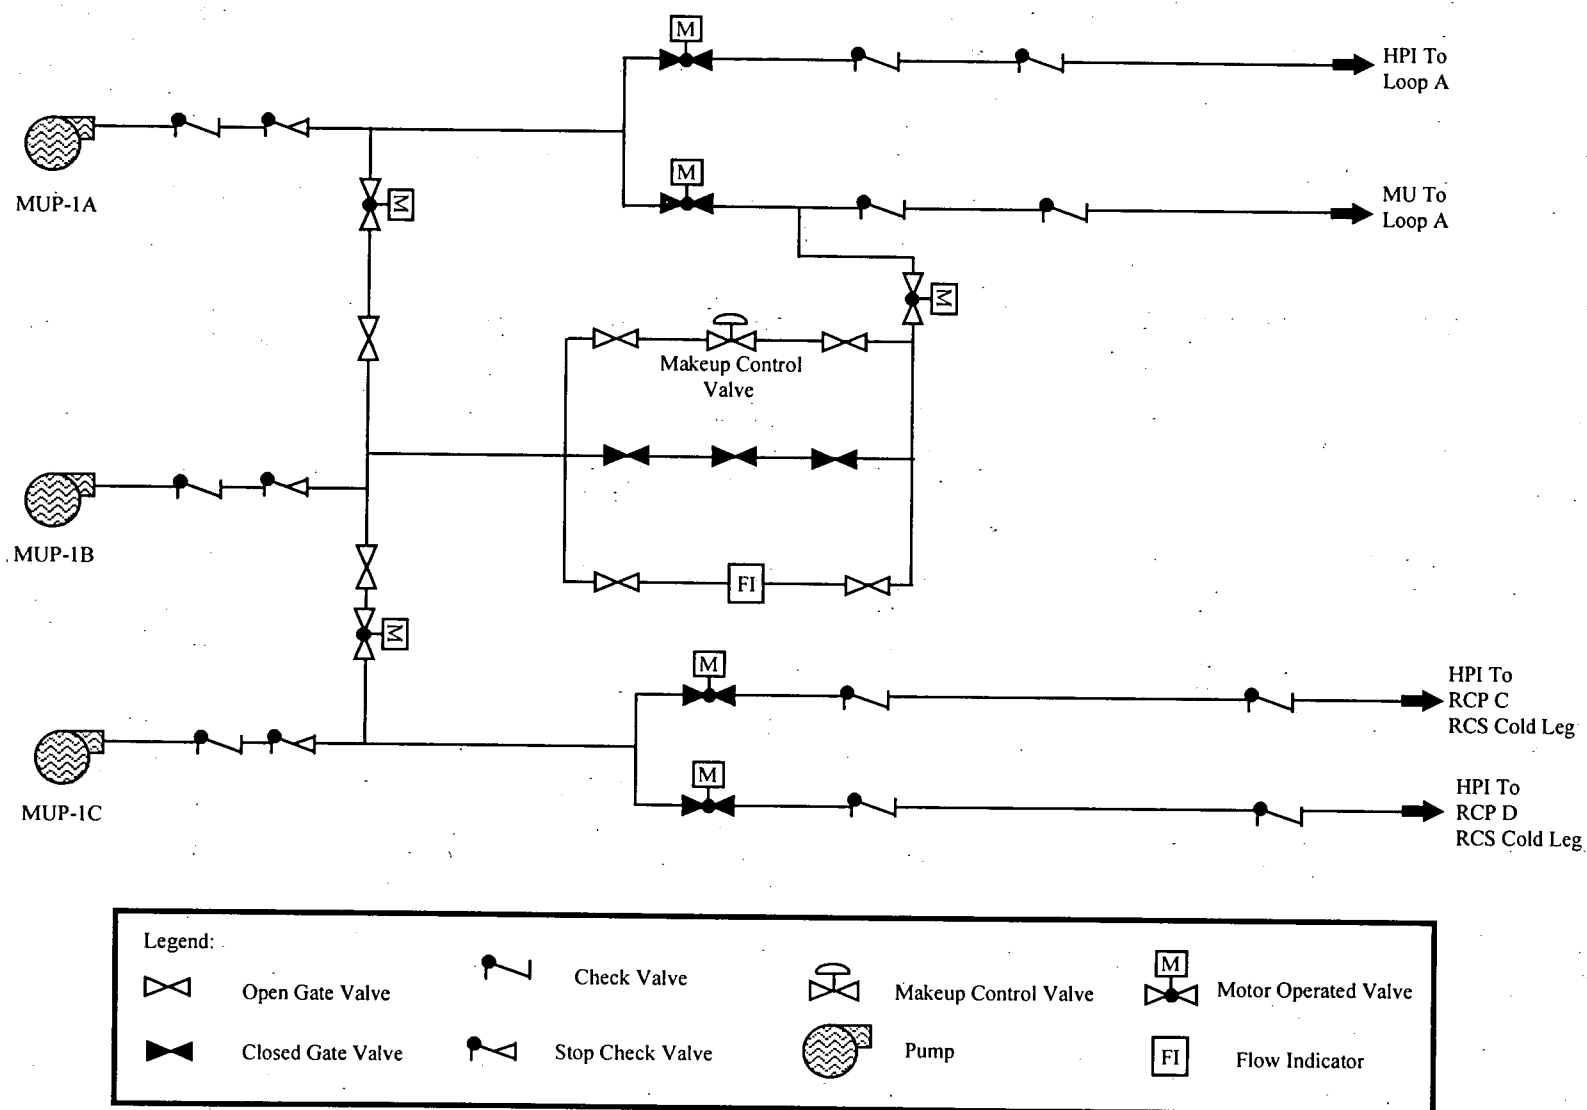
Figure 6-3 CR-3 HPI/MU System Schematic

Figure 6-3 shows that none of the HPI/MU nozzles are "cross-connected". Therefore, backflow from one loop to another is not a concern.

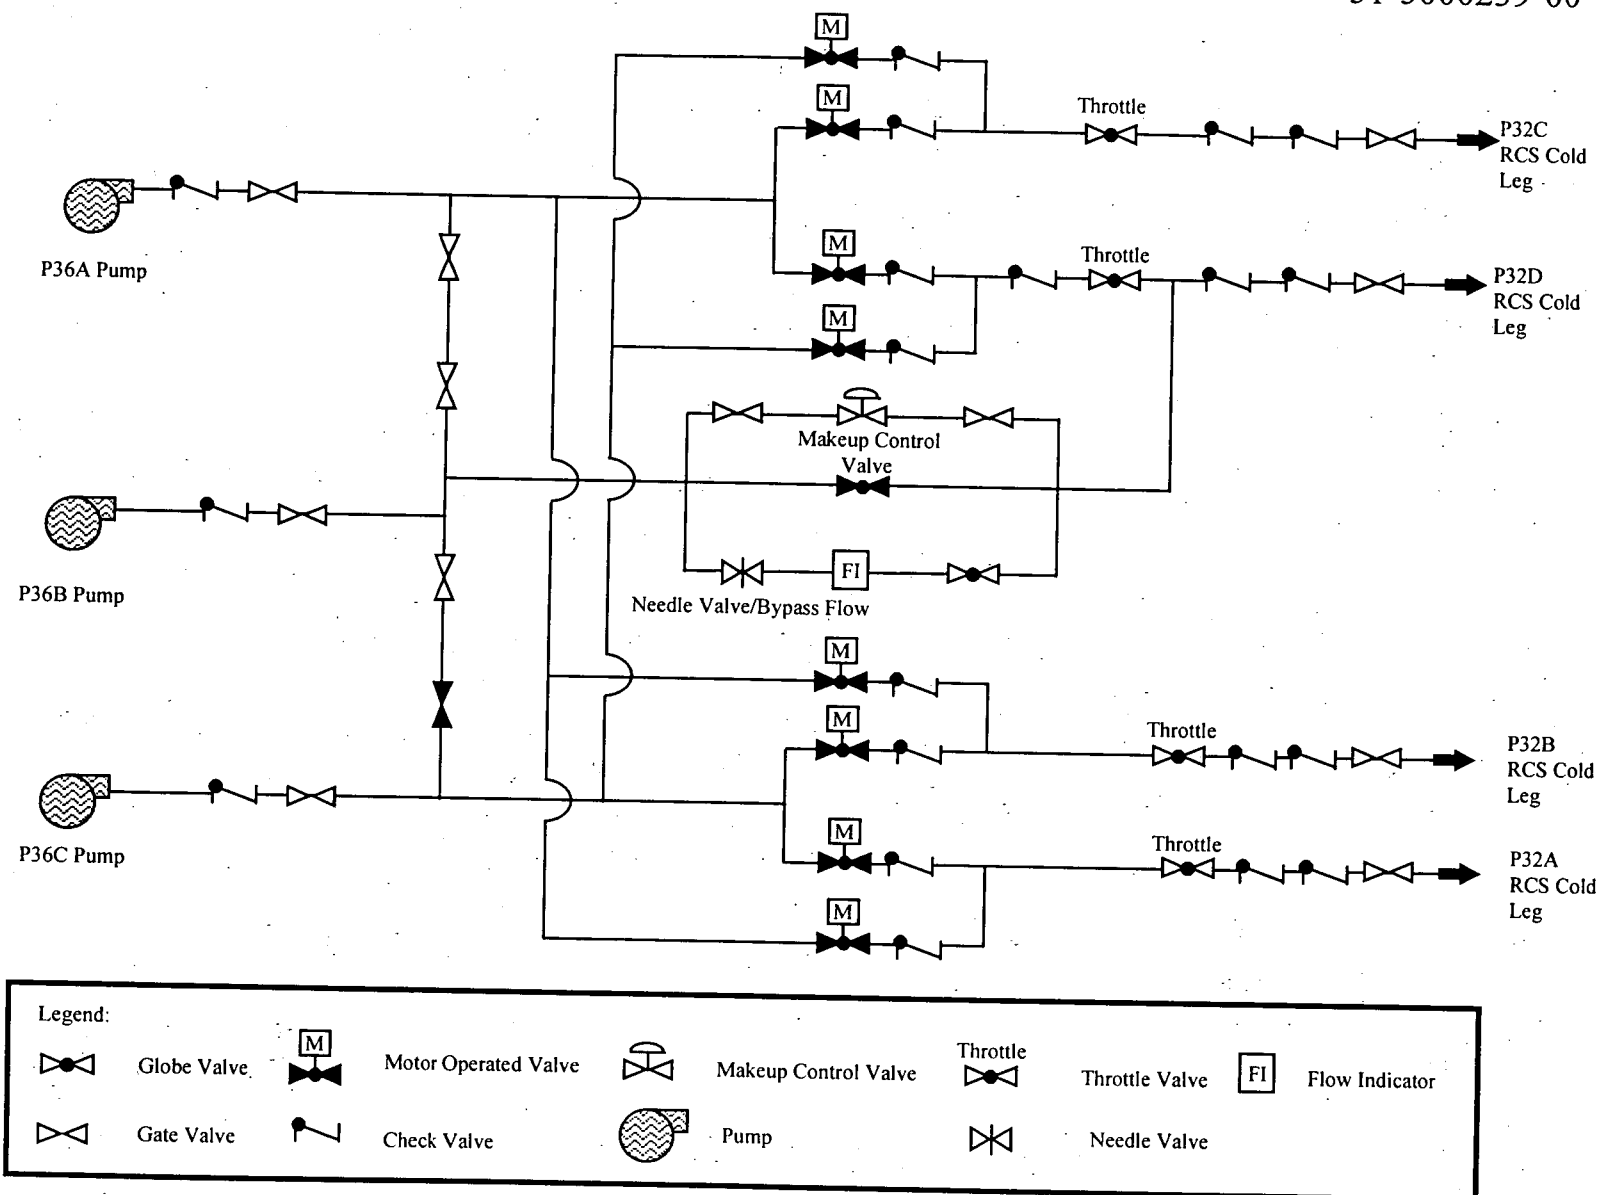
Figure 6-4 ANO-1 HPI/MU System Schematic

Figure 6-4 shows that none of the HPI/MU nozzles are "cross-connected". Therefore, backflow from one loop to another is not a concern. Prior to 1989, there was a "cross-connection" and a number of backflow events occurred. At that time, system modifications were made to eliminate the possibility of backflow.

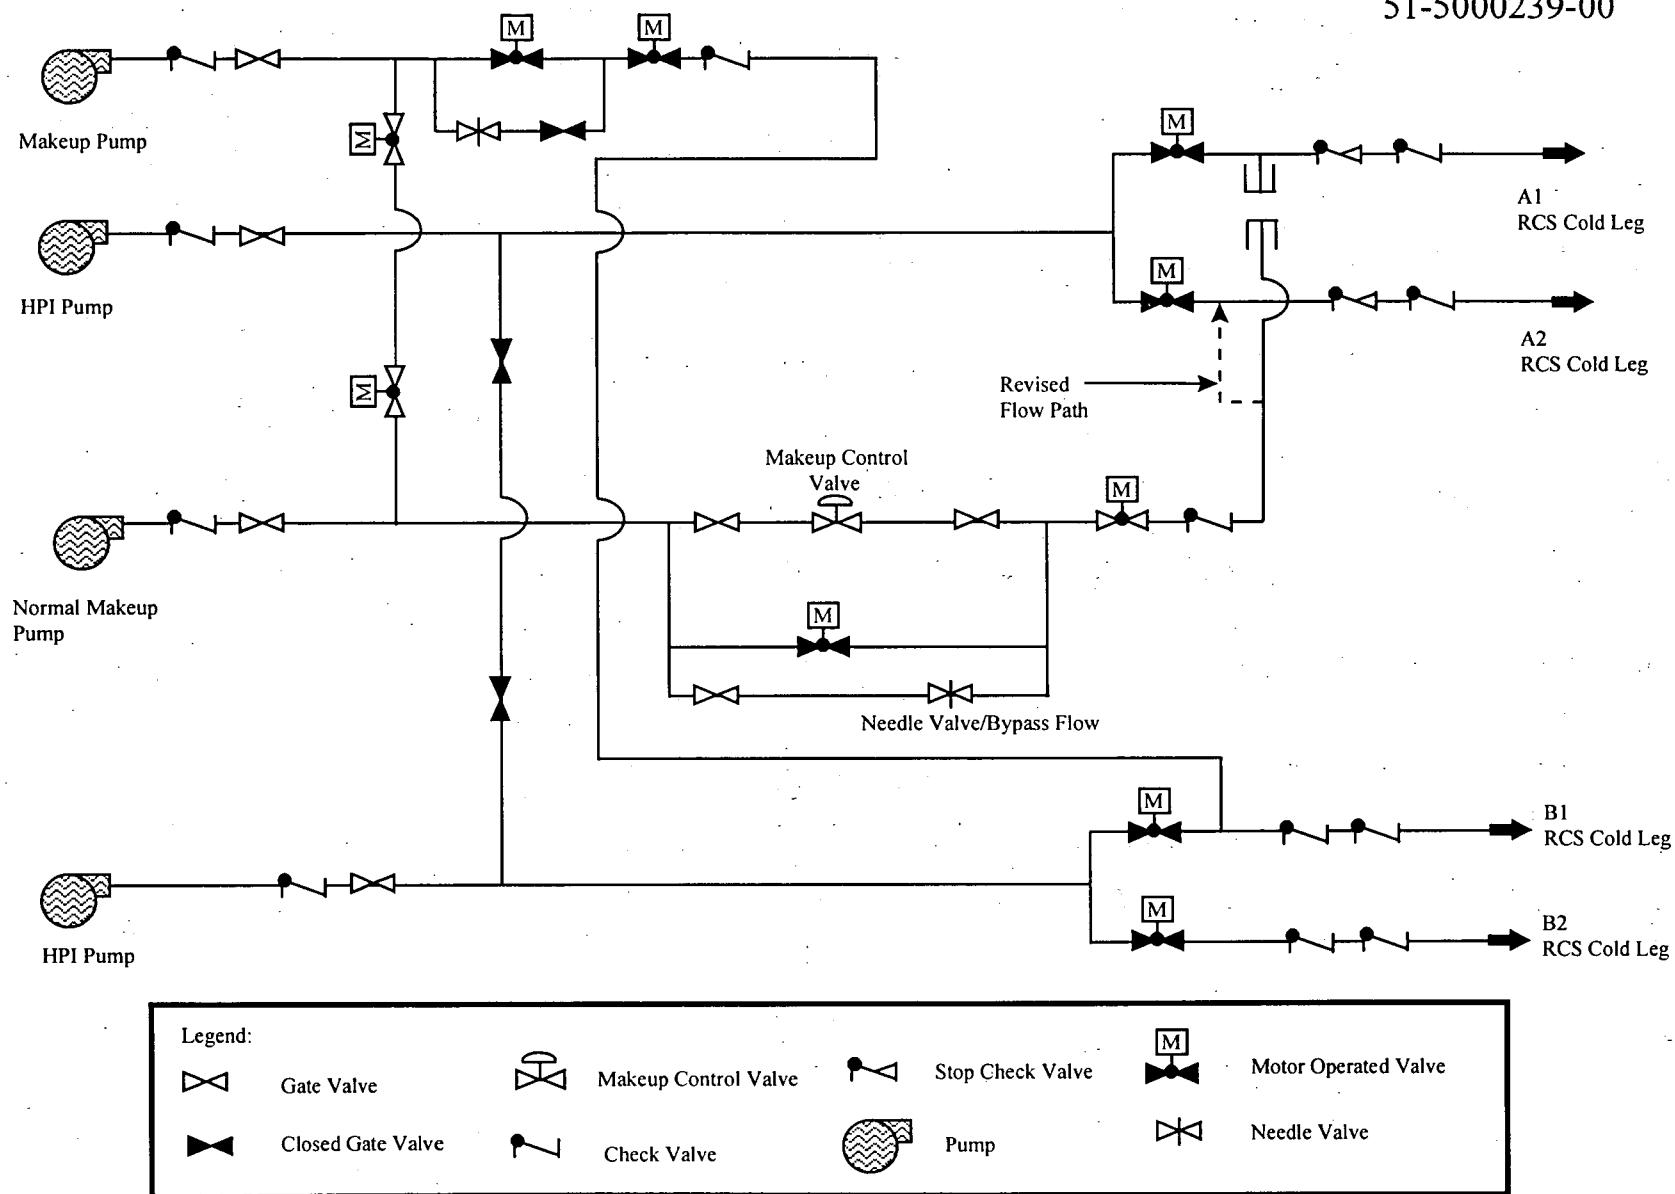
Figure 6-5 DB-1 HPI/MU System Schematic

Figure 6-5 shows that none of the HPI/MU nozzles are "cross-connected". Therefore, backflow from one loop to another is not a concern

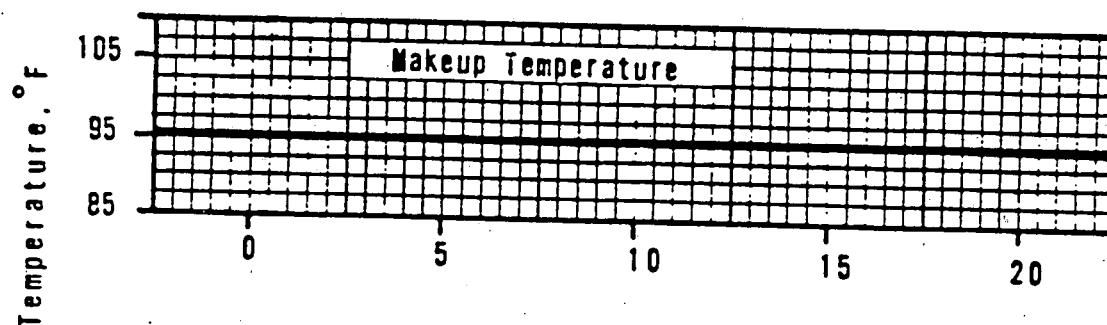
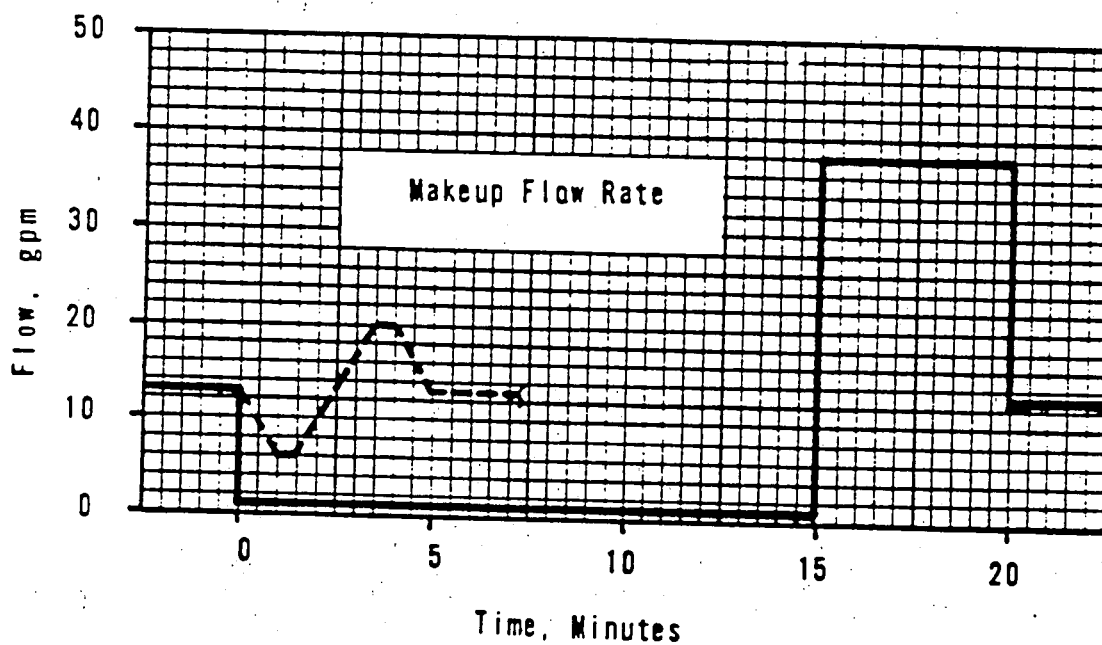
Figure 9-1 Transient 20 Makeup Flow and Temperature

The double-duty HPI/MU nozzles have two separate "at-power" design basis cycling periods as shown in Figure 9-1. The transient depicted in Figure 9-1 is typical of the normal operation miscellaneous transients considered in the design basis of the double-duty HPI/MU nozzles (references 23 - 27). They have a period of approximately 5 minutes and 20 minutes, respectively. The 5 minute transient is considered to occur for 4 million cycles over the design life of the plant and the 20 minute transient is considered to occur for 30000 cycles over the design life of the plant. These transients were intended to consider unknown transients such as valve cycling.
