LEUPA

Type B(U) Package to Contain Fissile Substances

**TESTS CARRIED OUT ON SPECIMENS
OF THE DESIGN OF TYPE B(U)
PACKAGE TO TRANSPORT
RADIOACTIVE MATERIAL
FINAL REPORT**

INAP

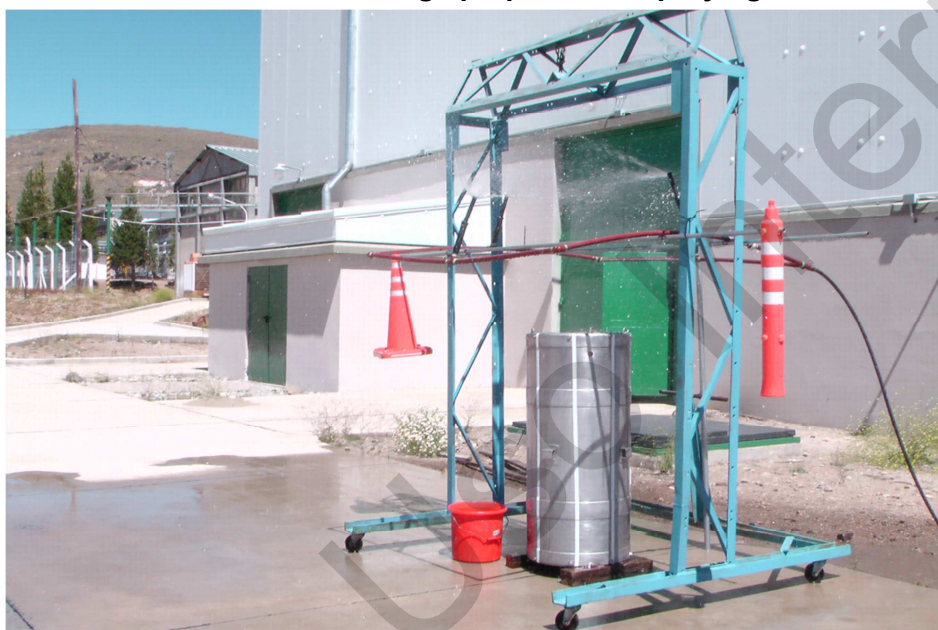
Picture 5: Package prepared for spraying water test

1. Once the test was finished, there was more than 5 cm of water inside the container.
2. The specimen LEUPA 01 did not suffer any alteration in its external structure, and there was no water in its inside.
3. After certifying and evaluating the damages suffered by the specimen LEUPA 01, the test was considered to be satisfactory, and it was released for the following test.

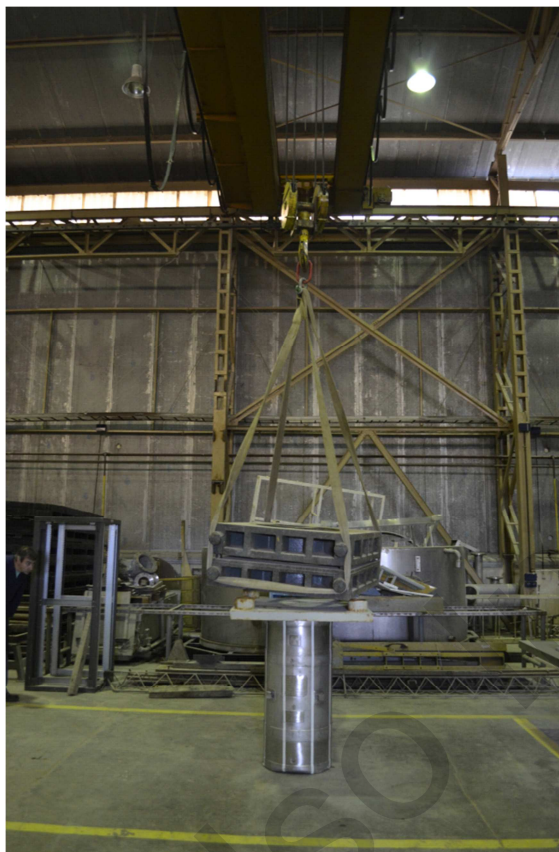
Picture 6: Package prepared for piling test

1. During inspection, it was, visually and dimensionally, proved that specimen LEUPA 01 had suffered no kind of deformation in its structure.
2. After certifying and evaluating the suffered damages by the specimen LEUPA 01, the test was considered satisfactory, and the specimen was released for the following test.

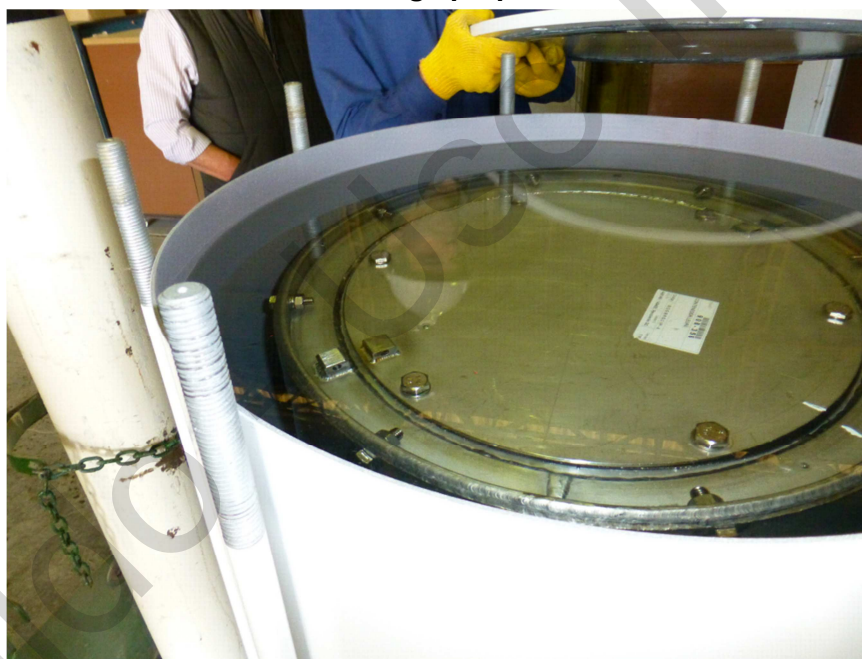
Picture 20: Package prepared for immersion test

1. After 3:30 pm the test tank was depressurized and the cover was removed.
2. The specimen LEUPA 02 was taken out from the test tank and its disassembly started.
3. Once the cover was removed, water could be seen in the first compartment, the second cover was removed and the second compartment was wet.
4. When the cover of the container of inner cans was removed, it could clearly be seen they were not wet, and both, the inner cans as well as their load, were in perfect state.
5. After certifying and evaluating the damages suffered by the specimen LEUPA 02, the test was considered satisfactory.

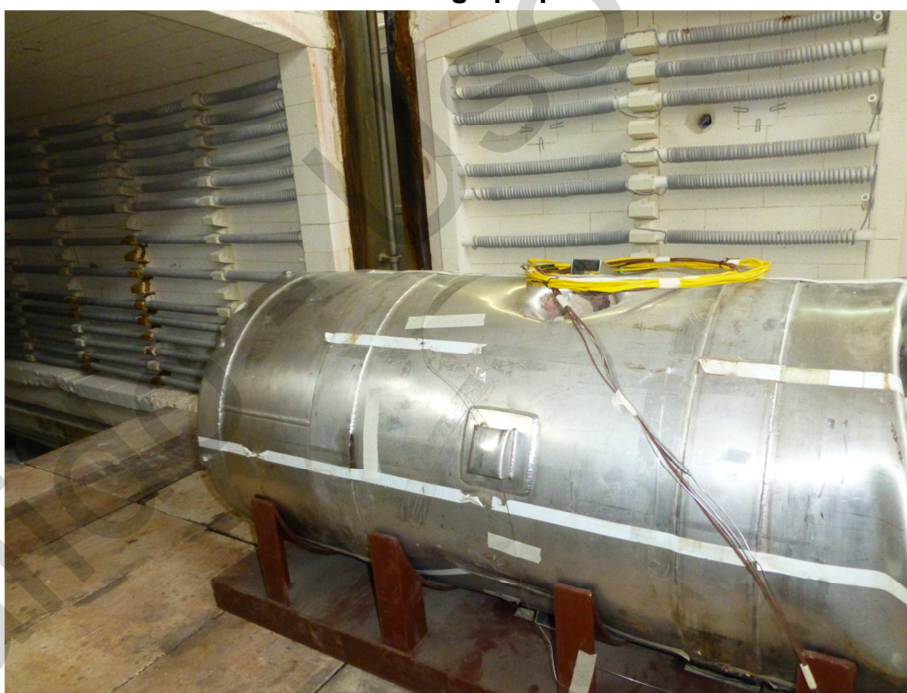
Picture 23: Package prepared for thermal test

1. After the ending of the test, the specimen was left for cooling during more than 20 hours.
2. With visual inspection the change of colour in specimen LEUPA 01 was observed, the gasket of the external cover was damaged; and thermocouples were removed.
3. After certifying and evaluating the damages suffered by the specimen LEUPA 01, the test was considered satisfactory, and the specimen was released for the last test.

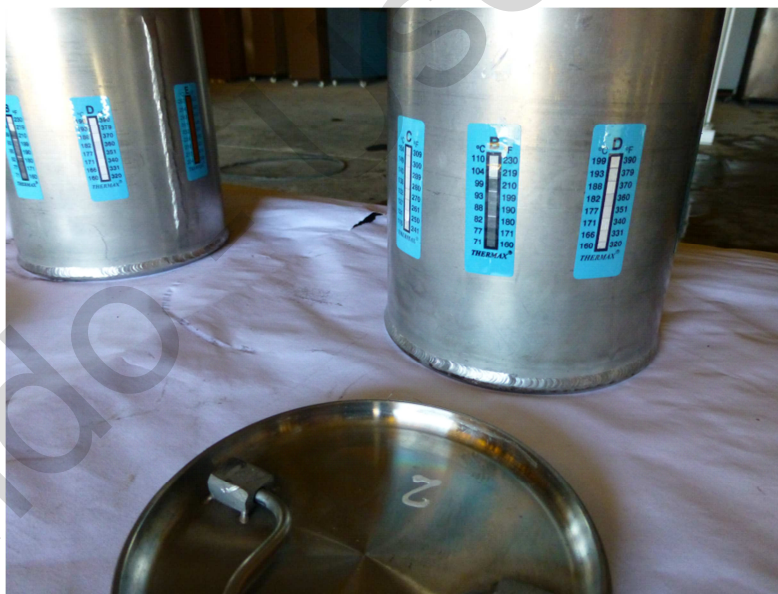
Picture 29: Inner cans

1. As a result of all the destructive tests made in accordance with Specification No. 0908-LE02-3BSIN-002, and Standard AR 10.16.1 Revision 2 of ARN, it could be seen that the content of the inner cans was fully preserved inside them (see).
