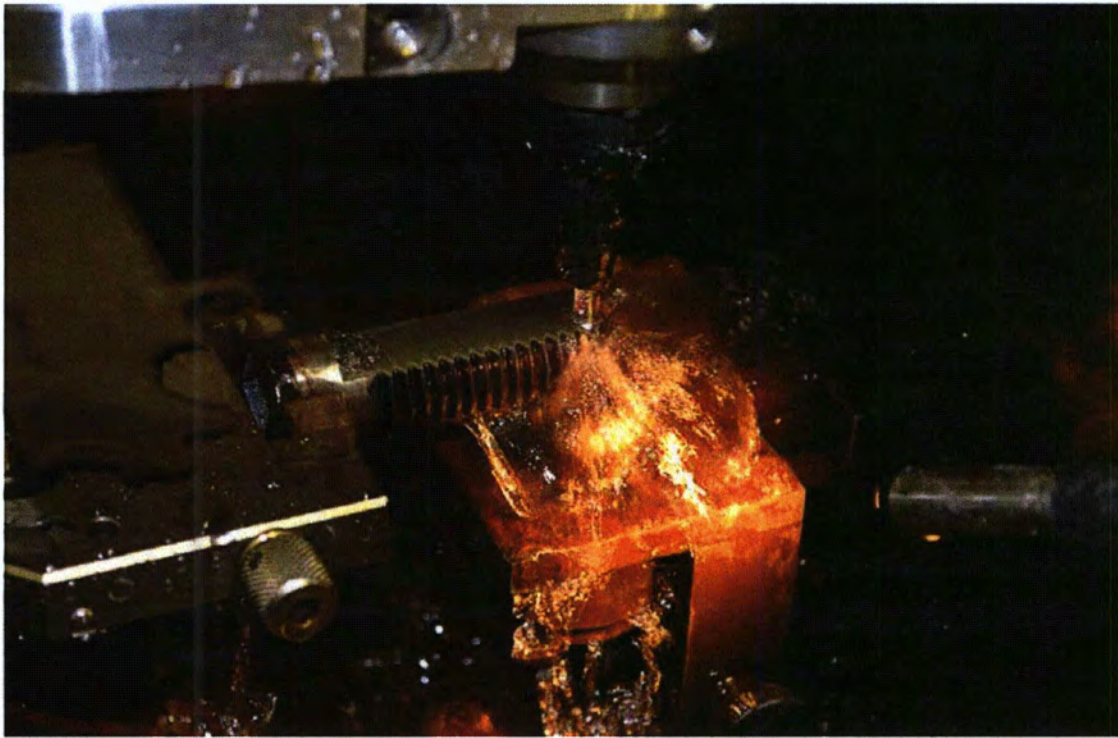
Figure 43: Wire EDM was used to section each bolt for destructive examinations. The above photo shows initial machining of the threaded region for hardness and tensile testing.

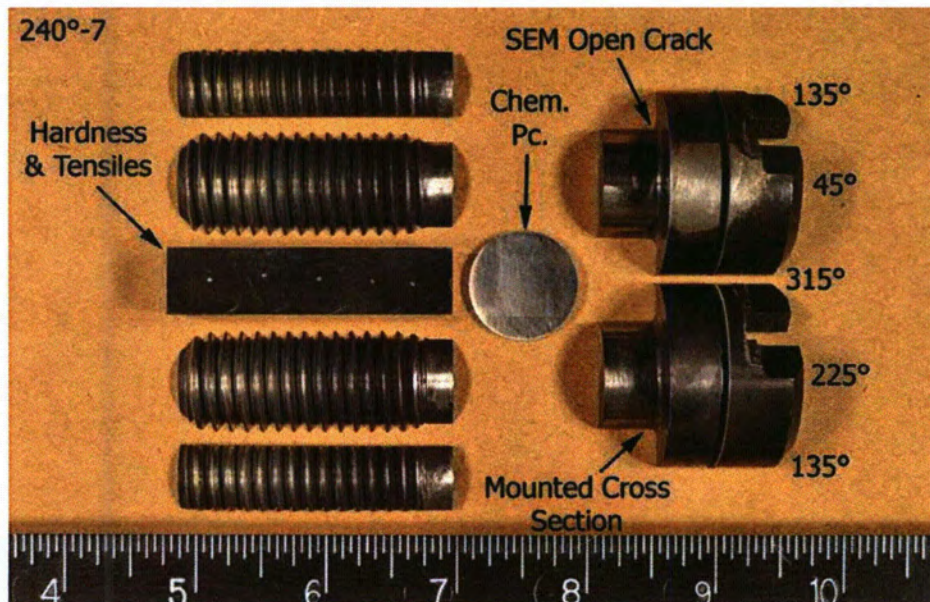
Figure 44: Section photograph for bolt 240°-7 showing the typical locations chosen for subsequent analysis. The five Rockwell C hardness indents are visible on the upper surface of the hardness/tensile blank.

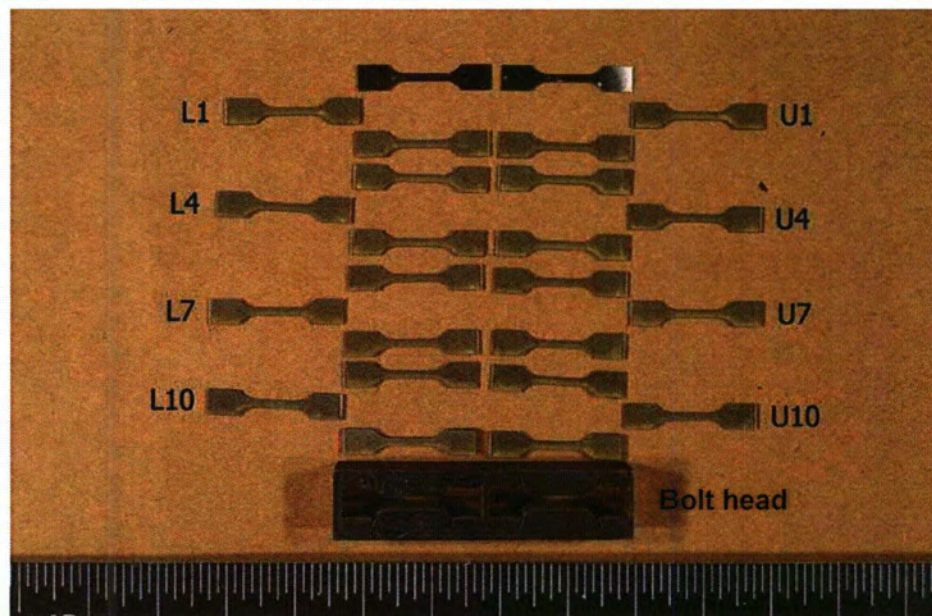
Figure 45: Typical location of tensile specimens machined from each bolt. The IDs of the tested specimens are shown.

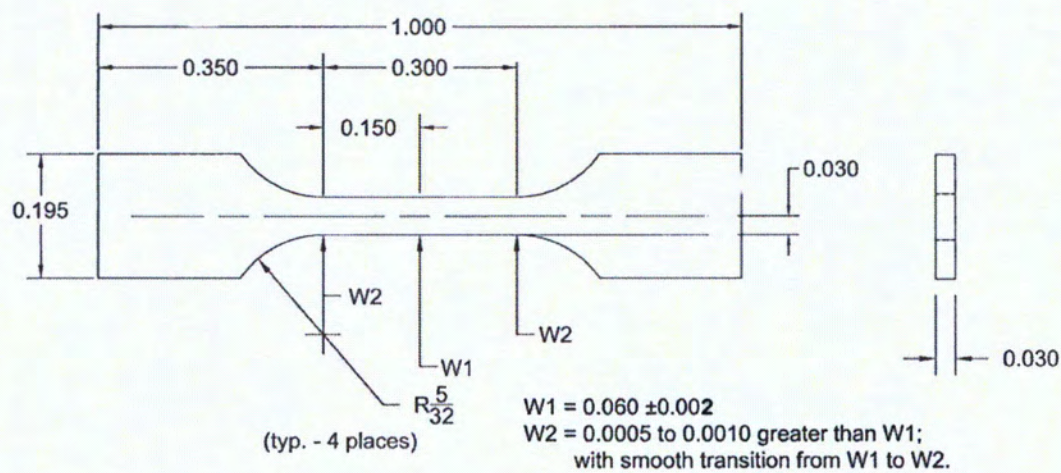
Figure 46: Miniature tensile specimen design showing dimensions.
