**Savannah River
Remediation**

Saltstone Disposal Facility SDU Cell 2A Core Drill Summary

SRR-CWDA-2015-00087

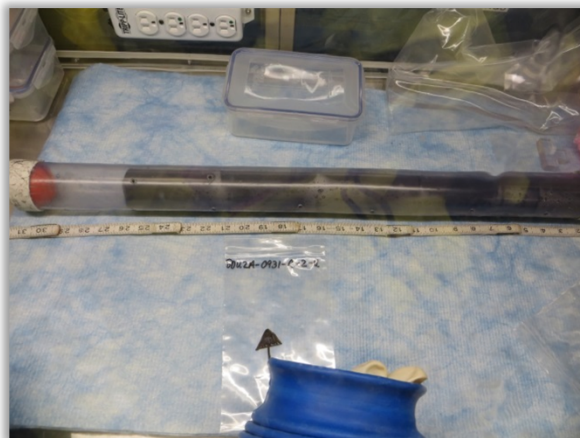
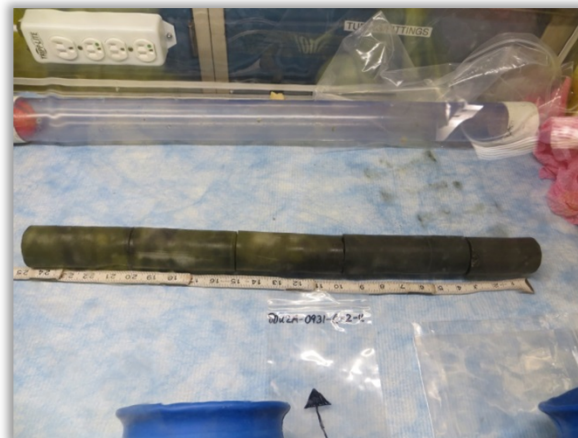
Discard First sample section length is 17 inches, hole depth 15 inches. Material has chips (some chips are suspected to have turned in the extraction tube).	Upper Sample Retrieved and discarded additional 6 inches off the top. Upper sample section 24 inches, hole depth 48 inches.	Lower Sample Lower core section length 28.5 inches. Excellent quality. Much like the upper section and clearly better than drill position 1.
--	---	--

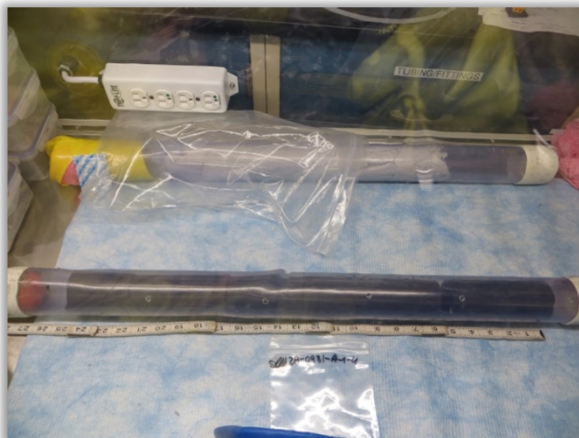
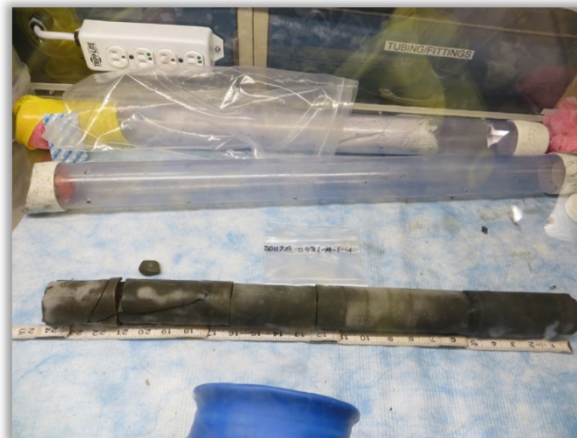
Upper Sample

Date	Port	Hole #	Drill Position	Approximate Sample Length (in)	Sample Region	Sample Condition	Notes
16-Apr	B	1	1	N/A	N/A	Undefined	Material found bound in drill bit. Drill activities suspended prior to core extraction
22-Apr	B	2	2	9	Lower	Degraded	Drilled to approximately 78 inches. Extraction tube could only be inserted into top 9 inches of the target region. Hole possibly obstructed with grout fragments
28-Apr	C	1	2	29	Upper	Excellent	
28-Apr	C	1	2	20	Lower	Good	
30-Apr	C	2	1	24	Upper	Excellent	
30-Apr	C	2	1	29	Lower	Excellent	
5-May	A	1	2	22	Upper	Average	
5-May	A	1	2	17	Lower	Marginal	
6-May	A	2	1	24	Upper	Excellent	
6-May	A	2	1	17	Lower	Average
