HOLTEC INFORMATION BULLETIN (HIB)*

Title of the Bulletin: VCT Restraint Strap Weld Failure

CoC Holder:	Holtec International	HIB No. (sequential):	67	Revision Log:		
					<u>Name</u>	<u>Date</u>
System Name:	Lift System VCT	Ref. Nuclear Plant:	Diablo Canyon Power Plant	Author (Rev. 0):	Arthur Barrett	7/28/15
				Reviewer (Rev 0):	Robert Tindal	7/28/15
Holtec Program No.:	1027	Period of Occurrence (m/y):	05/2015	Author (Rev. 1):		
				Reviewer (Rev 1):		
Affected Component(s):	Diablo VCT	Affected equipment or part	Diablo Lift Systems VCT	Author (Rev. 2):		
				Reviewer (Rev 2):

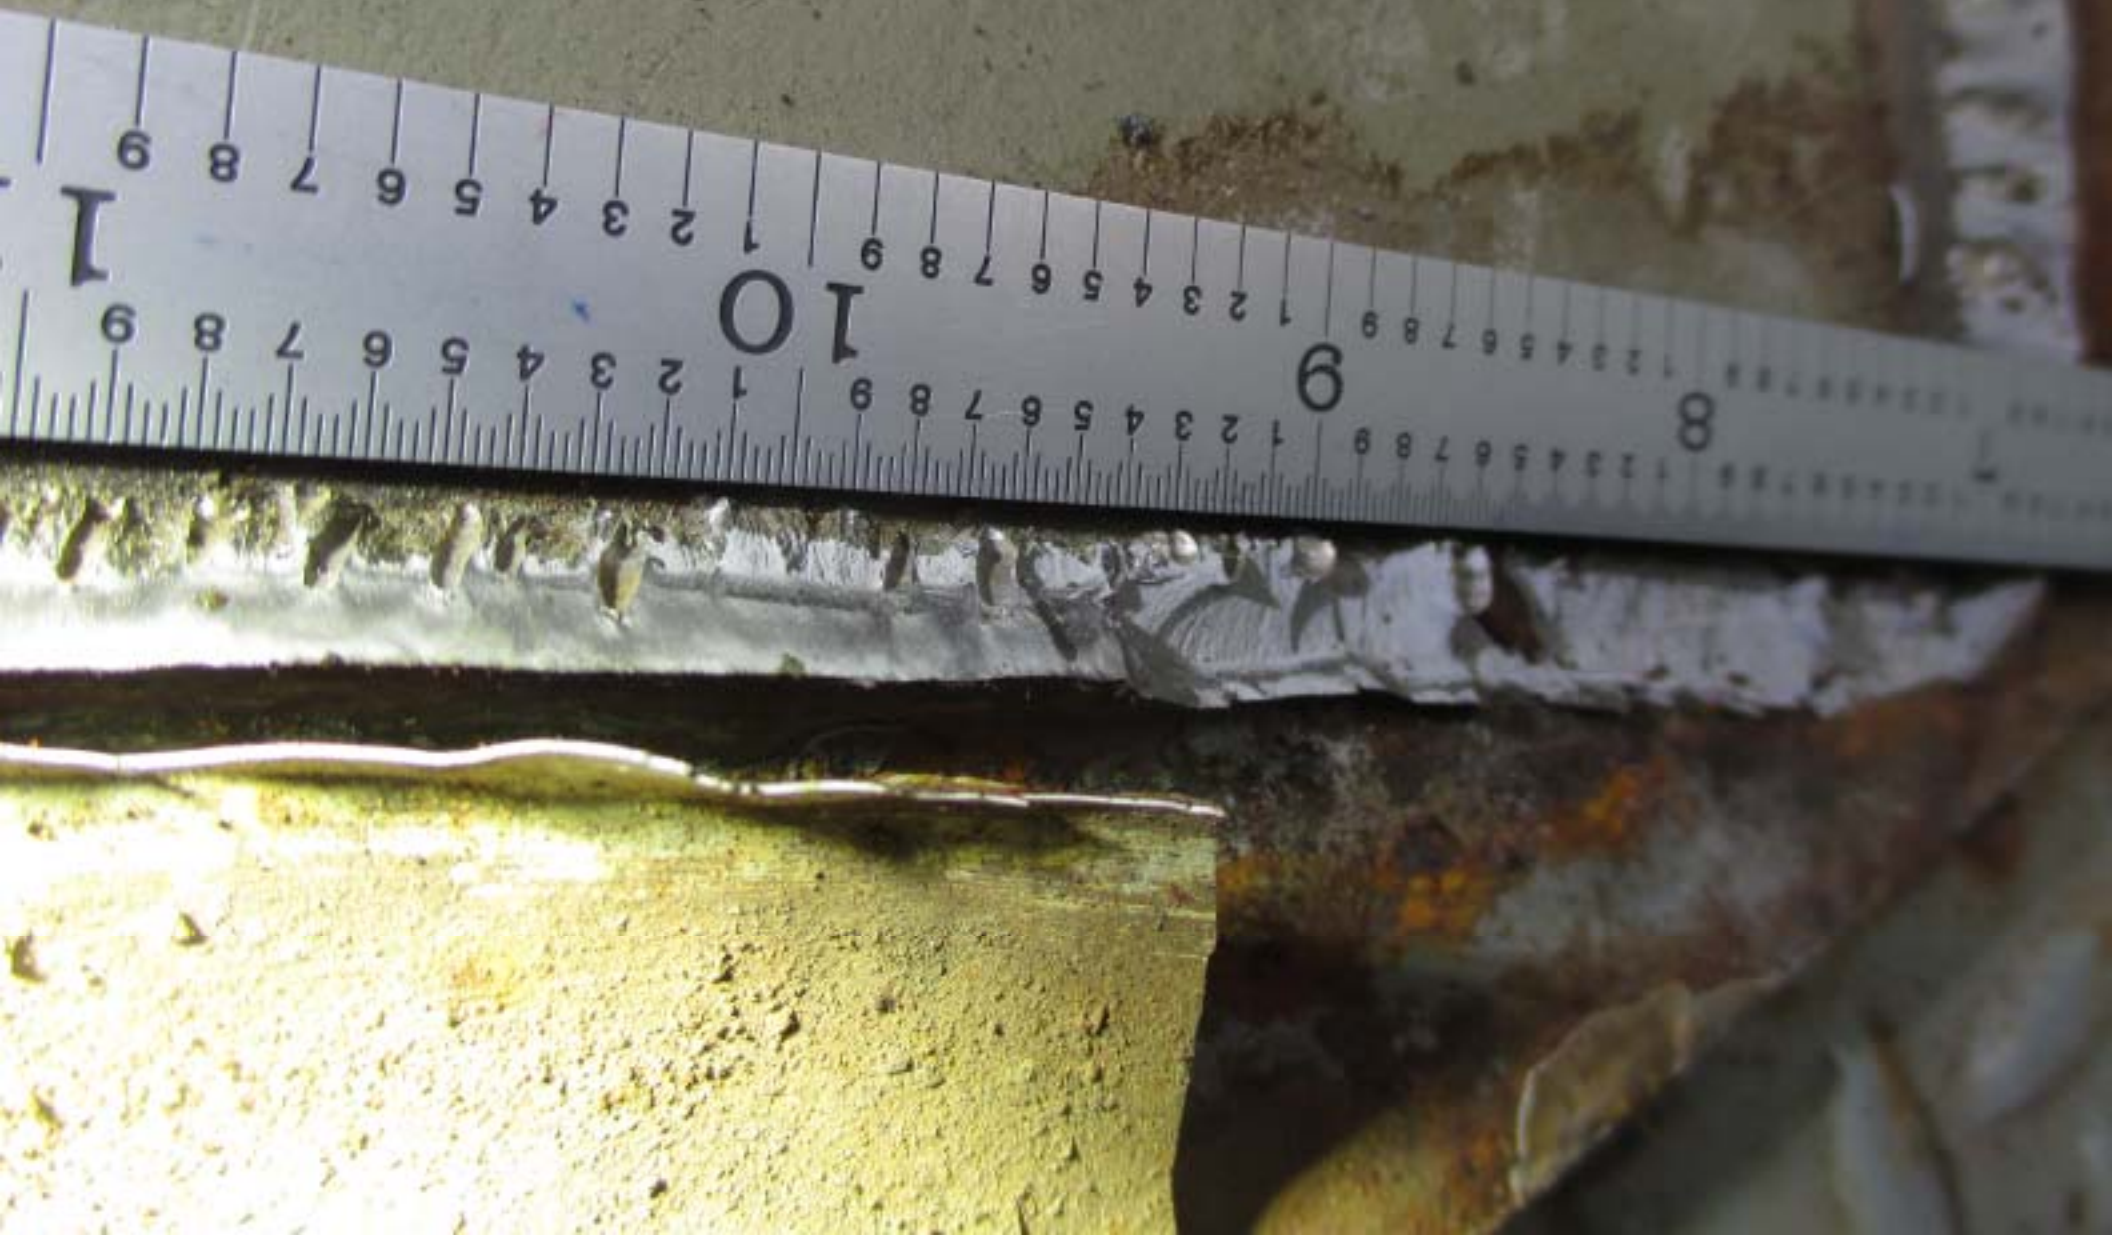
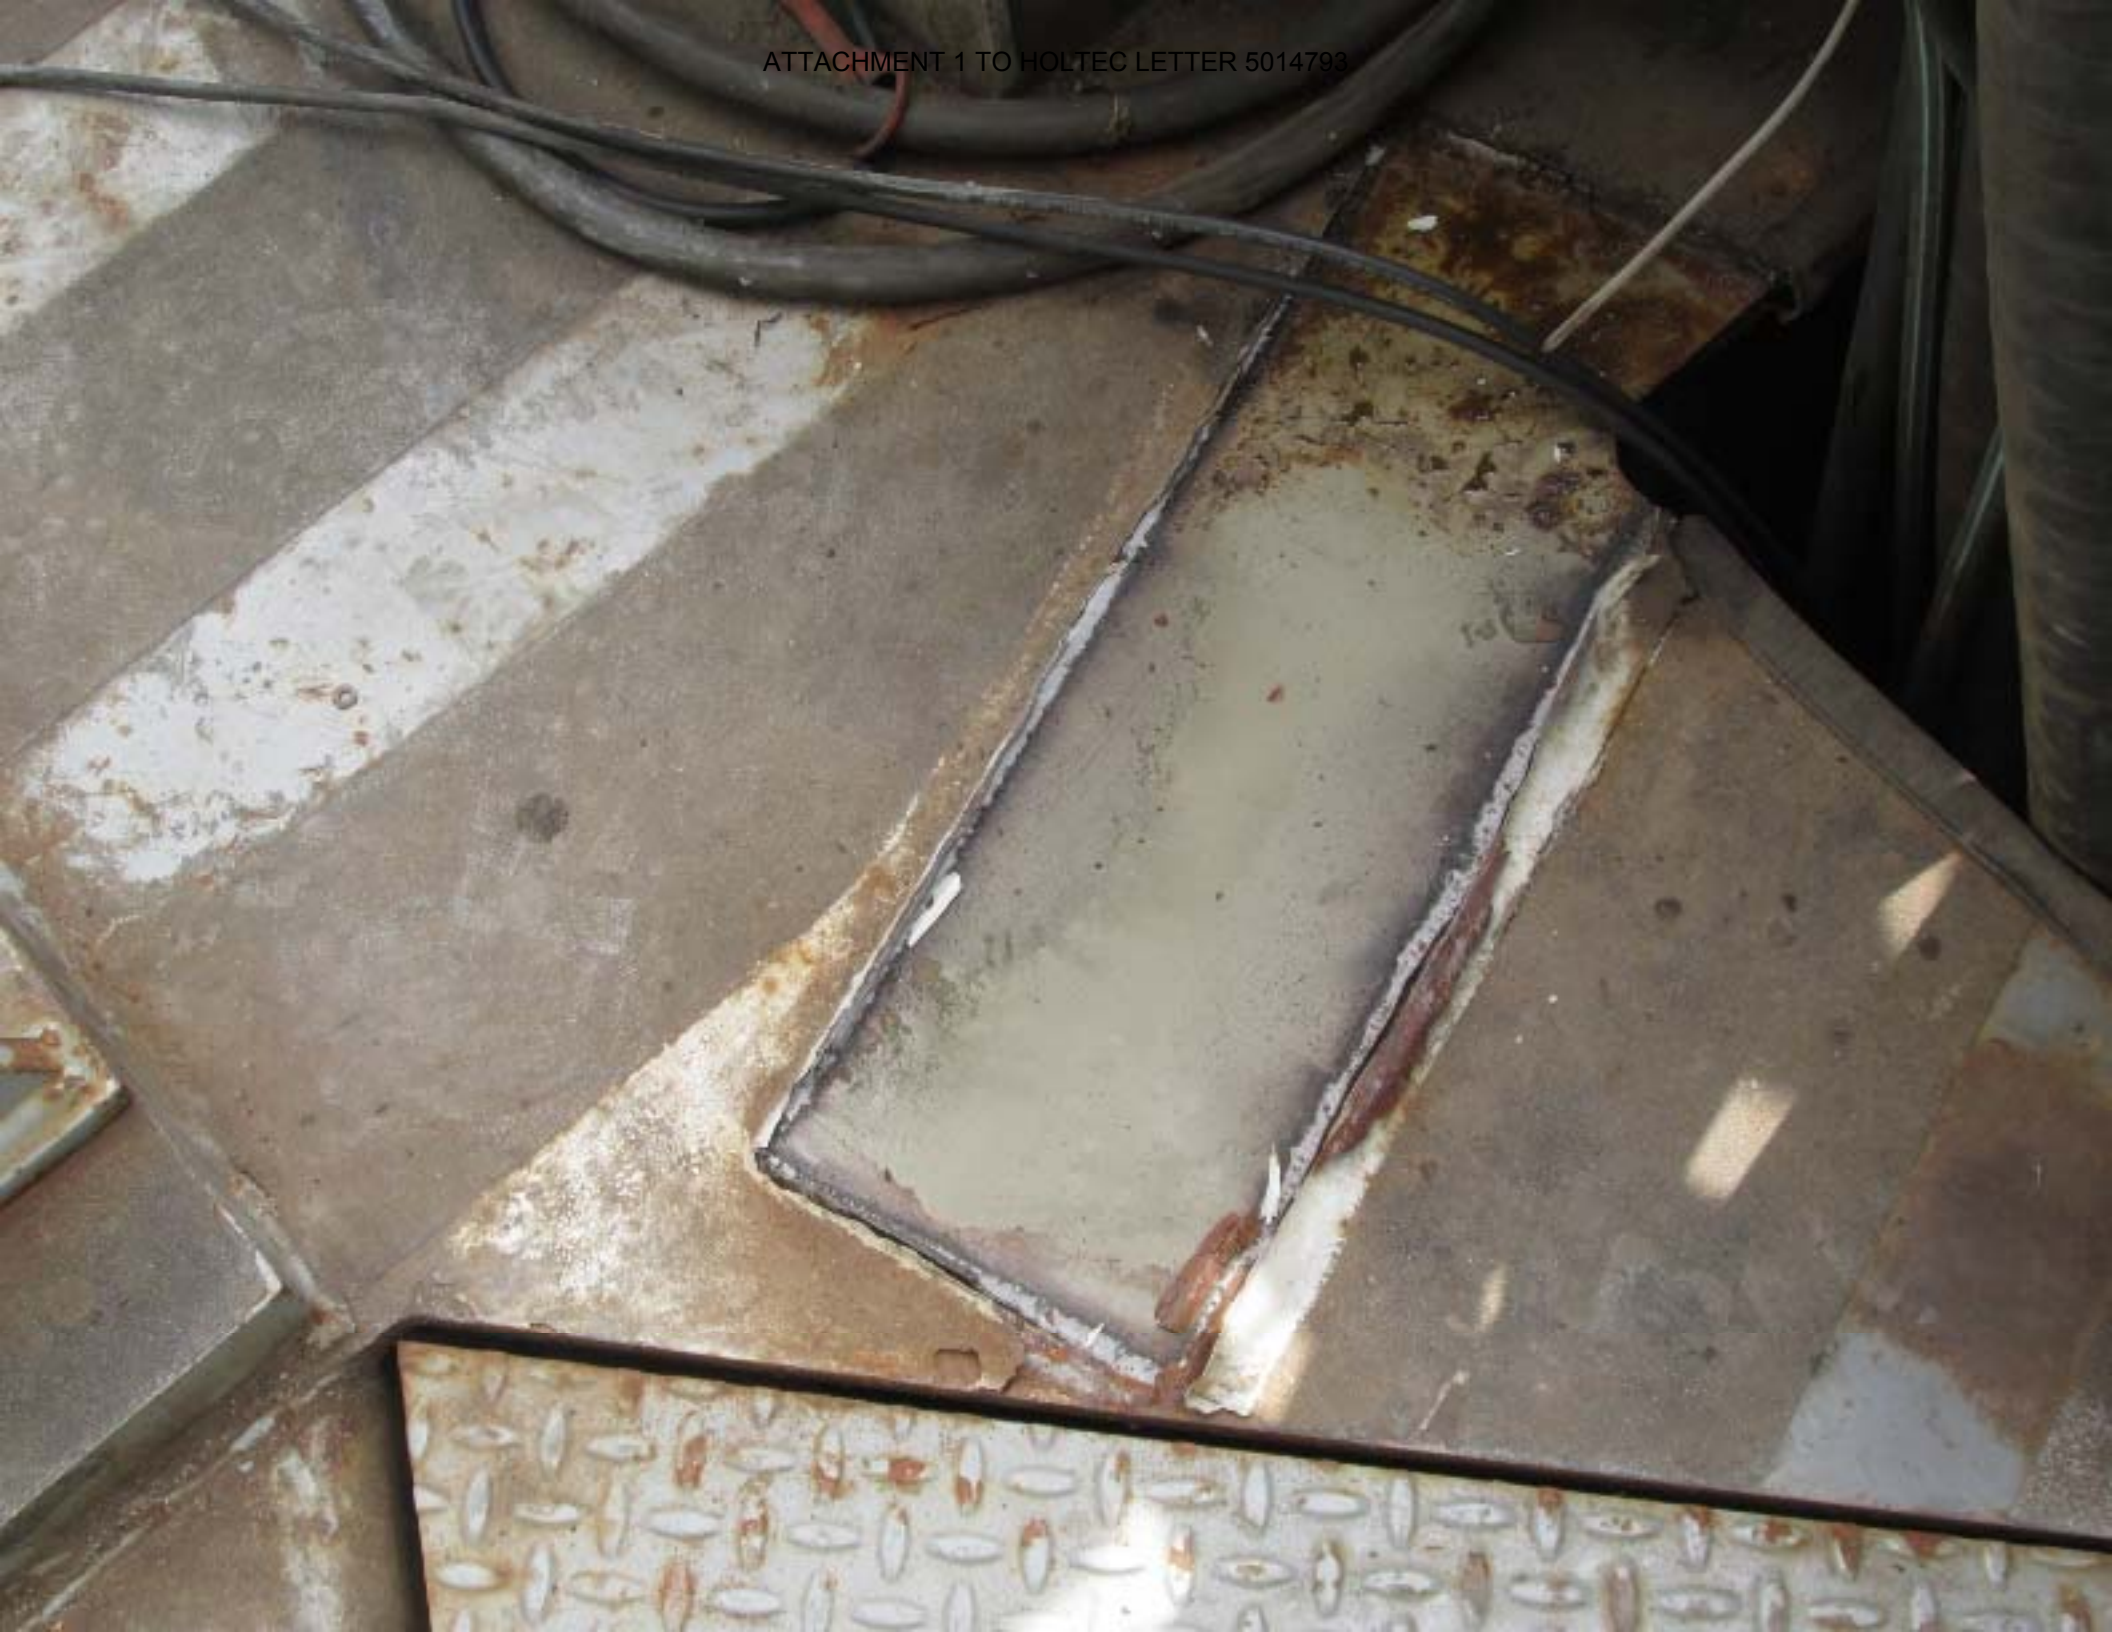
This issue is being treated as a defective weld issue on a Lift Systems manufactured machine supplied to PG&E. The weld was deficient in both size and quality. Probable Causes are laid out in the below section.

- Large porosity pores were noted in some portions of the failed weld, likely a result from welding on the painted surface.
- Lack of fusion at the weld root was noted in some instances.

- Rusting on the underside of the weld suggests this weld had failed over an extended period of time.

- Holtec recommends that all users owning a Lift Systems manufactured VCT add a visual inspection of the clevis to deck assembly weld into their VCT maintenance programs and perform this inspection prior to their next campaign. If there are visible cracks or stress induced defects to the weld, the weld should be repaired accordingly.
- Owners of J&R and MMH/KoneCrane manufactured VCTs may add the equivalent systems weld to their VCT maintenance programs as a defense in depth approach, however this matter is believed to be isolated to a single vendor at this time.
- Sites shall continue to stress the importance of situational awareness practices and instruct workers to stay clear of anchorage points in pre-job briefings.
