Subject: Duke Power Company  
Oconee Nuclear Station, Unit 1  
Docket No. 50-269  
Third Ten Year Inservice Inspection Interval  
Request for Relief No. 96-05

**OCONEE NUCLEAR STATION**  
**Unit 1**  
**Third Ten Year Inspection Interval**

**Request # 96-05**

**EVALUATION OF INDICATIONS  
IN THE OCONEE UNIT 1  
REACTOR COOLANT PUMP MAIN FLANGE**

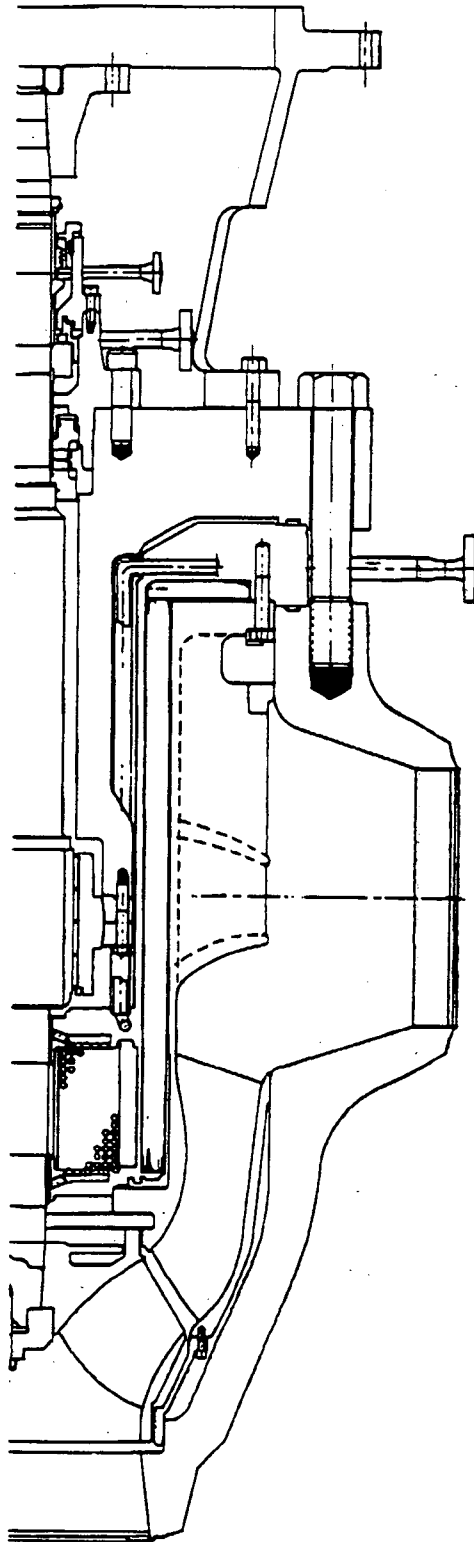
Figure 1 Geometry of the 93A Reactor Coolant Pump,  
Showing the Main Flange Region

During the fall outage of Oconee Unit 1 a leak was discovered at the bore of the reactor coolant pump main flange. The main flange is cast stainless steel, and the geometry is shown in Figure 1. Investigation of the leak led to the conclusion that it had resulted from a series of small cracks on the inner bore of the main flange which had occurred on both sides of an O-ring seal on the bore, causing a bypass of the seal, as shown in Figure 2.
