FACIL: 50-270 Oconee Nuclear Station, Unit 2, Duke Power Co.

SUBJECT: LER 92-004-00: on 921019, loss of offsite power, generator load rejection & trip from 100% power occurred, causing spurious breaker failure relay actuations. Caused by mgt deficiency. Switchyard restored to normal status. W/921118 ltr.

Subject: Oconee Nuclear Site
Docket Nos. 50-269, -270, -287
LER 270/92-04

TITLE (4) Loss of Off-site Power and Unit Trip Due to Management Deficiency, Less Than Adequate Corrective Action Program

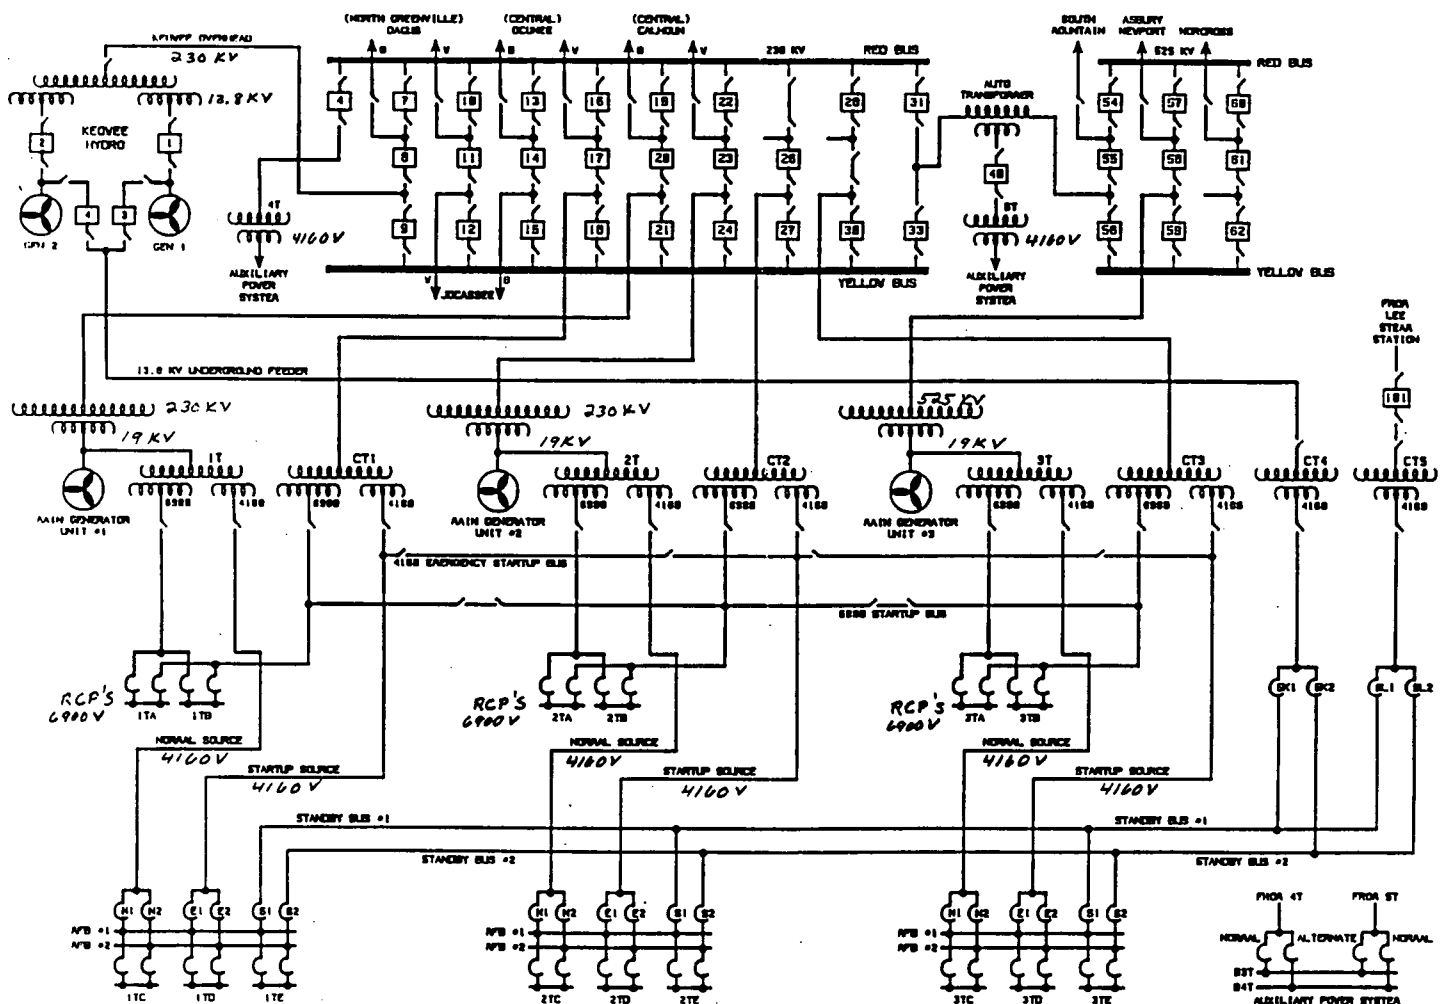
EMERGENCY POWER DISTRIBUTION

The emergency power systems generally performed as expected to restore power after the first loss of power. The loss of the overhead path due to the YELLOW bus lockout essentially constituted a design scenario single failure. The action of the KH operator to trip ACB-1, potentially defeating the safety function of KH Unit 1, is significant in that it provides one mode of failure of a safety train.

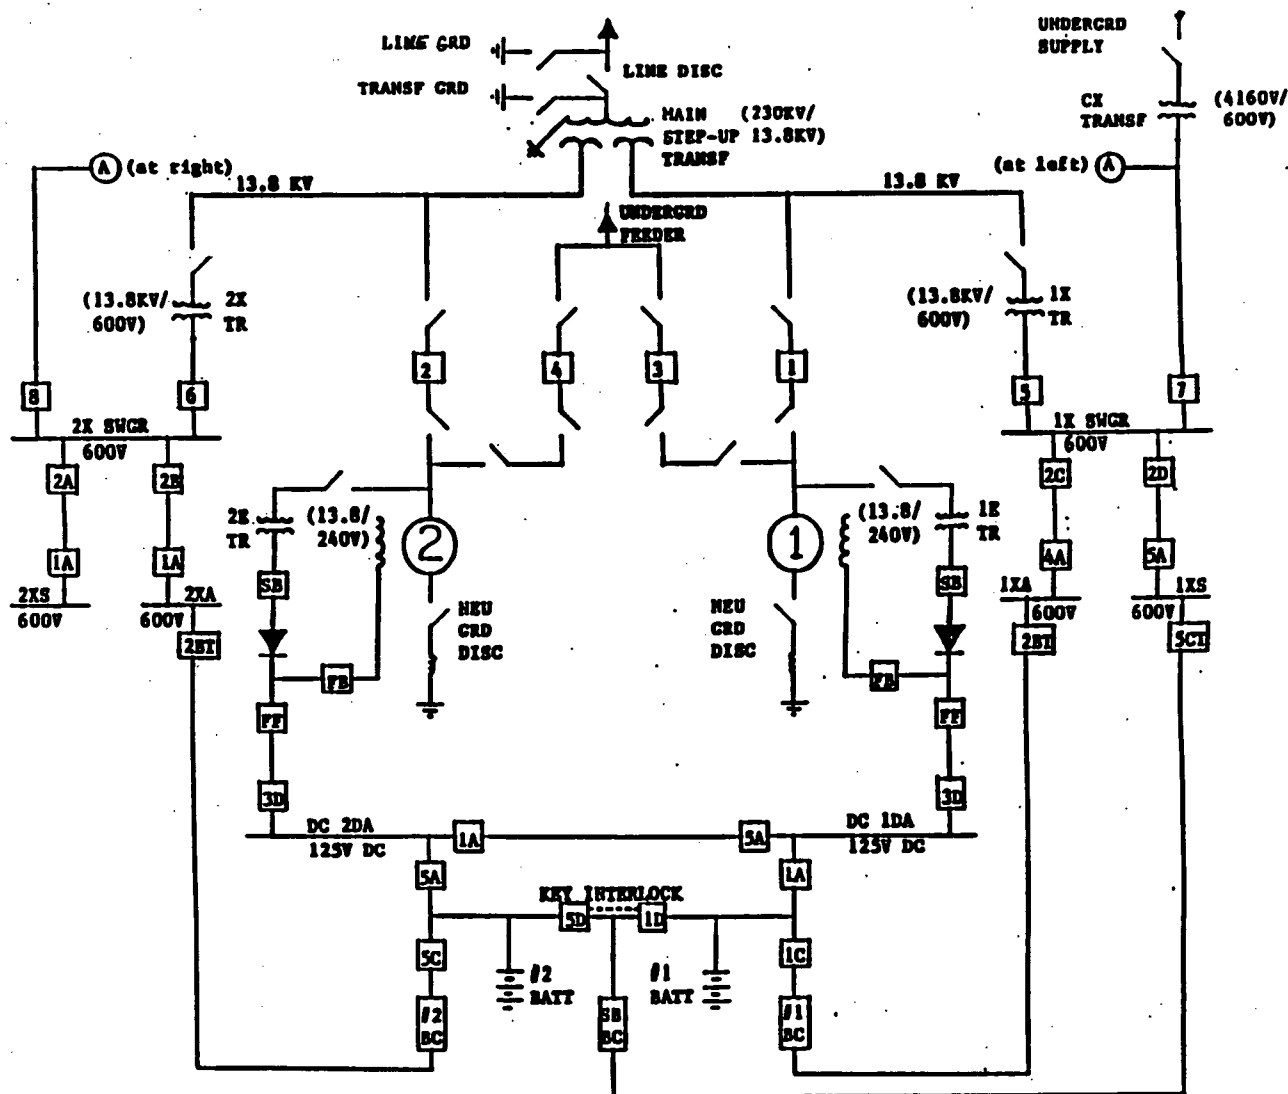
KEOWEE HYDRO STATION AC & DC SYSTEMS

Even though power was not available from the switchyard, it was available from the underground path. The unsuccessful transfers to auxiliary power at KH are significant in that they provided potential common mode failures which could possibly have resulted in the loss of both KH trains, and, therefore, all automatic emergency power. Specifically, in this event, the operating KH unit could have been lost due to these failures. During this event KH Unit 1 operated 51 minutes without auxiliary power. KH Unit 2 operated 37 minutes without auxiliary power.

The action of the speed switch in the anti-pump circuit prevented KH Unit 2 from being able to perform its safety function. It also represents a single failure mode for one unit. Prior to modification of KH Unit 1, the speed switch design would have represented a potential single mode failure for both KH units.
