NL-16-032

SUBJECT: Entergy Transmittal of Indian Point 2 ASME Section XI, IWL Concrete Containment Inspection In Accordance With the Parties' Approved Settlement of License Renewal Contention NYS-24
Indian Point Unit Number 2
Docket No. 50-247
License No. DPR-26

ENTERGY ENGINEERING REPORT IP-RPT-15-00029,
“IP2 ASME SECTION XI, IWL CONCRETE CONTAINMENT
INSPECTION FOR 2015”

IP2 ASME Section XI, IWL Concrete Containment Inspection for 2015

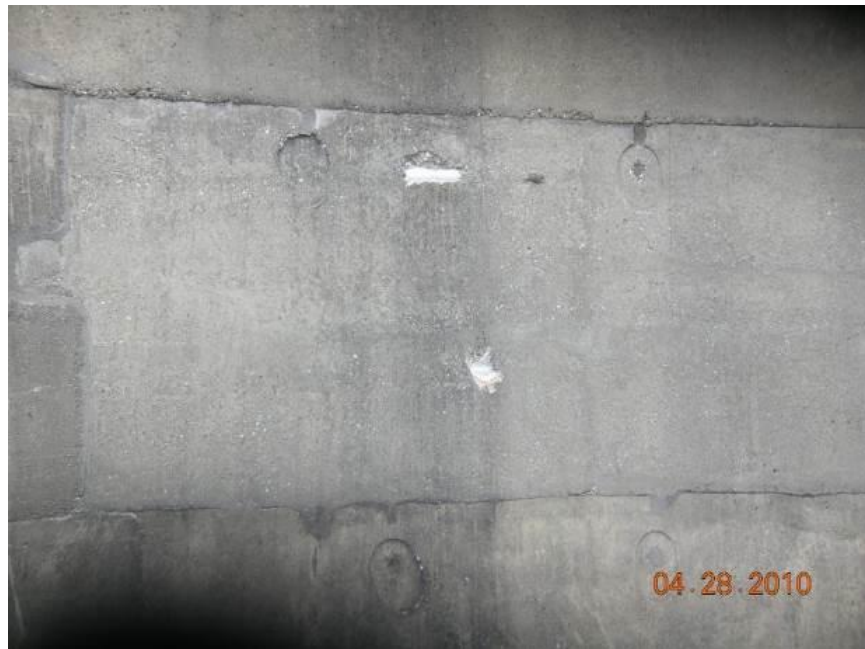
Photo Z1-005

No.	Comment	Initials
1	Cadweld exposure due to 9" x 3" of spalling, insufficient concrete cover (less than 1/2"). The exposed cadweld was coated to inhibit future potential corrosion in 2009. Some degradation to the coating has occurred. Some cracks extend horizontally from the ends of the spall. See photos Z1-005, Z1-005A, Z1-006 and Z1-006A	SK
2	Exposed cadweld at spall. 4" x 2", at El. 51'. The exposed cadweld was coated to inhibit future potential corrosion. Some degradation to the coating has occurred since the last inspection. See photos Z1-005, Z1-005A, Z1-007 and Z1-007A	SK
3	One form tie hole not filled and one partially filled. These holes have remained in the same condition as several previous inspections.	SK
4	Scrap steel exposed at surface with some cracking approx. 6". No change noted since 2010 inspection. See photo Z1-008	SK
5	Leaching over a length of 20' close to joint from grout patch. This area has remained unchanged since the 2010 inspection. There has been no notable change since the baseline inspection. See photos Z1-009 and Z1-009A	SK

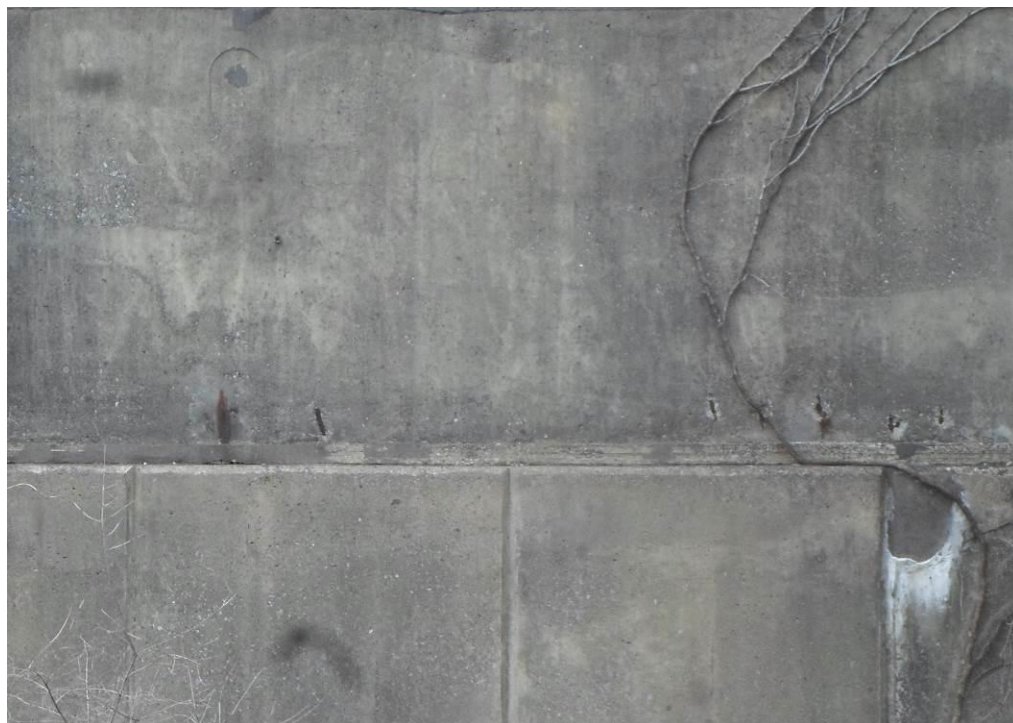
Photo Z1-010

6	Ribs of some embedded steel (scrap) exposed at the surface at El. 44'. Some rust bleeding is apparent. Pitting noted in 2010 inspection was not identified.	SK
7	Vertical rebar exposure with rust marks maximum of 9" at 10 locations over 20' width at basement junction. This area remains unchanged since the previous inspection. See photos Z1-010 to Z1-010C	SK
8	A previously repaired area near AFB has degraded. See photo Z1-011	SK

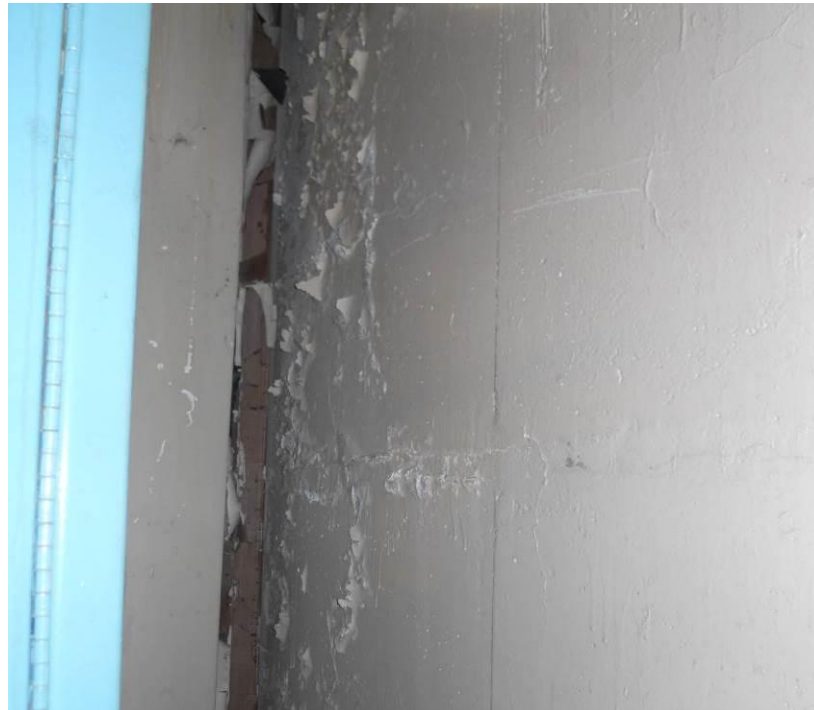
Photo Z2-010

3	A delamination was found at approx. El. 49' behind BFD-6-1. The area was estimated to be 30" at the widest part (top) and 18" at the lower portion by 12" high by combination of visual inspection and sounding the concrete (tapping the surface with a metal object). See photos Z2-009, Z2-009A and Z2-009B .	JK
4	This area was examined from the floor level at El. 43'. The examination distances were a maximum of 20 feet. While this distance exceeds the limits for direct visual examination, it was too short for use of the binoculars due to their minimum focal length. Lighting levels using the flashlight exceeded the 50 foot-candle requirement. The upper 5 feet of this zone were not visible for inspection by direct line of sight due to piping and structural steel obstructions. Area has been coated.	JK
5	There are a number of areas within this section where the coating is flaking and peeling. There is no evidence that this is due to degradation of the concrete substrate. It is a coatings related issue and not containment degradation. See sample photos Z2-010, Z2-010A, Z2-011 and Z2-012 .	JK

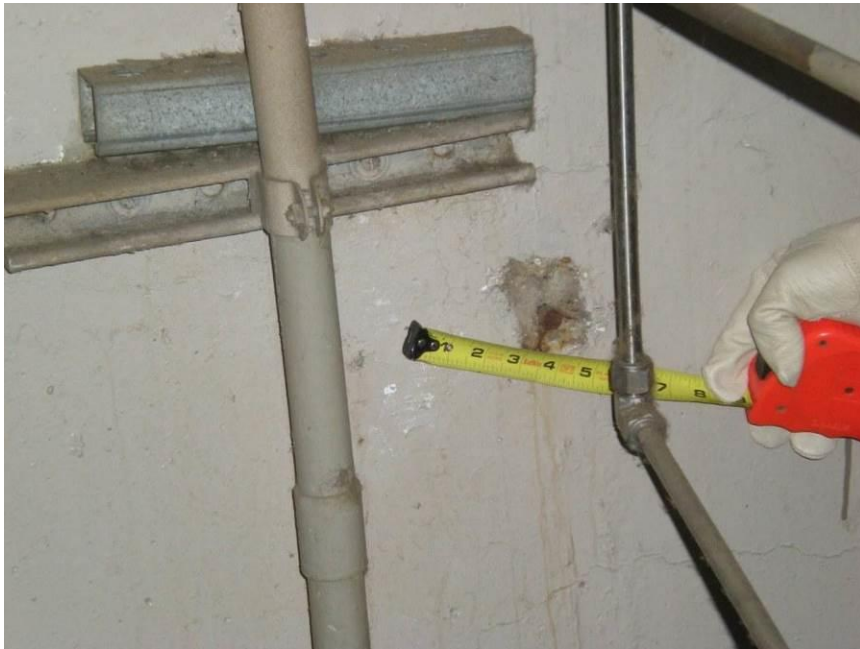
Photo Z2-013

6	Although previously identified as rebar, the steel bar sticking out (~ 3/4" dia.) with rust and staining at El. 46' behind Rack 15 appears to be an anchor cut flush to the concrete and not reinforcement for the Containment concrete. The spall at this location is 2" x 3". See photo Z2-013 .	JK
7	Floor level delamination, 5" x 5" x 1/4" deep, at DPI-7291, 22 Steam Generator ΔP Indicator. See photos Z2-014 and Z2-014A . No notable change since the previous inspection.	JK
8	Spall with exposed cadweld, 11-1/2" x 3" x 3/8" deep (~4" exposed cadweld) having minimal surface rust located at floor level near DPI-7293. See photos Z2-015 and Z2-015A .	JK
9	Pattern cracking in zone believed to be from the ILRT testing performed every ten years. See photo Z2-016 .	JK
10	Sloppy joint with a 4" x 1" void. There is no evidence of rust staining from void. See photo Z2-017 .	JK
11	Leaching approximately 12' up from floor level. See photo Z2-018 .	JK

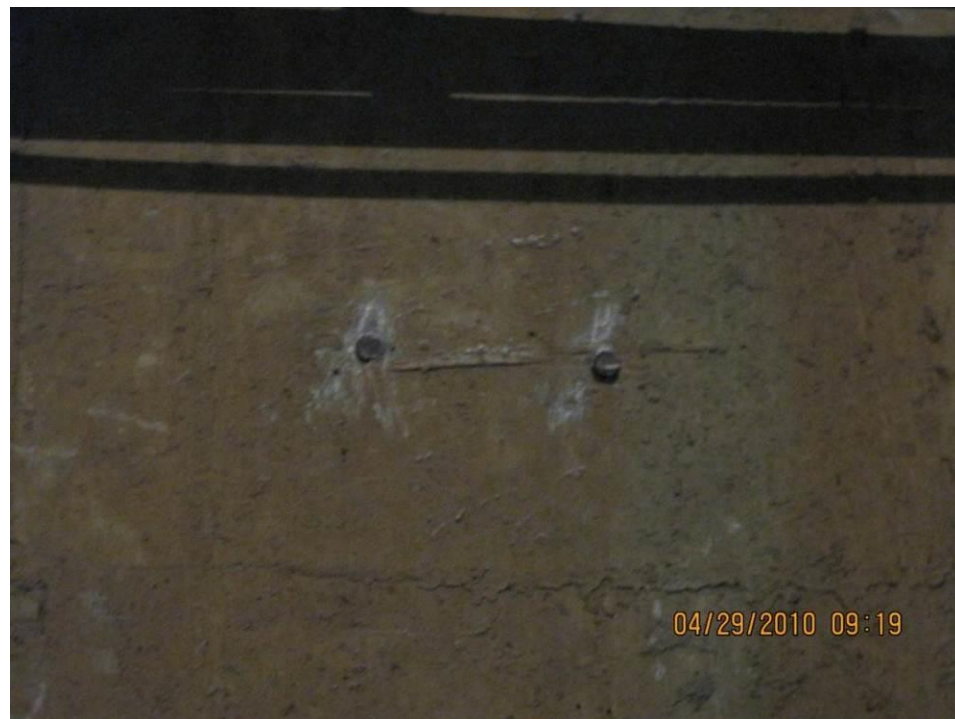
Photo Z3-001

No.	Comment	Initials
1.	Two pieces of embedded steel, appearing to be anchors cut flush, are exposed at the surface of the concrete. Slight rusting is evident but no streaking or staining of the concrete. No notable change since 2005 inspection. See photo Z3-001 .	JK

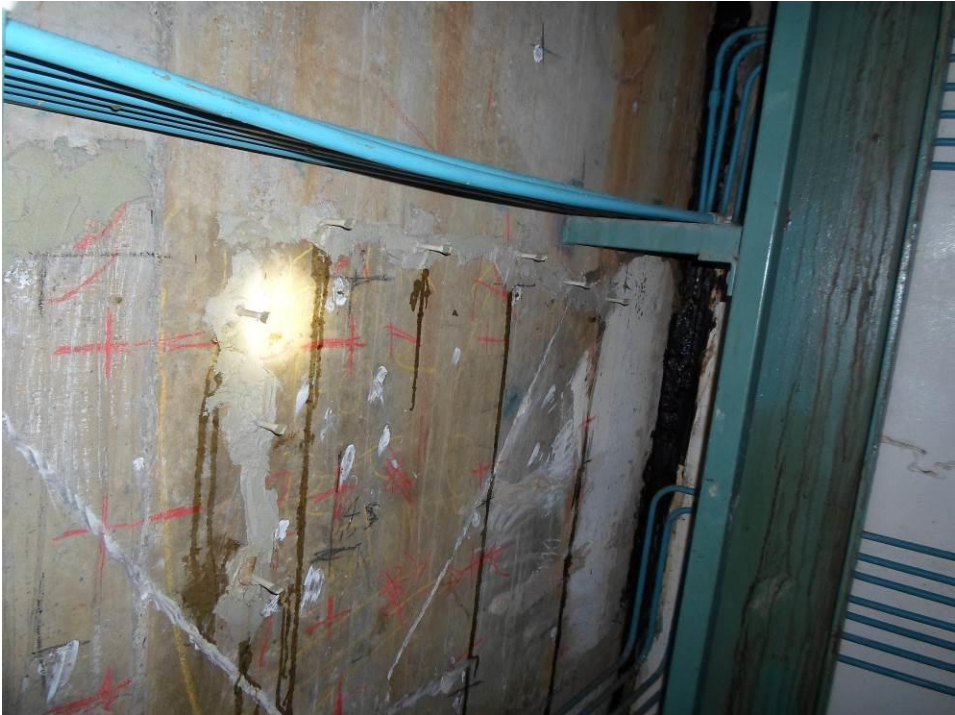
Photo Z3-006

8.	Epoxy injection tubes near Pipe Penetration wall up to ~6'. See photo Z3-006 .	JK
9.	Cut anchors in top corner behind column. Slight corrosion is evident but no streaking or staining of the concrete. See photo Z3-007 .	JK

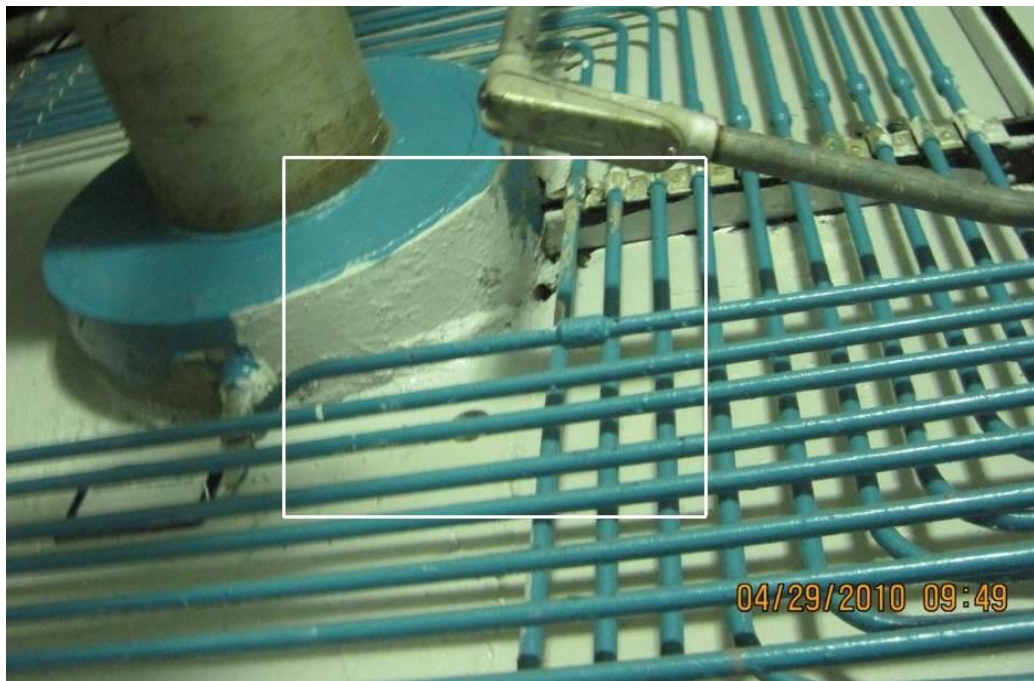
Photo Z4-005

8	1" diameter void, appears to be manmade, and 3/4" void at penetration "GG" (upper first penetration from far right wall). See photos Z4-005 and Z4-005A .	JK
9	Minor pattern cracking and peeling/flaking coating in some areas.	JK

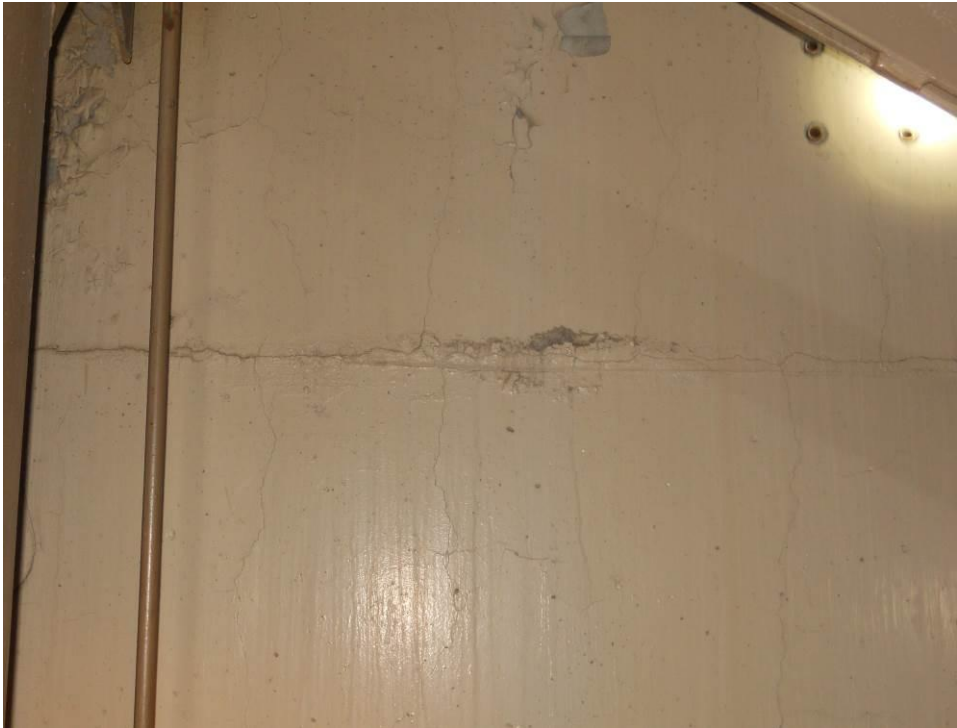
2015 Photo IWL-068-002 Photo Z2-022

4	Hairline pattern cracking (<1/32") at El. 70' approximately 25' from right boundary. Identified in previous inspection. See photo Z2-022 .	JK
5	Joint cracking, pattern cracking and minor spalling at El. 82', behind S/O Relief MS-45C. Identified in previous inspection. See photo Z2-023	JK
6	1-1/2" x 1-1/2" discolored area (rust color) at El. 68' behind MS-42. Same as last inspection. See photos Z2-024 and Z2-024A .	JK
7	Multiple retired anchors left embedded in containment at El. 77'. No degradation to concrete.	JK
8	There is a small void just below roof level behind MS-48A. See photo Z2-020C .	JK
9	Several form tie holes were found not patched. There is also a sloppily formed joint at this location. These are not significant relative to containment structural integrity. See photo Z2-025 .	JK
10	There is a spall behind the column at the far end of the room. See photo Z2-026 .	JK

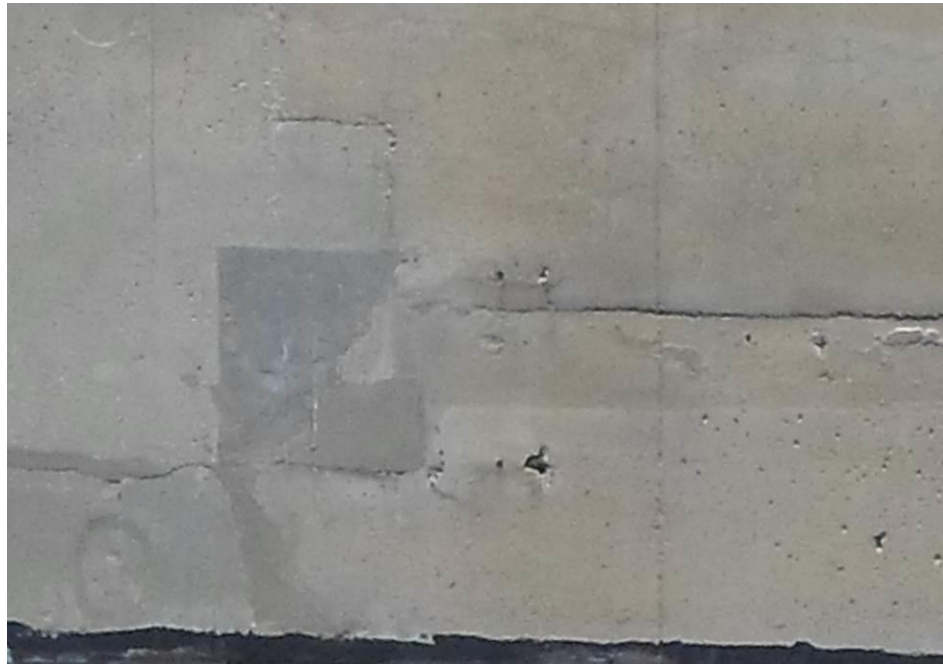
Photo Z3-009

No.	Comment	Initials
1	At El. 68' in the right side of the zone, two possible cadwelds beginning to spall near the red zone. See photo Z3-009 .	JK
2	At El. 79' on the far right side in the red zone there is a possible piece of wood leftover from the formwork. See photo Z3-010 .	JK
3	Exposed miscellaneous wire (3" long) at El. 85'. Coated in 2009, no change in condition since previous inspection. See photos Z3-011 and Z3-011A .	JK
4	Exposed miscellaneous steel (3" long) at El. 87'. Coated in 2009, no change in condition since previous inspection. See photos Z3-011 and Z3-011B .	JK
5	Exposed miscellaneous steel (4" long) at El. 88'. Coated in 2009, no change in condition since previous inspection. See photos Z3-011 and Z3-011C .	JK
6	Exposed miscellaneous steel (1/2" diameter at 7 locations) at El. 88'. This location is in the red zone. Possibly cut off anchors. Some corrosion staining present. Condition previously identified with no noticeable change. See photos Z3-012 , Z3-012A , Z3-012B and Z3-012C .	JK

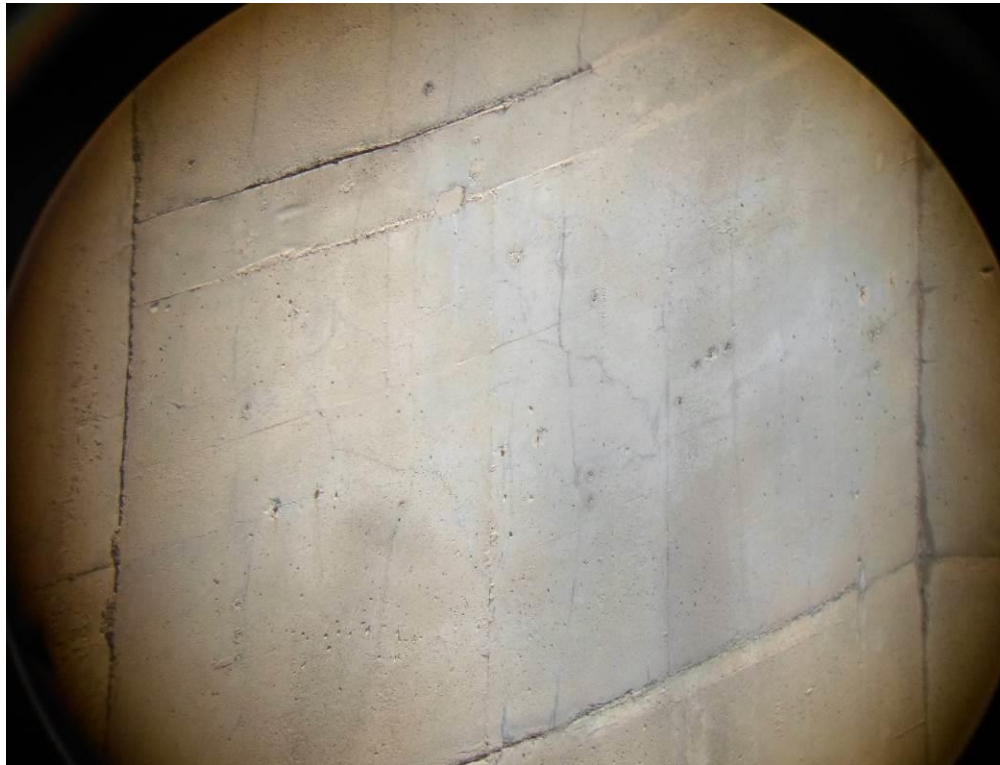
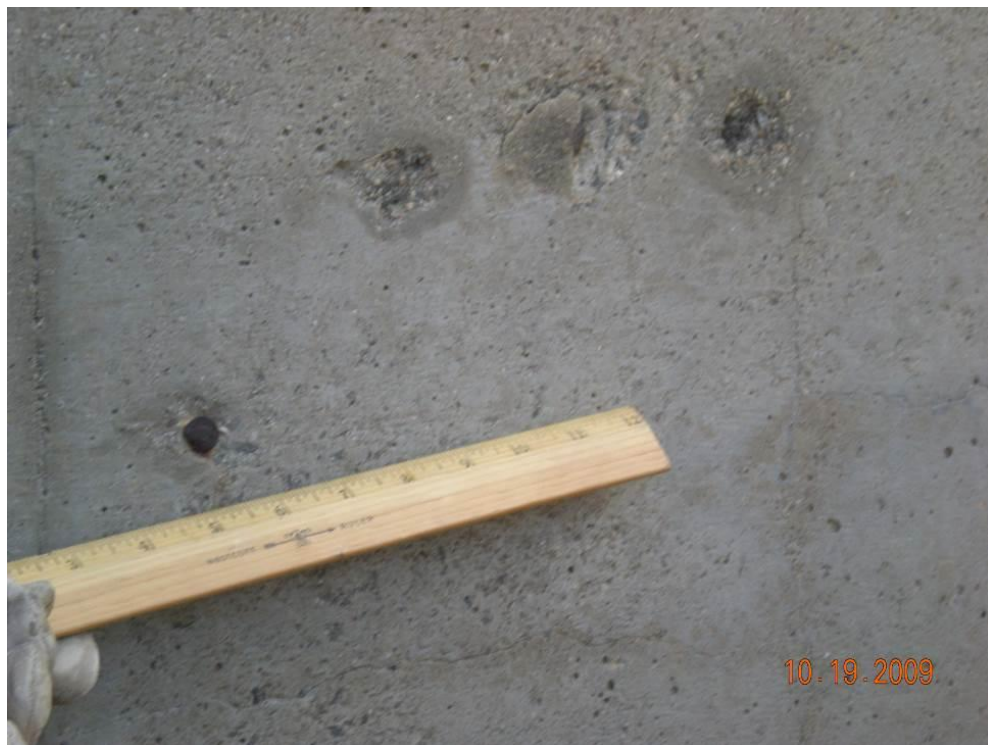
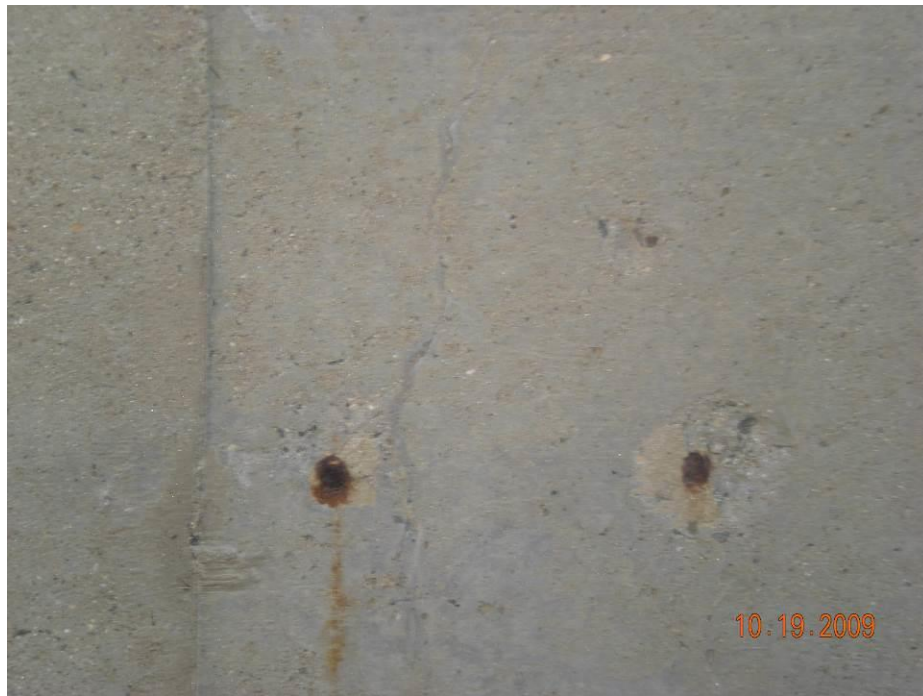
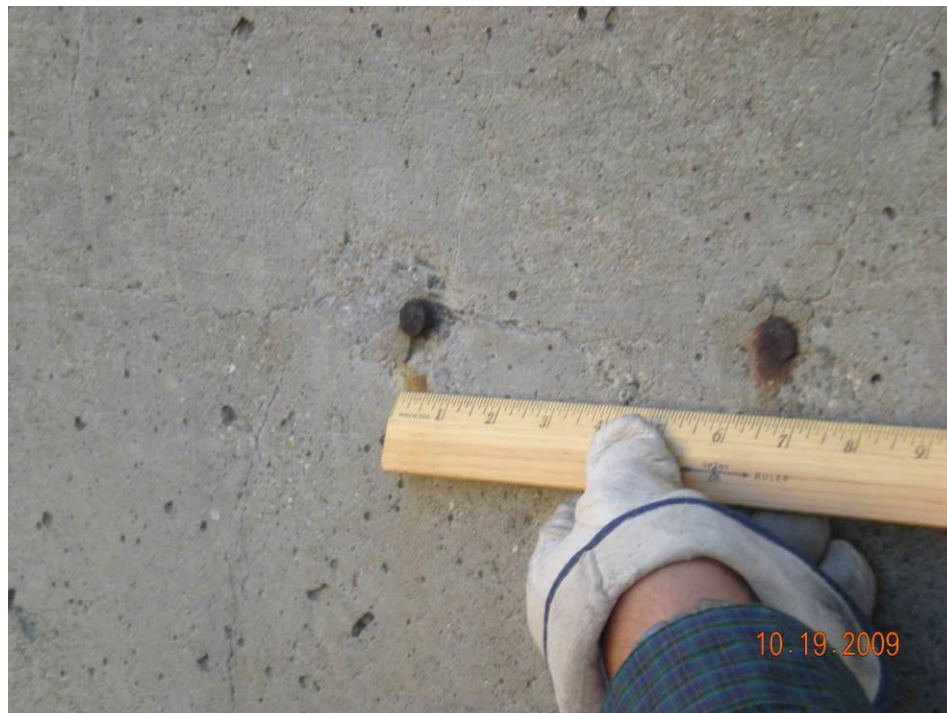
Photo Z3-012

7	3 form holes popouts and 4 partial popouts in the red zone. See photos Z3-013 and Z3-013A .	JK
8	General joint cracking with spalls, pattern cracking, scaling, and bugholes throughout the entire section. These conditions are minor observations that were identified previously.	JK
9	Some hairline cracking in the red zone. See photos Z3-012 and Z3-013A .	JK

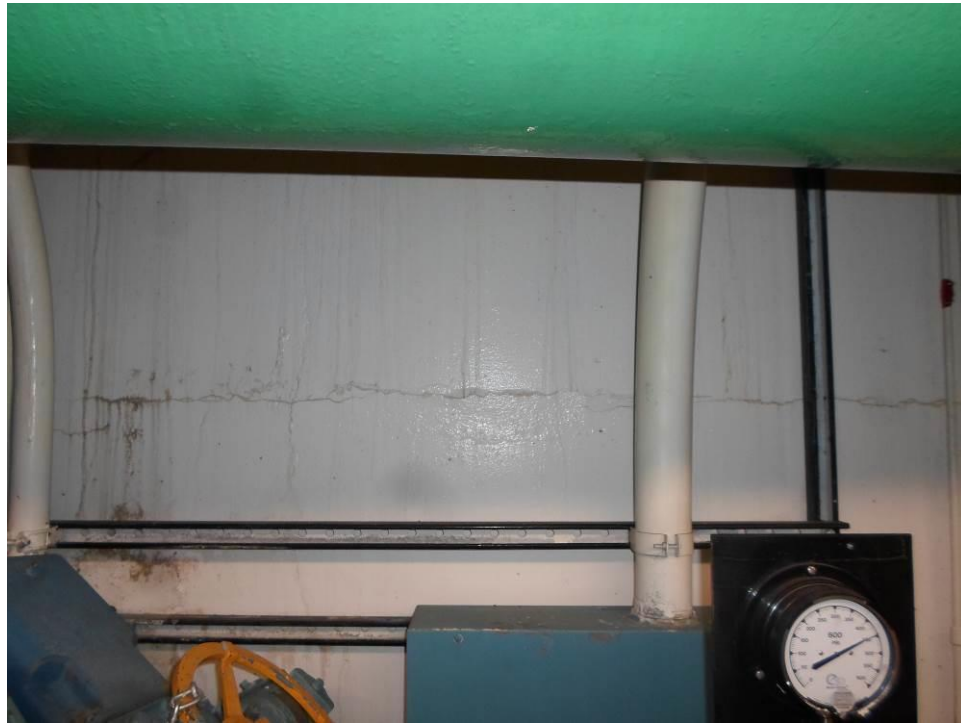
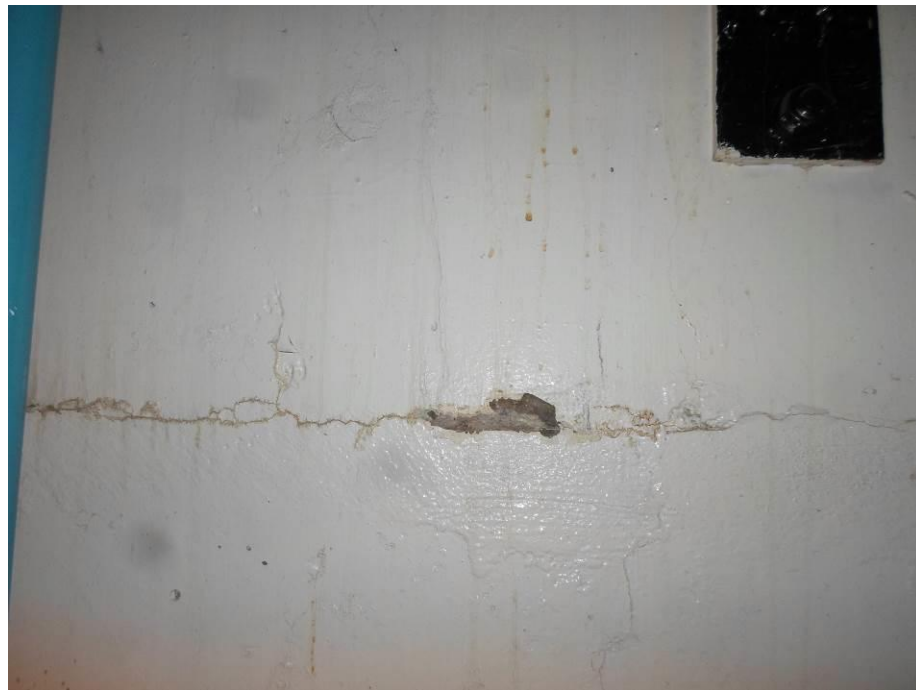
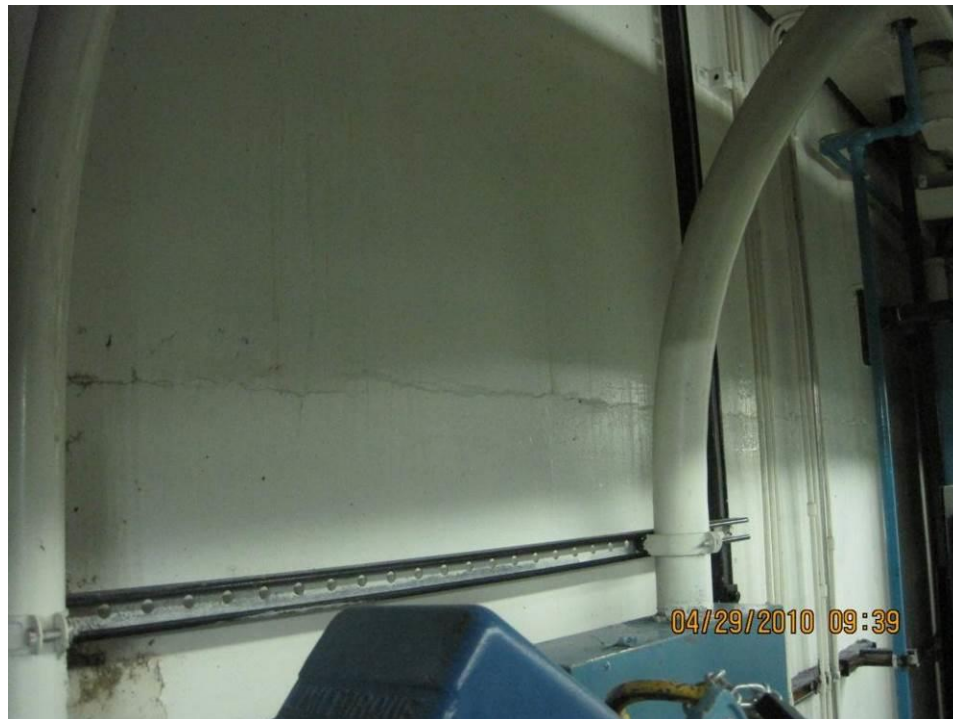
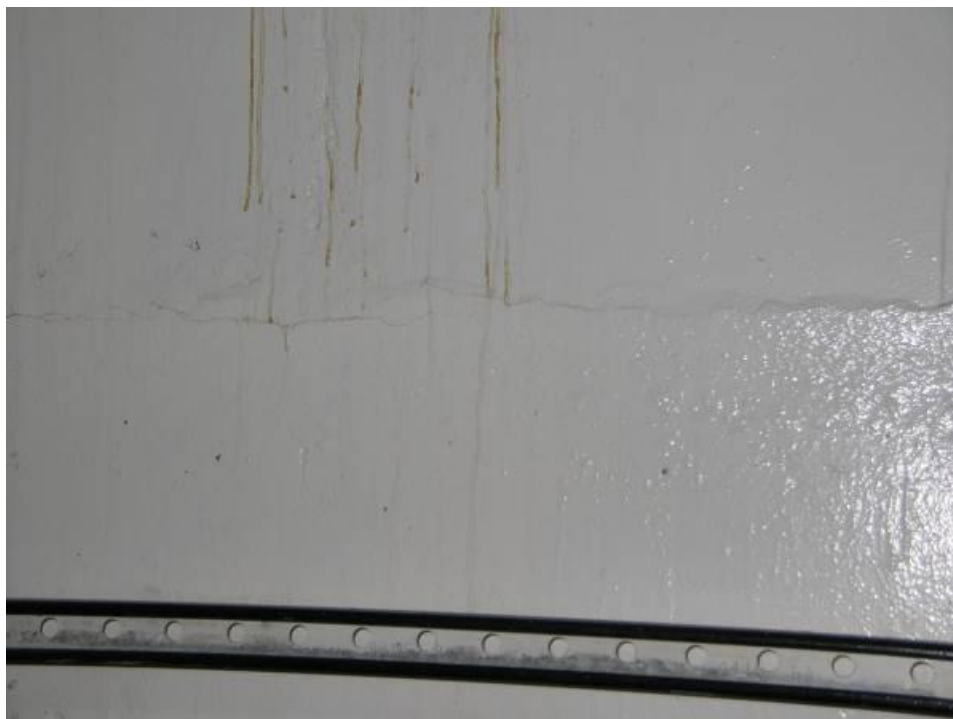
Photo Z4-006

No.	Comment	Initials
1	An area approximately 20' x 8' was not visible for direct visual examination due to obstruction by electrical cabinets.	JK
2	Joint cracking approximately 10' long. Repair to cracked joint is beginning to flake off. See photos Z4-006 , Z4-006A , Z4-006B and Z4-006C .	JK
3	General pattern cracking and bugholes. The condition was previously identified. See photos Z4-007 , Z4-007A , Z4-007B and Z4-007C .	JK
4	Staining from previous leaching (~18" long) is visible from a patched popout area.	JK
5	6" x 8" area of failed coating on the Mezzanine. Minor degradation to concrete surface in this area has been painted over but is peeling / flaking. See photos Z4-008 and Z4-008A .	JK
6	1" dia. hole appears to be manmade at ceiling line where wall juts out. See photo Z4-009 .	JK
7	Several drop-in anchors have been abandoned in-place in the alley between Containment and the Fan House. The anchors were used to erect scaffold around the vent stack. Leaving the anchors will not jeopardize containment integrity. See photo Z4-010 (typical).	JK

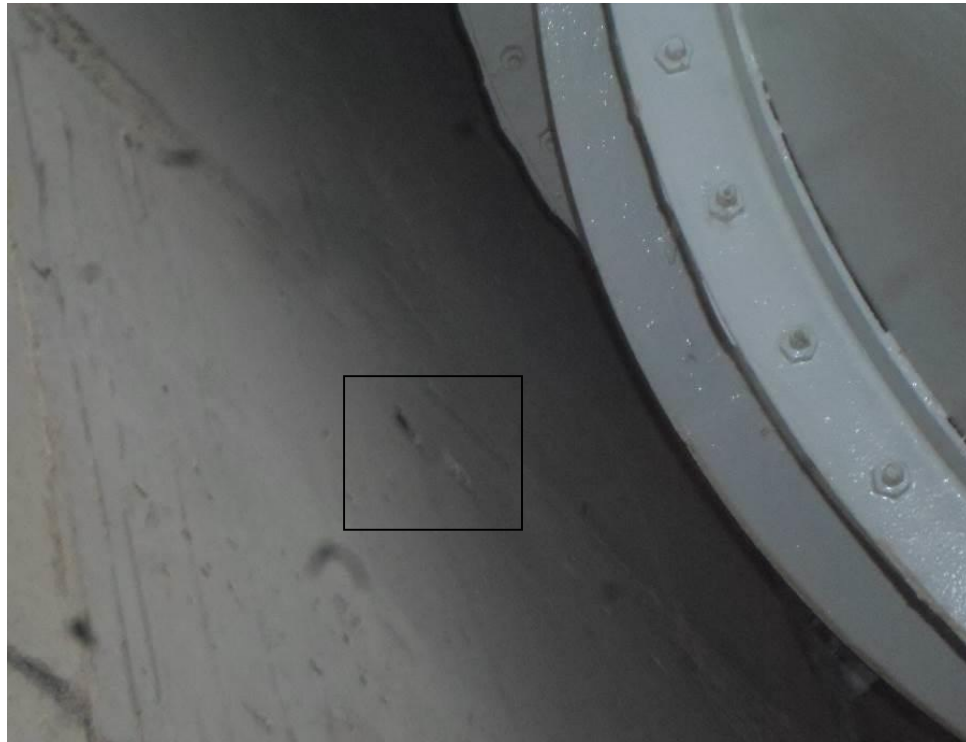
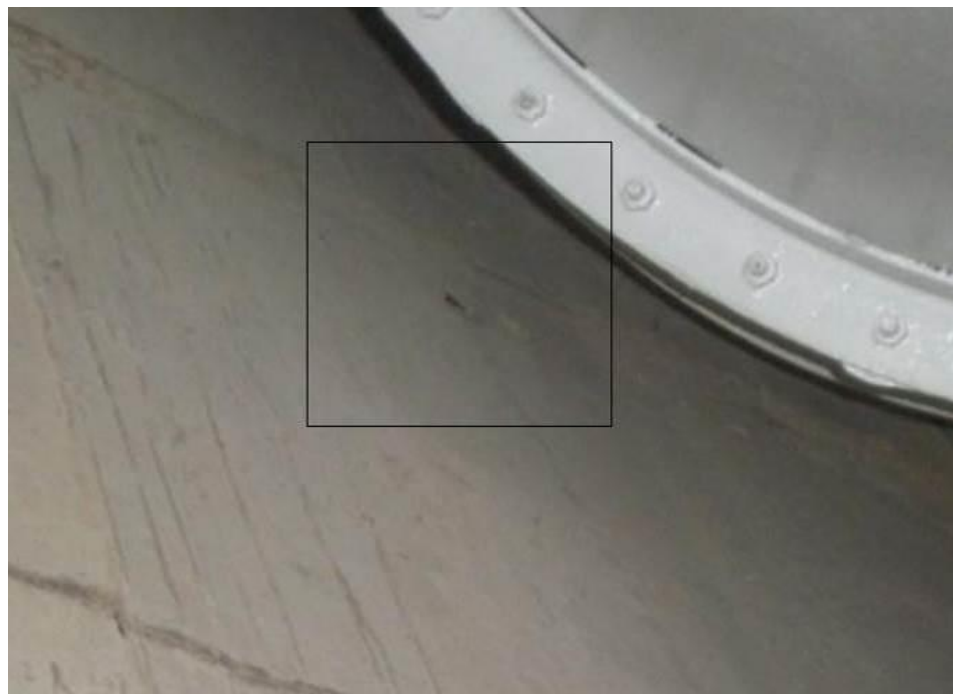
Photo Z4-011

8	1-1/2" diameter void with no rust staining evident behind vent stack in alley. See photos Z4-011 and Z4-011A .	JK
9	Surface discoloration from metal inserts.	JK

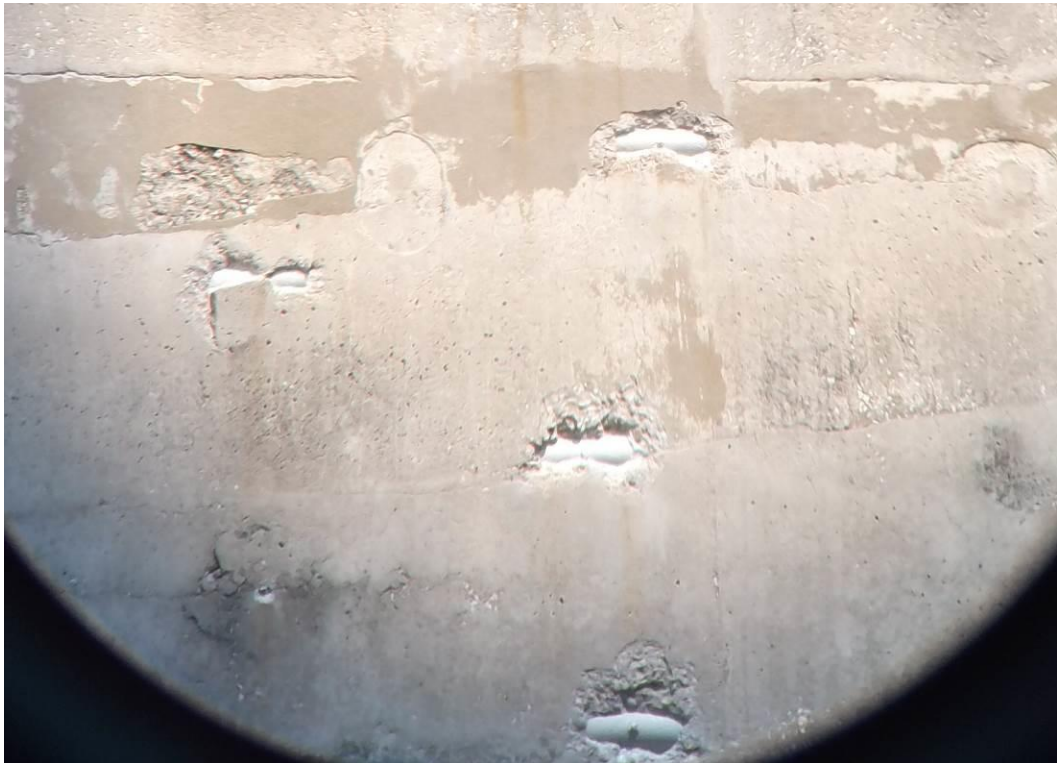
Photo Z4-012

4	Approximately 5 bugholes with rust streaks and local spalling occur between El. 107' and El. 108'. Update => Only 1 bughole remains visible during the 2010 inspection due to the coating efforts in 2009. The rust streak is minimal.	JK
5	Scaling (12" x 5") at El. 107' in cluster of exposed cadwelds listed above. See photos Z4-012 , Z4-012A and Z4-012B .	JK

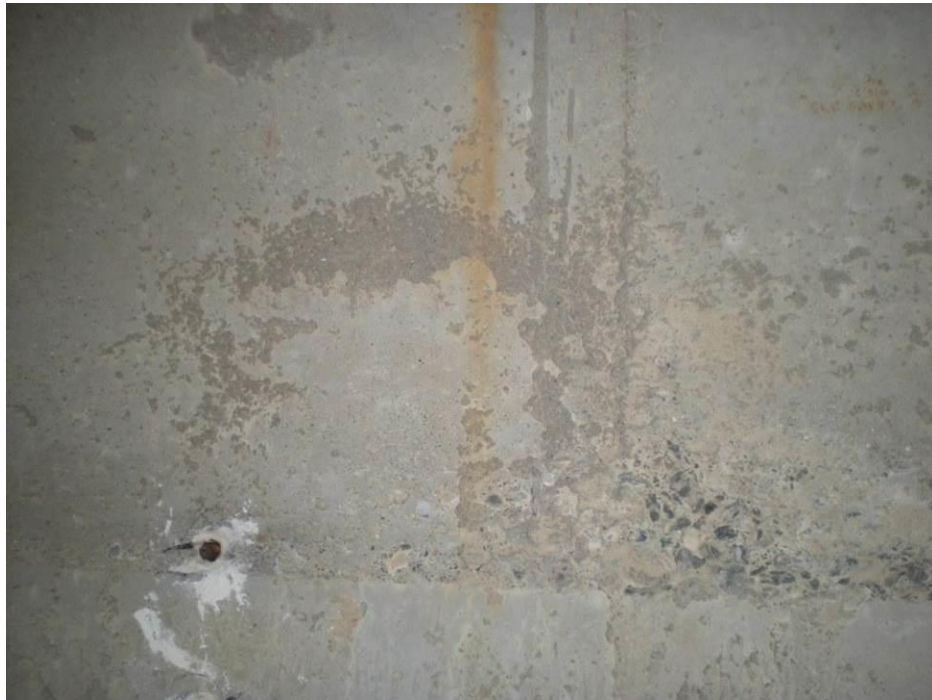
Photo Z5-002A

No.	Comment	Initials
1	Three sets of two popouts (approx. 2" dia.) behind the duct (approx. El. 97', El. 102' and El. 107') possibly from unfilled form ties or drilled holes. See photo Z5-001.	<i>AMP 9-28-15</i>
2	Exposed aggregate due to loss of matrix from initial vibration. Cement paste streaks due to improper form work installation is visible. Rust stains appear from surface mounted steel. No change since 2005 inspection. See photos Z5-002, Z5-002A, Z5-002B and Z5-002C.	<i>AMP 9-28-15</i>
3	An additional 10' of inspected elevation (El. 78' – 88') was added to this component and pertain to comment 2 above.	<i>AMP 9-28-15</i>
4	Drop-in anchors were installed to allow scaffold to be built for painting of the vent stack. See sample photos Z5-002A and Z5-002B.	<i>AMP 9-28-15</i>

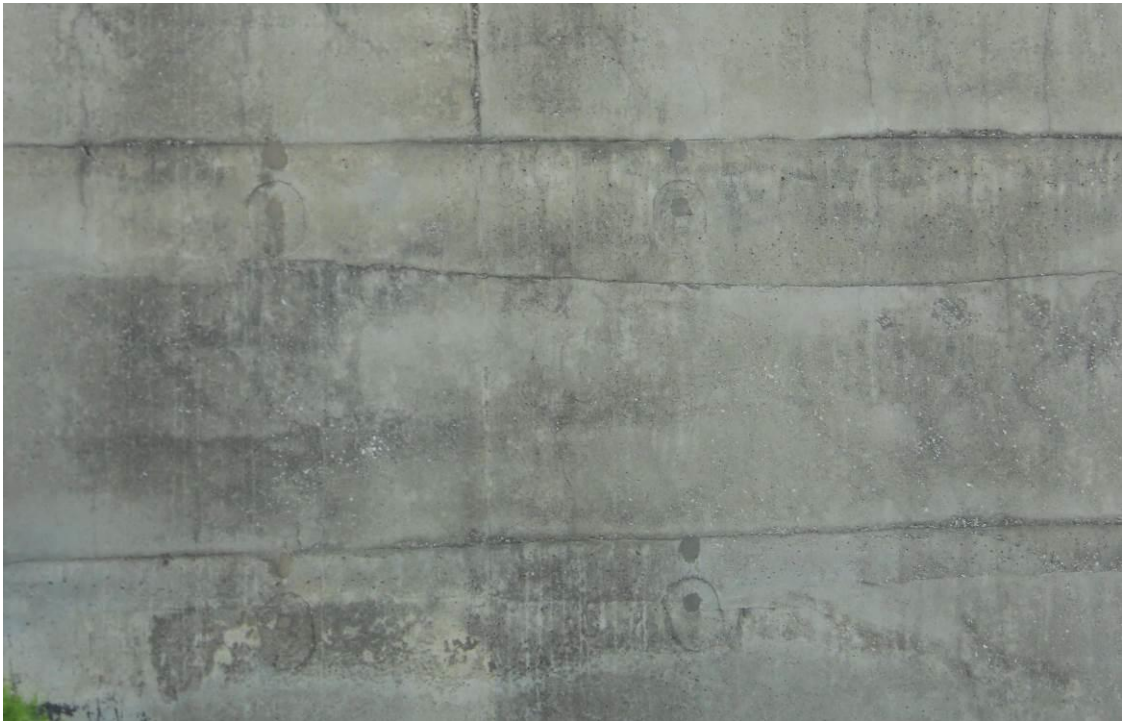
Photo Z6-001

No.	Comment	Initials
1	8' long horizontal crack at El. 91' identified in past inspection. Inspected up close and appears to only be a pour line and is not a structural concern. See photo Z6-001	AMD 9-28-15
2	General pattern cracking, abrasion, and leaching between El. 88' and El. 95'. These deficiencies were previously identified in 2005. All are minor and show no evidence of being active or worsening.	AMD 9-28-15
3	Vegetation growth on the component is very minor only	AMD 9-28-15
4	2" long exposed rebar at El. 93' near hatch area. See photo Z6-002	AMD 9-28-15
5	6' Tall vertical crack on equipment hatch protrusion area. Up to 1/32" wide. Some leaching from the lower portion of the crack. See photo Z6-003	AMD 9-28-15

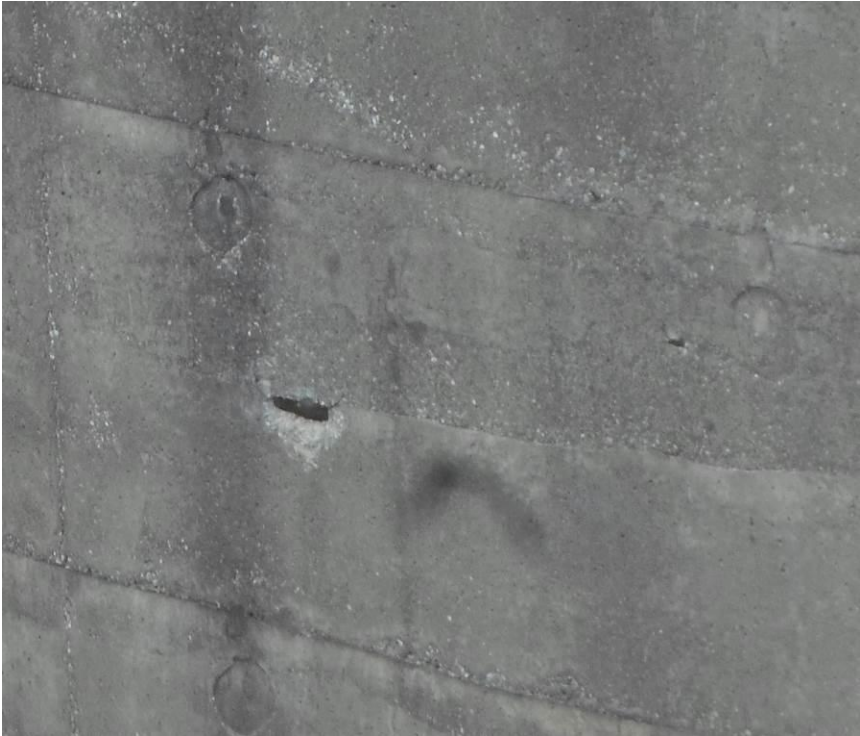
Photo Z2-031

No.	Comment	Initials
1	Exposed cadweld (approx. 9" long) with corrosion apparently due to inadequate cover. The concrete directly above was noted as ready to fall in the previous inspection but there is no change in condition since the 2005 inspection. See photos Z2-031, Z2-031A and Z2-031B.	JK
2	A small spot of corrosion appears on the concrete surface, it is not apparent whether this is reinforcing steel, a cadweld, or miscellaneous steel. No notable change since previous inspection. See photos Z2-031, Z2-031A and Z2-032.	JK
3	A small spot of corrosion appears on the concrete surface, it is not apparent whether this is reinforcing steel, a cadweld, or miscellaneous steel. Additional degradation in the immediate vicinity includes some abrasion, leaching, honeycomb and 8 popouts (2 roughly 1" dia, and 6 smaller). There has been no change since the previous inspection. (Note: This area is on the border of zones 1 and 2). See photos Z2-033 and Z2-033A.	JK

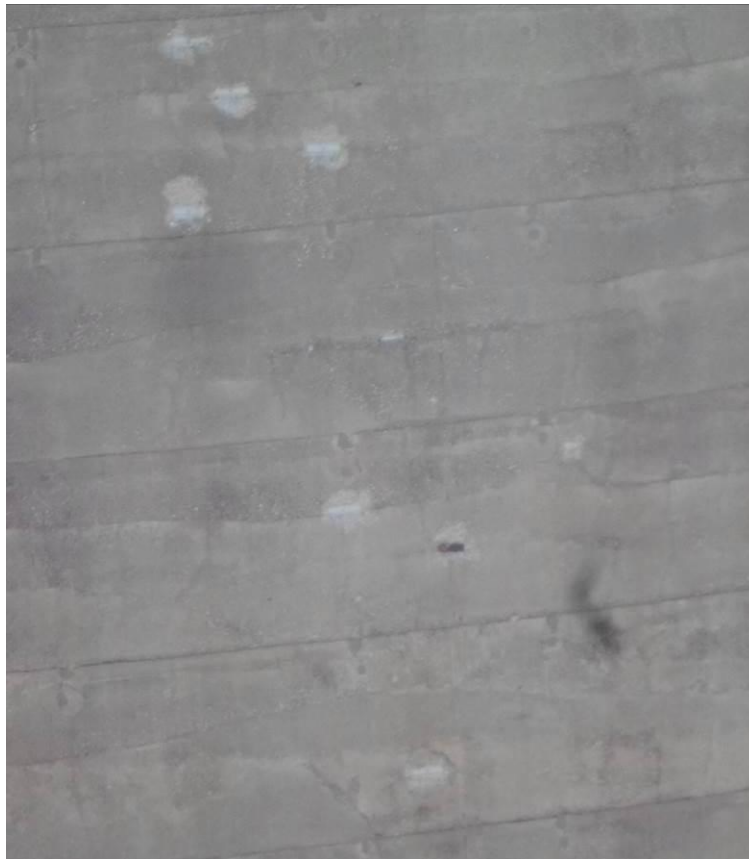
Photo Z3-016

No.	Comment	Initials
1	Exposed cadweld (10" x 3") with additional spalled concrete at El. 109'. Steel was coated in 2009. No notable change in condition since last inspection. See photos Z3-016, Z3-017 and Z3-017A.	JK
2	Exposed miscellaneous steel (1" diameter) at El. 113'. Steel was coated in 2009. No notable change in condition since last inspection. See photos Z3-018 and Z3-019.	JK
3	Exposed miscellaneous steel (1" long) at El. 114'. Steel was coated in 2009. Minor spalling appears to have continued since previous inspection. See photos Z3-018 and Z3-020.	JK
4	Exposed cadweld (8" x 3") at El. 115'. Cadweld is not coated and is newly exposed since the last inspection. See photos Z3-016 and Z3-018.	JK
5	Exposed cadweld (10" x 3") with additional spalled concrete at El. 116'. Steel was coated in 2009. No notable change in condition since last inspection. See photos Z3-016, Z3-016A and Z3-021.	JK

6	Exposed cadweld (5" x 2") at El. 117'. Steel was coated in 2009. No notable change in condition since last inspection. See photos Z3-016, Z3-016A and Z3-022.	JK
7	Exposed rebar (7" x 1-1/2") at El. 120'. Steel was coated in 2009. Additional horizontal cracking has occurred at this location approx. 2-3' long. See photos Z3-016, Z3-016A, Z3-023 and Z3-023A.	JK
8	4 bugholes along a minor horizontal crack ~ 20 mils wide. The condition has not further degraded since the 2009 inspection. The exposed miscellaneous steel (1" long) at El. 120' was coated in 2009. Just left of rebar in comment #7. See photos Z3-023, Z3-023A, Z3-024 and Z3-024A.	JK
9	Two exposed cadwelds (9" x 3") with additional spalled concrete at El. 124'. Steel was coated in 2009. No notable change in condition since last inspection. See photos Z3-016, Z3-016A, Z3-025 and Z3-025A.	JK
10	Exposed cadweld (10" x 3") with additional spalled concrete at El. 125'. Steel was coated in 2009. No notable change in condition since last inspection. See photos Z3-016, Z3-016A and Z3-026.	JK

11	Exposed cadweld (10" x 3") with additional spalled concrete at El. 127'. Steel was coated in 2009. No notable change in condition since last inspection. See photos Z3-016, Z3-016A and Z3-027.	JK
12	Corrosion staining from 1 1/4" void hole. The corrosion staining and the void have remained the same since 2005. The void was coated in 2009.	JK
13	Exposed vertical rebar at El. 109' near the right side of the zone. See photo Z3-028.	JK
14	Exposed cadweld at El. 127' on the far right side of the zone. The steel is coated.	JK

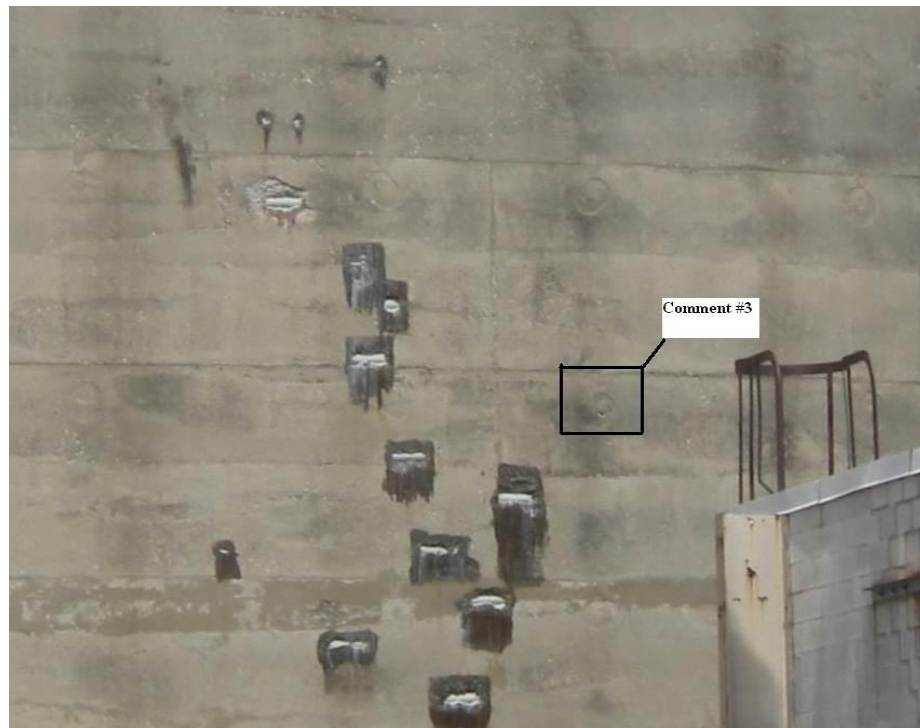
Photo Z4-020

No.	Comment	Initials
1	<p>Refer to photos Z4-020, Z4-020A and Z4-020B for general area / arrangement</p> <ul style="list-style-type: none"> - Exposed miscellaneous steel (1" long) at El. 109'. Previously identified as located at El. 104' in lower section. Steel was coated in 2009. See photo Z4-021. - Exposed cadweld (10" x 2") at Elevation 109'. Steel was coated in 2009. See photos Z4-022 and Z4-022A. - Exposed cadweld (9" x 3") at Elevation 110' with additional spalled concrete above and below and a tight crack vertically down from bottom approx. 20". Steel was coated in 2009. See photos Z4-023 and Z4-023A. - Exposed cadweld (10" x 3") at Elevation 111' with some cracking and 1" dia. exposed misc. steel just to the right. Cadweld was coated in 2009. See photos Z4-024 and Z4-024A. - Exposed cadweld (9" x 2") with additional spalled concrete at Elevation 113'. Steel was coated in 2009. See photos Z4-025 and Z4-025A. - Exposed cadweld (4" x 2") at Elevation 114'. Steel was coated in 2009. Right side continues to crack and push out slightly. See photos Z4-026 and Z4-026A. - Exposed cadweld (5" x 2") with additional spalled concrete at Elevation 115'. Steel was coated in 2009. See photos Z4-027 and Z4-027A. - Exposed miscellaneous steel (2" long) at Elevation 117'. Steel was coated in 2009. See photo Z4-028. - Exposed cadweld (10" x 3") with additional spalled concrete at Elevation 117'. Steel was coated in 2009. See photos Z4-029 and Z4-029A. - Exposed cadweld (2" x 1-1/2" & 1-1/2" x 1-1/2") at Elevation 119'. Steel was coated in 2009. See photos Z4-030 and Z4-030A. - Exposed cadweld previously identified as rebar (1-1/2" x 1-1/2") at Elevation 120'. Steel was coated in 2009. Left side appears to continue to crack and push out. See photos Z4-031 and Z4-031A. - Area beginning to spall at El. 117' near right side of zone below lightning arrestor. Based on size and shape appears to be cadweld. See photo Z4-032. - Exposed miscellaneous steel (1/2" diameter) at Elevation 126'. Steel was coated in 2009. See photo Z4-033. - Exposed cadweld (9" x 3") with additional spalled concrete at Elevation 127'. Steel was coated in 2009. See photo Z4-034. 	AWD 9-28-15

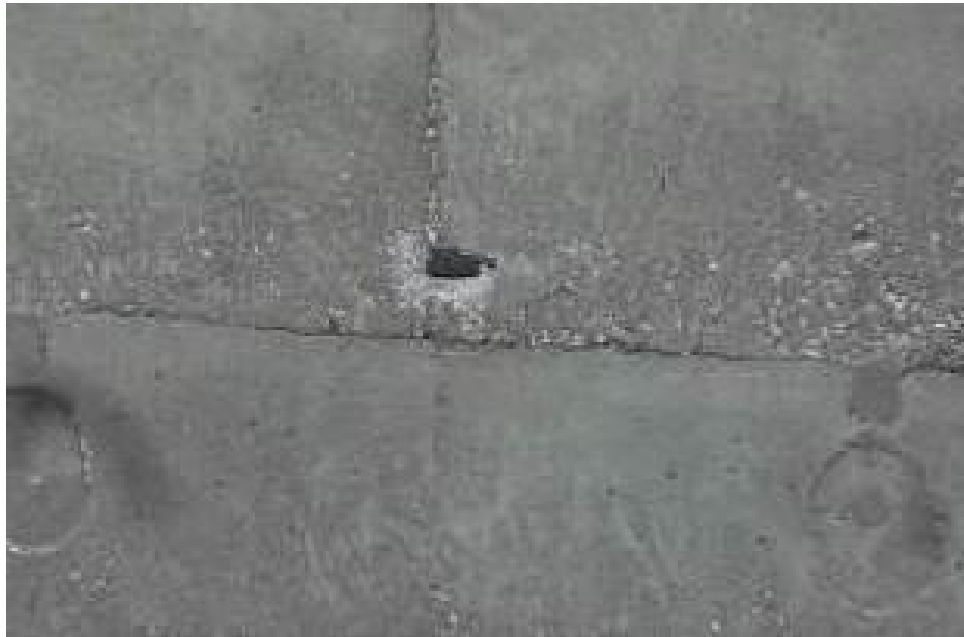
Photo Z2-036

No.	Comment	Initials
1	Exposed cadweld (4" x 3") with additional spalled concrete at El. 129'. No change in condition since the previous inspection. See photos Z2-036 and Z2-036A.	JK
2	Exposed cadweld (9" x 3") with additional spalled concrete at El. 144'. No significant change in condition since the previous inspection. See photos Z2-037 and Z2-037A.	JK
3	Exposed cadweld (4" x 2") with additional spalled concrete at El. 145'. No significant change in condition since the previous inspection. See photos Z2-037 and Z2-037A.	JK
4	Exposed cadweld at El. 146'. The right end remains 1" diameter and the left end is increased to 2" diameter with some additional spalling below. It is expected to continue to spall to expose the entire cadweld. See photos Z2-037 and Z2-037A.	JK
5	New spall forming just above and right of #4, at El. 147'. Based on the size and shape, it appears to be another cadweld. It is somewhat visible in the 2010 photo but is now clearly spalling. See photos Z2-037 and Z2-037A.	JK
