NL-16-032

SUBJECT: Entergy Transmittal of Indian Point 2 ASME Section XI, IWL Concrete Containment Inspection In Accordance With the Parties' Approved Settlement of License Renewal Contention NYS-24
Indian Point Unit Number 2
Docket No. 50-247
License No. DPR-26

ENTERGY ENGINEERING REPORT IP-RPT-15-00029,
“IP2 ASME SECTION XI, IWL CONCRETE CONTAINMENT
INSPECTION FOR 2015”

IP2 ASME Section XI, IWL Concrete Containment Inspection for 2015

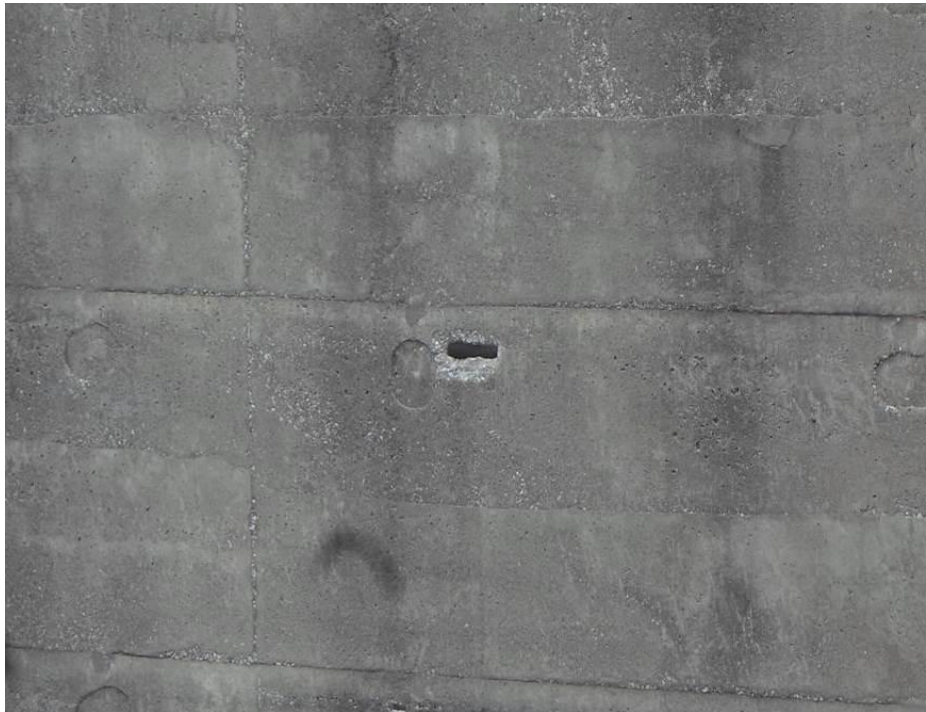
Photo Z2-038

6	Exposed cadweld (9" x 3") with additional spalled concrete at El. 132'. No change in condition since the previous inspection. See photo Z2-038.	JK
7	Exposed cadweld (9" x 2") with additional spalled concrete at El. 141'. Appears to have gotten slightly wider vertically exposing more of the cadweld since the previous inspection. See photo Z2-039.	JK
8	Exposed cadweld (9" x 2") with additional spalled concrete at El. 140'. Appears to have gotten slightly wider vertically exposing more of the cadweld since the previous inspection. See photo Z2-039.	JK
9	Exposed miscellaneous steel at El. 140' and El. 141'. No change in condition since previous inspection.	JK
10	Joint cracking identified in previous inspection along El. 128' is possibly a poor seam along the concrete pour lines.	JK
11	Bugholes appear throughout the entire section.	JK
12	Joint spalls and cracks noted in the previous inspection along El. 133' may just be rough edges of pour lines	JK

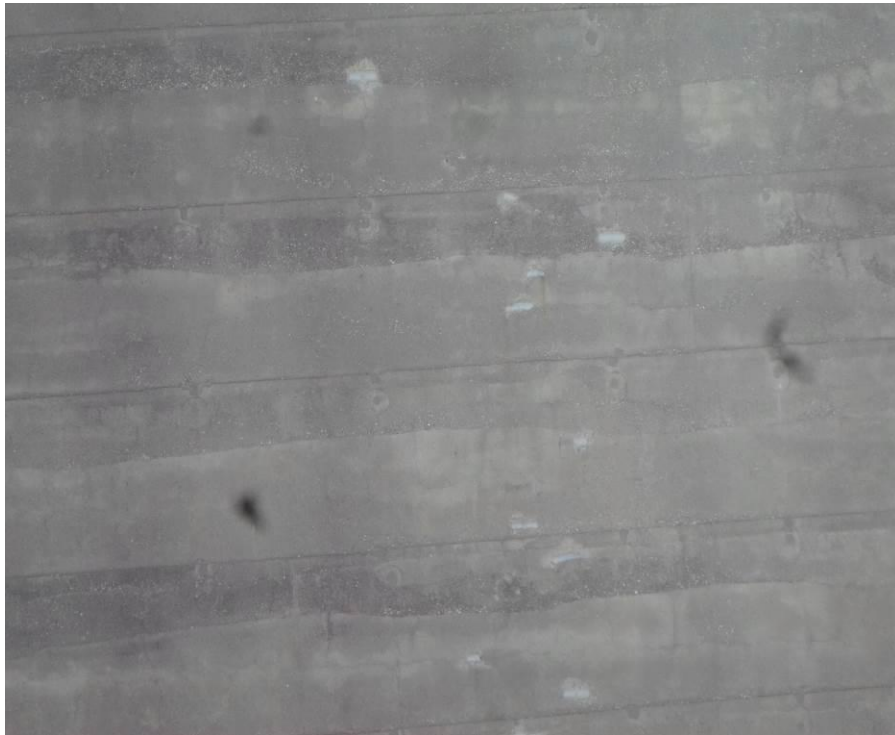
Photo Z3-029

No.	Comment	Initials
1	<p>Refer to photos Z3-029 and Z3-029A for general photos of the following:</p> <ul style="list-style-type: none"> - Exposed cadweld (9" x 3") with additional spalled concrete at El. 129'. Steel was coated in 2009. See photo Z3-032. - Exposed cadweld (4" x 2") with additional spalled concrete at El. 130'. Steel was coated in 2009. There is slightly more cracking since the last inspection. See photos Z3-030 and Z3-033. - Exposed misc. steel (1" dia.) El. 131'. Steel was coated in 2009. Surrounding concrete is degraded and beginning to crack and spall similar to the shape of the cadwelds. See photos Z3-030 and Z3-034. - Exposed cadweld (10" x 2") with additional spalled concrete at El. 132'. Steel was coated in 2009. See photos Z3-030, Z3-031 and Z3-035. - Exposed cadweld (9" x 3") with additional spalled concrete below the joint at El. 133'. Steel was coated in 2009. See photos Z3-030, Z3-031 and Z3-036. - Area beginning to crack and push out at El. 134' that will likely expose a cadweld based on size and shape. See photos Z3-030 and Z3-031. - Exposed cadweld (5" x 3") with additional spalled concrete at El. 135'. Steel was coated in 2009. Concrete is bulging out like it will soon expose the rest of the cadweld. See photos Z3-030, Z3-031 and Z3-037. - Exposed cadweld (10" x 3") with additional spalled concrete at El. 139'. Steel was coated in 2009. See photo Z3-038. - Exposed cadweld (5" x 3") with additional spalled concrete at El. 140'. Steel was coated in 2009. See photo Z3-039. - Exposed cadweld (9" x 3") with additional spalled concrete at El. 141'. Steel was coated in 2009. See photo Z3-040. - Exposed cadweld (5" x 3") with additional spalled concrete at El. 143'. Steel was coated in 2009. See photos Z3-041 and Z3-041A. - Exposed misc. steel (1" long) at El. 144'. Steel was coated in 2009. See photo Z3-042. - Exposed cadweld (9" x 3") with additional spalled concrete at El. 147'. Steel was coated in 2009. See photo Z3-043. - Exposed cadweld (9" x 2") with additional spalled concrete at El. 132' on the far right side. Steel was coated in 2009. See photo Z3-044. - Exposed cadweld (3" x 2") with exposed aggregate at El. 141' on the far right side. Steel was coated in 2009. See photo Z3-045. 	JK

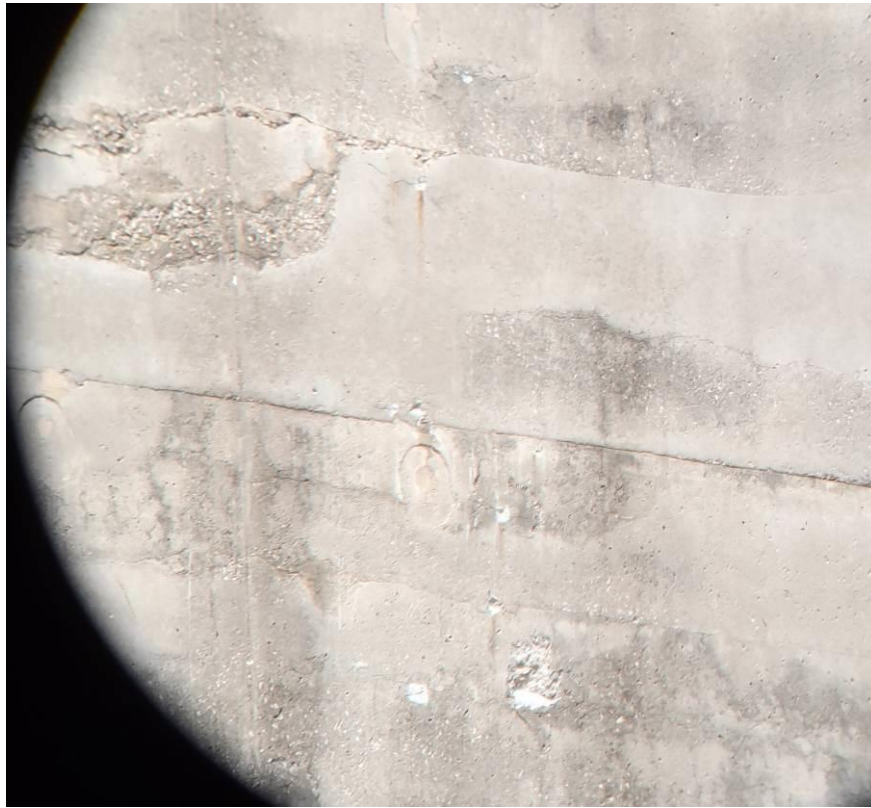
Photo Z4-036

No.	Comment	Initials
1	<p>See photos Z4-036, Z4-036A and Z4-036B for general area photos of these identified indications</p> <ul style="list-style-type: none"> - Exposed cadweld (6" x 3") with additional spalled concrete at Elevation 130'. Steel was coated in 2009. See photos Z4-037 and Z4-037A. - Exposed miscellaneous wire (2-1/2" long) at Elevation 130'. Steel was coated in 2009. See photo Z4-038. - Exposed miscellaneous steel (1" diameter) at Elevation 131'. Steel was coated in 2009. See photo Z4-039. - Exposed miscellaneous steel (1/2" diameter) at Elevation 132'. Steel was coated in 2009. Beginning to spall in the shape of a cadweld, especially on the right side. See photo Z4-040. - Exposed miscellaneous steel (1/2" diameter) at Elevation 133'. Steel was coated in 2009. See photo Z4-041. - Exposed cadweld (1/2" & 1-1/2" x 1-1/2") at Elevation 133'. Steel was coated in 2009. See photo See photos Z4-042 and Z4-042A. - Exposed miscellaneous steel (1/2" diameter) at Elevation 135'. Steel was coated in 2009. See photo Z4-043. - Exposed miscellaneous wire (1" long) at Elevation 137'. Steel was coated in 2009. See photo Z4-044. - Exposed cadweld (5" x 2") at Elevation 138'. Steel was coated in 2009. Delamination beginning to separate to right of steel. See photos Z4-045 and Z4-045A. - Exposed miscellaneous steel (1/2" diameter) at Elevation 140'. Steel was coated in 2009. See photo Z4-046. - Exposed cadweld (6" x 2") at Elevation 142'. Steel was coated in 2009. See photo Z4-047. 	AWD 9-28-15

2	<p>Loss of mortar 1/4" deep over an area 2'x6'. This area has remained unchanged since previous inspection. See photos Z4-036, Z4-036A, Z4-036B and Z4-048.</p>	AWD 9-28-15
3	<p>Group located at far right side of zone</p> <ul style="list-style-type: none"> - Signs of delamination and future spalling at El. 142'. Size and shape suggest it is a cadweld. See photo Z4-049. - Exposed cadweld (3" x 2") at Elevation 144'. See photos Z4-049, Z4-050 and Z4-051. - Exposed cadweld (4" x 2") with a 12" x 6" delamination ready to spall at Elevation 145'. See photos Z4-050 and Z4-051. - Exposed cadweld (4" x 2") at Elevation 147'. See photos Z4-050 and Z4-051. 	AWD 9-28-15

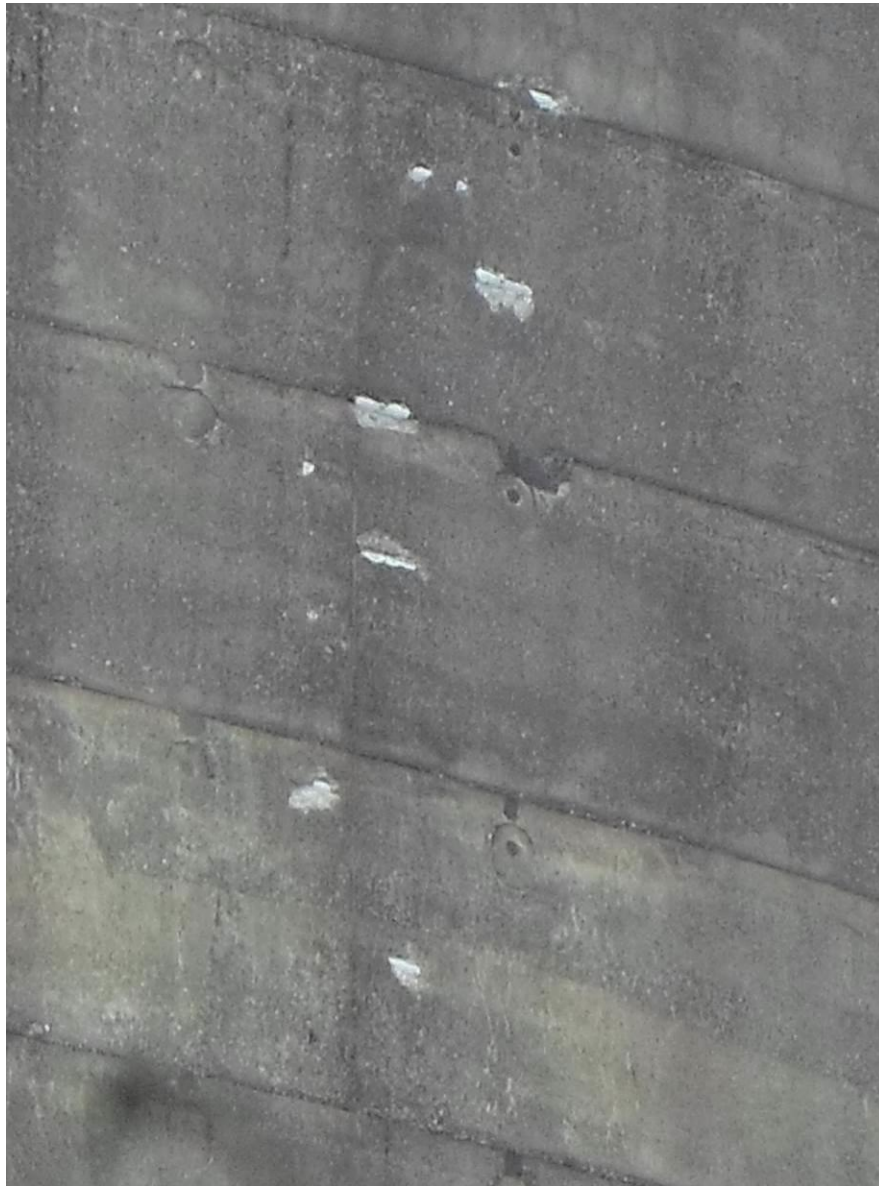
Photo Z1-021

No.	Comment	Initials
1	Exposed cadweld (4" & 1" long x 2" wide) with exposed aggregate at El. 168'. Coating that was applied in 2009 is beginning to crack and degrade. See photos Z1-021 and Z1-022.	JK
2	Exposed cadweld (4" & 2" long x 2" wide) at El. 166'. Coating that was applied in 2009 is beginning to crack and degrade. See photos Z1-021 and Z1-023.	JK
3	Exposed cadweld (10" x 3") with additional spalled concrete at El. 165'. Coating that was applied in 2009 is beginning to crack and degrade. See photos Z1-021 and Z1-024.	JK
4	Exposed cadweld (10" x 3") with additional spalled concrete at El. 163'. Coating that was applied in 2009 is beginning to crack and degrade. See photos Z1-021 and Z1-025.	JK
5	Exposed cadweld nut (1" diameter) at El. 162'. Coating that was applied in 2009 is beginning to crack and degrade. See photos Z1-021 and Z1-026.	JK
6	Exposed cadweld (10" x 2") with additional spalled concrete at El. 161'. Coating that was applied in 2009 is beginning to crack and degrade. See photos Z1-021 and Z1-027.	JK

7	Exposed cadweld nut (1" diameter) at El. 161'. Coating that was applied in 2009 is beginning to crack and degrade. See photos Z1-021 and Z1-028.	JK
8	Exposed cadweld (8" x 2") with additional spalled concrete at El. 157'. Coating that was applied in 2009 is beginning to crack and degrade. See photos Z1-021 and Z1-029.	JK
9	Exposed cadweld (7" x 3") with additional spalled concrete at El. 155'. Coating that was applied in 2009 is beginning to crack and degrade. See photos Z1-021 and Z1-030.	JK
10	General exposed aggregate leaving a rough surface to the concrete. Discoloration is also present.	JK

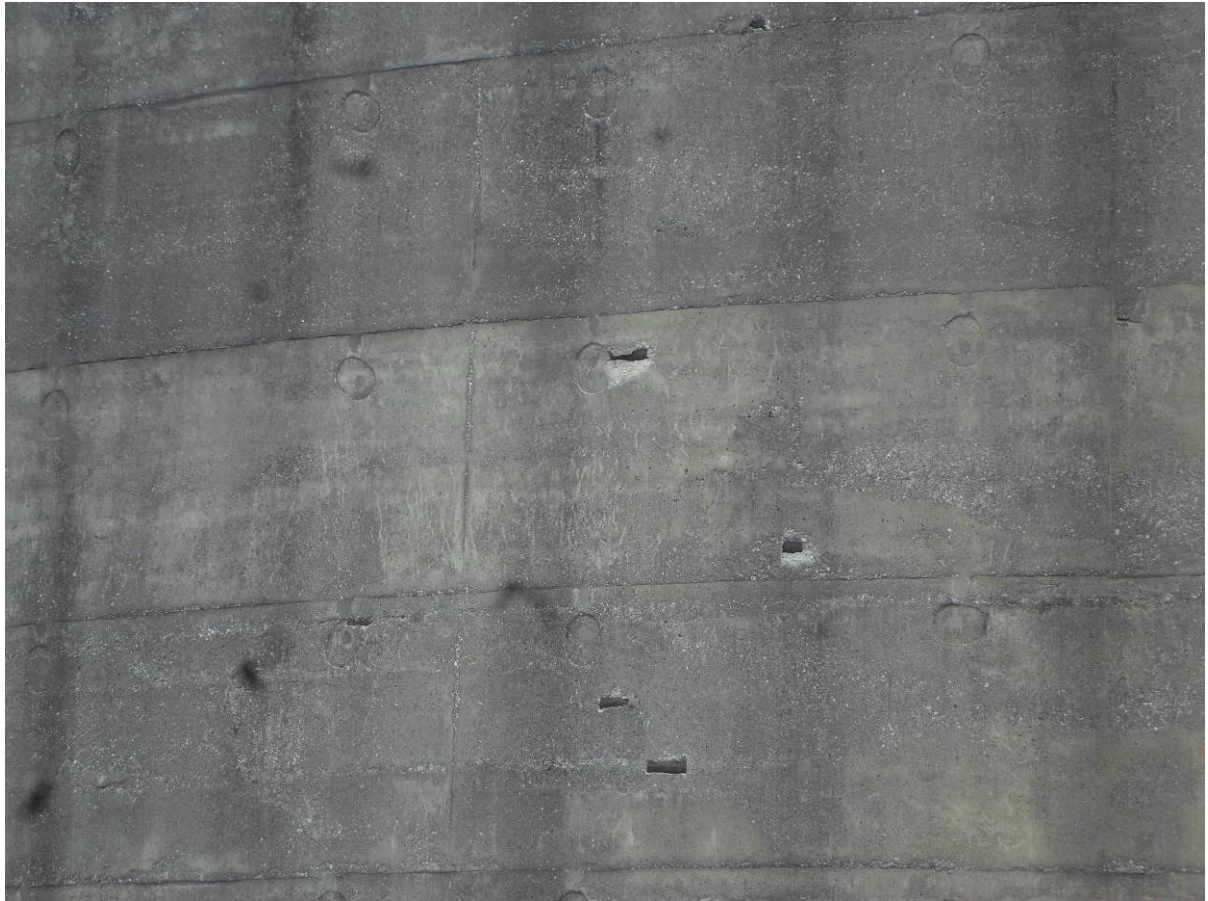
Photo Z2-040

No.	Comment	Initials
1	Exposed cadweld (8" x 3") at El. 149'. No change in condition since the previous inspection. See photos Z2-040, Z2-040A and Z2-040B.	JK
2	Exposed cadweld (6" x 3") at El. 151'. Condition has expanded from 4" long as noted in the previous inspection. See photos Z2-040, Z2-040A and Z2-040B.	JK
3	Exposed steel appears to be a cadweld (6" x 1") at El. 152'. Visible in photo from previous inspection but not specifically noted. See photos Z2-040, Z2-040A and Z2-040B.	JK
4	Exposed cadweld (4" x 3") with additional spalled concrete at El. 154'. No change in condition since the previous inspection. See photos Z2-040, Z2-040A, Z2-040B, Z2-041 and Z2-041A.	JK
5	Exposed cadweld (4" x 3") with additional spalled concrete at El. 157'. No change in condition since the previous inspection. See photos Z2-040, Z2-041 and Z2-041A.	JK
6	Exposed cadweld (3" x 3") at El. 163'. No change in condition since the previous inspection. See photos Z2-040, Z2-042 and Z2-042A.	JK

13	Joint cracks in the concrete as well as pitting along El. 158'. This was noted in the previous inspection.	JK
14	Miscellaneous steel with some rust in the top left corner of the block to the right of the items shown in photos Z2-039A and Z2-039B. (Approximately El. 153'.) See photo Z2-040.	JK

General view of comments 1-6

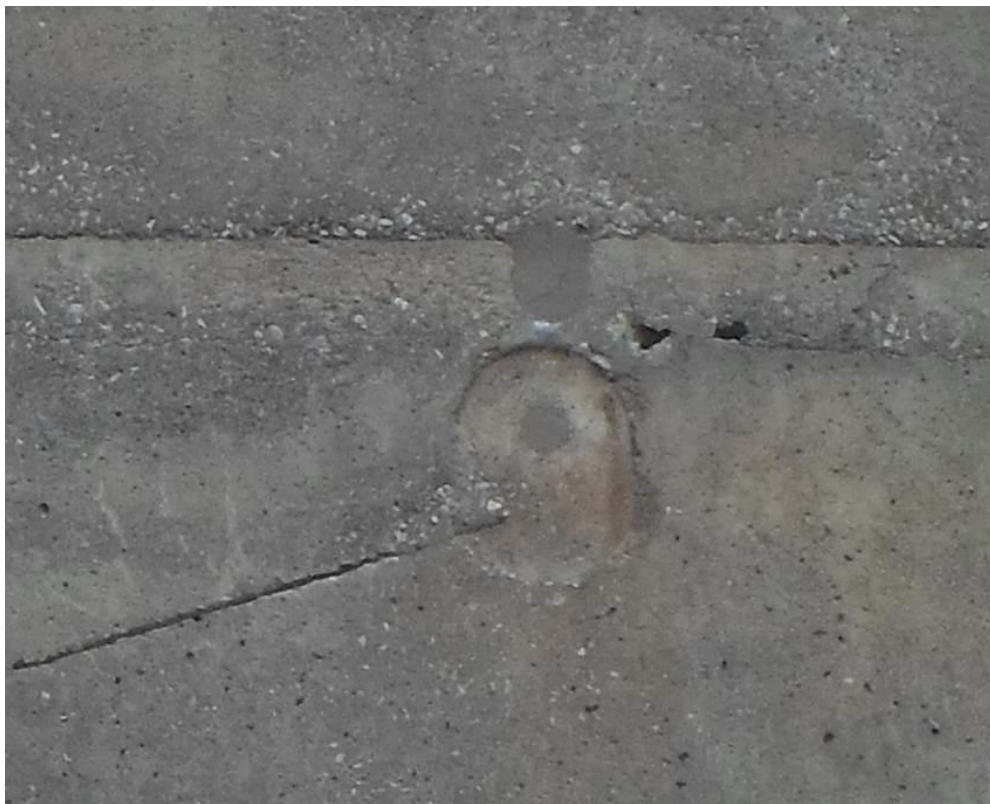
Photo Z2-043

7	Exposed cadweld (two spots 1-1/2" x 1-1/2" each) at El. 152'. The spots have increased just enough to be noticeable since previous inspection. See photos Z2-043, Z2-044, Z2-044A and Z2-044B.	JK
8	A piece of steel is exposed at the concrete surface on a diagonal line approximately 6" long. Previously noted as 3' long however there is no photo of the area to fully compare. See photos Z2-043, Z2-044, Z2-044A and Z2-044B.	JK
9	A small spot of steel (2" long) is exposed with minimal corrosion. It does not appear to be reinforcing steel and there has been no change in condition since previous inspection. See photos Z2-043, Z2-045 and Z2-045A.	JK
10	A joint spall, cracking, and small popouts appear at El. 148' in the center of the zone. This was noted in the previous inspection.	JK
11	A crack with popout (4" x 1" x 1/2" deep) at El. 157'. This was noted in the previous inspection.	JK
12	Pitting in a small area at El. 154'. This was noted in the previous inspection.	JK

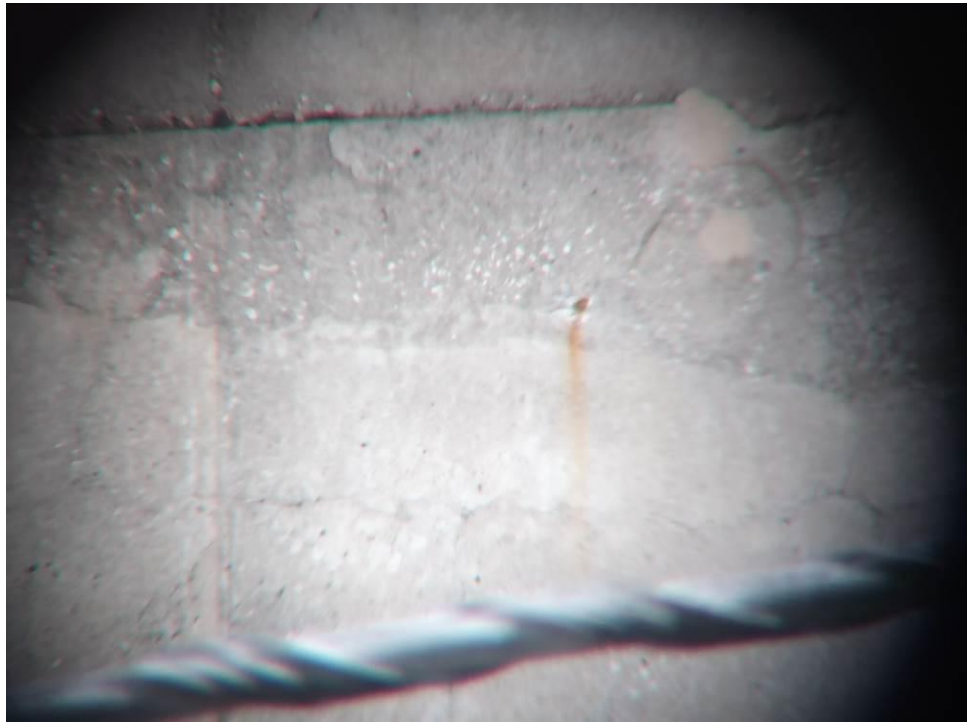
Photo Z4-052

No.	Comment	Initials
1	<ul style="list-style-type: none"> - Exposed miscellaneous steel (1" diameter) at El. 152' with rust bleeding. Near left side of zone. See photo Z4-052. - Signs of spalling in the shape of cadwelds at El. 152' and 153' above the cadwelds in the lower section near right side of the zone. See photo Z4-053. - Exposed miscellaneous steel template (3" long) at Elevation 156'. Identified as EL 160' in previous inspection. Steel was coated in 2009. See photo Z4-054. <p>Exposed cadweld (2" x 2") with exposed aggregate identified at El. 156' in previous inspection moved to next section at El. 178'.</p>	AWD 9-28-15
2	General pattern cracking, discoloration, and numerous bugholes between El. 158' and El. 168'.	AWD 9-28-15
3	3" popout exposing rebar at El. 155', approx. 20' from left boundary.	AWD 9-28-15
4	General pattern cracking and discoloration between El. 148' and El. 153'.	AWD 9-28-15

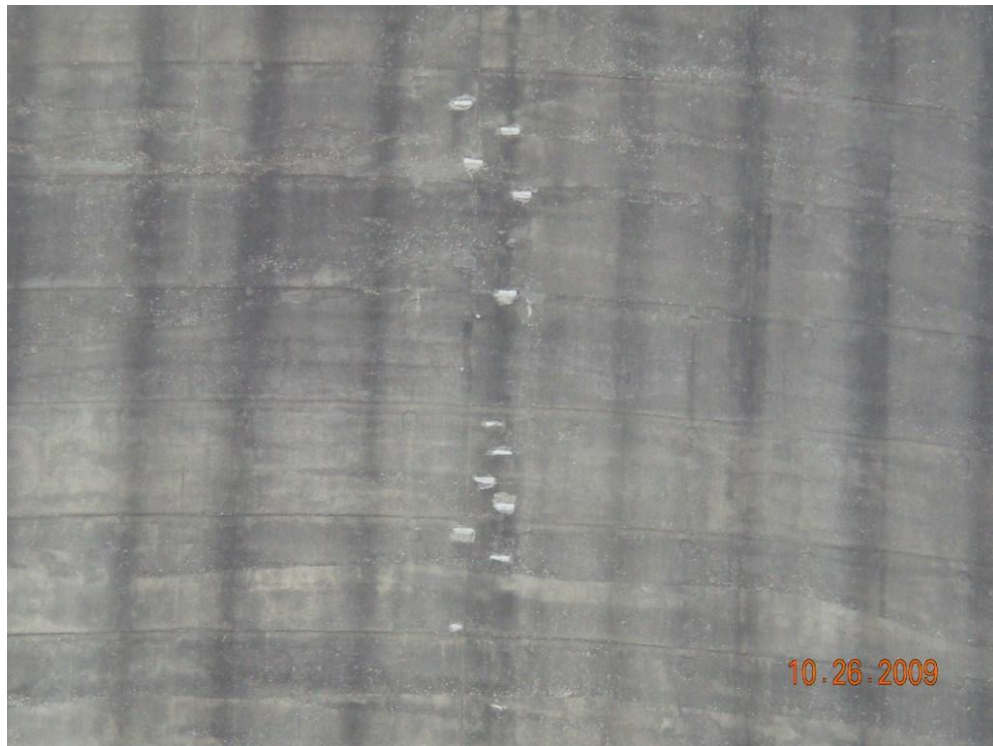
Photo Z6-010

No.	Comment	Initials
1	<p>See photo Z6-010 for 2009 general area photo for some of the identified indications.</p> <ul style="list-style-type: none"> - Exposed cadweld (5" x 2") at Elevation 148'. Steel was coated in 2009. See photos Z6-011 and Z6-012. - Exposed cadweld (9" x 3") at Elevation 151'. Steel was coated in 2009. See photos Z6-011 and Z6-013. - Exposed cadweld (9" x 2") with additional spalled concrete at Elevation 152'. Steel was coated in 2009. See photos Z6-011 and Z6-014. - Exposed cadweld (9" x 3") at Elevation 154'. Steel was coated in 2009. See photos Z6-015 and Z6-016. - Exposed cadweld (9" x 2") at Elevation 155'. Steel was coated in 2009. Concrete is separating more above and some rust bleeding appears to be coming from behind the separating concrete. See photos Z6-015 and Z6-017. - Exposed cadweld (9" x 3") at Elevation 156'. Steel was coated in 2009. Concrete beginning to separate below in the same shape as what is already missing. See photos Z6-015 and Z6-018. - Exposed cadweld (5" x 2") at Elevation 157'. Steel was coated in 2009. Concrete beginning to separate to the right to expose rest of cadweld in future. See photos Z6-019 and Z6-020. - Exposed miscellaneous steel wire (1" long) at Elevation 160'. Steel was coated in 2009. See photo Z6-021. - Exposed miscellaneous steel (3/4" diameter) at Elevation 162'. Steel was coated in 2009. See photos Z6-022 and Z6-023. - Exposed cadweld (9" x 3") with additional spalled concrete at Elevation 163'. Steel was coated in 2009. See photos Z6-023 and Z6-024. - Exposed cadweld (9" x 3') at Elevation 167'. Steel was coated in 2009. See photo Z6-025. <p>Coating beginning to degrade on all cadwelds. Minor cracking and rust bleeding through coating.</p>	AND 9-28-15

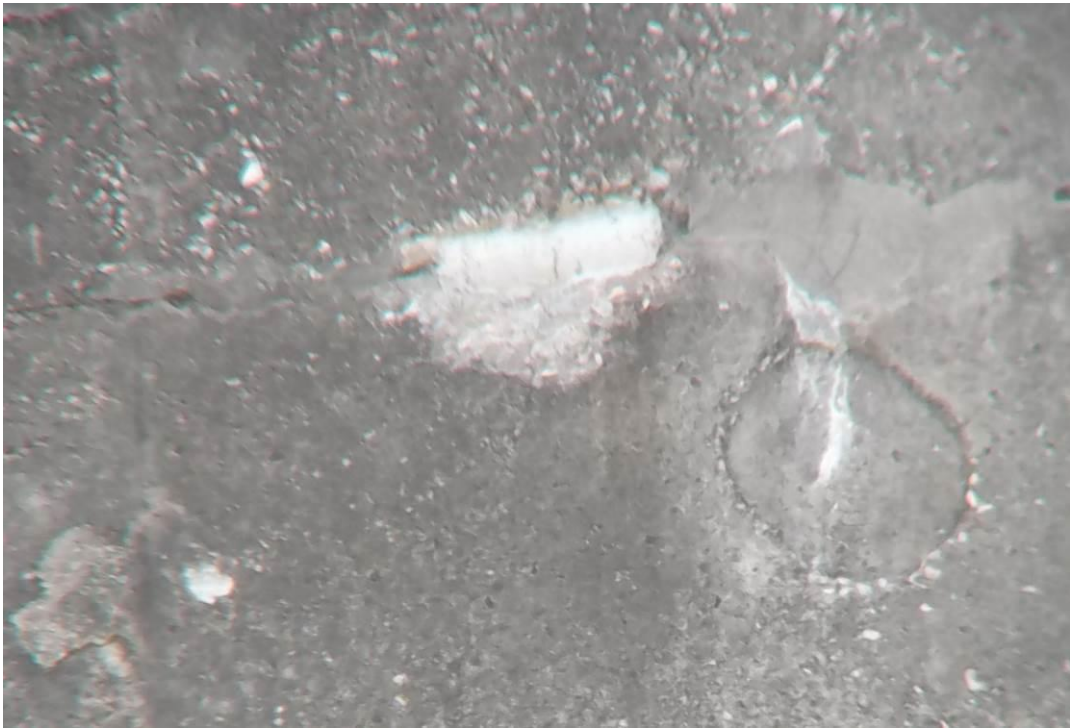
Photo Z6-023

2	Form tie hole at El. 154'.	AND 9-28-15
3	White deposit from concrete cover patch over exposed cadweld at construction joint 6" long. Same as previous inspection. See photos Z6-023 and Z6-024.	AND 9-28-15
4	General pattern cracking.	AND 9-28-15

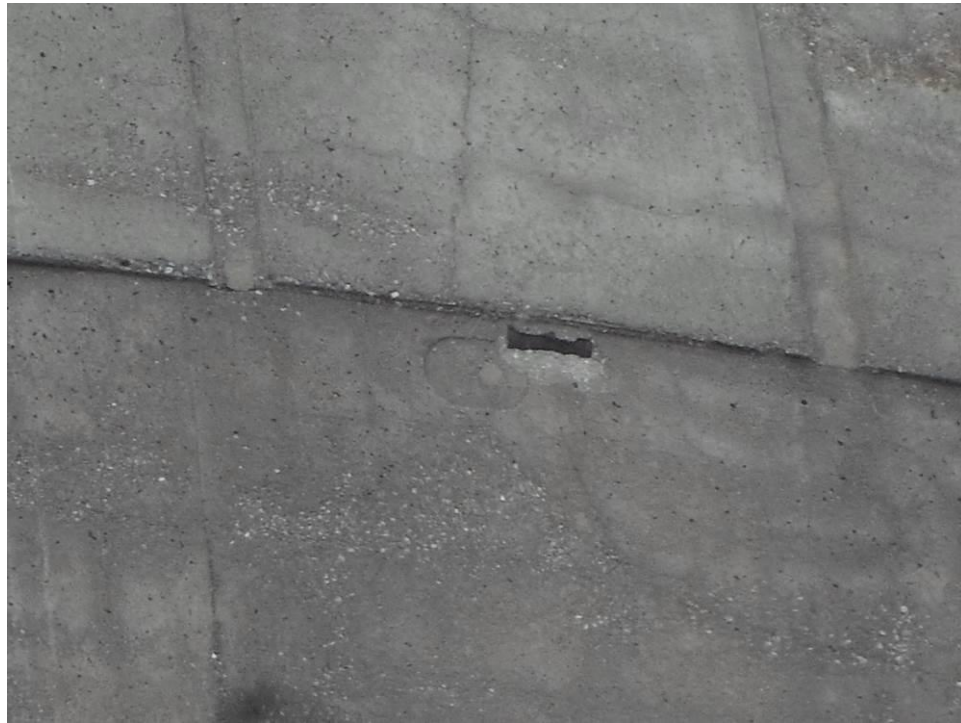
Photo Z2-046

No.	Comment	Initials
1	Exposed cadweld (8" x 2") at El. 188'. See photos Z2-046, Z2-046A and Z2-046B.	JK
2	Two small areas of exposed steel with rust staining at El. 180', one of which is a cadweld that is continuing to spall and appears that another piece will fall off soon. See photos Z2-047 and Z2-047A.	JK
3	Patch of shallow popouts just below El. 188'. Including some cracking and bulging which by comparison to other similar areas is believed to be a cadweld. See photo Z2-048.	JK
4	Between El. 168' and 173' near the middle of the zone there is leaching 6" long. There is also a pour joint just below this location with some separation likely due to consistency during placement. See photo Z2-049.	JK
5	A joint spall and some pitting is visible at El. 173'.	JK
6	Area of light abrasion with a slightly red color approximately 4' long between El. 168' and 178'. See photo Z2-050.	JK
7	Minor crack with light efflorescence on the right side of the section at El. 178'. See photo Z2-051.	JK

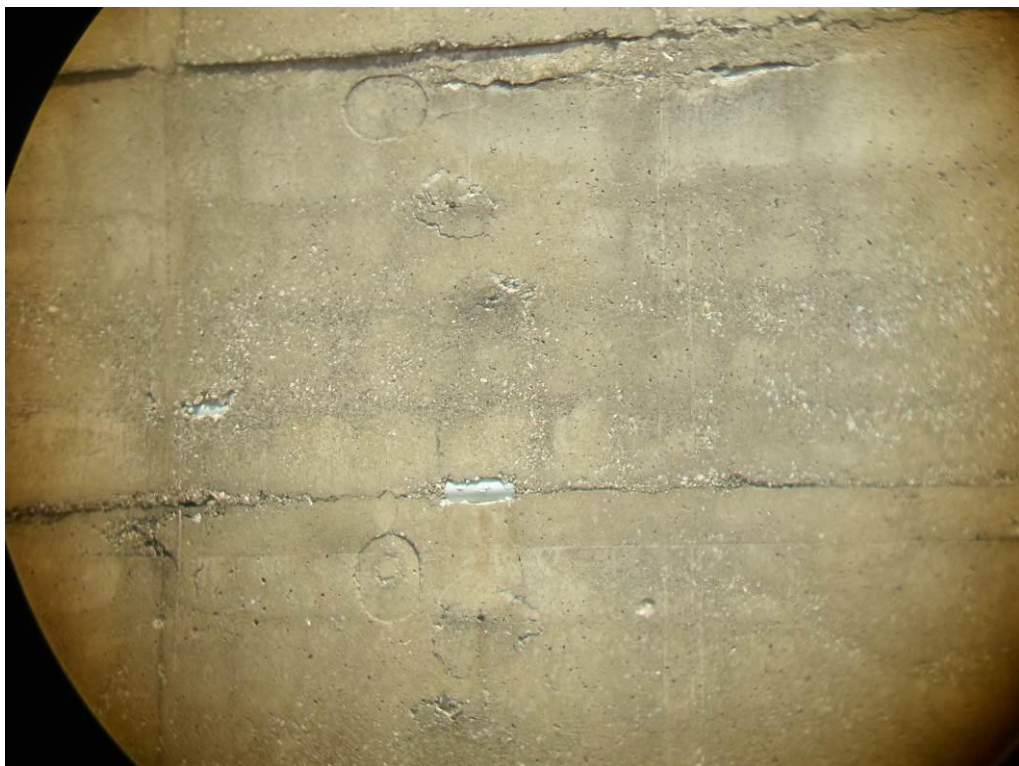
Photo Z3-049

No.	Comment	Initials
1	Exposed cadweld (10" x 3") at El. 183'. Steel was coated in 2009. See photos Z3-049, Z3-049A and Z3-050.	JK
2	Above the exposed cadweld at El. 183', two exposed cadweld nuts with some concrete cracking and beginning to push out. See photos Z3-049 and Z3-049A.	JK
3	Exposed cadweld (5" x 2") at El. 184'. Steel was coated in 2009. No change since last inspection. See photos Z3-049, Z3-049A and Z3-051.	JK
4	Exposed cadweld (9" x 3") at El. 188'. Steel was coated in 2009. No change since last inspection. See photos Z3-049, Z3-049A and Z3-052.	JK
5	Bugholes with visible rust (2" long) at El. 174' in the middle of the zone.	JK
6	General joint cracking, bugholes, and spalls between El. 173' and El. 178'. This was noted in the previous inspection.	JK
7	General pattern cracking, minor joint cracking, and light spalling between El. 178' and El. 183'. This was noted in the previous inspection.	JK

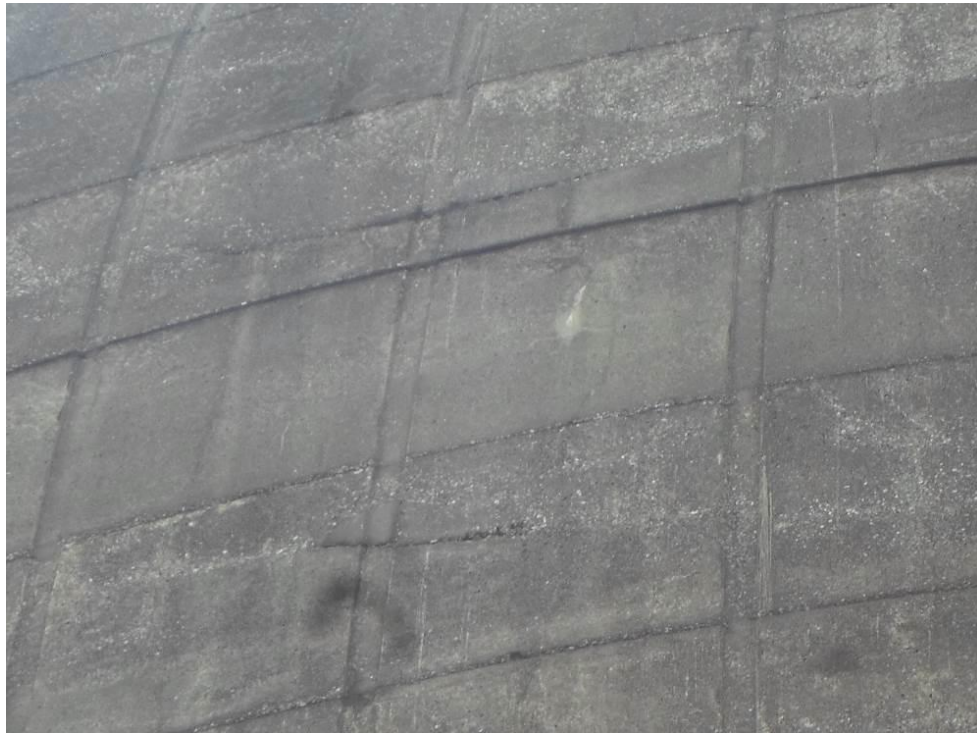
Photo Z2-053

No.	Comment	Initials
1	A horizontal 5' long rough pour line with separation and possible minor spalling along the pour. See photo Z2-053.	JK
2	Another horizontal 5' long rough pour line with separation and possible minor spalling located two rows above the one noted in comment 1. See photo Z2-053.	JK
3	General light to medium scaling, numerous joint spalls, pattern cracking, and areas of pitting were found throughout the dome. Also noted which could be misidentified as spalling or scaling were rough edges to blocks with exposed aggregates (form scabbing).	JK
4	Small hole found in a joint.	JK
5	Large rust stains are evident on the surface of the dome at and below the concrete pier which supports the lightning rod. Rust is clearly from the lightning rod. This area has remained unchanged since 2005 inspection. Lightning rods were coated in 2009.	JK
6	Area identified in previous report as exposed metal 5" long x 1" wide with no rust or staining located 4 rows down and 6 columns across from left arrester appears to be a shadow due to concrete overlap	JK

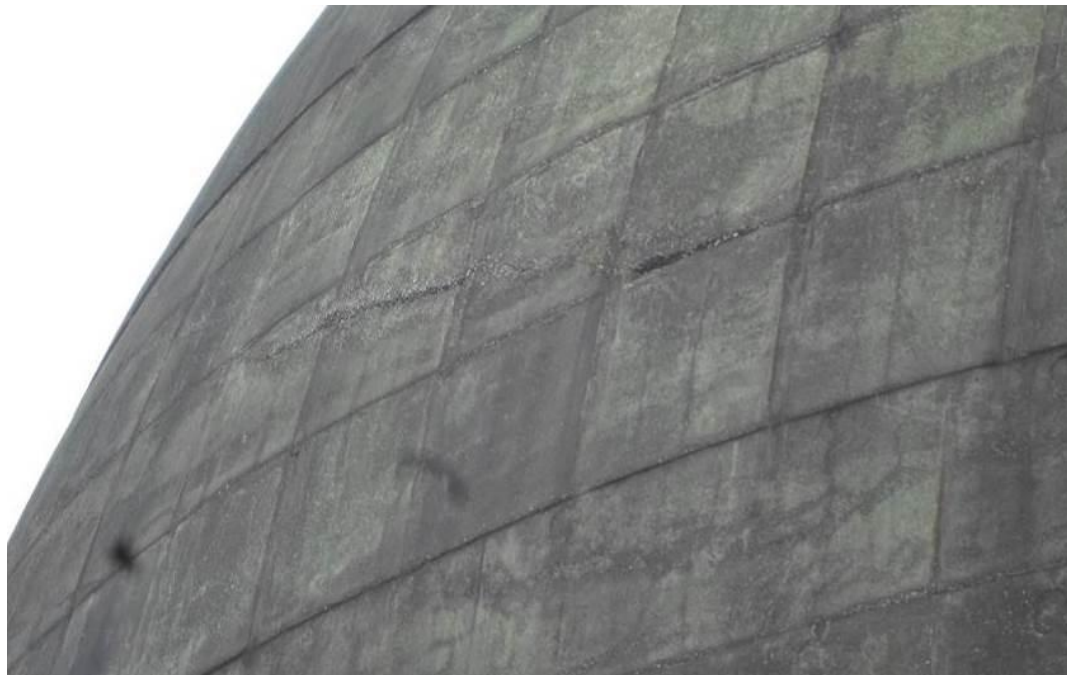
Photo Z2-054

7	Abraded/spalled area on joint (1" depth x 2' long) at left edge of zone, one row up from spring line. This area then spans diagonal across three panels (12' long x 1' wide with 1/4 inch maximum depth). Possibly extends in to zone 1. See photo Z2-054.	JK
8	Three tight cracks (~ 1/32" width) to the right of middle of the zone in the row above the spring line spanning vertically from top to bottom. See photo Z2-055.	JK
9	~5 rows up from upper dome joint, small hole in joint, hand prints.	JK
10	Repaired area of spalling 2 blocks wide located on the right side of the zone 3 rd row up from the second dome joint. See photo Z2-056.	JK

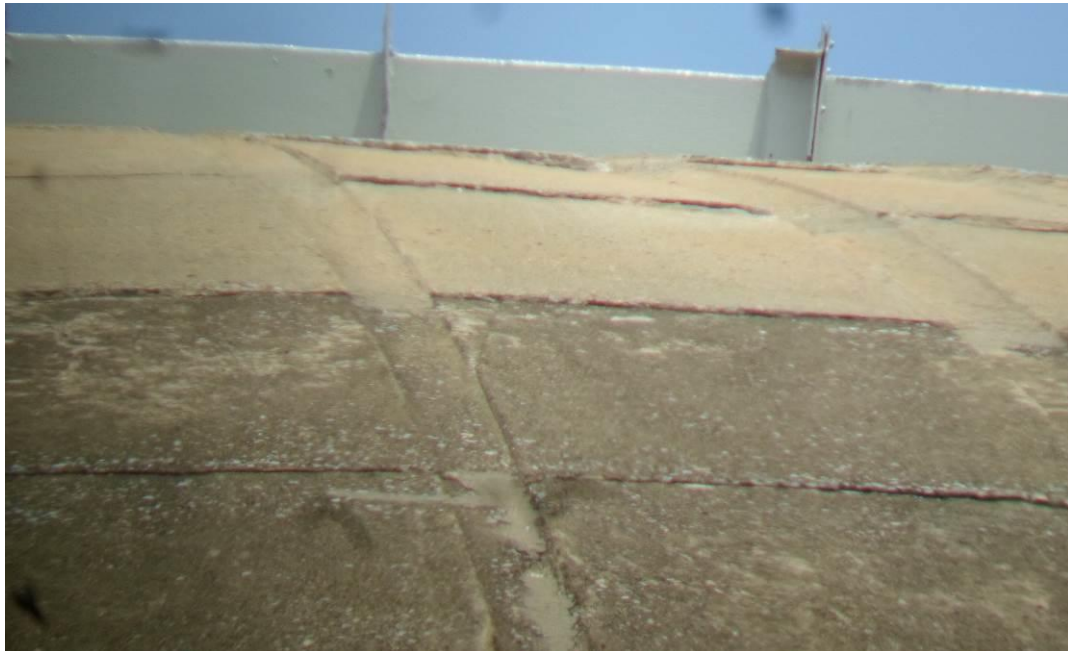
Photo Z3-054

No.	Comment	Initials
1	Over 10' span on the upper right corner of dome, previously identified popouts, joint spalling, and cracking is visible. Mostly appear to be just rough form edges seen from an angle. See photo Z3-054.	JK
2	Two bugholes with visible rust at approx. El. 210' and 15' from right boundary.	JK
3	Two bugholes with possible exposed steel vertically lined between El. 228' and El. 233'. See photo Z3-055.	JK
4	Large amounts of pattern cracking exist between El. 188' and El. 203'.	JK
5	Exposed cadweld due to a 2" spall or popout at El. 197'. See photos Z3-056, Z3-056A and Z3-057.	JK
6	A horizontal joint crack exists greater than a 1/4" wide and approx. 3' long identified in previous inspection. Possibly an old repair that is separating near the left side of the zone at approx. El. 228'.	JK
7	General pattern cracking, light scaling, localized spall areas (2"-4"), numerous bugholes, and joint cracks exist on dome.	JK

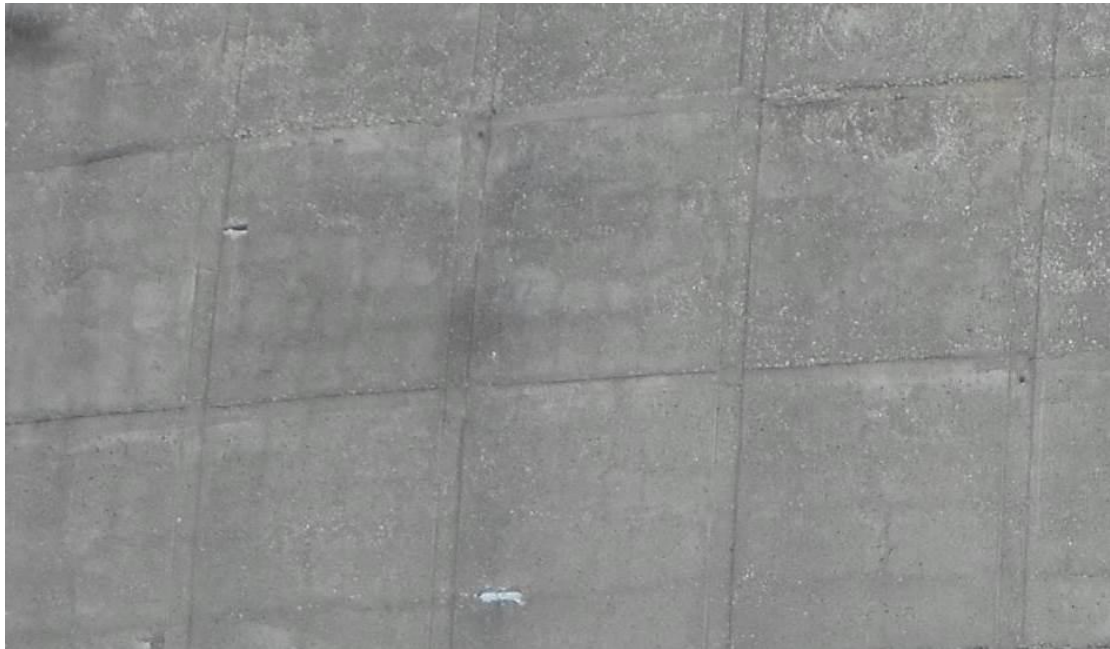
Photo Z3-056

8	A visible honeycomb appears at El. 228' to the right of the middle of the zone.	JK
9	Exposed cadweld (9" x 2") at Elevation 189'. Steel was coated in 2009. See photos Z3-056, Z3-056A and Z3-058.	JK
10	Approximately 4 blocks from the right edge of the zone at El. 190', there is a small 2" x 4" spall with tight horizontal cracks.	JK
11	Discoloration due to concrete leakage through formwork that has chipped off revealing lighter concrete below. Located at El. 233' near the middle of the zone, two blocks wide. See photo Z3-059.	JK
12	Rust staining from the lightning arresters.	JK
13	At the top of the zone at the left side there are 4 small, shallow areas of scaling. See photo Z3-060.	JK

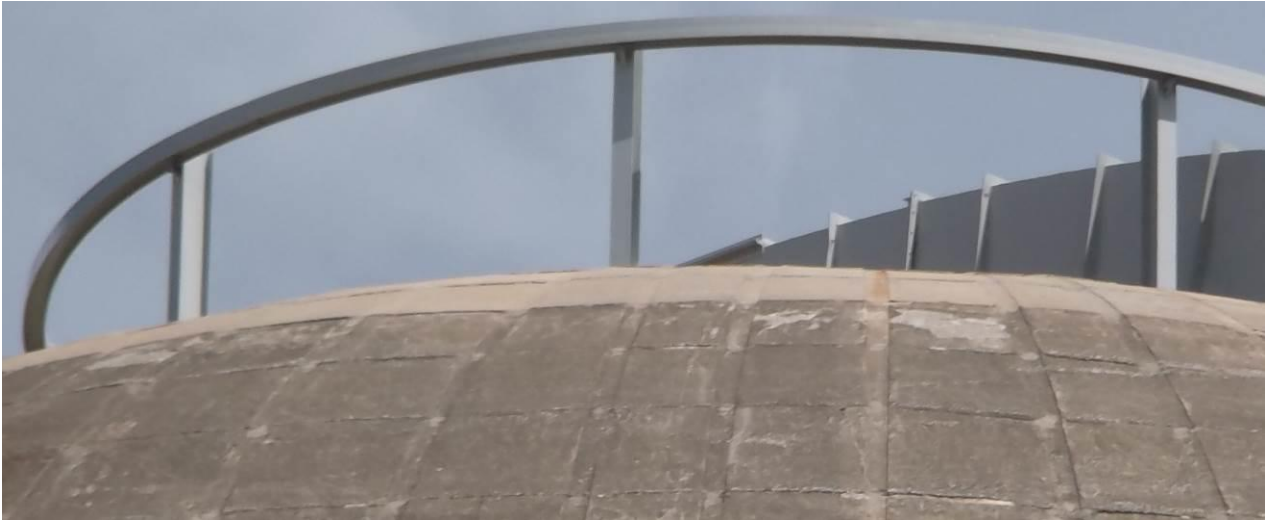
Photo Z4-056

No.	Comment	Initials
1	3" long spall at El. 193', approximately 5' from right boundary identified in previous inspection. Does not appear to be a spall.	AMD 9-28-15
2	General bugholes and pattern cracking between El. 188' and El. 208'.	AMD 9-28-15
3	Numerous joint spalls and popouts above El. 208' identified in previous inspections. Very minor, mostly appear to be rough form edges.	AMD 9-28-15
4	General light spalling over dome area identified in previous inspections. Very minor, mostly appear to be rough form edges.	AMD 9-28-15
5	Large rust stains are evident on the surface of the dome at and below the concrete pier which supports the lightning rod. The rust is clearly from the lightning rod. This area has remained unchanged since 2005 inspection. The lightning rods were coated in 2009.	AMD 9-28-15
6	Tight pattern cracking between El. 188' and El 198'.	AMD 9-28-15
7	Beginning 1 row below the lightning arrestors and continuing upwards there is minor spalling of form edges and shallow delamination of concrete cover. See photos Z4-056 and Z4-056A.	AMD 9-28-15

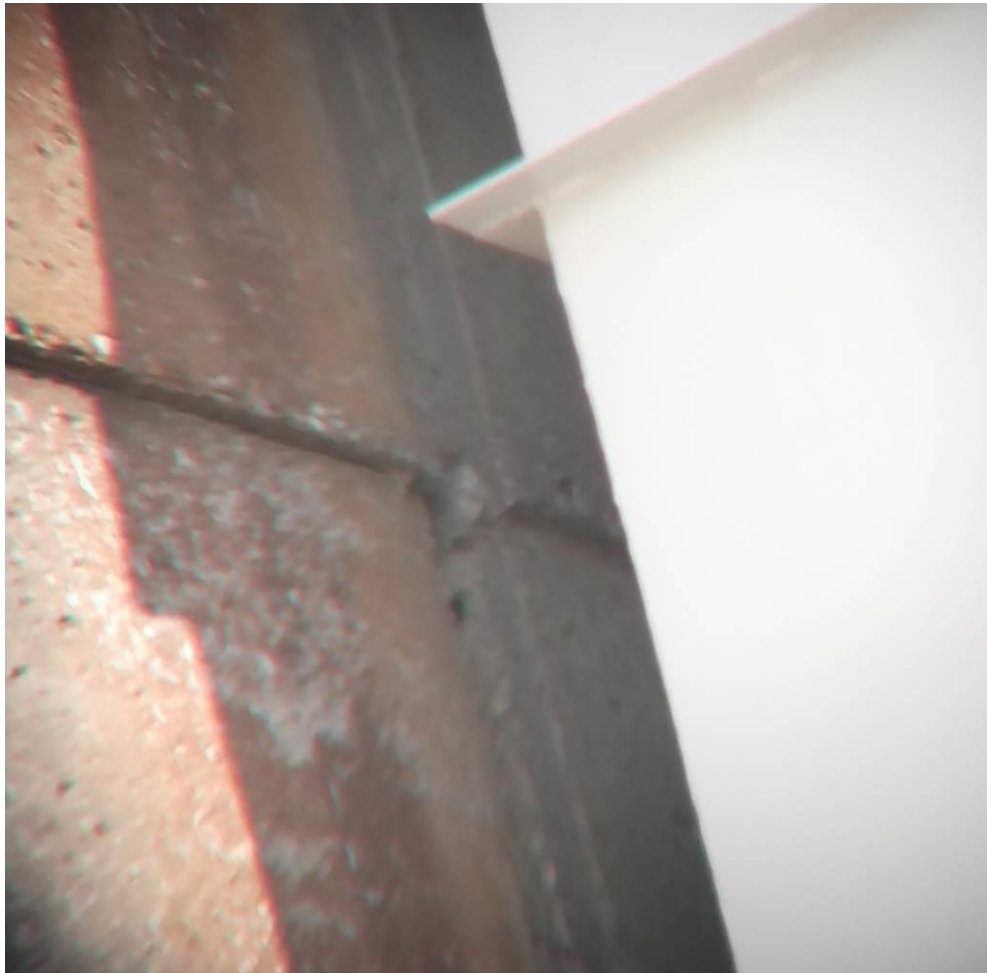
8	Small (1"-2" dia.) voids or possible abandoned drilled holes in multiple locations behind the vent duct See photo Z4-057.	AMD 9-28-15
