Licensee: Houston Lighting & Power Company (HL&P)  
Facility: South Texas Project (STP)  
License Nos.: NPF-76; NPF-80  
Docket Nos.: 50-498; 50-499  
Subject: MANAGEMENT MEETING CONCERNING ESSENTIAL COOLING WATER (ECW)  
SYSTEM AND EMERGENCY DIESEL GENERATOR (EDG) ISSUES

**ESSENTIAL COOLING WATER SYSTEM**

STANDBY DIESEL GENERATORS

# **METALLURGY AND FAILURE ANALYSIS OF** **ALUMINUM BRONZE WELDS FROM STP ECW SYSTEM**

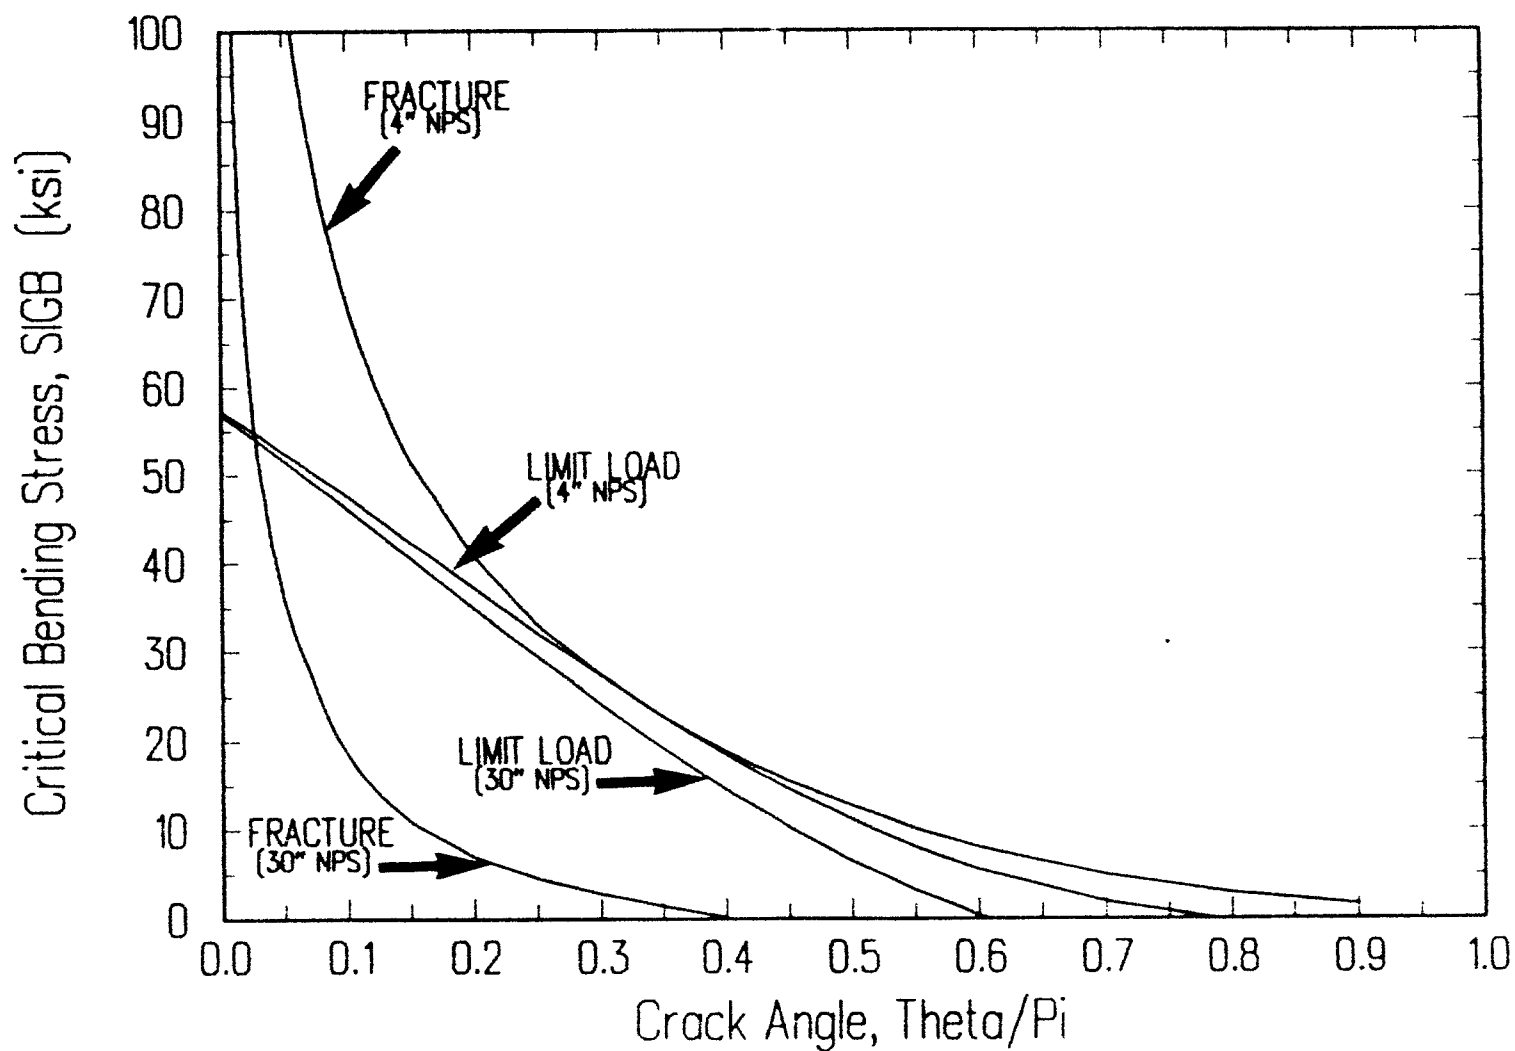
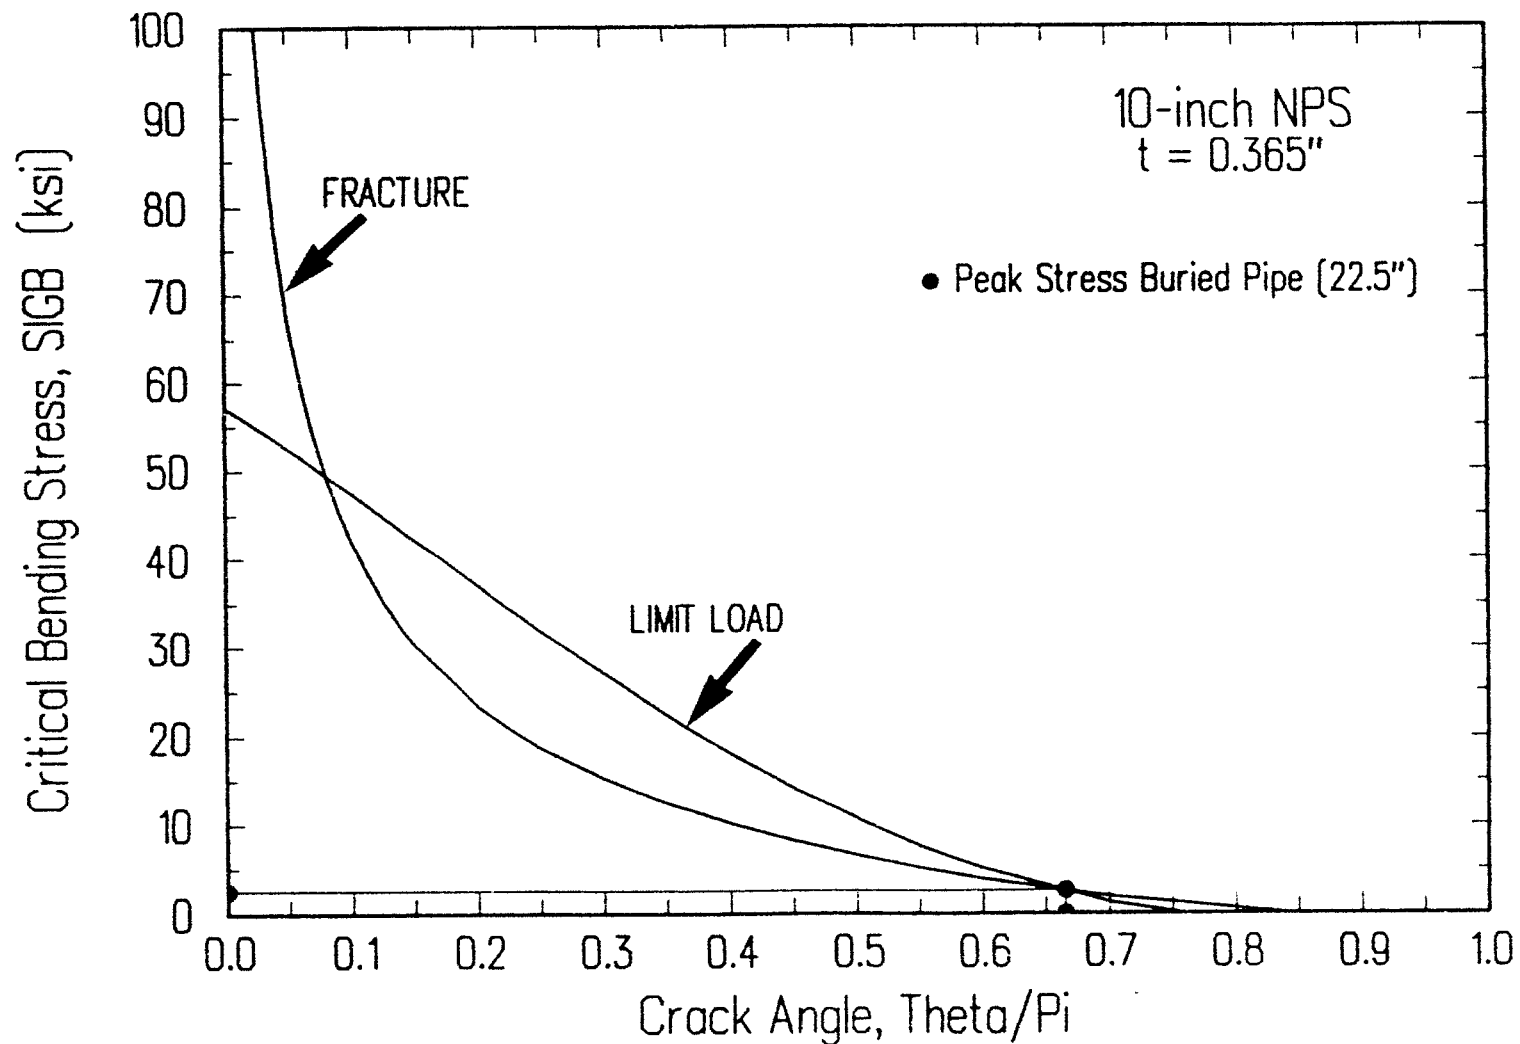
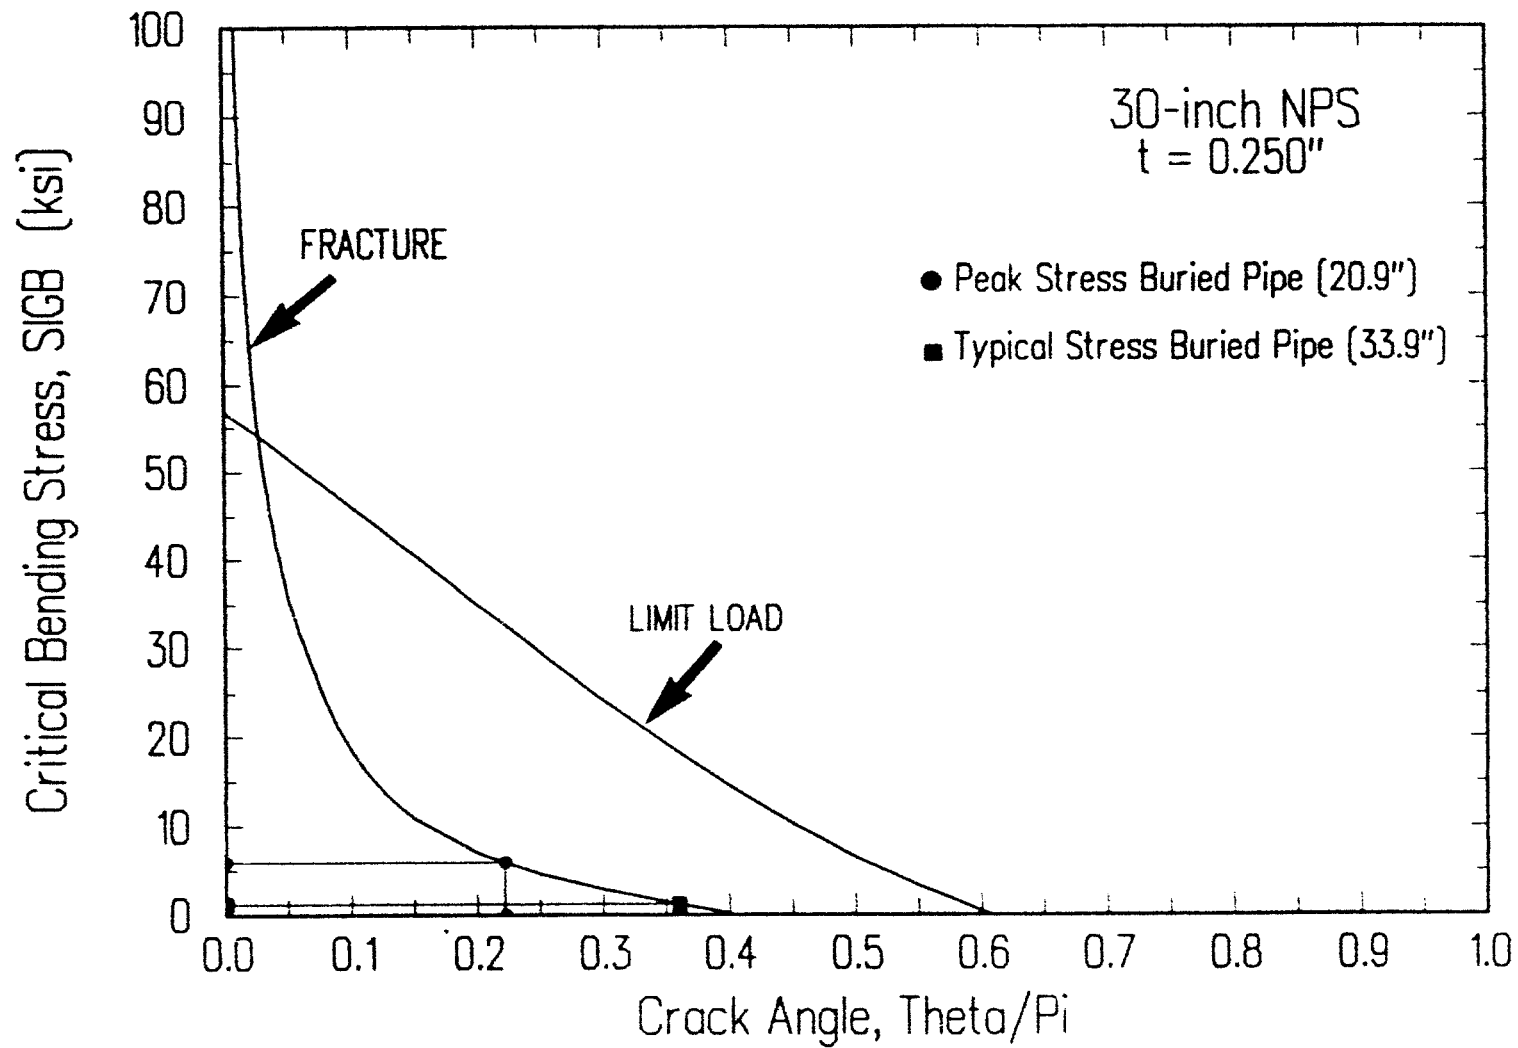
## CRITICAL BENDING STRESS - THROUGH-WALL CRACK

## RESULTS — GENERIC ANALYSIS

<u>Pipe Size (in)</u>	<u>Location</u>	<u>Wall Thickness (in)</u>	<u>Peak Applied Bending Stress (psi)</u>	<u>Critical Flaw Size (% Circ.)</u>	<u>Critical Flaw Size (in)</u>
30	Above Ground	0.25	13,500	12.5	11.8
30	Below Ground	0.25	5,927	22.2	20.9
30	Below Ground	0.25	1,147*	36.0	33.9
10	Below Ground	0.365	2,538	66.5	22.5

- **Analysis Shows That Large Flaws in Large Pipes are Controlled by Fracture Failure Mode**
- **Small Flaw Controlled by Limit Load**
- **For Typical Flaws Large Margins Exist in Terms of Stresses of Flaw Sizes**
- **For Generic Analysis at Peak Bending Stress for Above Ground Piping Large Flaws May be Safely Tolerated (~12 Inches)**
- **Below Ground Piping More Tolerant to Flaws Because of Lower Stresses**
