Final ASP Program Analysis - Reject

Accident Sequence Precursor Program – Office of Nuclear Regulatory Research			
Callaway Plant, Unit 1		Auxiliary Feedwater Control Valves in Motor Driven Pump Train Inoperable due to Faulty Electronic Positioner Cards	
Event Date: 8/11/2015		LERs: 483-2015-003 and 483-2015-004 IR: 50-483/2015-009	CCDP= 1.1×10 ⁻⁶
Plant Type: Westinghouse 4-Loop PWR with Large Dry Containment			
Plant Operating Mode (Reactor Power Level): Mode 3 (0 Percent Reactor Power)			
Analyst: David Aird	Reviewer: Keith Tetter	Contributors: N/A	BC Approved Date: 6/7/2016

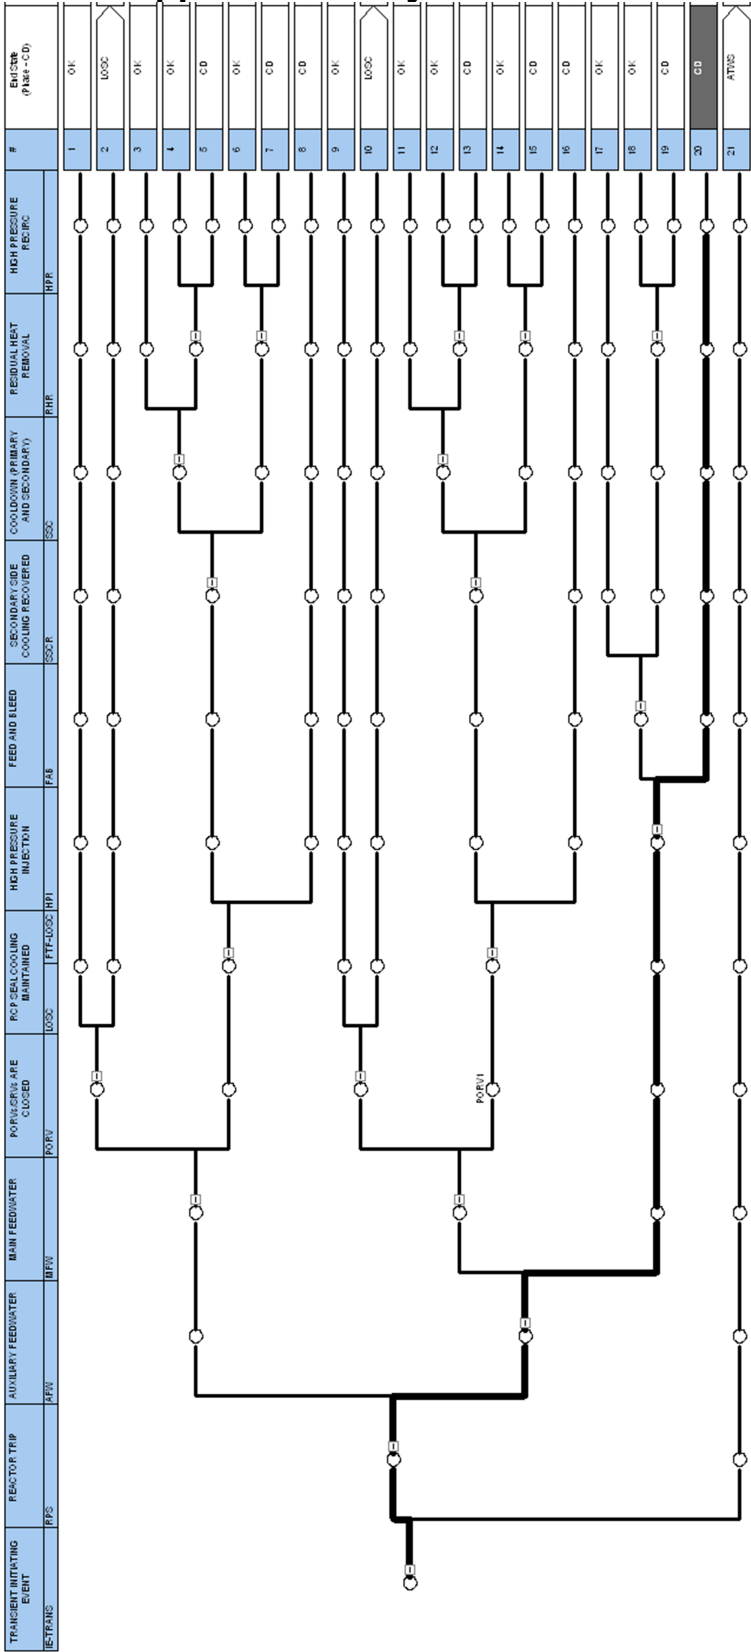
Figure 1: Callaway General Plant Transient Event Tree (Sequence 20 Bolded)

Dominant Sequence. The dominant accident sequence is Transient (TRANS) Sequence 20 (CCDP = 6.8×10^{-7}) that contributes approximately 65% of the total internal events CCDP. Figure 1 in Appendix B illustrates this sequence. The cut sets/sequences that contribute to the top 95% and/or at least 1% of the total internal events CCDP are provided in Appendix A.

The events and important component/system failures in TRANS Sequence 20 are:

- A plant transient occurs,
- Reactor protection system succeeds,
- Auxiliary feedwater system fails,
- Main feedwater system fails,
- Feed and bleed fails.
