**UNITED STATES
NUCLEAR REGULATORY COMMISSION**
REGION II
245 PEACHTREE CENTER AVENUE NE, SUITE 1200
ATLANTA, GEORGIA 30303-1257

EN 52090

**SUBJECT: NUCLEAR REGULATORY COMMISSION AUGMENTED INSPECTION TEAM
REPORT NO. 70-1151/2016-007**

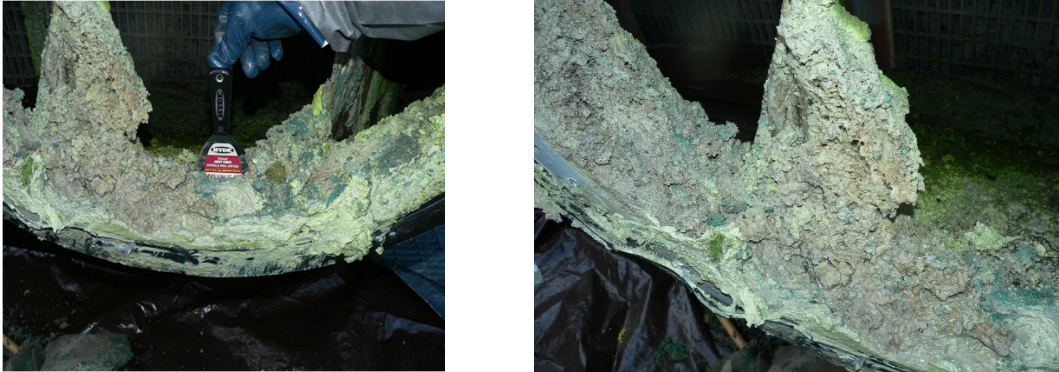
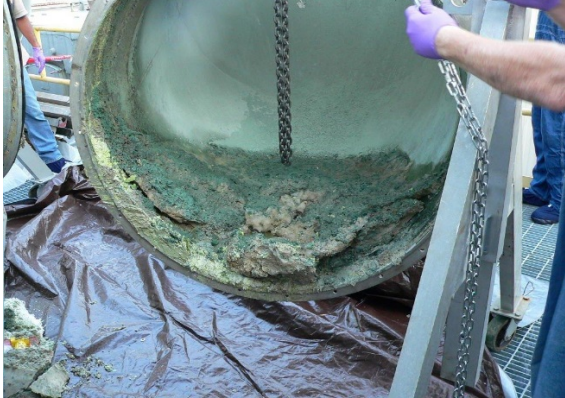
<u>DATE</u>	<u>ACTIVITY</u>
2001-2002 (5/28/02)	<ul style="list-style-type: none"> • Removal of S-1056, 3A, and 3B scrubbers • <i>Installation of S-1030 to replace above scrubbers (CCF 01-152)</i>
6/2005	<ul style="list-style-type: none"> • Removed and replace Blue M filter box with straight 6" duct
5/30/06-6/7/06	<ul style="list-style-type: none"> • <i>S-1030 Transition Piece, inlet elbow and tellerettes Cleaned-out</i> • <i>High U material was removed</i> (WO 390126) • 23kg of U removed from scrubber packing area. Transition section had significantly U accumulation >29kg.

2007	<ul style="list-style-type: none"> • <i>S-1030 Transition Piece and elbow removal Clean-out indicate significant build up</i>

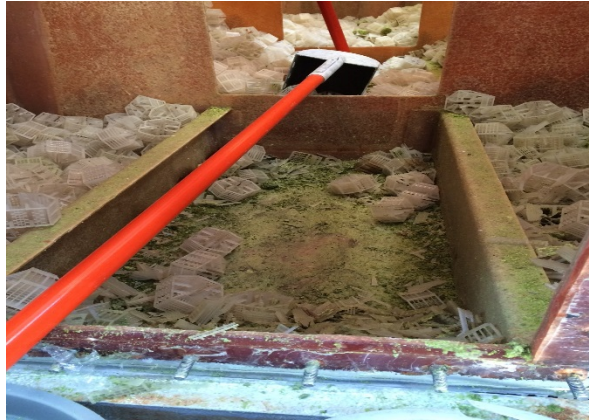
7/15/16

6/1/16	<ul style="list-style-type: none"> • A total of 36 popcorn buckets of material were removed from inlet transition for a total of 197 kgs (net weight) of wet, green sludge, and solid green chunks and 1 popcorn bucket of material removed from inlet elbow. • Process engineer received additional uranium concentration sample results.
6/2/16	<ul style="list-style-type: none"> • Process Engineer received the remaining uranium concentration sample results. • Discovery that “popcorn” buckets not dimensionally verified (failed IROFS) which resulted on NRC Event Notification (EN) 51974 • S-1030 scrubber was restarted.
6/20/16	<ul style="list-style-type: none"> • Red Book 71195 was updated stating that the total accumulation removed weighed approximately 463 lbs (gross weight) • Material from 37 buckets placed in 22 cream cans to be dissolved for isotopic analysis
6/21/16	<ul style="list-style-type: none"> • Personnel changes (New acting NCS manager)

-
- Westinghouse reported to the NRC EN 52090
 - Plan to cleanout scrubber after 6 weeks of operation delayed due to storms
 - First attempt to dissolve the material from the transition cleanout (using water)
